Causes of Major Geotechnical Disasters

S. Van Baars

University of Luxembourg, Luxembourg

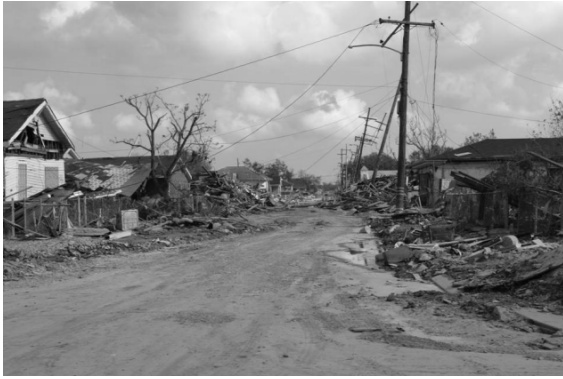
Figure 1. Destroyed housing area Lower Ninth Ward.

The biggest geotechnical failure of the last ten years in modern countries is probably the disaster of New Orleans on August 29th, 2003. The water levels provoked by hurricane Katrina were not higher than their local design level and also not extreme for Dutch standards, nevertheless the water defenses could not withstand it, due to many mistakes in the design. The water defense system was too long by not using a secondary water system. Some of the dikes or gates were missing. Some of the dikes or I-walls were too light and were whipped away. Very often the height of the dikes or walls was insufficient and also very often the effect of piping was not taken into account for in the design.

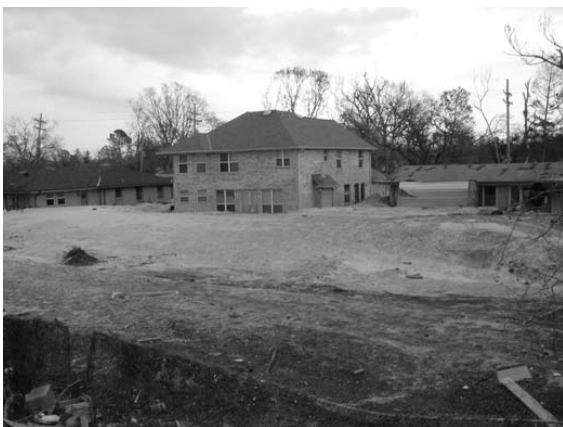
Figure 2. Washed-in sand by piping.

In the city center there are two examples of this. In just the short moment of the passage of the hurricane, large quantities of sand of the shallow sand layers were washed underneath the water defenses into the housing areas. It is even for Geotechnical Engineers interesting to see that a housing area can be washed under a layer of sand of more than a meter in just a few hours.

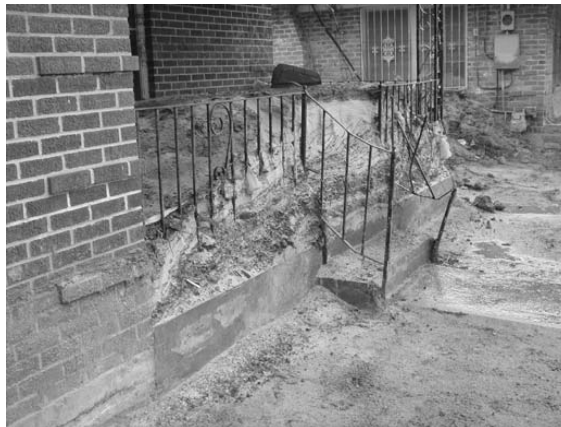
Figure 3. Thickness of the washed-in sand layer.

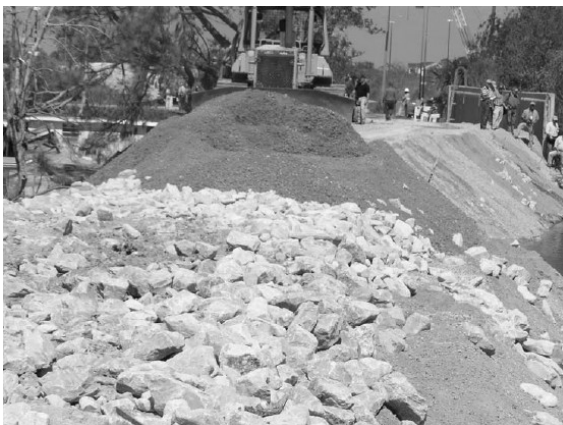
Figure 4. Creation of a new dike.

It is also interesting to see how the United States Army Corps of Engineers think they can make new impermeable dikes after the disaster. Some dikes become therefore far too permeable.

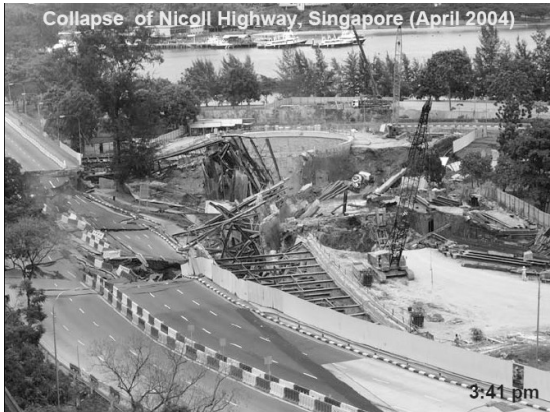
Figure 5. Collapse of the metro tunnel along Nicoll Highway, Singapore

In 2004 the building pit of a metro tunnel under construction in Singapore collapsed. Four people died. Many simple mistakes have been made in the design of the building pit and readings of instruments on site have indicated that things were not going as planned, but the warnings were not acted upon. The responsible manager was sent to prison.

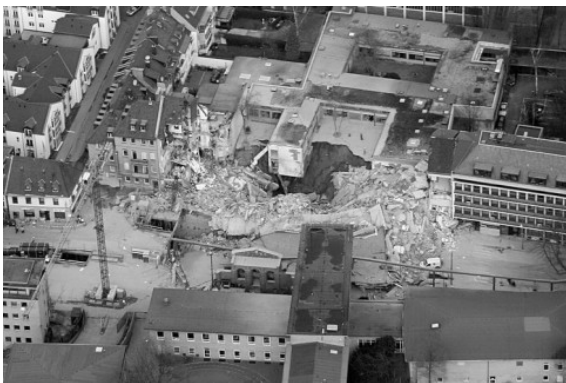
Figure 6. Collapse of a building pit of the North-South Line in Köln

The biggest construction disaster in Germany of the last few years is the collapse of a building pit of the North-South Line in Köln in 2009, leaving 2 people death and destroying one of the most important historical archives of the country. Workers had stolen up to 83% of the steel supports of the diaphragm walls and have sold this as old steel. And of course nobody, not even the inspectors, remember to have noticed anything.

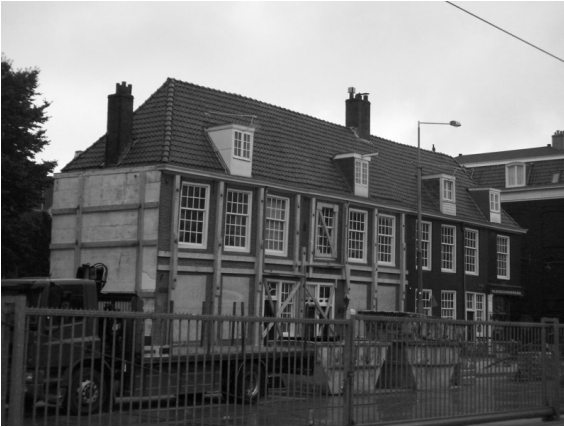
During the construction of a building pit for a new underground station of the North-South Train Line in Amsterdam there were two identical incidents. Twice a diaphragm wall was leaking groundwater. This water washed sand particles away below the foundation piles of surrounding buildings, causing a subsidence of up to 23 cm of these old weaver houses. The only internal inspections of the diaphragm wall seemed to have been insufficient and there was no backup plan for this risk. There could have been a second line of defense for the most vulnerable areas like these fragile houses. In the meantime the predicted costs have gone up from 1.5 to 3 billion euros and the project end shifted from 2011 to 2017.

Figure 7. Subsidence along an underground station of the North-South Train Line in Amsterdam

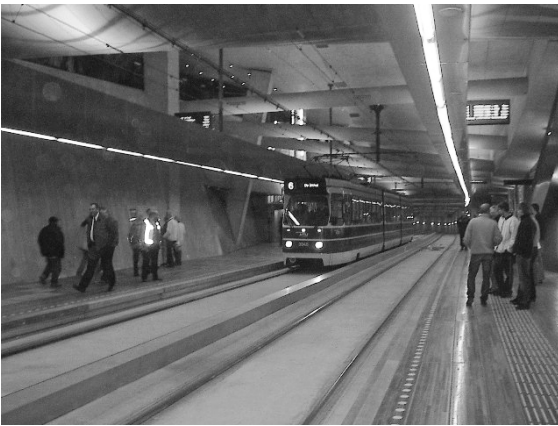
Figure 8. Big Market tram tunnel in Den Hague

In 1996 the city council in Den Hague, the Netherlands ordered to construct a Tram tunnel. In order to save some money, they had chosen not to use the common technique of a building pit with an underwater concrete floor retained by tension piles, but to use an experimental technique of deep arch-grouting. All contractors warned the municipality for the high risk of leakage with this technique, but that did not change the plans of the city council. Also the insurance companies warned the city council and decided not to ensure the project. The city council took the risk themselves.

The predicted leaks appeared in 1998 causing the construction of the Tram tunnel to halt. The tunnel was for a long time under water, waiting for a new plan. This gave this tunnel its nick names: The Den Hague Swimtunnel and The Tramtanic. The tunnel was finished with a complex technique using high air pressure. In total 35.000 man-hours were worked under high air-pressure. The construction costs went up from 139 to 234 million euros and the opening was delayed from 1999 to 2004. In this way the construction of a 1250 m tunnel in Den Hague became more expensive than an 8 km long tunnel in Thüringen, built at the same time.

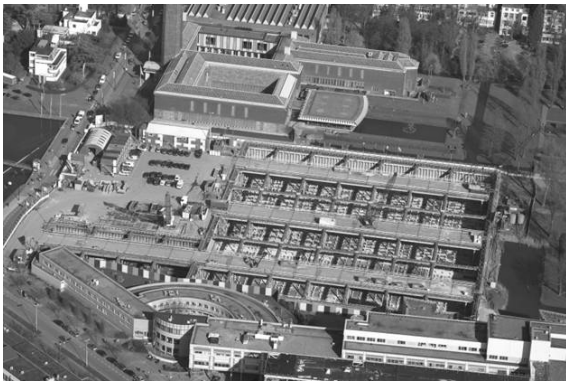
Figure 9. Construction of the Museum Park Garage in Rotterdam

Another example is the construction of the Museum Park Garage in Rotterdam, the Netherlands, which started in 2004. During construction the demolition of a large retention wall was needed, but the project organisation never thought of checking the effect of this on nearby buildings. Also excavating beyond a depth of NAP -4 m took place even though the geotechnical report had forbidden this. Therefore the construction of this so called “blunder-pit” caused damage to nearby buildings in 2005 and 2006. The municipality had to accept a delay of more than a year and an increase of the costs from 53 to 103 million euros.

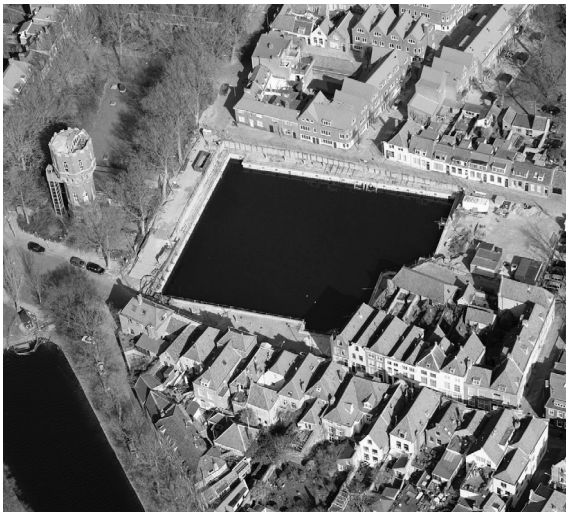
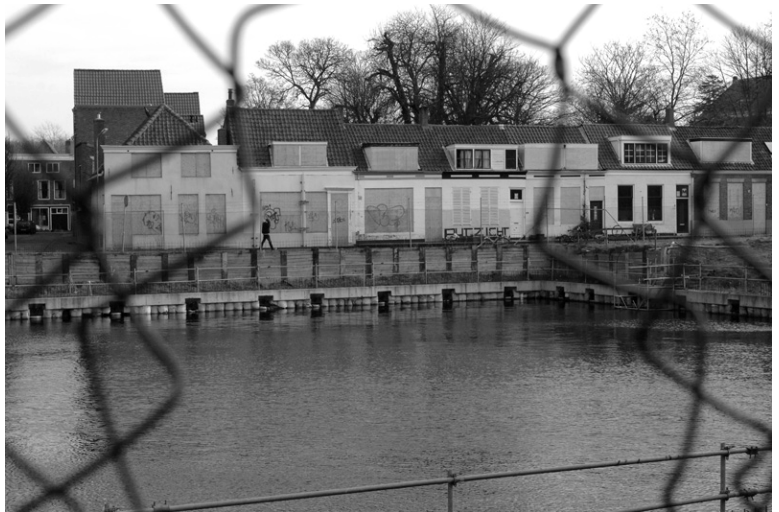
Figure 10. and Figure 11. Leakage and damage at the building pit of the new theater Middelburg

In 2004 in Middelburg, The Netherlands, the building of a new Theater with a large underground parking garage started. In 2005 a diaphragm wall started to leak and surrounding houses started to subside. To stop the disaster, the pit was filled with water and was nick-named the Biggest Swimming Pool. It remained this way until 2009 when new walls were placed in the pit and the pit was filled with 13,350 m³ of concrete; a loss of almost half the volume of parking space. The remaining and very expensive parking is rather useless now, because the old theater has been renovated in the meantime.

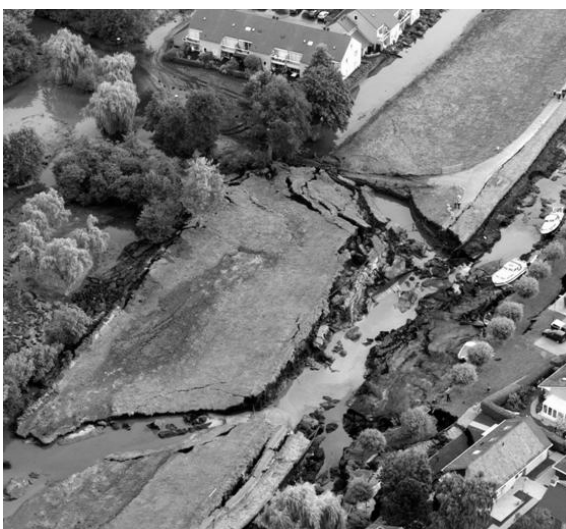
Figure 12. Failure of a peat dike in Wilnis

In the summer of 2003 a peat dike in the Netherlands failed in the village Wilnis near Mijdrecht. The dike was shifted horizontally by the water pressure in the canal. This type of failure is not uncommon. In the summer of 1947 a peat dyke in Zoetermeer, the Netherlands, failed in an identical way. And also in January 1989 in Edenderry, Ireland, a peat dike failed in a similar way. The failure of the dike in Wilnis came not as a surprise, because this dike, only made out of peat, was for 28 years disapproved, but the responsible waterboard never improved the dike in all those years. Both in smaller hand calculations and in finite element calculations, the effect of the drying out of the crest of the dike above the groundwater table and the failure of the dike can be simulated. Not the failing of the dike is a mystery, but the reason why the Waterboards accepted for so many years to do nothing about the many dikes which were disapproved.

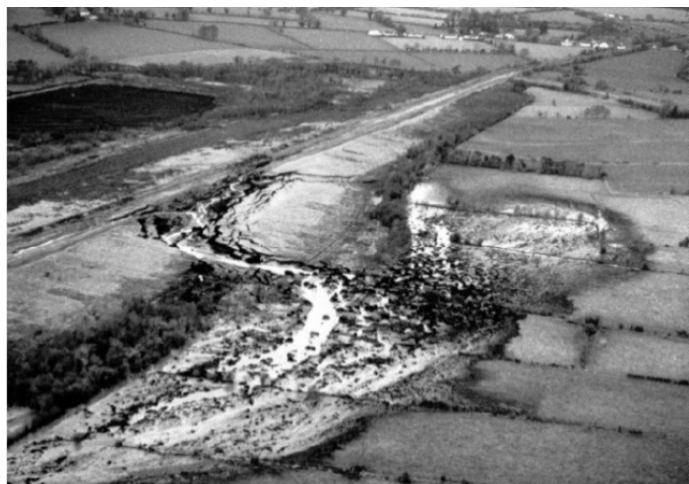
Figure 13. Failure of a peat dike in Edenderry

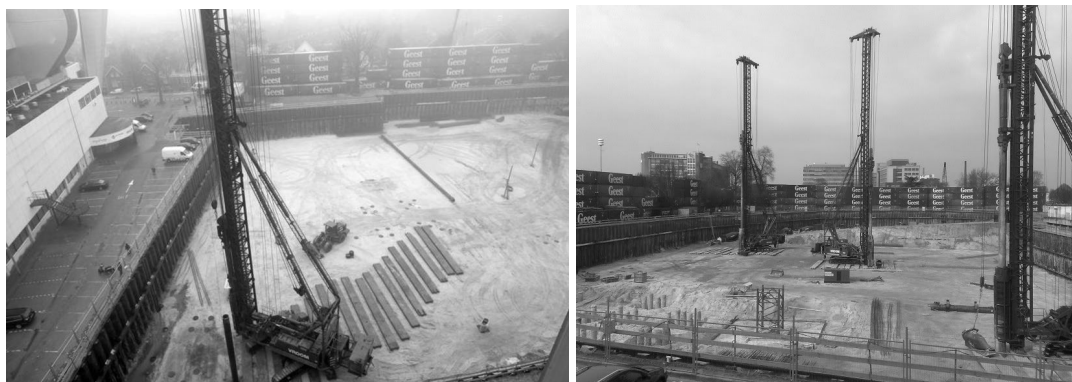
In 2009 and 2010 in Eindhoven a new underground parking garage was build next to the PSV football stadium. A large number of big precast foundation piles have been driven through very dense sand layers in 2009. Therefore a production of very strong ground vibrations for many months was obvious, which would exceed the allowed maximum of the Dutch standards. The corresponding high level of environmental vibration nuisance for the people living around the building pit should not have been ignored by the project organisation and also by the controlling municipality.

Figure 14. and Figure 15. Vibration and noise nuisance at precast pile driving in Eindhoven

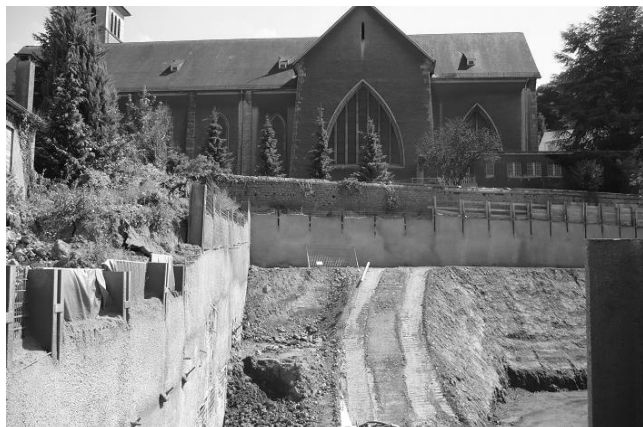
Figure 16. Failing retaining wall in Differdange

In 2010 in Differdange, Luxembourg, very close to the shallow foundation of the local church a building pit was made, in order to make a housing residence with a sub terrain parking garage. The project was halted when suddenly many cracks appeared in the church. Verification of the design calculations made

clear that several major mistakes were made. Only an active earth pressure was used in the calculations, while in order to prevent horizontal deformations, a more neutral earth pressure had to be used. Also the water pressure behind the Berlin-wall was forgotten. The anchoring was made very close to and just below the fundament of the church. And a very high drained cohesion was used in the calculations, only based on undrained phicometer borehole field tests.

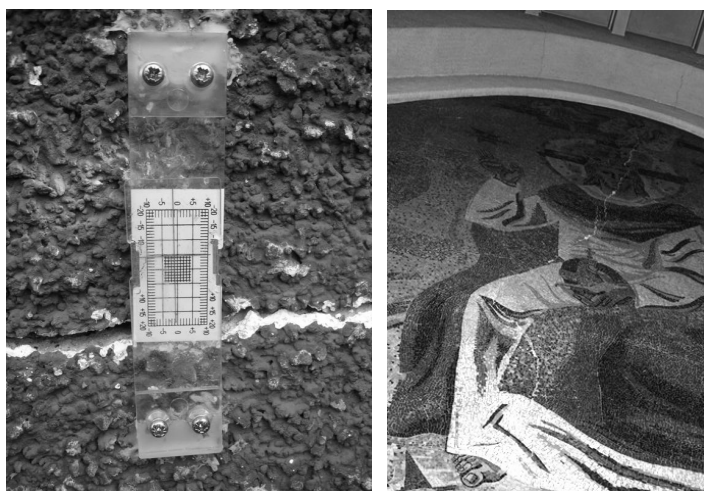
Figure 17. and Figure 18. Cracks in church Differdange

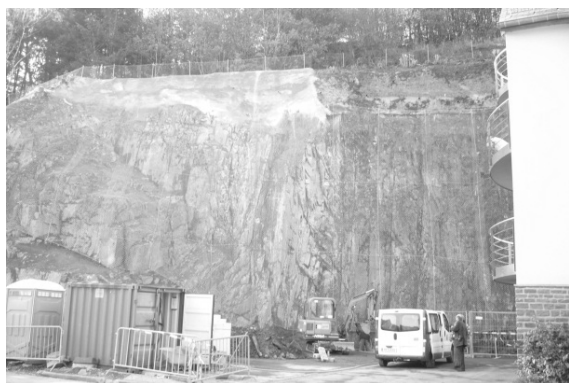
In Clervaux, Luxembourg, a vertically-layered rock-face was inspected by a geological and geotechnical engineer. He warned for the danger of rock parts breaking off. Nevertheless the owner never secured the rock-face. A few years later a large part broke loose and crushed a parked car; luckily nobody was in the car. First then the authorities intervened and secured the wall on the expenses of the owner.

Figure 19. Rock face instability at Clervaux.
