BAW Letter No. 1 – January 2011

Studies on Alternative Technical-Biological Bank Protection Measures Applied on Inland Waterways (Joint R&D Project of BAW and BfG)

Results from Test Stretch Stolzenau/Weser km 241.550 – 242.300, Right Bank

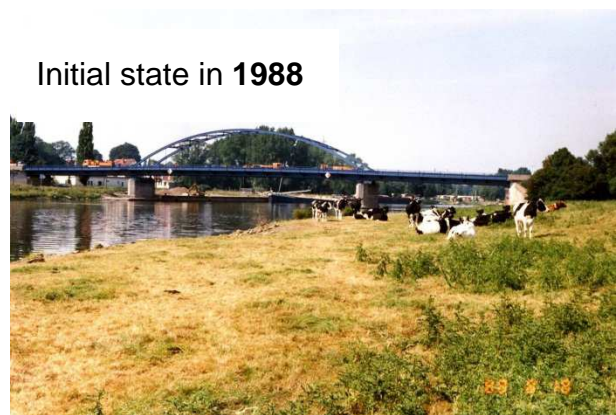
Fig 2: Initial condition of the test stretch: intensive use for grazing right up to the banks

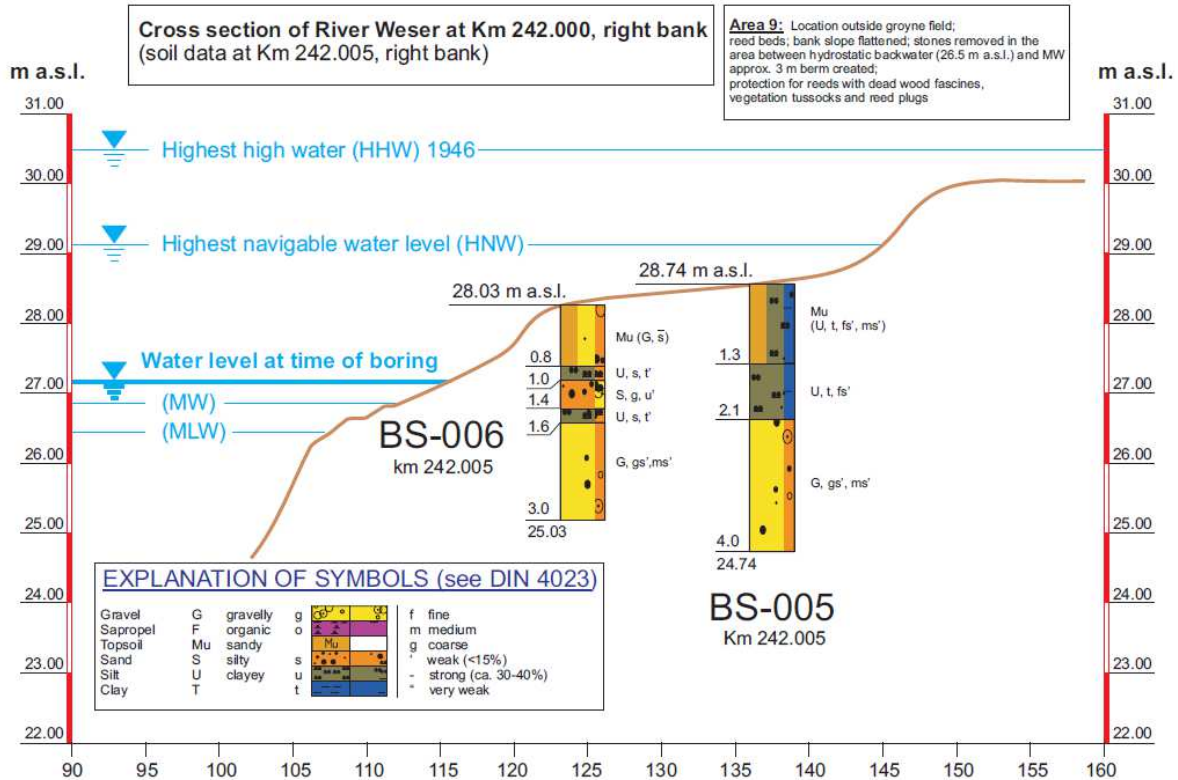
borings at km 242.00 are illustrated in Fig. 4. Under the topsoil, the bank consists primarily of sandy and clayey silts and of sands. Further below, at the MW and MLW level, medium to coarse sandy Weser gravel with a granularity from 0.2 mm to 60 mm can be found.

Fig 4: Results of exploratory borings at Weser km 242.000.

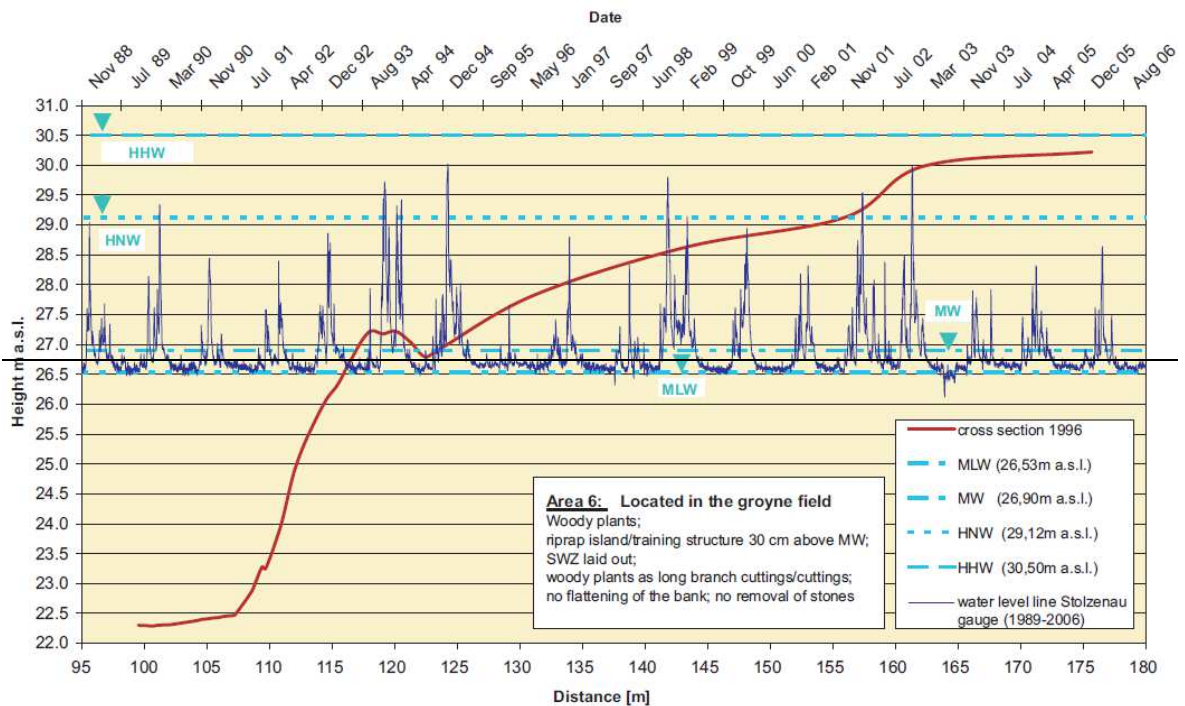
Fig. 5 also illustrates the underwater slope zone with its inclination of 1:3, which is still secured by riprap, as well as the modified area above MW, which has remained unchanged at the inclination of 1:7 since its construction. The stone mound in front of the bank can be seen easily.

Fig. 5: Cross section at km 241.800, right bank (1996) with water levels of the Weser (Stolzenau gauge at km 243.400)

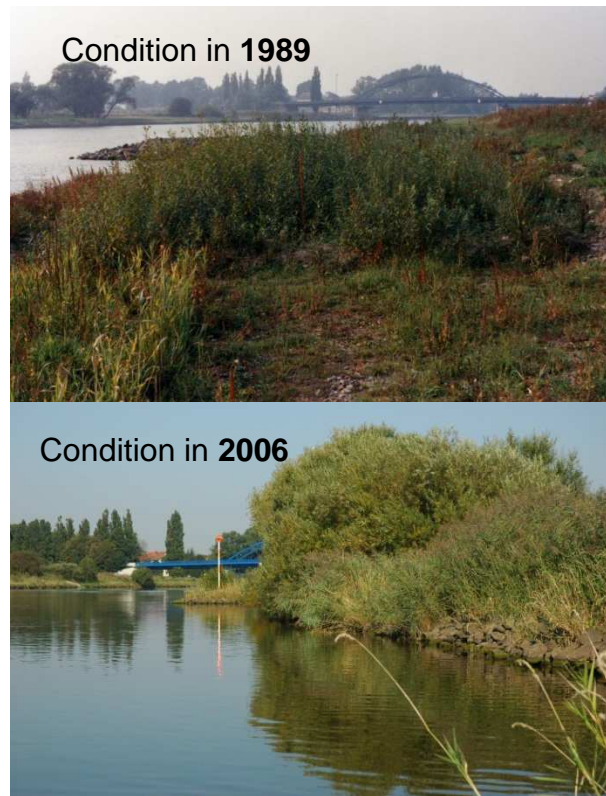
The analysed time period showed a positive development of the reed and willow plantings (Fig. 10). Thus, the redesign of the river bank with technical-biological measures could be qualified as successful.

Fig. 10: Development of the vegetation in one section of the test stretch between 1989 and 2006
