**Test stretch with technical-biological  
bank protection measures  
Rhine km 440.6 to km 441.6, right bank**

**Final report of the monitoring phase  
2012 to 2017**

BAW No. B3952.04.04.10151  
BfG No. 1677

02.08.2023

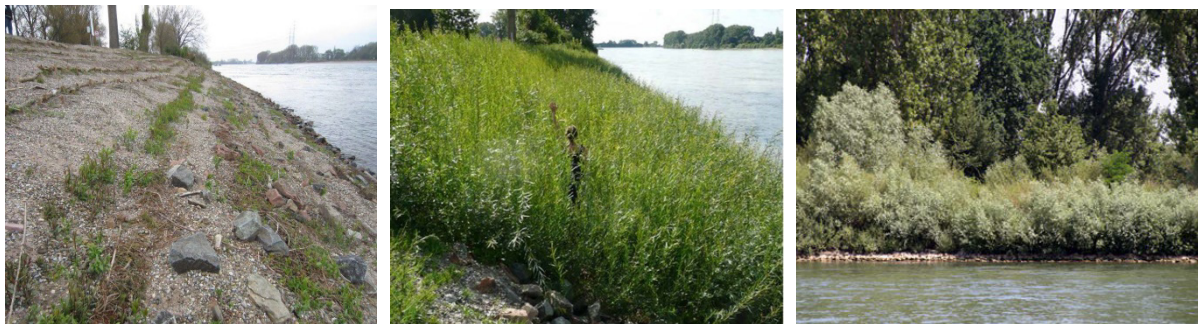
After some remedial work had been undertaken (i.e. driving the stakes back into the ground, renewing the soil cover), the willows developed well (Figure 9) and the bank's stability improved with the growth of roots and shoots. The willows' growth initially appeared to be somewhat weaker in the lower slope zone up to approximately 1 m above MW and in the upper third of the slope. At the lower end, the willows are exposed to high stress resulting from ship-induced loads and often persistent flooding. However, in the upper third of the slope, dryness and shade pressure from the nearby poplars have an adverse effect on shrub growth. Moreover, the much thinner shoots were caused to die off locally due to infestation with parasitic dodder (*Cuscuta lupuliformis*, Figure 10), whose flooding tolerance is only very low.

Figure 9: Overview: development of willow brush mattresses in TF 3 – 4/2012 (left), 7/2012 (centre), 7/2017 (right) (photos: BAW)

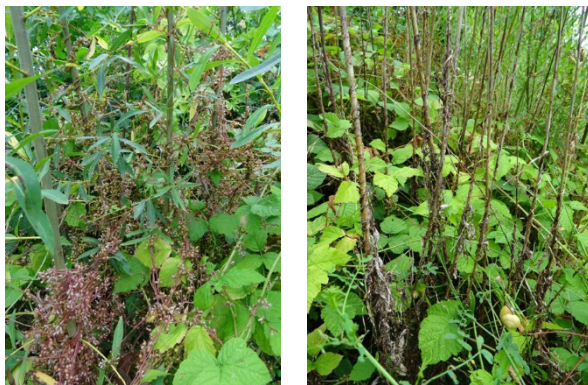
Figure 10: Infestation of young willow shoots with dodder in TF 2, 8/2016 (left); local shoot die-back, 8/2016 (right) (photos: Katja Behrendt, BfG)

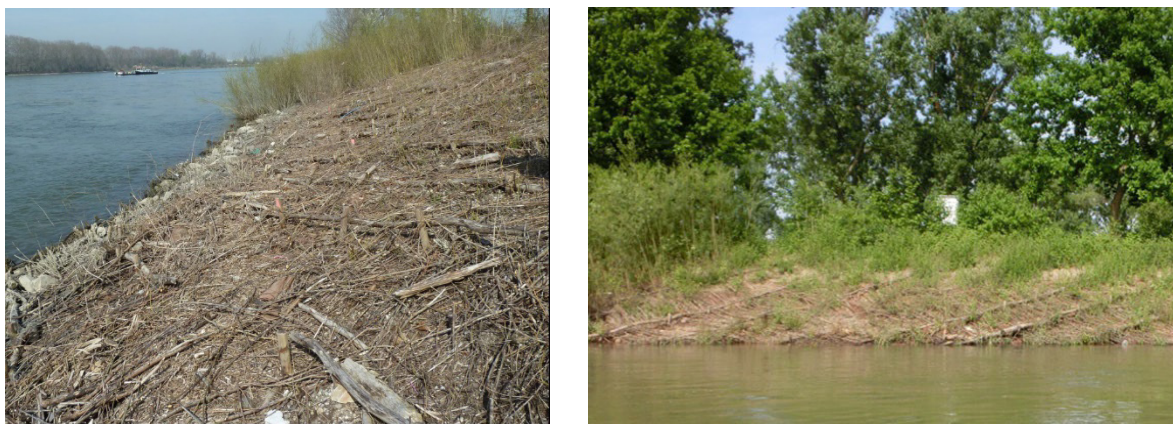
*Figure 11: State of TF 2 shortly after pruning on 10.04.2015 (left) and on 11.05.2015 (right) (photos: BAW)*

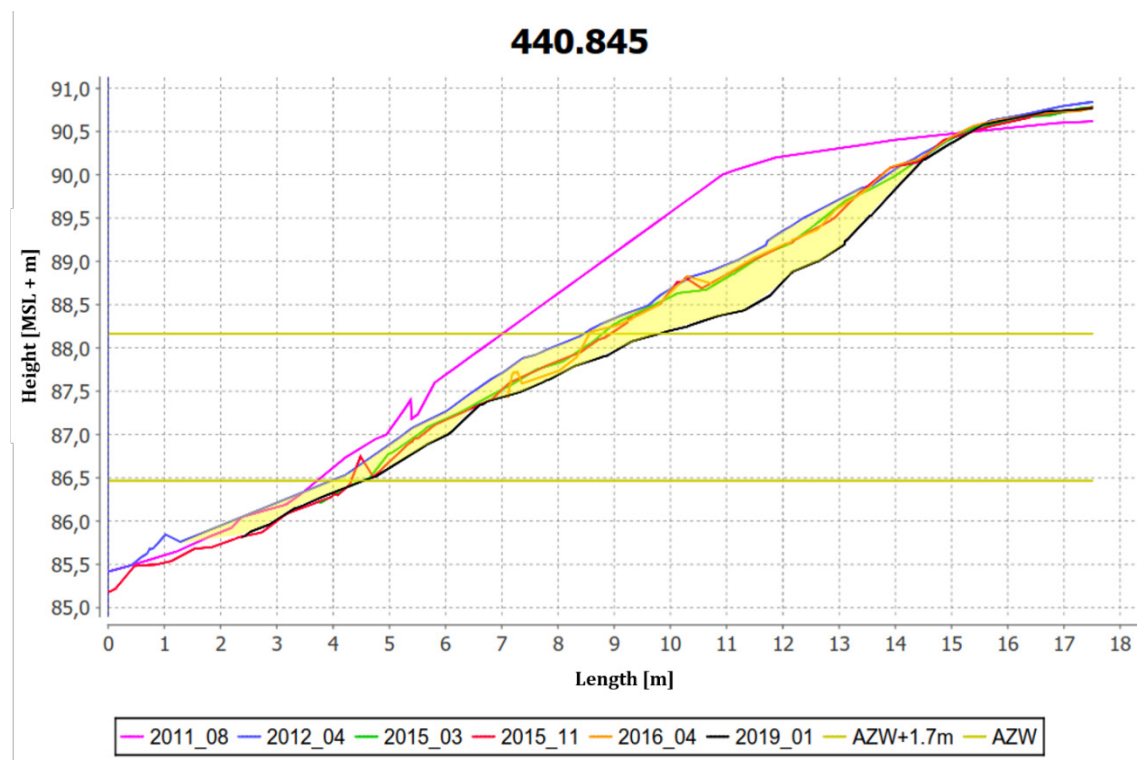
Figure 12: Cross section at km 440.845 (TF 2, large-area pruning) – highlighted in yellow: eroded area in the period from 04/2012 to 01/2019

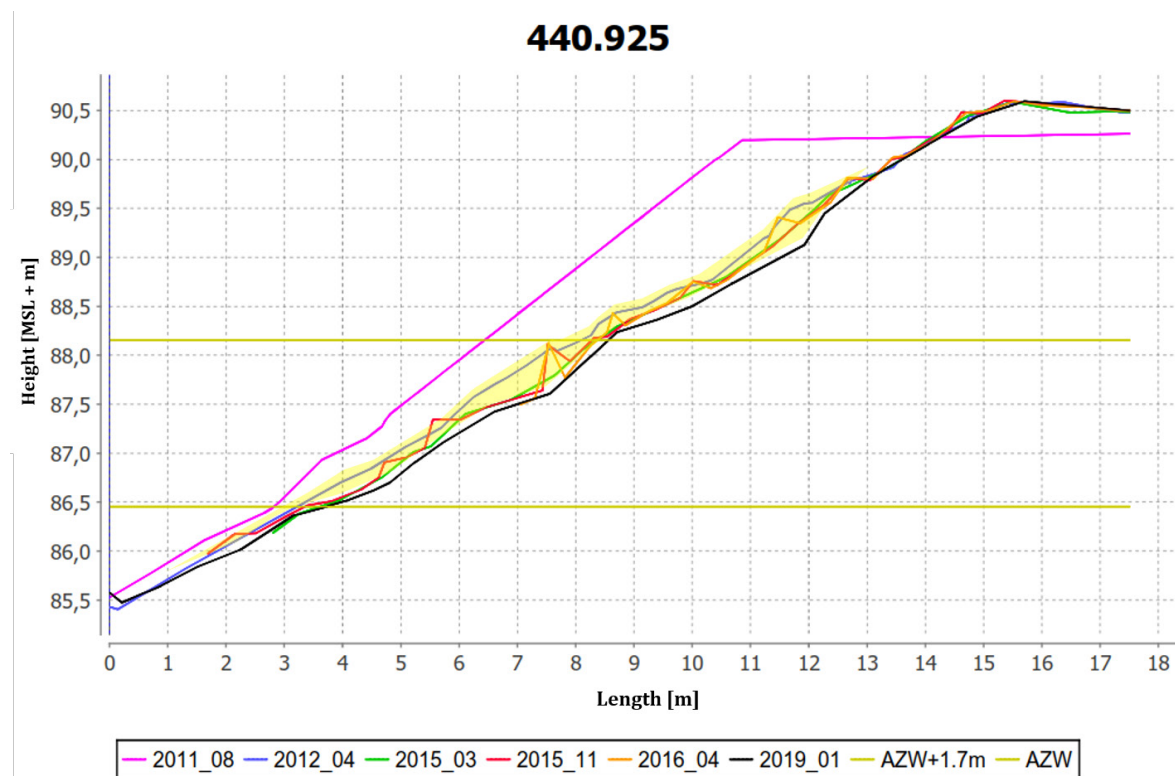
Figure 13: Cross section at km 440.925 (TF 3, limited pruning) – highlighted in yellow: eroded area in the period from 04/2012 to 01/2019

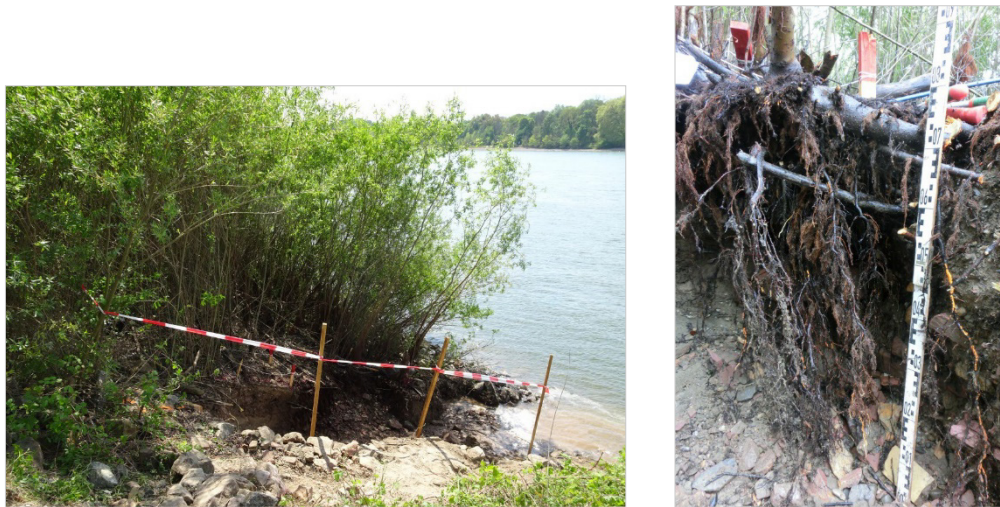
Figure 14: Exposed roots of willows in TF 3 (photos: BAW)

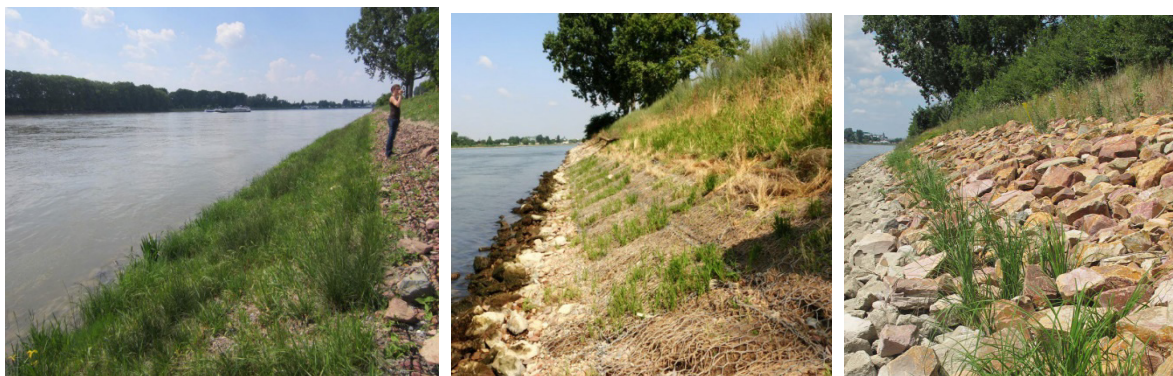
Figure 17: Development of the gabions, from left: 07/2012 – 07/2013 – 07/2017 (condition rehabilitated with one stone layer) (photos: BAW)

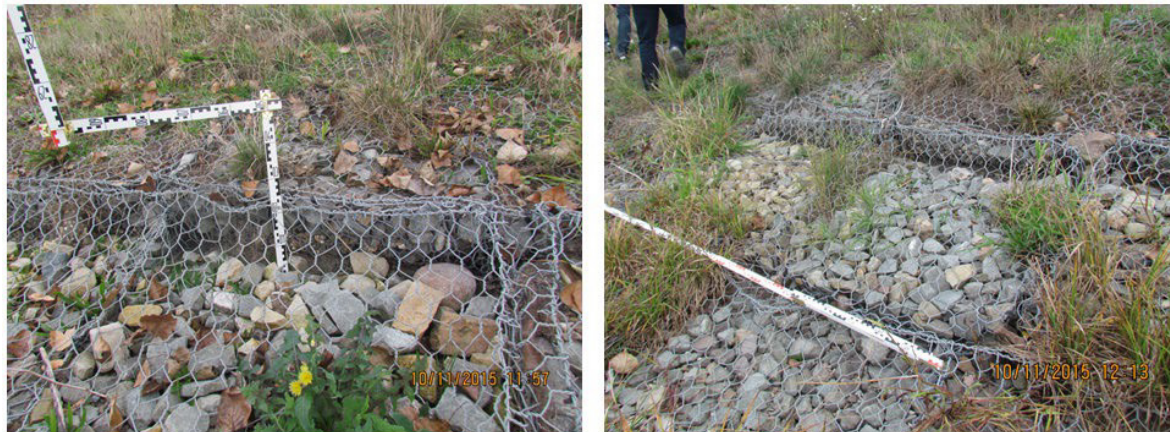
*Figure 18: Reed gabions on 10.11.2015, vertical edge due to stone displacements within the gabions (photos: BAW)*

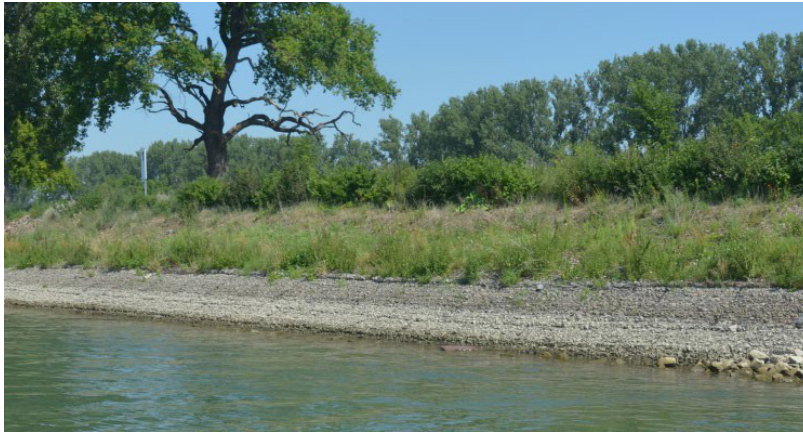
*Figure 20: TF 5b – Stone mattresses, well vegetated on the upper half of the slope and with almost no vegetation on the lower half (2.7.2015) (photo: BAW)*

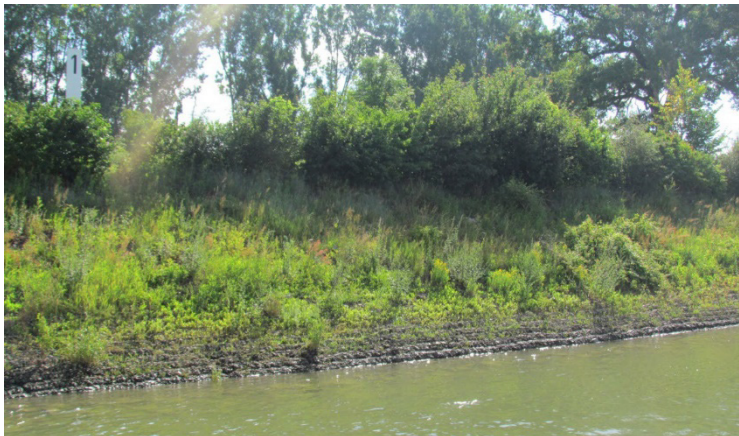
*Figure 21: Condition of the stone mattresses (20.6.2018) (photo: BAW)*

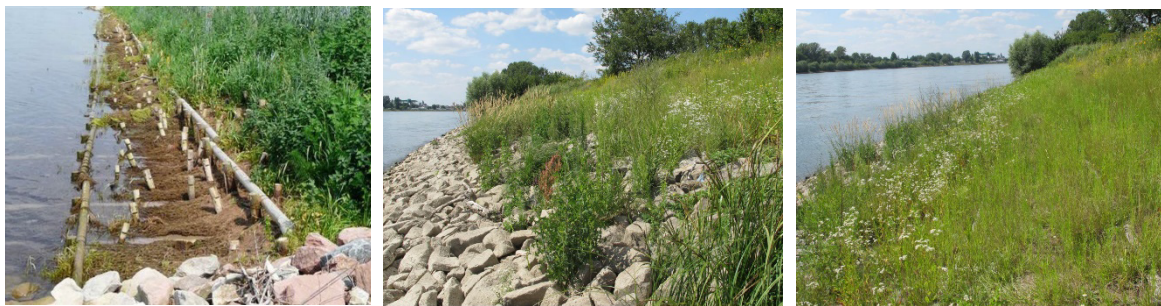
Figure 22: Damage in the lower slope area 5/2012 (left); rehabilitated condition 7/2017 (centre); good development in the upper slope area (right) 7/2017 (photos: BAW)

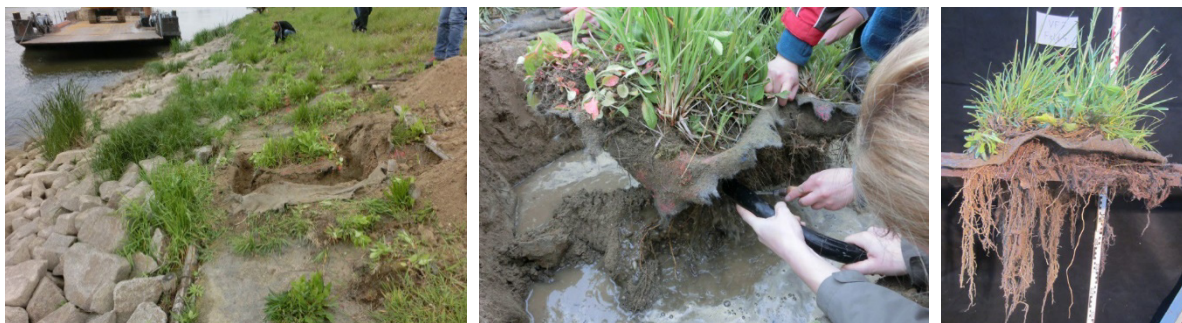
*Figure 24: Roots exposed by water in the study area U3, right: excavated roots in study area U4 (photos: BAW)*

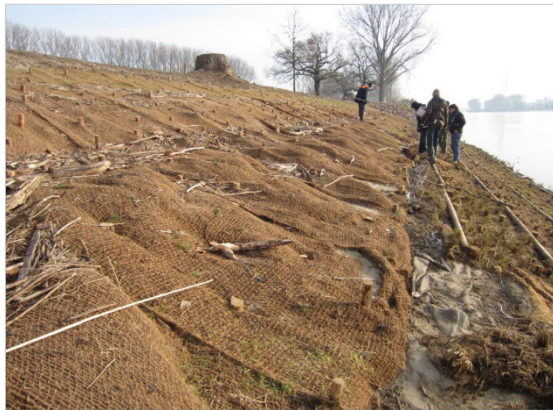
*Figure 27: Slope deformations after flooding in TF 7a, upper zone (22.3.2012) (photo: BAW)*

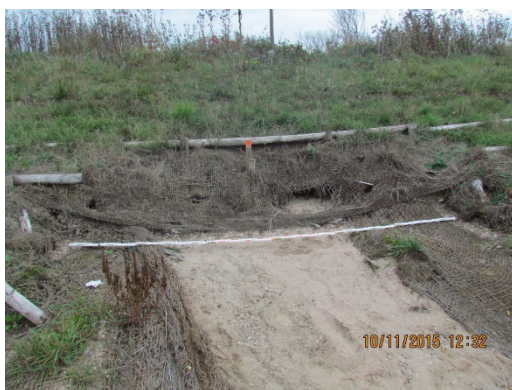
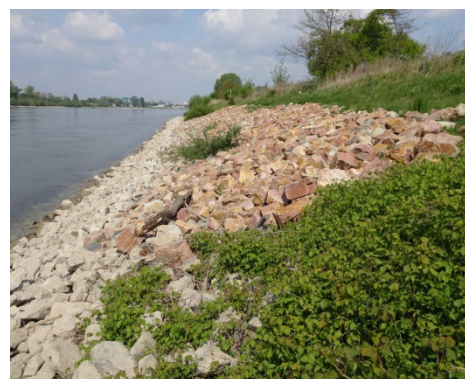
*Figure 28: Left: largest damaged area in TF 7a, upper zone, km 441.200 (11/2015); right: condition after rehabilitation (4/2017) (photos: BAW)*

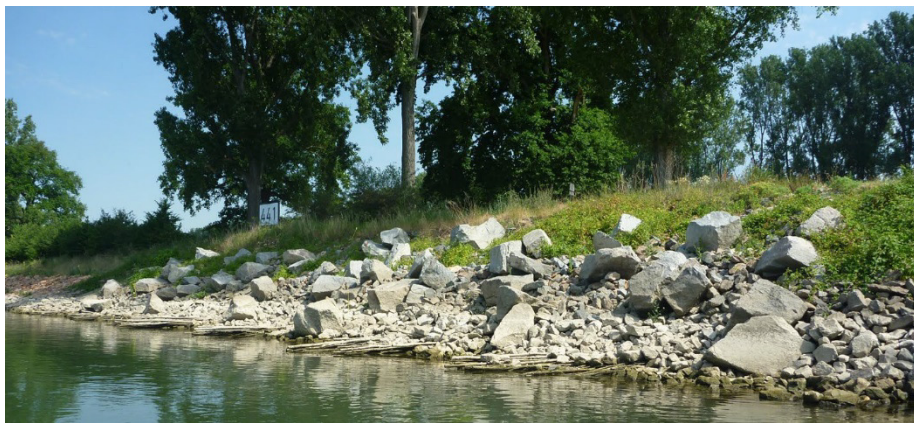
Figure 32: Lower/middle slope zone without vegetation and more vegetated upper slope zone subject to lower hydraulic loads (06/2017) (photo: Steffen Wieland, BfG)

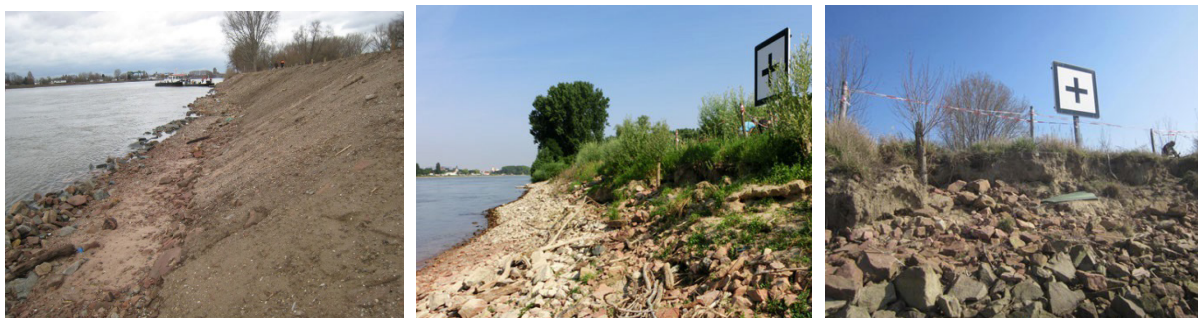
*Figure 35: Development in TF 9 – 12/2011 (left, after completion of construction), 7/2013 (centre), 3/2014 (right) (photo: BAW)*

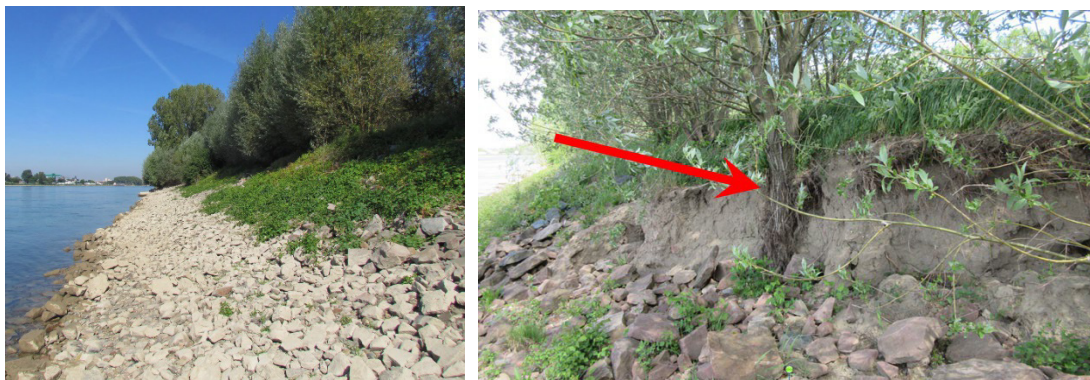
Figure 37: Left: old armourstones in the ground exposed by water in TF 9 (8.9.2016); right: log branch cuttings exposed by water (26.04.2018) (photos: BAW)

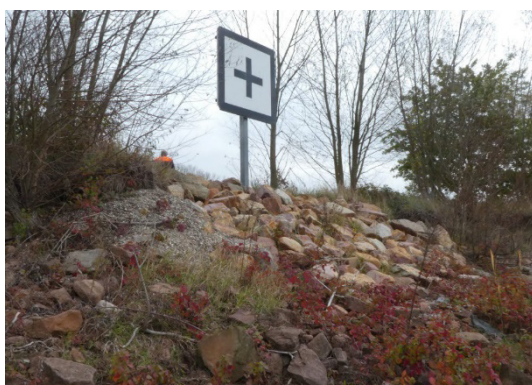
Figure 39: Km-sign at km 441.500 secured with armourstones (7.11.2017) (photo: BAW)

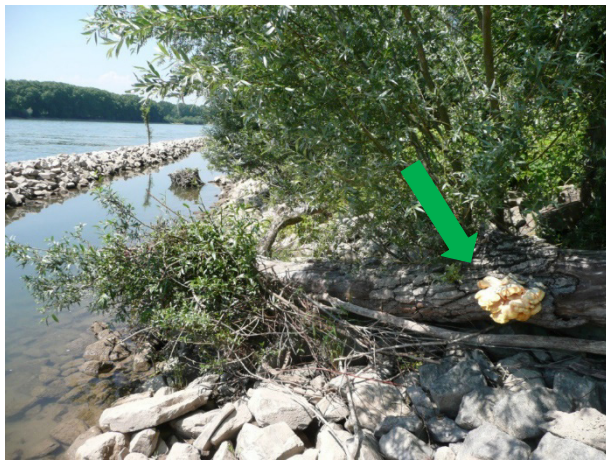
*Figure 59: Dead wood deposit in TF 1 (vegetated riprap) infested with sulphur polypore fungus (arrow) (photo: Katja Behrendt, BfG)*
