Prof. Dr.- Ing. habil. R. Rogala, (PL)
Dr.- Ing. W. Rędownicz, (PL)
Wroclaw University of Technology,
Institute of Geotechnics und Hydrotechnics

Winter Season Repairs of the Oder Locks

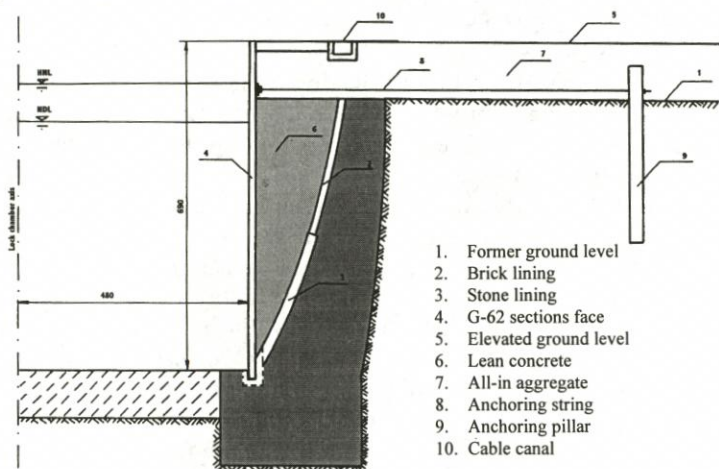
The main parameters of the lock include: length — 187.8 m, width — 9.60 m. The sloping on the lock is 2.40 m. The ordinates of the upstream and downstream heads were 125.65 m and 124.20 m above sea level, respectively, and the ordinates of the thresholds — 119.96 m and 118.50 m, respectively. The level at which navigation is still possible is 124.53 m above sea level at the downstream stand. Such a condition hindered navigation remarkably as water flooded the lock platform at higher water levels (Fig. 1).

Fig. 1: Lock chamber's cross section

The lock walls were made of concrete and shaped appropriately to the loads evoked by ground pressure (Fig. 1), which minimised the structure's weight in this way. The face of the wall downstream part was made of granite cut-stone and the upstream — of clinker brick. The bottom slab, 1 metre in thickness, was made of concrete.

The repair of the lock's left wall included facing by means of G-62 steel piling sections, elevating the platform level to the ordinate 125.40 m above sea level and constructing a cable canal (Fig. 1). The scope of the repair of the two heads was identical and included the replacement of the support gates and the flow canal wedges alongside with their drive mechanisms, a reconstruction of the heads, facing them with G-62 steel piling sections and building cable canals for distributing the wiring for the feeding, drive and signalling systems. The reconstruction of the heads consisted of an elongation and elevation of the lock head top and a change of wedge shaft dimensions. The upstream head was elevated to the ordinate 126.25 m above sea level and the downstream one — to 124.40. Such an elevation of the heads allowed for the installation of typical Ib support gates, meeting the condition of the minimum elevation of the lock top over the level of normal damming, thereby eliminating the threat of flooding the platform and the servo motor's and the upper bearing's cavities. The elongation of the head by 1.22 rendered it possible to build new recesses for standardised flashboard repair closures. The increase of the size of the existing wedge shaft allowed placing a typical steel walling of the wedge shaft. The work connected with the refurbishment of the lock's wall required high working discipline and a strict technological regime. Due to the complexity and variety of the work to be performed, the effective repair of the lock's heads meant the involvement of more measures and resources offered by dedicated contractors. Since the type of repair work on the lock's wall is the same as part of the repair work on the heads, later in this paper the authors will focus on describing the refurbishment of one of the lock's heads — the upstream head.

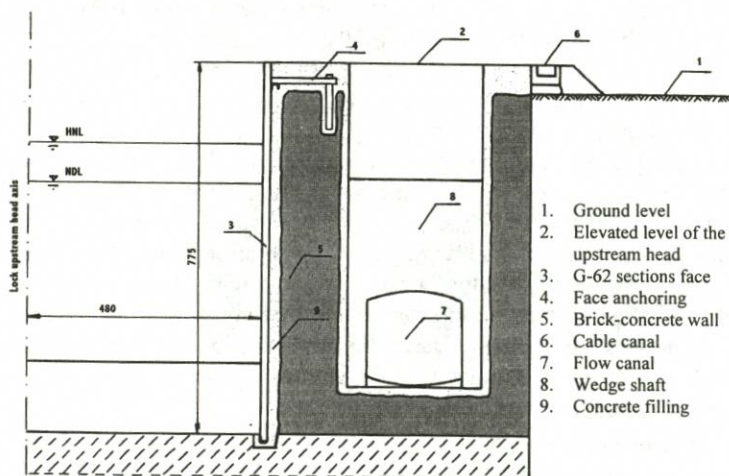
Fig. 2: The lock's upper head cross-section

The next stage of the refurbishment included assembly and reinforcement activities. In the groove hammered in the bottom and on the walls (Fig. 2), the support girts for wall facing were fixed. The lower girt was made of angle steel 200 x 200 x 20 and the structure of the upper girt — of a 160 c-bar and 120 x 120 x 20 angle steel, fixed in the lock's head. Then, in the wall face, wall upstream elongation reinforcement anchoring bars were fixed. After the groove under the lower girt was filled with concrete and when the concrete had hardened, the wall face was put up. The G-62 sections, which were supposed to make the facing, had been pre-cut to the appropriate length, sand-blasted and coated with an anti-corrosion paint. The inner side of the sections was fitted with — appropriately bent — welded reinforcement bars ensuring a better fastening of the facing. The sections, put up sequentially, were welded to the girts and then joined together with a butt joint along their entire height. The top of the lining was finished with a girt made of 200 x 100 x 12 angle steel. While putting up the facing, the walling of flow canals inlets and outlets, on-wall bollards and repair needle closure recesses were made. The subsequent work included: putting up the wedge shaft in the flow canal, insertion of the gate recess and upper bearing casings, putting up the reinforcement, recess furniture, all necessary boarding, fixing the servo motor bases and pillars, as well as all necessary steel markers. After all the work specified above had been done, concrete work started.
