Lime Treatment of Soils

The Friant-Kern Canal experience

G. Herrier
E. Berger
S. Bonelli

Lhoist R&D
Lhoist North America
Irstea

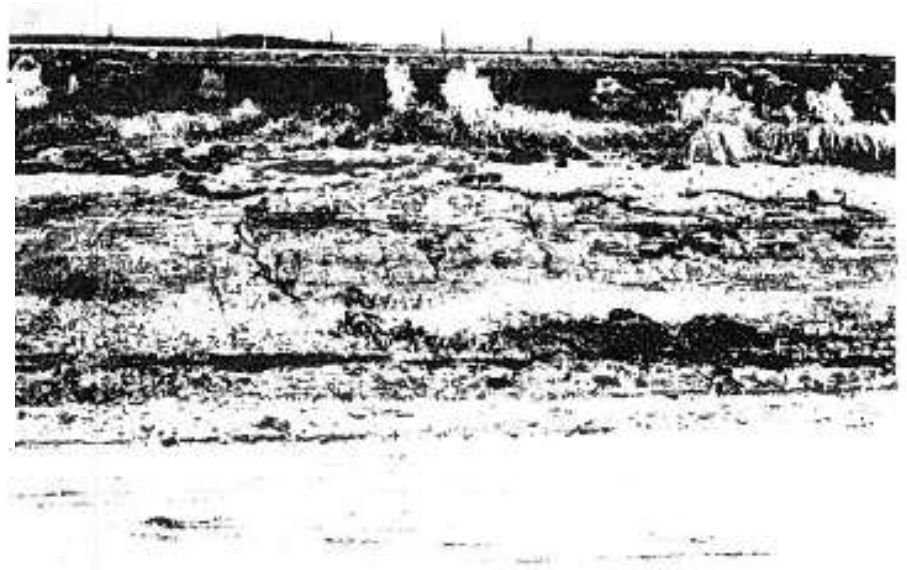
- 87 km of the canal built with Porterville clays (montmorillonitic clayey soil)
- Below water level : volumic expansion, lowering density and strength
- Above water : shrinkage, cracks, loss of shear strength and slidings

Fig. 2 Typical slide failure, Friant Kern Canal

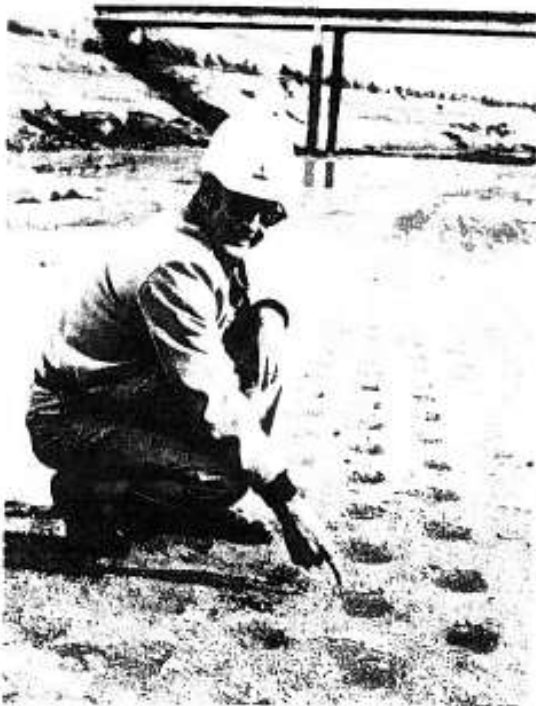
- After 1 year irrigation : sheepfoot rollers imprints still visible
- No new slips or slides since the renovation works
- Rc on cored specimens : 2.2 MPa (after 1 month) to 3.4 MPa (after 1 year)

Fig. 8a Sheepsfoot imprints after 10 months

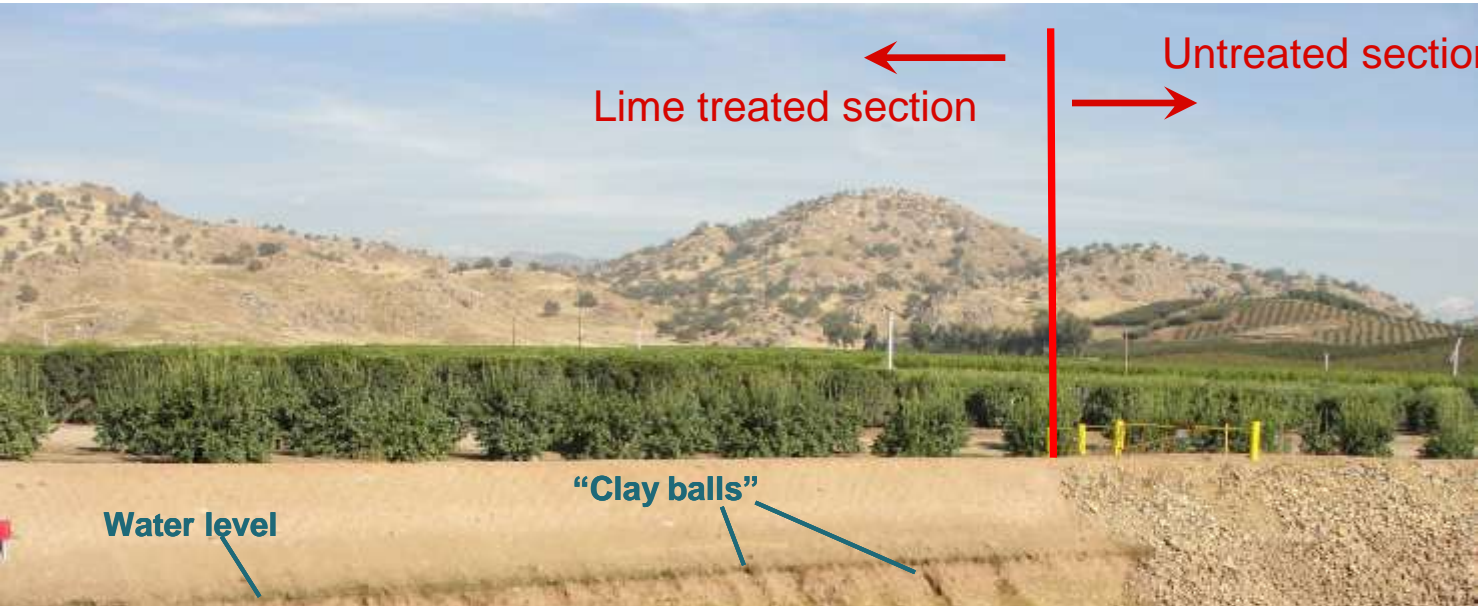
Water level

"Clay balls"

Sheepfoot roller prints

Untreated section
