A Case Study of Ground Cave-in due to Large Scale Subsurface Erosion in Old Land Fill

Mari SATO, Reiko KUWANO
The University of Tokyo, Japan

Accident of ground Collapse

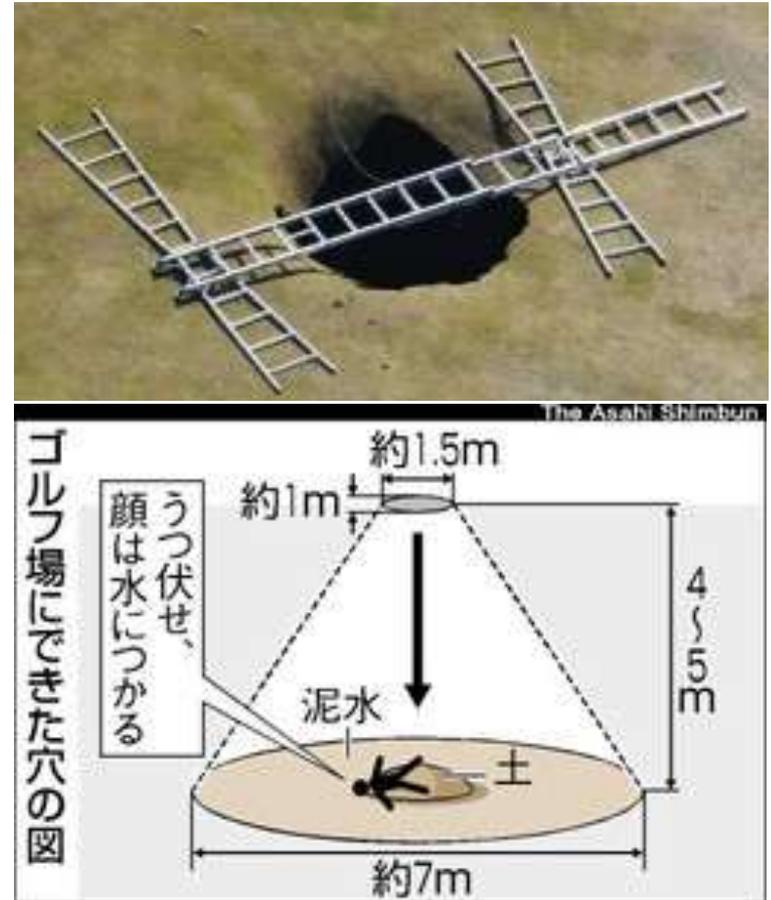
A sudden collapse of the ground in the fairway of a golf course in Hokkaido on April 2, 2009
A woman fell and found dead.

Although the golf course was daily checked by maintenance staff, they could not get any sign of the hidden hole even in the morning of the accident. The ground collapse seemed to have happened all of sudden, as the victim's son who walked just a couple of meters behind her saw her suddenly disappearing into the ground.

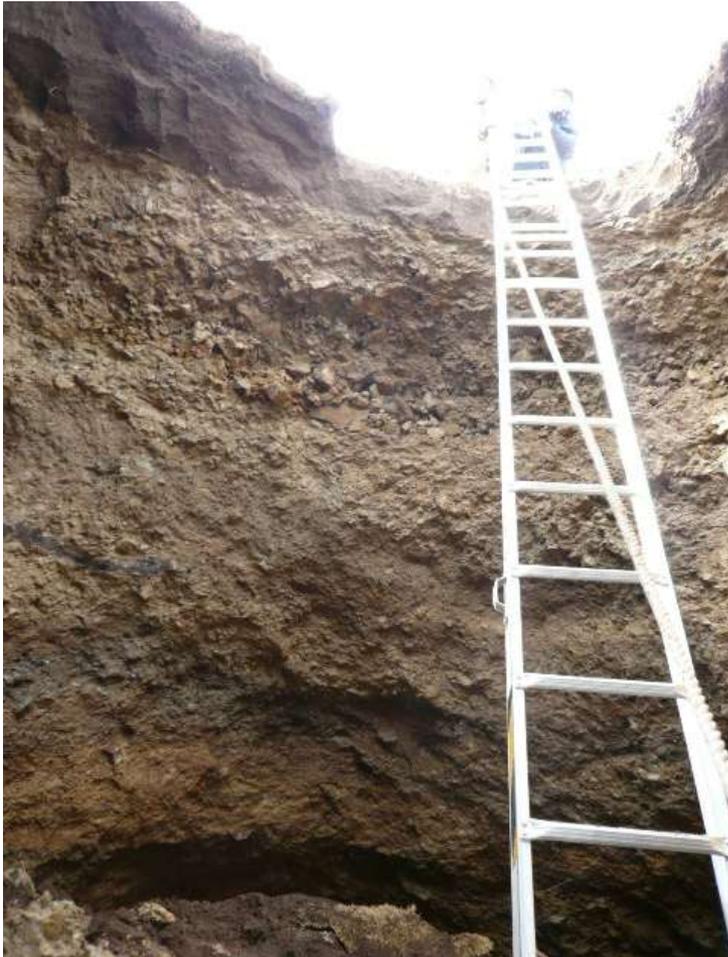
Inside the hole (2 days after the collapse)

The hole was 5m deep and 7m wide at the bottom.

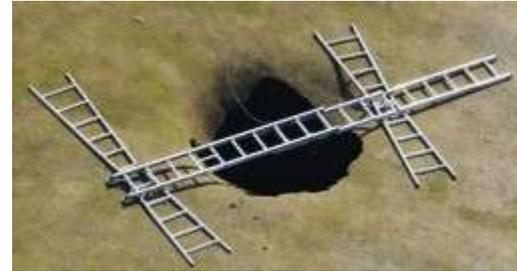
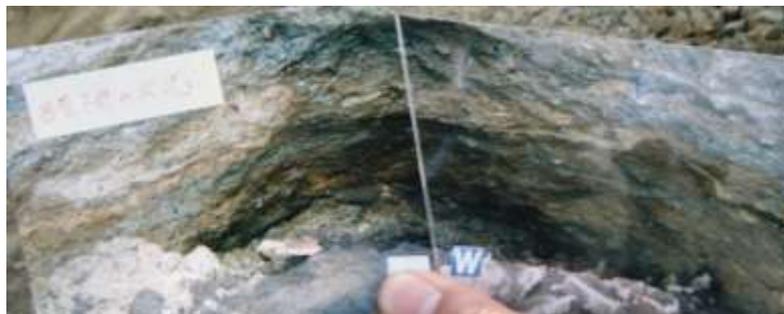
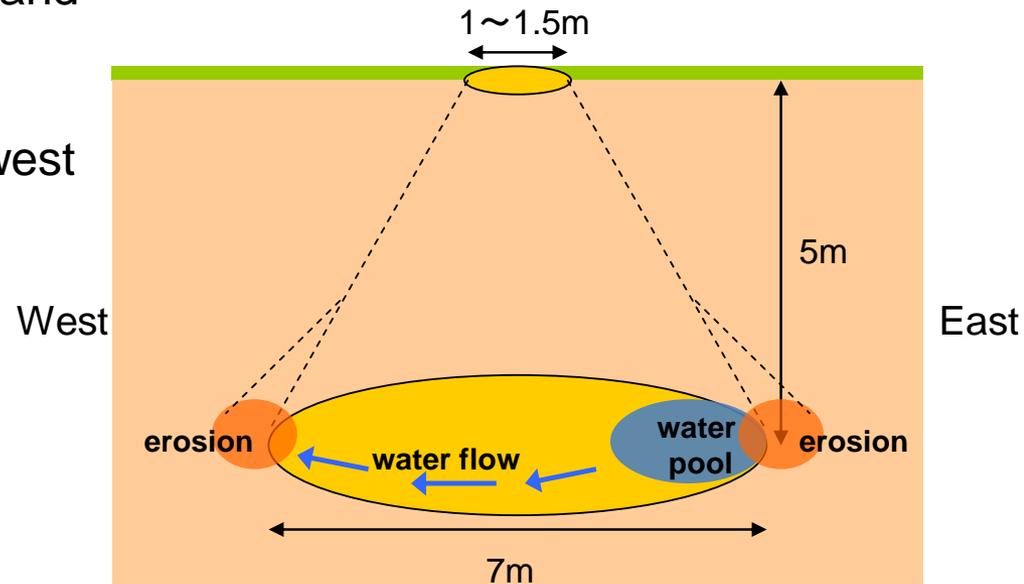
There was an about 0.6m deep shallow water pool in the east side of the hole, and the water flew to the west direction.

Noticeable erosion was found in both west and east sides.

(erosion in the west side, April 3, 2009)

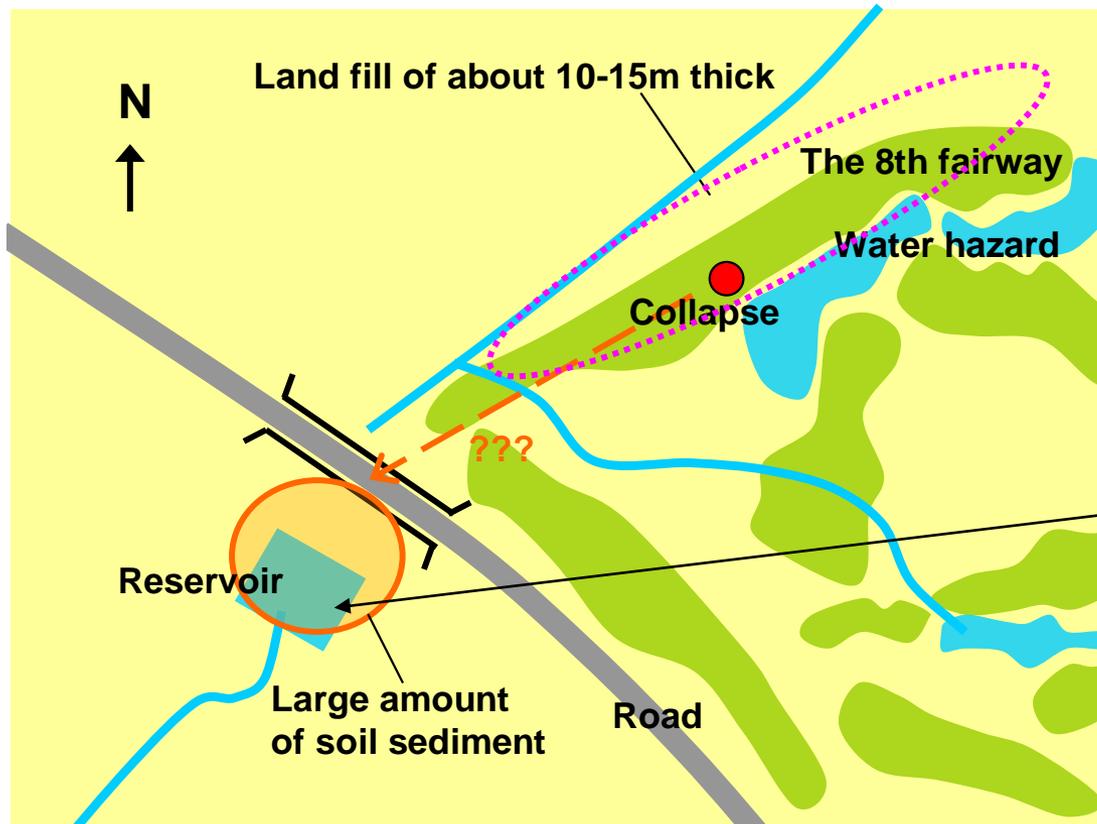
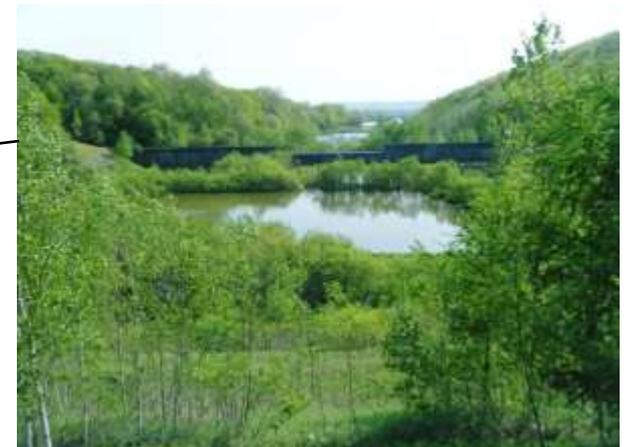
There is a water reservoir in the down stream of the 8th fairway, where large amount of soil sediment was found. It may be the possible destination of the soil flown from the cavity.

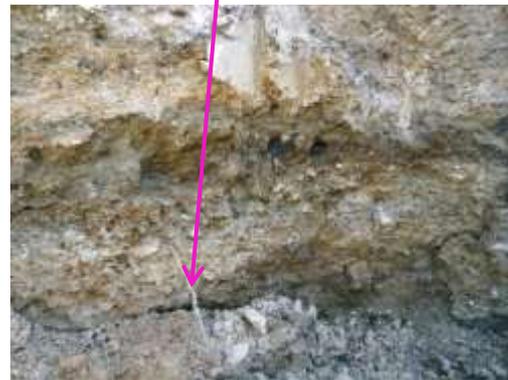
Plant root

Roots of plants were also included, which indicates the excavated strata was filled soil.

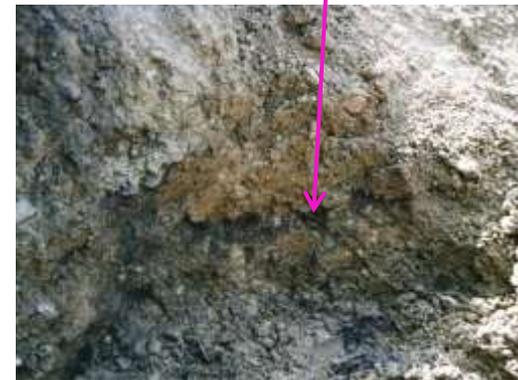
Sand with high water content

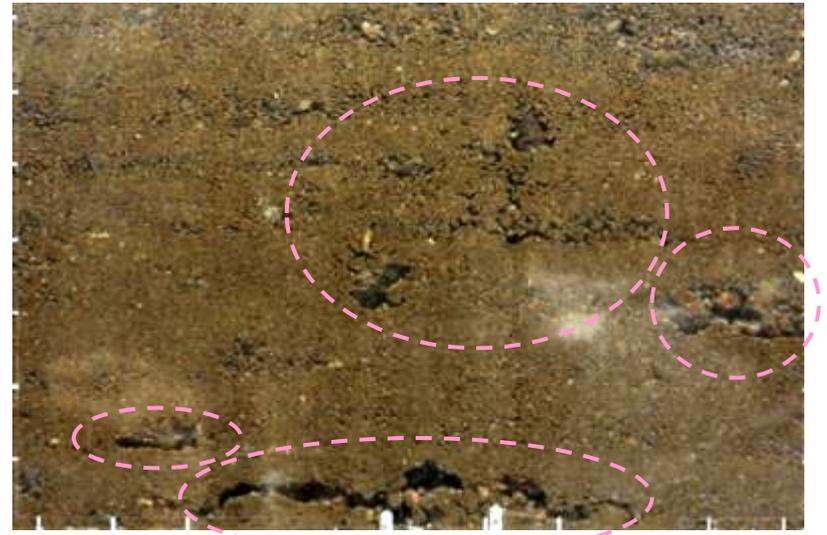
After the repeated water infiltration of 24 times

The soil seemed to be highly permeable. When the repeated water infiltration was applied to the compacted soil sample, fine particles around gravels tended to easily move and flown out with water, resulting in the formation of scattered voids in the sample

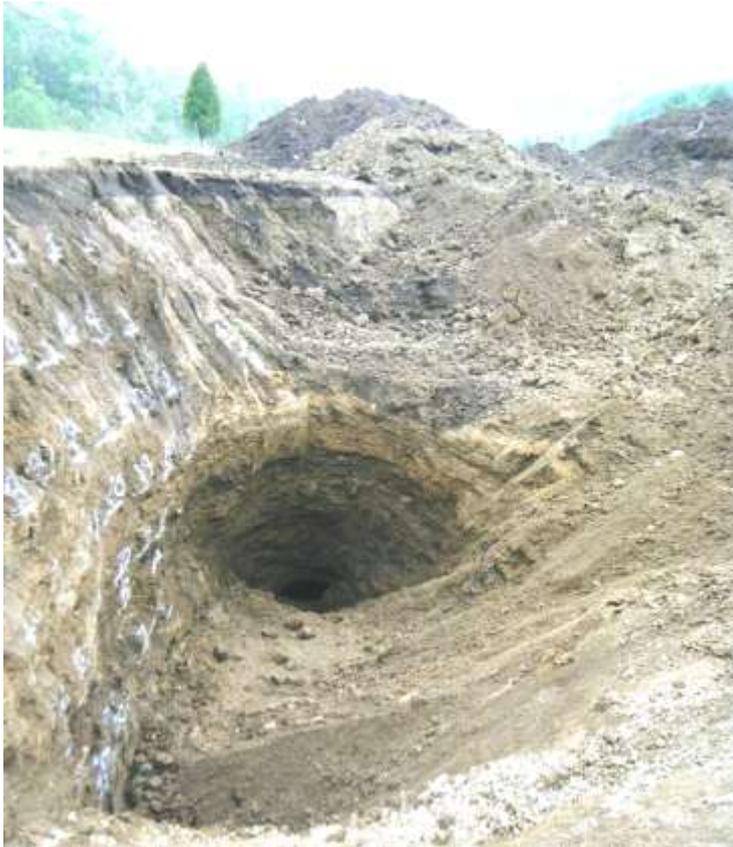
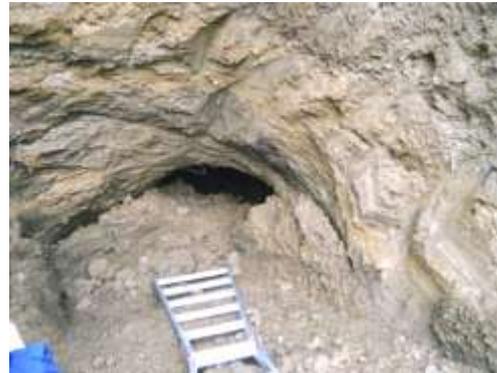
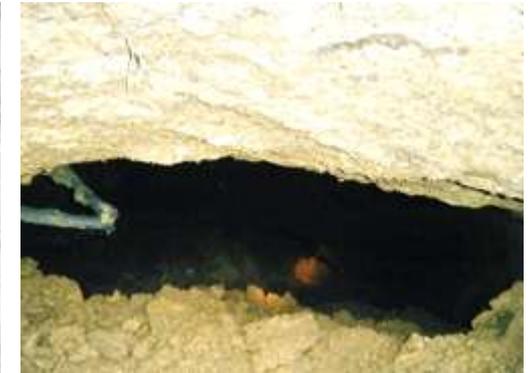
a lateral ground cavity: soil pipe

GL-8m , at the boundary between original stiff ground and filled soil about 20m west from the center of the hole.

the clear sound of water flow
at least 6m in length, 2m in width

A path through which soil with water was transported out of the hole.

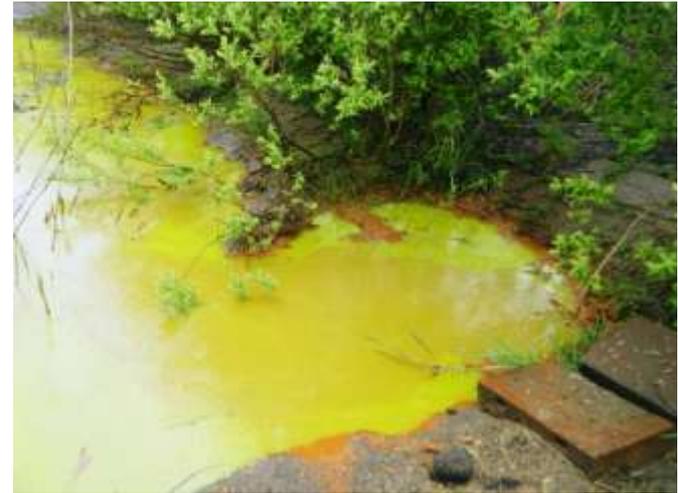
20 minutes
later

the colored water started flowing out at the reservoir, 700m down from the cavity.

A soil pipe seemed to be formed in the ground between the collapsed location and the reservoir

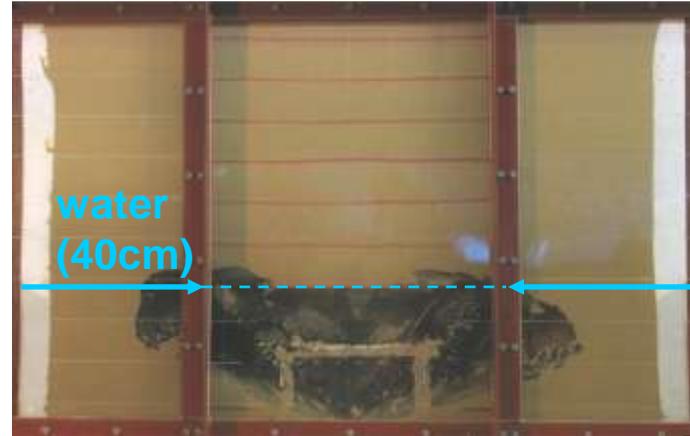
84 min.
after water table was raised to 40cm

Soil above
the cavity fell
