CHARACTERIZATION AND REPAIR OF INTERNAL EROSION IN SANDSTONE FOUNDATION

By J-J FRY & G. JORGE

INTERNAL EROSION IN DAM FOUNDATION

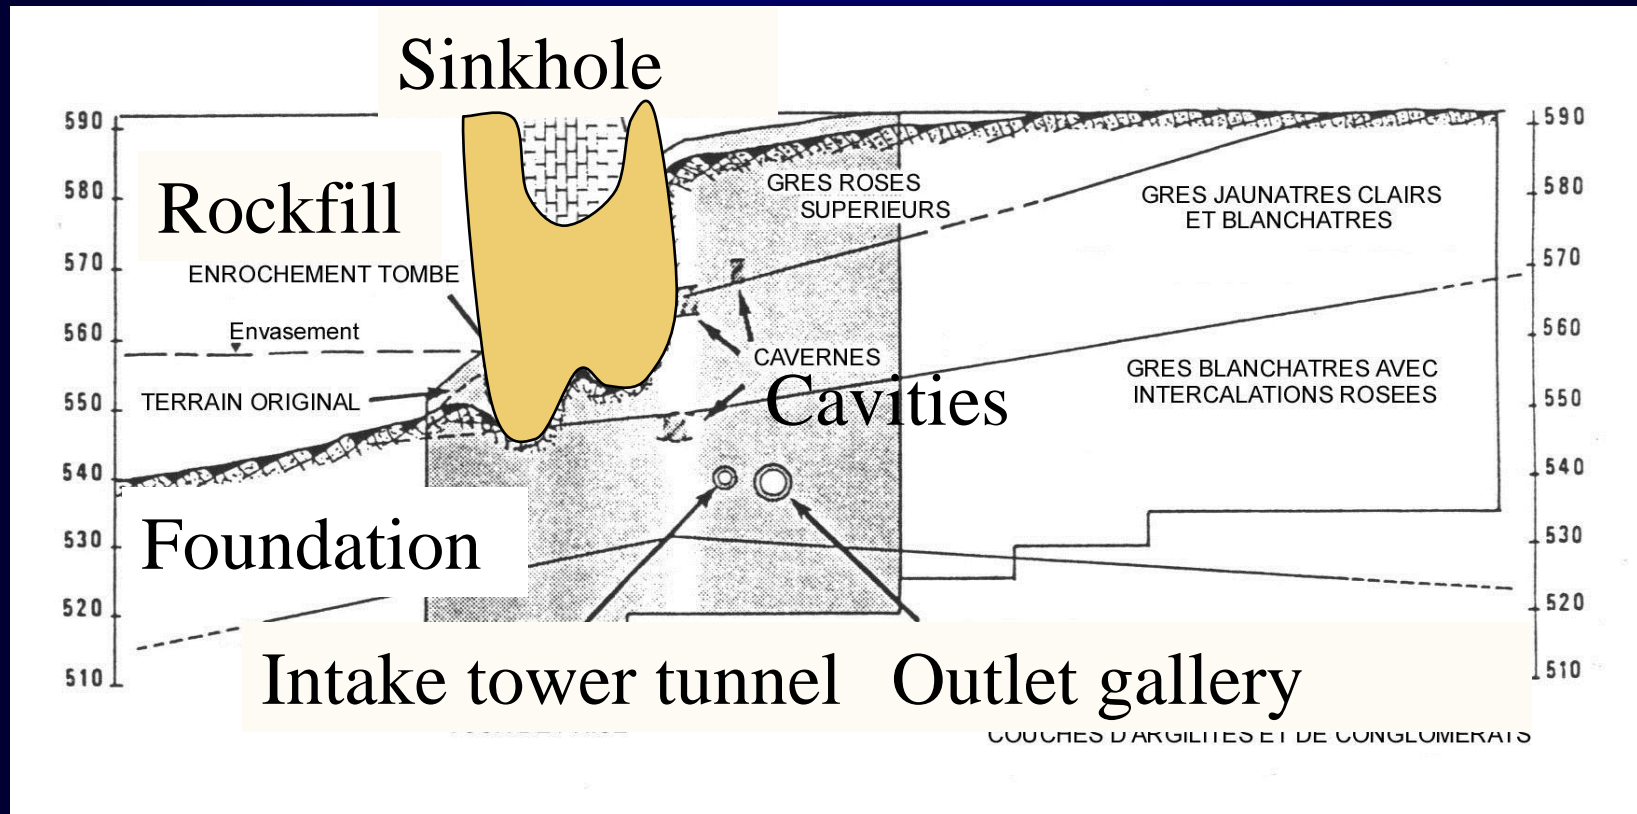
Lessons from ITIYURO dam

Leakages caused internal erosion in the sandstone foundation ($>1000\text{m}^3$) Sinkholes occurred in the rockfill crest and upstream face

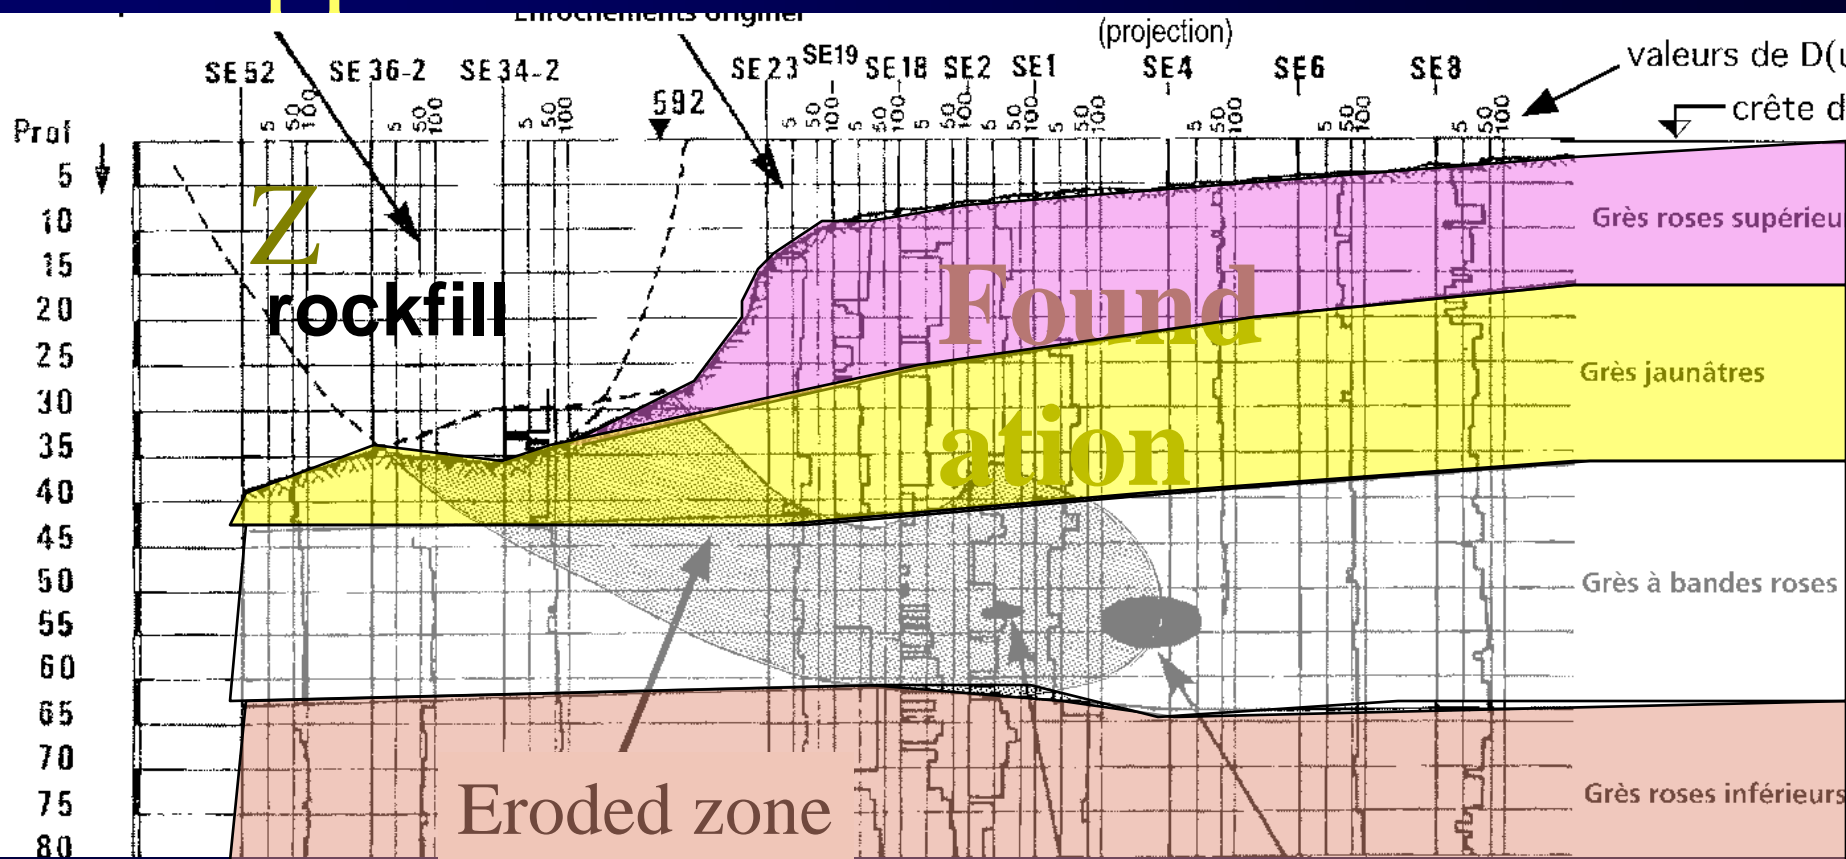
Application to ITIYURO dam

weak sandstones which suffered internal erosion have very low hardness values :

$$\text{DUR} < 20.$$

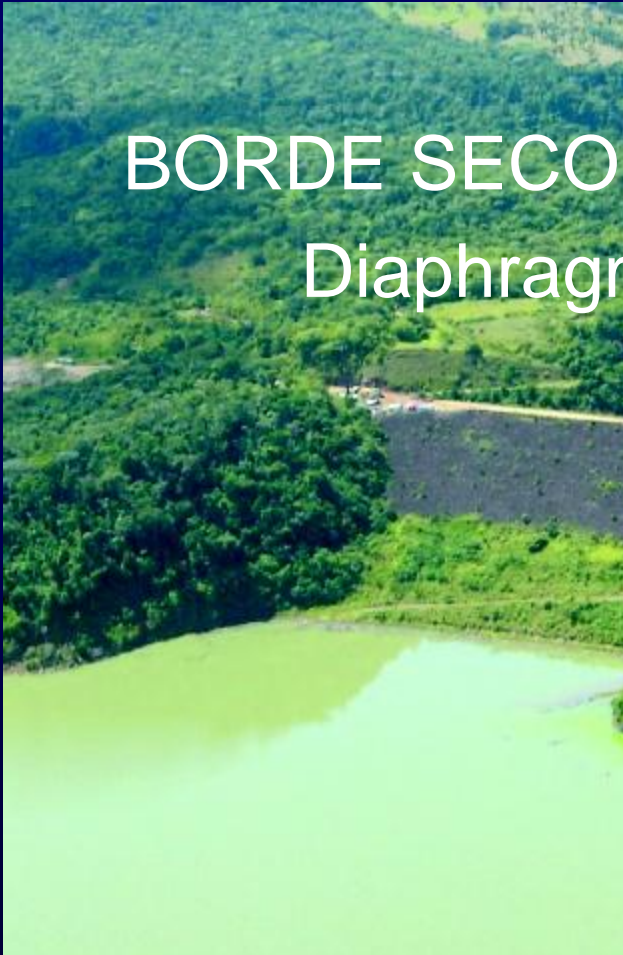
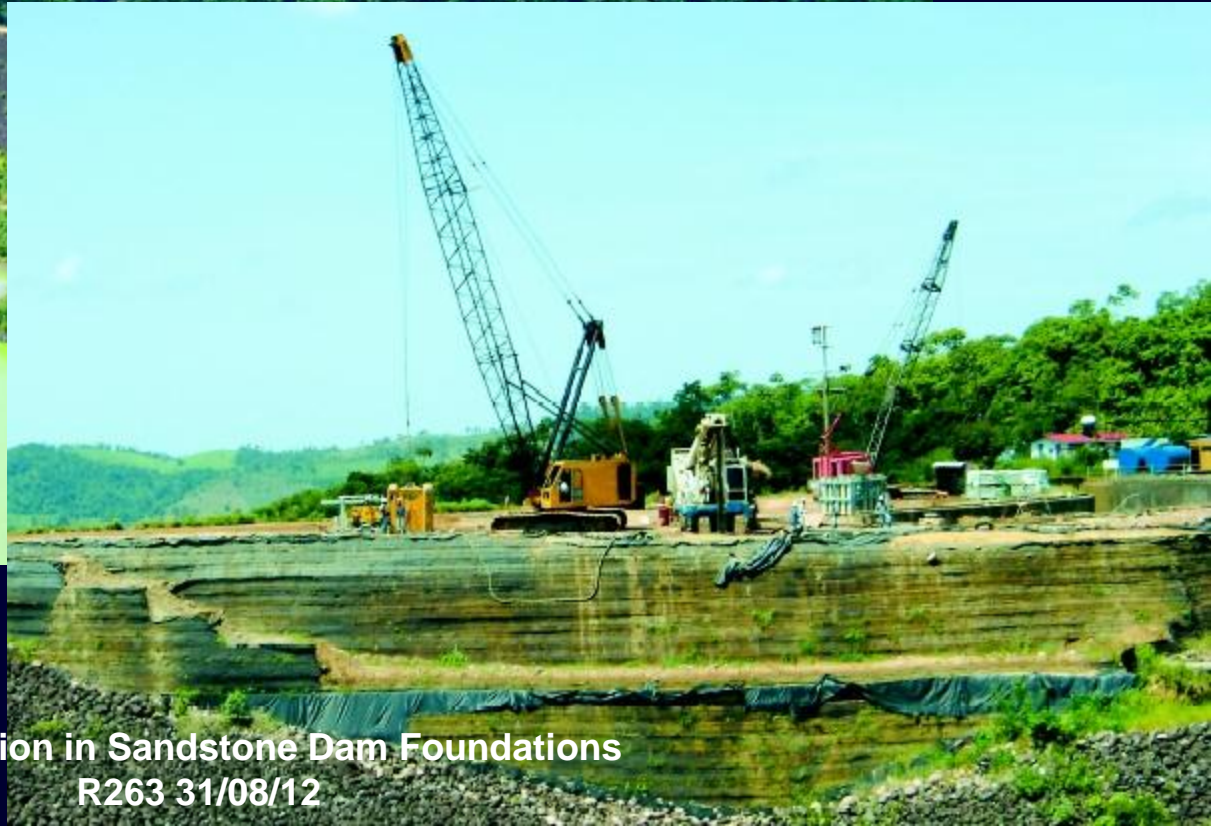
BORDE SECO suffered internal erosion
Diaphragm wall was required
