# Classification of the Eroded Cavings behind Concrete-faced Embankments by Ground-Penetrating Radar

Jian-Hong Wu

Dept. Civil Engineering,

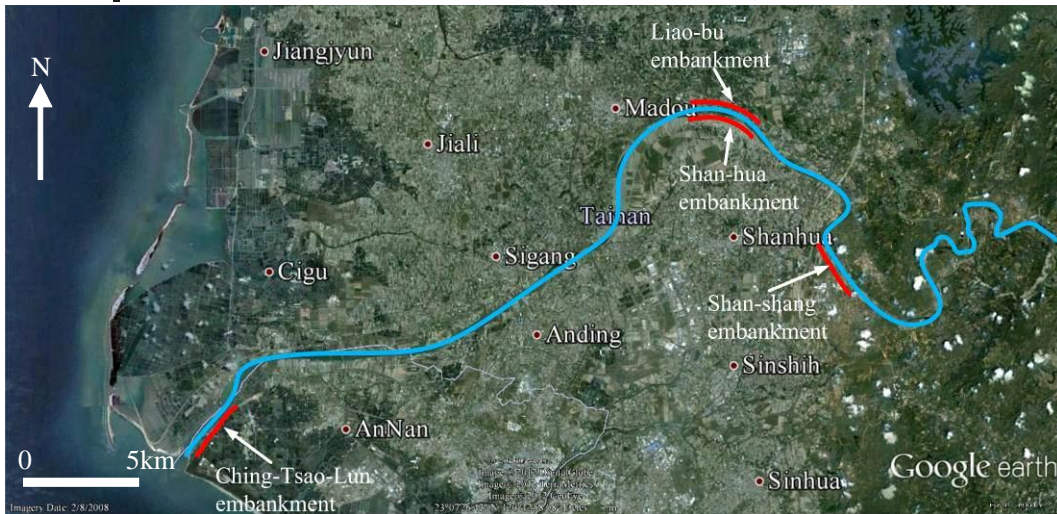
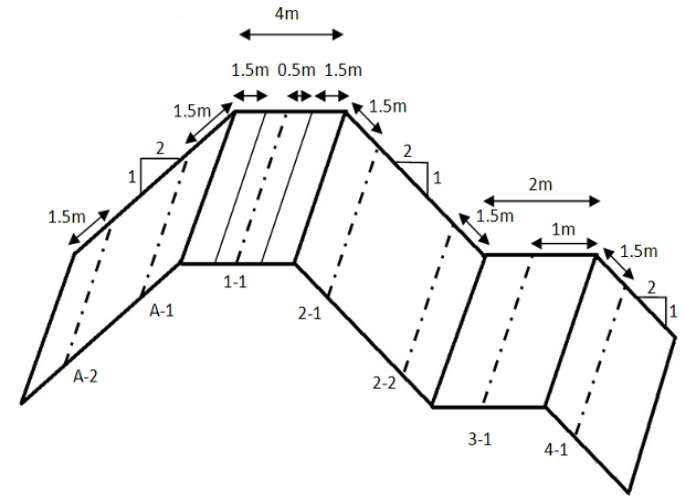
- Shan-shang embankment was built between 1998 and 2011.
- This section is close to the river trench (about 40-70 m) and often scoured out by the stream.
- The land side slope has 1 step concrete-faced, and the river side slope has 2 steps .
