RECENT DAM INCIDENTS AND FAILURES IN SWEDEN

Granö
Hästberga
(Kvistforsen)

Ingvar Ekström

Granö Hydro Power Plant in Mörrumså

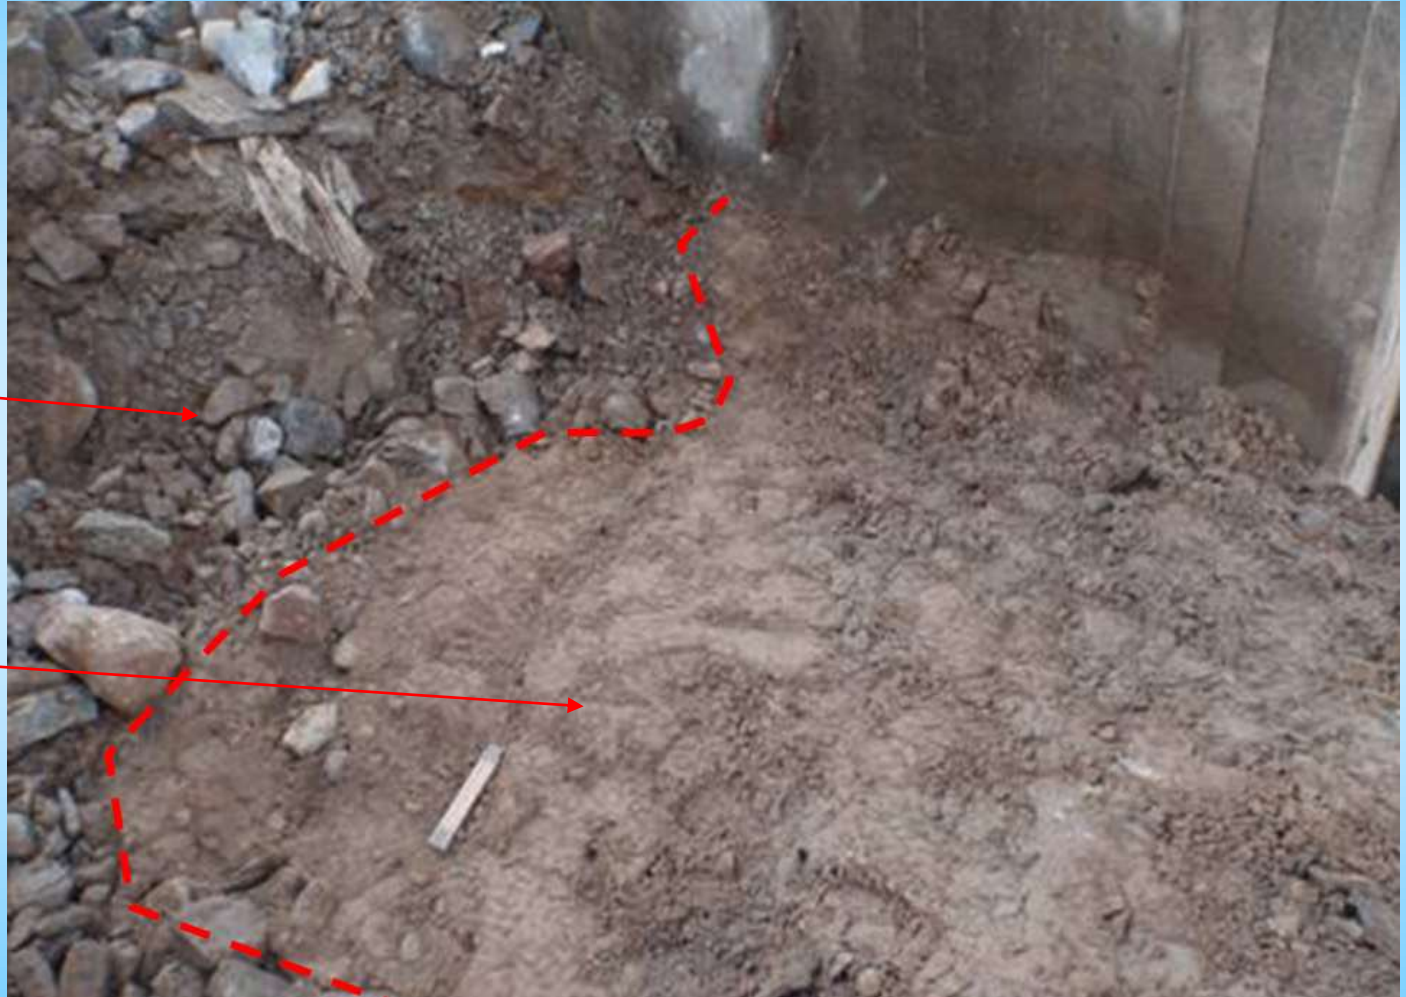
No downstream filter

Loosely
compacted rock
fill with high
porosity

Till core

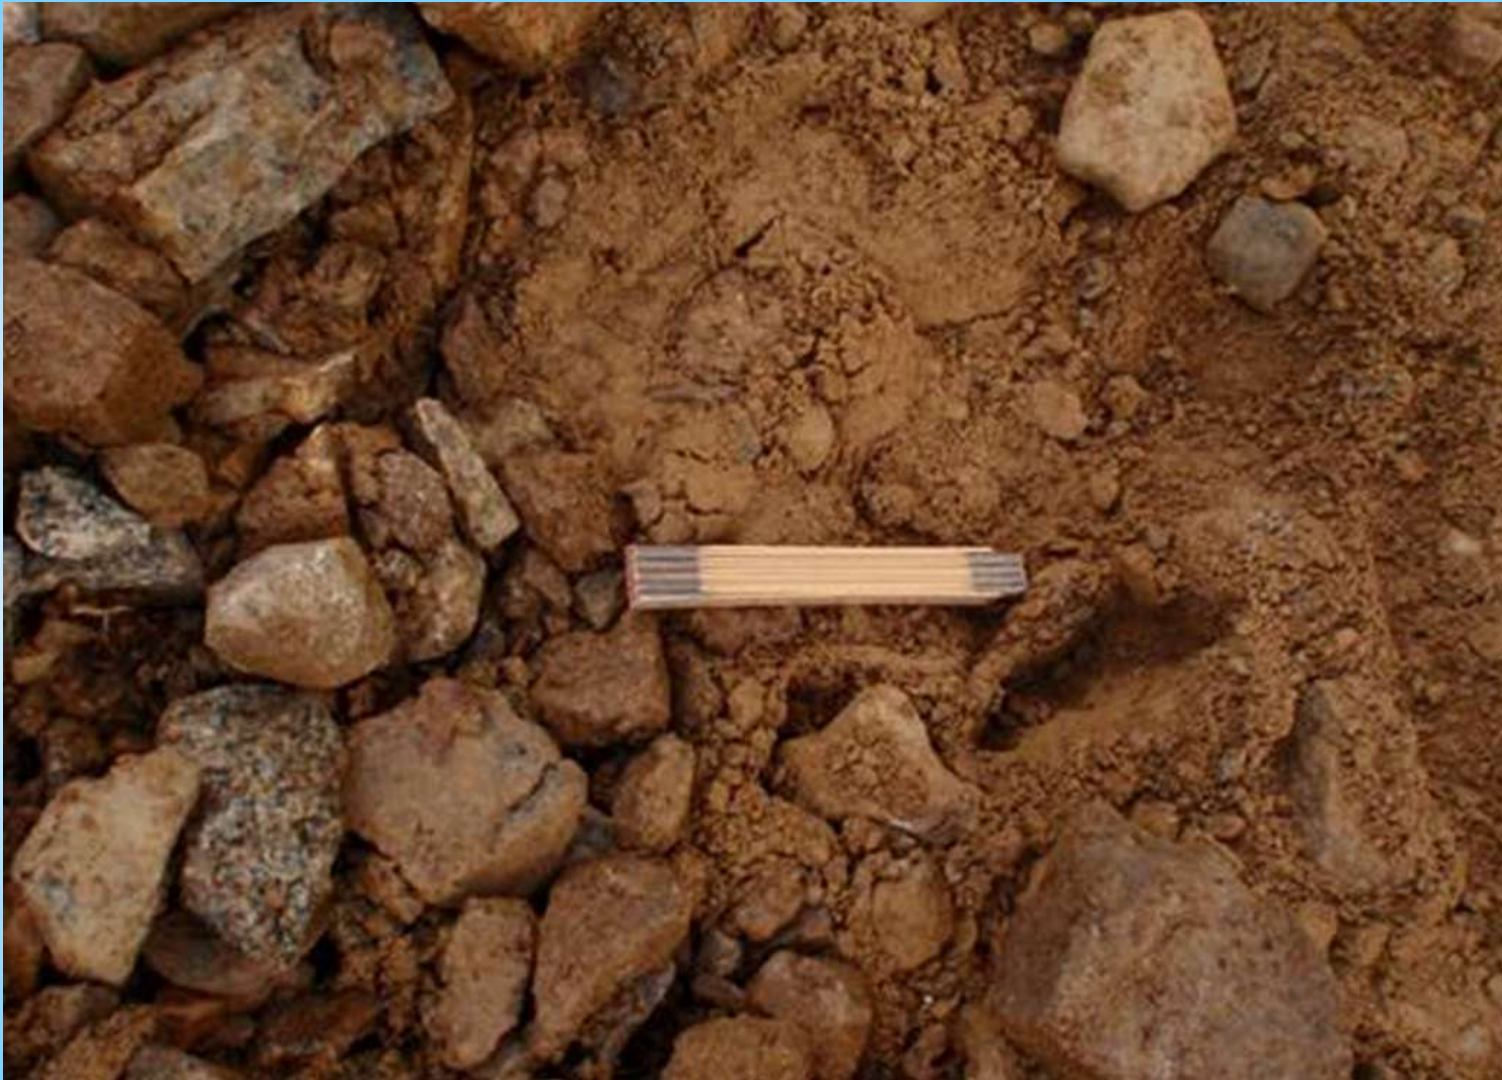
Connection core – "filter"

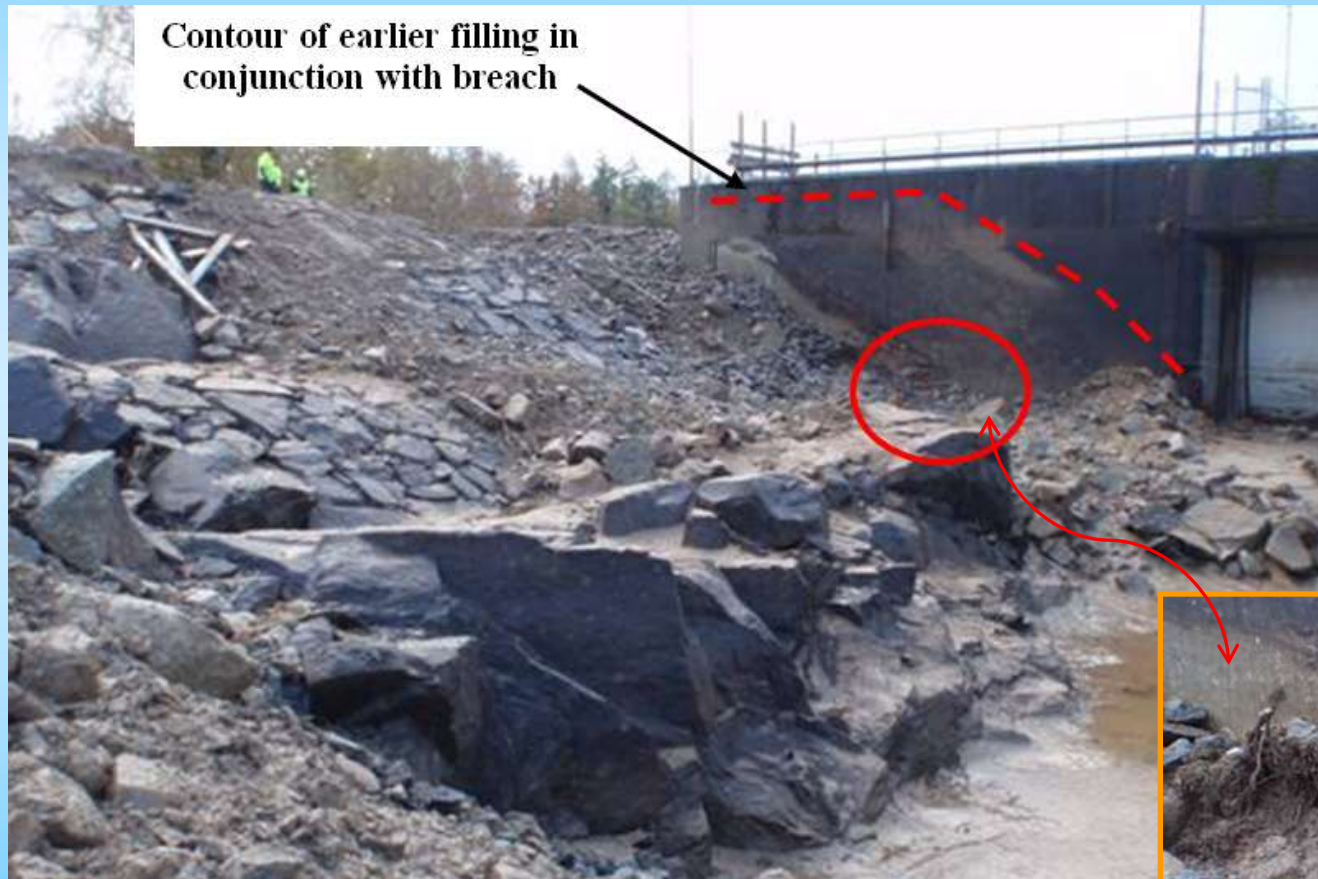
Wooden sheet pile found upstream in the canal

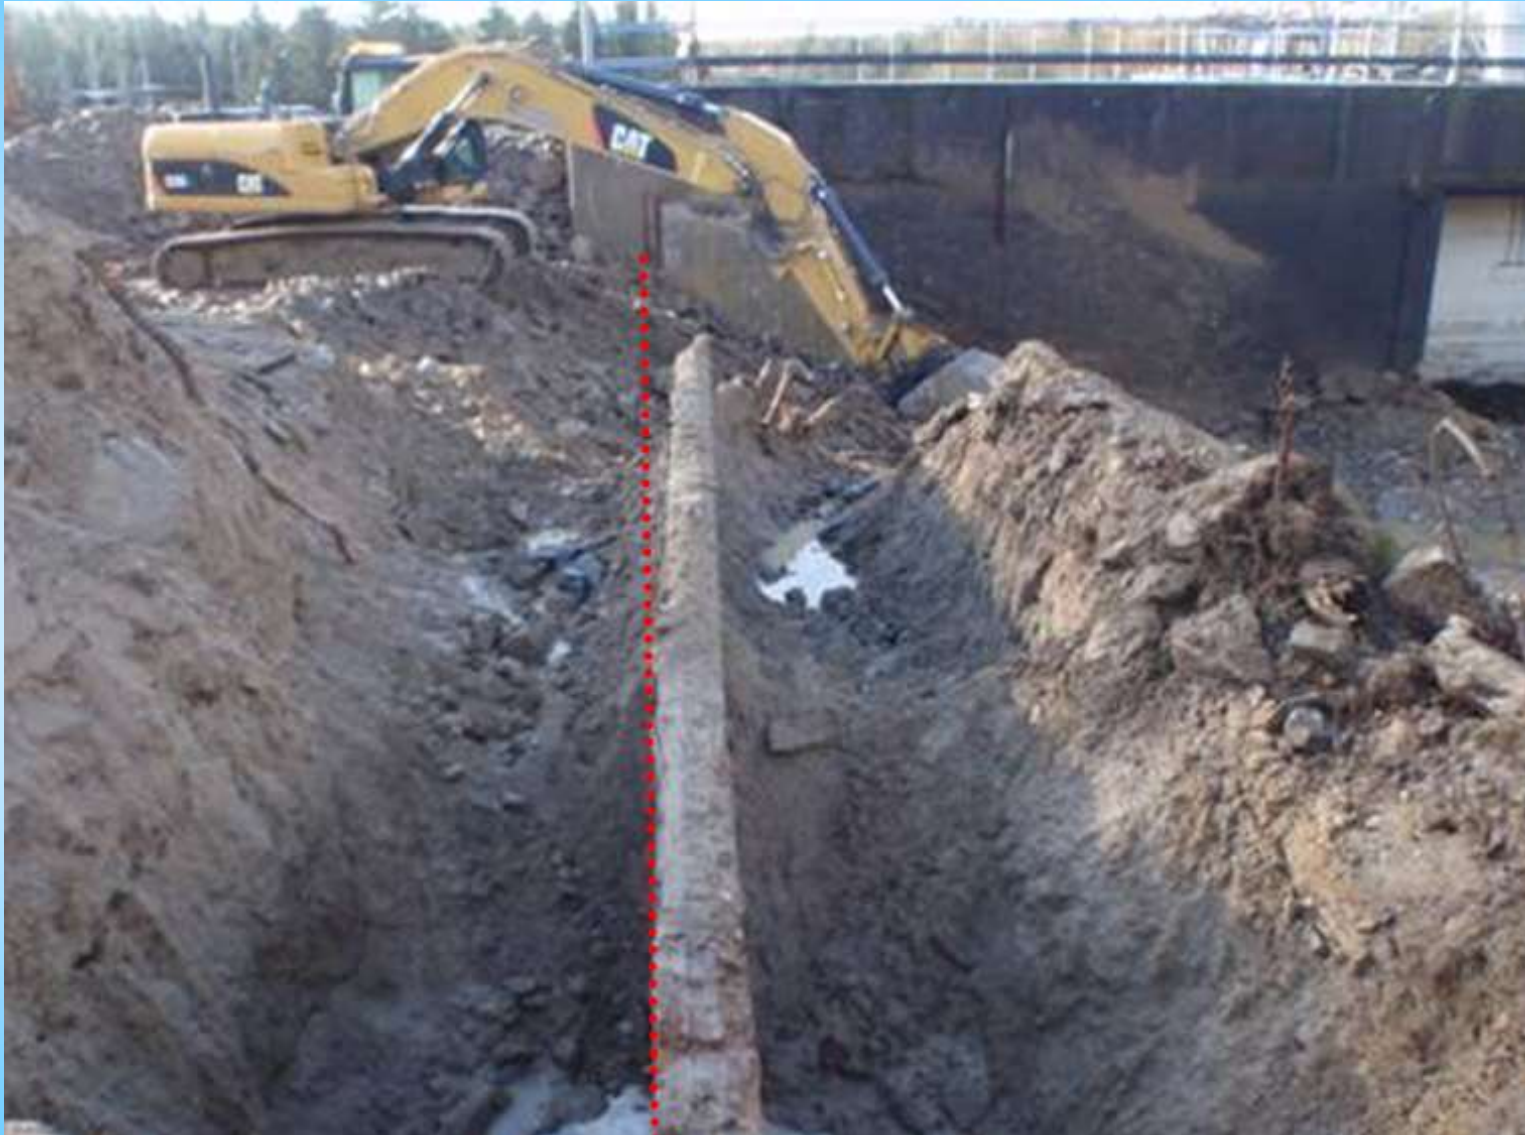
Displacement of sheet pile

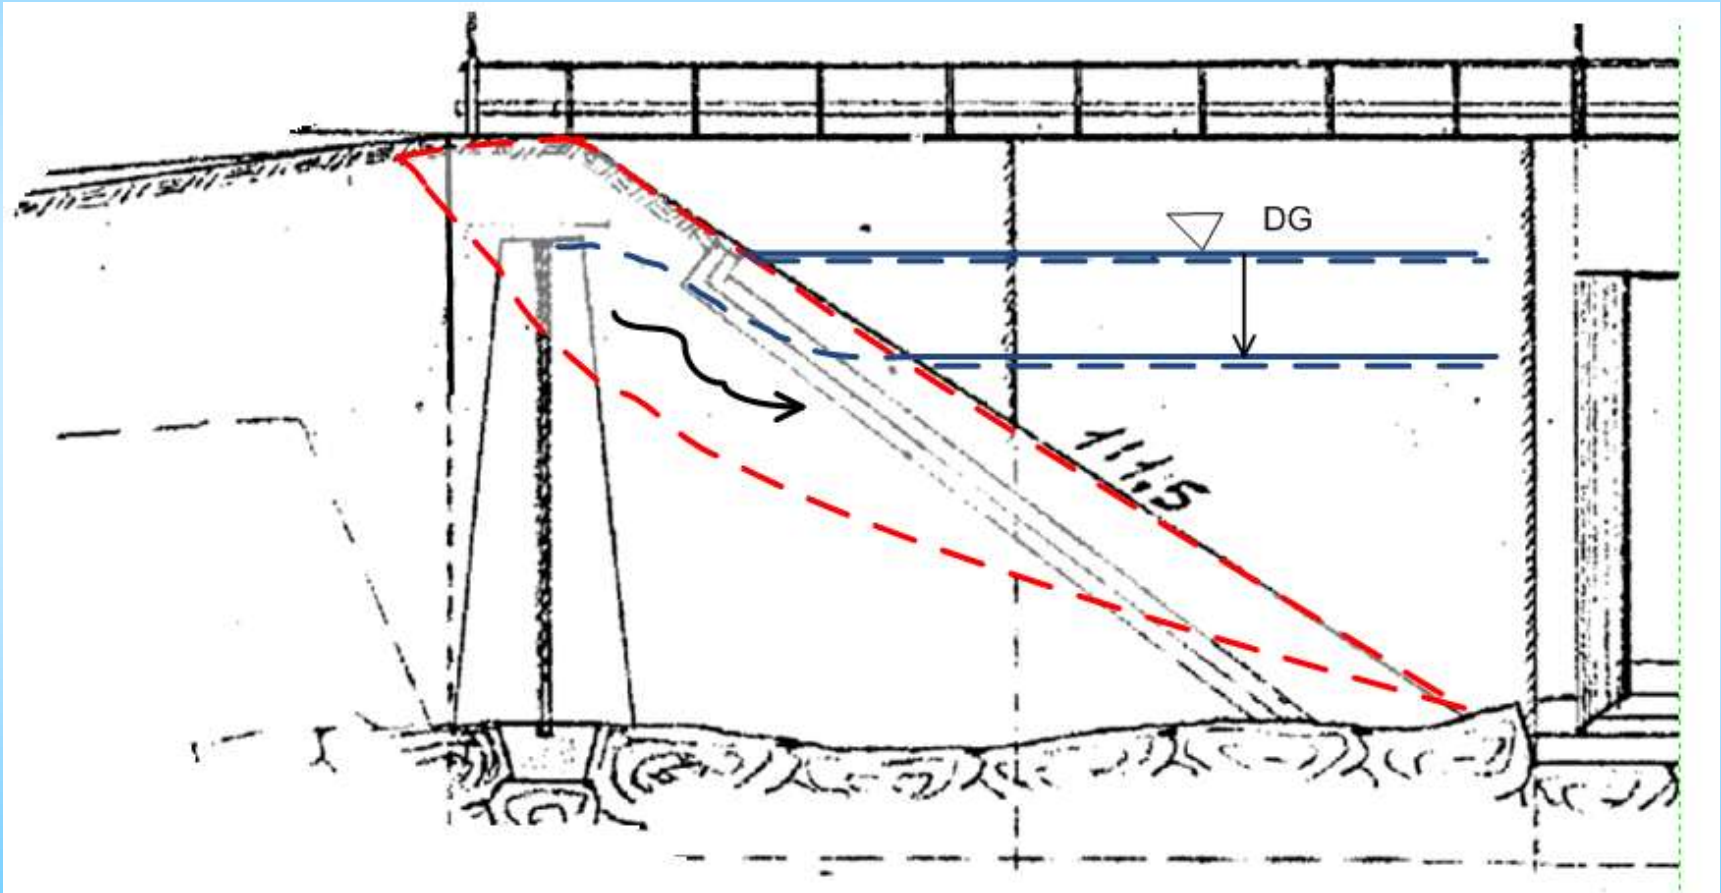
Cause of failure, slide in upstream direction, followed by downstream erosion

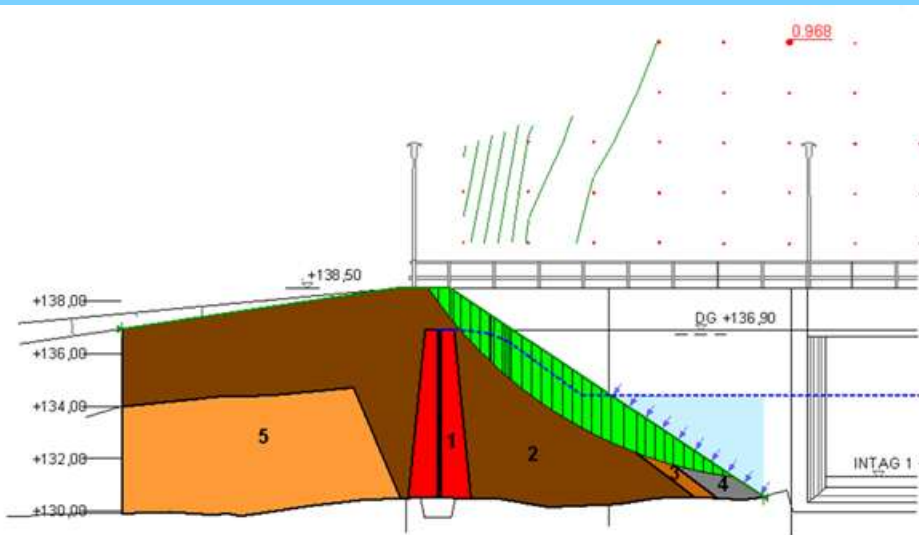
Stability in the upstream direction

2.5 m draw down $F = 0.97$

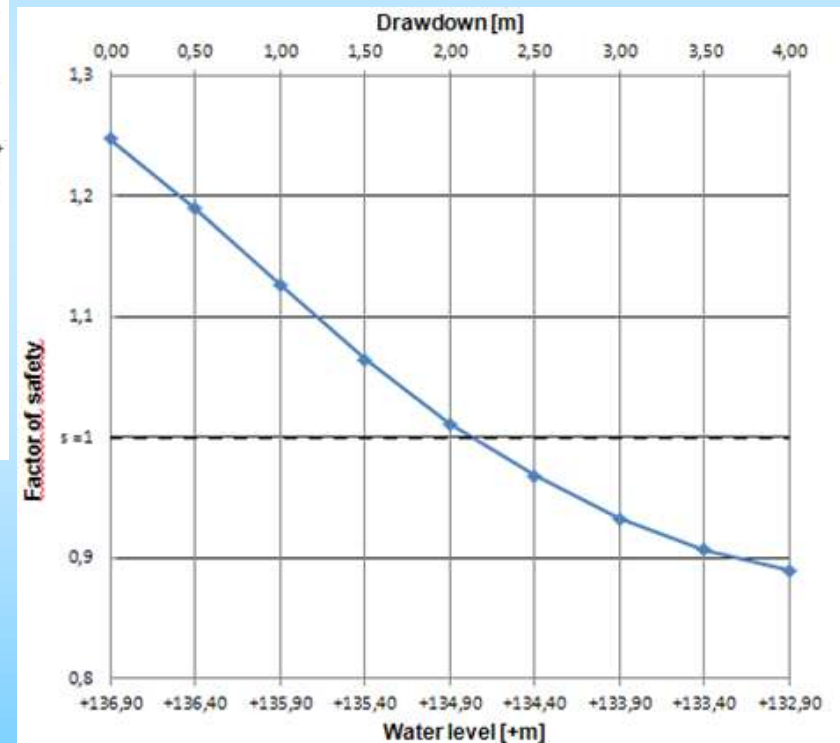
Fine grained fill resulting in high pore pressure uplift

Factor of safety as a function of drawdown

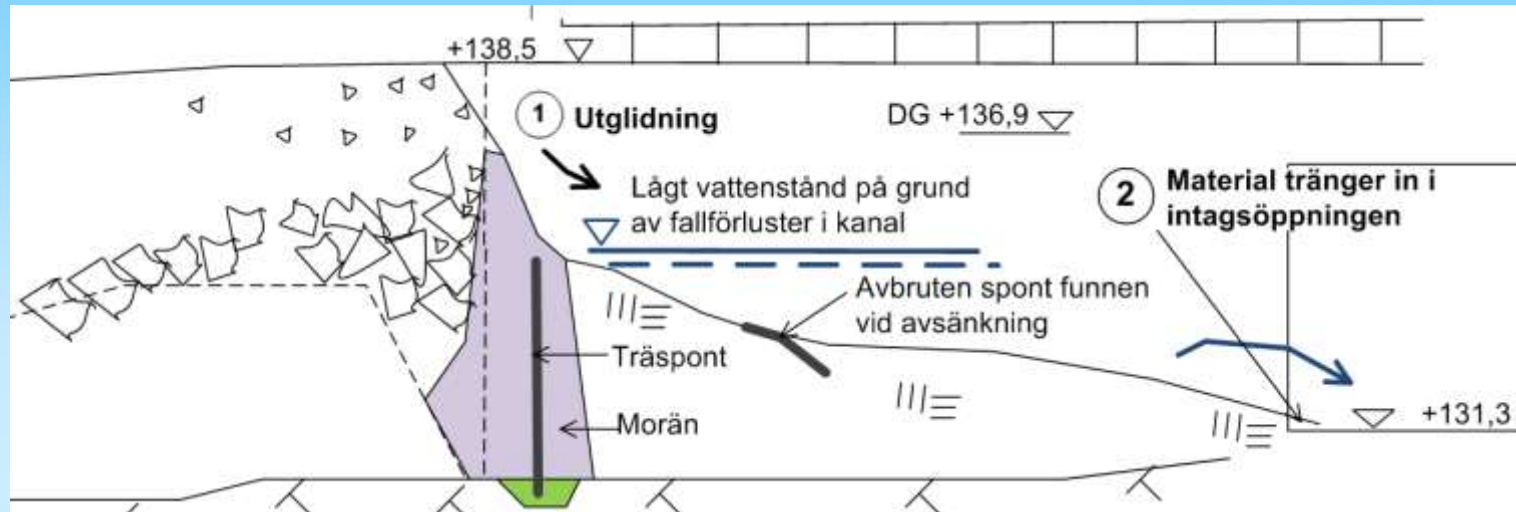
1. Failure in the upstream direction caused by the sudden drawdown

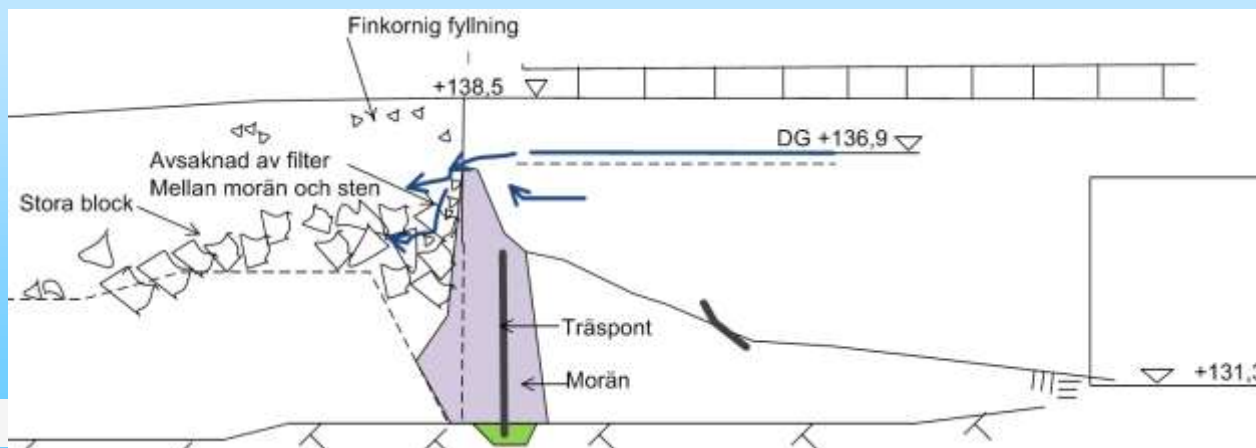
2.

The turbine effect decreases and the operational center shuts it down, causing a sudden raise of the water level to the maximum retention level and overflow the damaged section and erodes the remaining part of the core. 4 hours ...

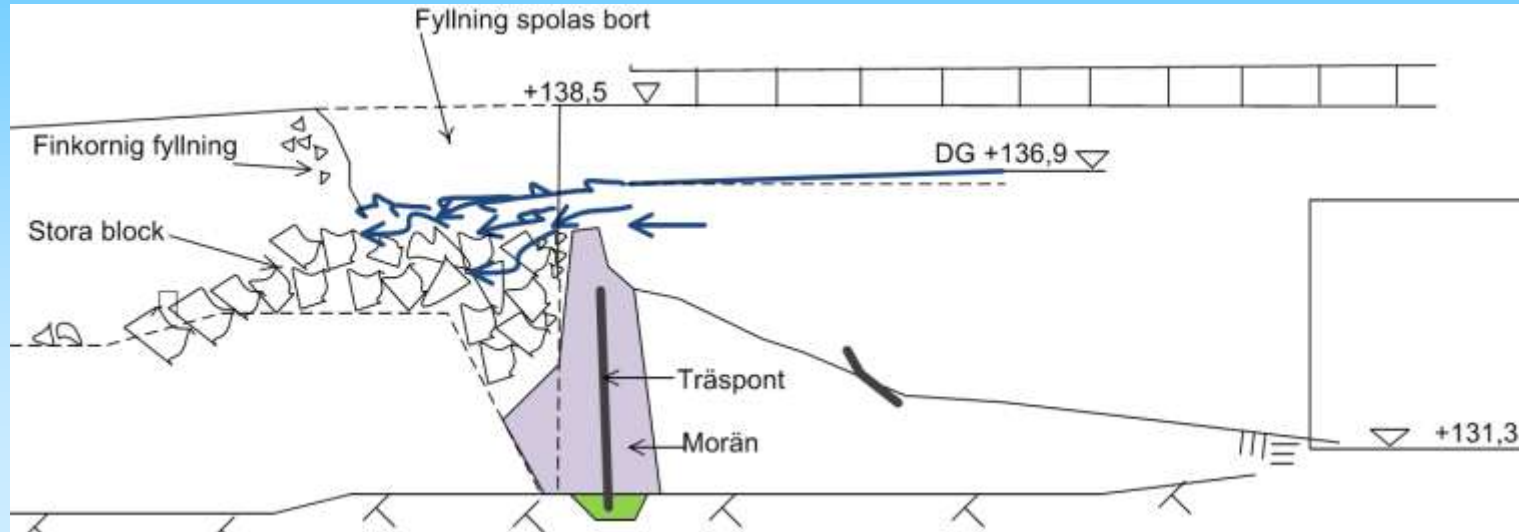
3.

Fine material from the core and remaining upper fill is washed into the coarse loosely compacted rock fill below.

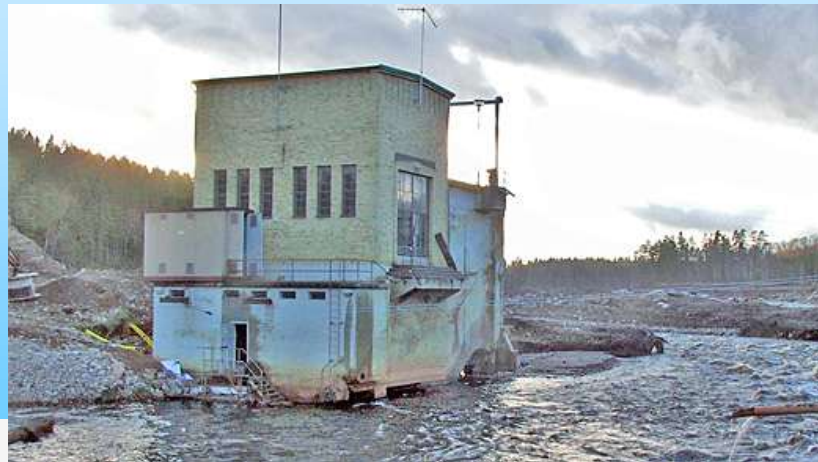
Hästberga – still awaiting court decision. Will affect insurance case
