Living shoreline techniques for bank protection along estuarine waterways

Collection of measures in tidal areas

25. April 2022

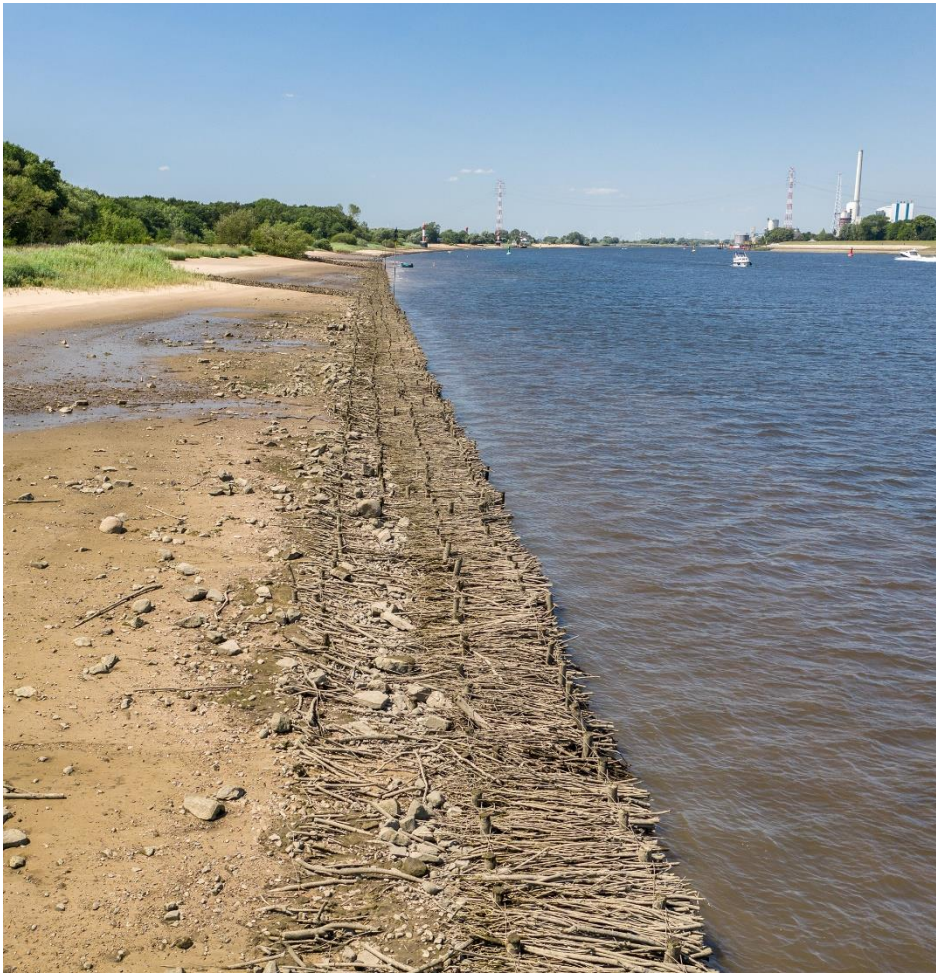
Beach protection with brushwood training wall Warflether Sand

- **Km 23.50-24.90** left bank Weser
- **Implementation period:** n/a
- **Contact:** Branch office Farge:
sven.wennekamp@wsv.bund.de
- **Construction design:** Brushwood training wall (longitudinal structure consisting of tied fascines) made of hardwood fascines to protect the beach
- Maintenance of the training wall is carried out on a section by section basis

Brushwood training wall and brushwood groynes acting as beach protection.

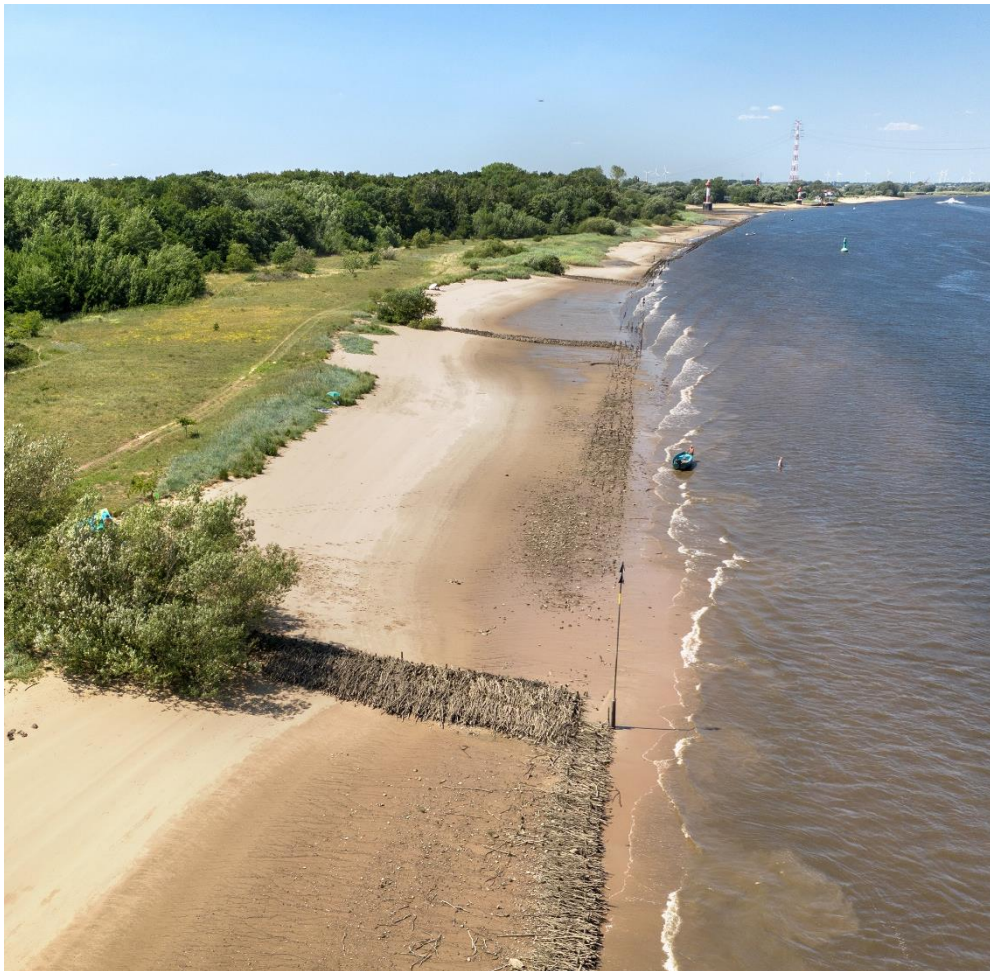
Beach protection with groynes Warflether Sand

- **Km 23.50-24.90** left bank Weser
- **Implementation period:** n/a
- **Contact:** Branch office Farge: sven.wennekamp@wsv.bund.de
- **Construction design:** Brushwood groynes made of hardwood fascines tied to stakes
- Groynes are patched as necessary (every 2-4 years)

Brushwood groynes protecting the beach, combined with a complementary brushwood training wall.

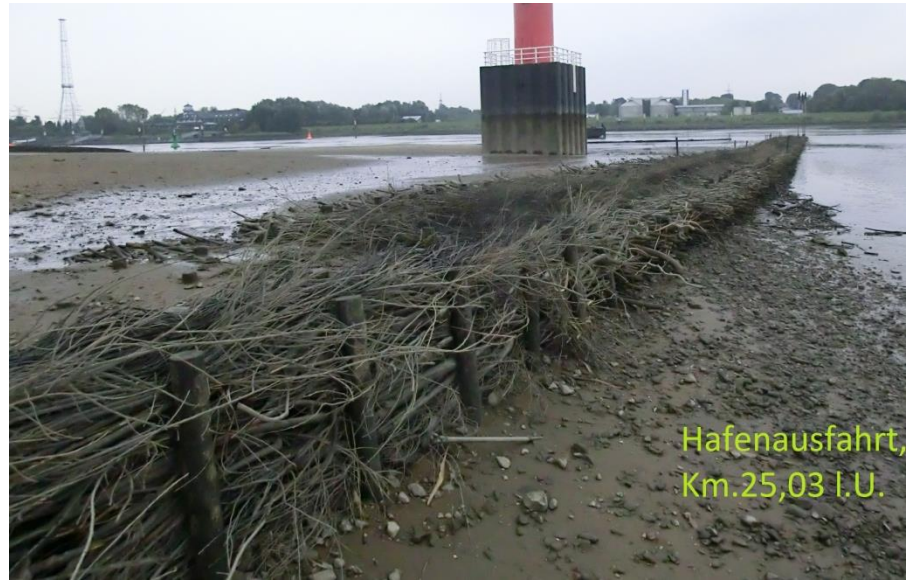
Beach protection with training wall Juliusplate

- **Km 25.00-25.50** left bank Weser
- **Implementation period:** n/a
- **Contact:** Branch office Farge: sven.wennekamp@wsv.bund.de
- **Construction design:** Brushwood training wall made of hardwood to protect the beach
- Reinstatement works are carried out as necessary

Brushwood training wall made of hardwood acting as beach protection.

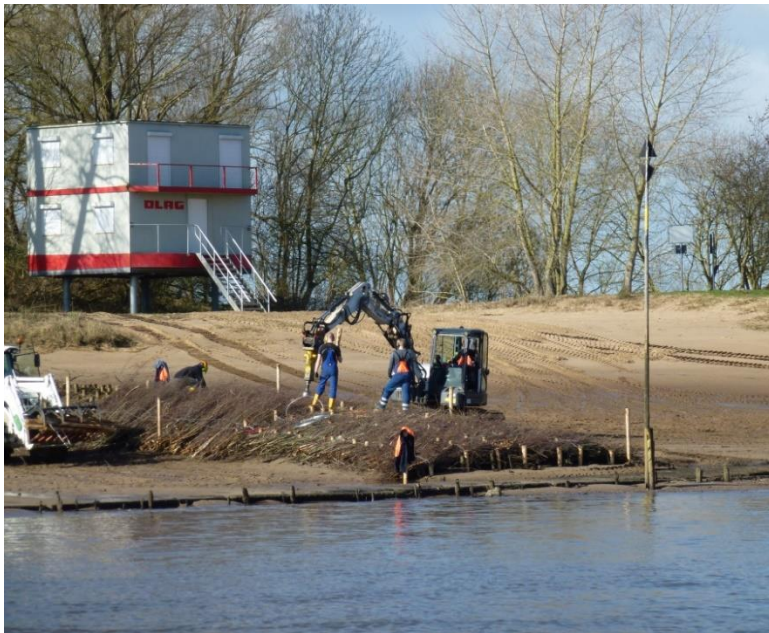
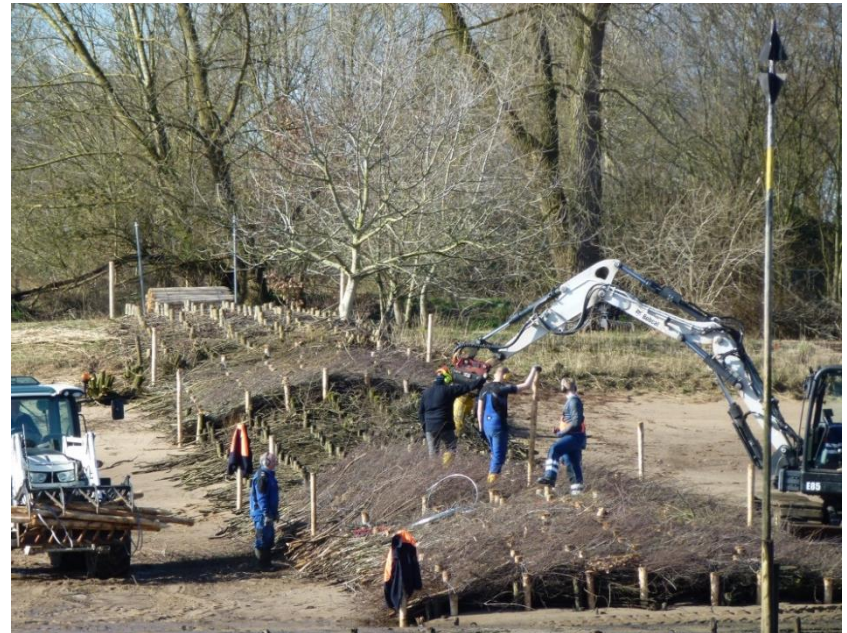
Beach protection with groynes Juliusplate

- **Km 25.00-25.50** left bank Weser
- **Implementation period:** n/a
- **Contact:** Branch office Farge: sven.wennekamp@wsv.bund.de
- **Construction design:** Brushwood groyne made of hardwood fascines tied to stakes to protect the beach
- Refilling of the groynes is carried out as necessary

Reinstatement of the brushwood groynes acting as beach protection (March 2020).

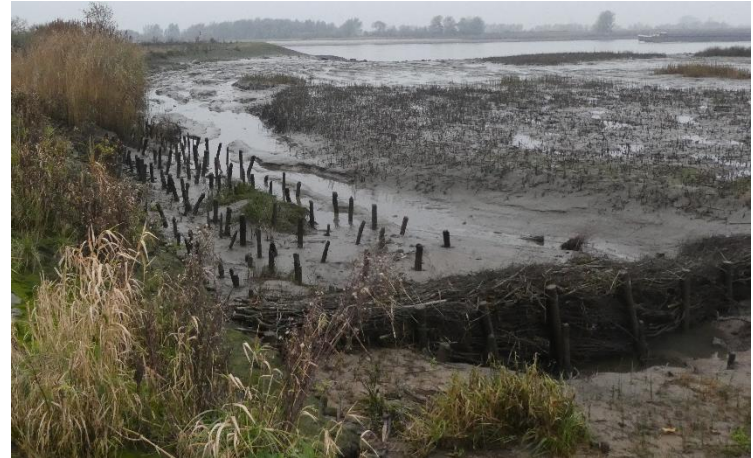
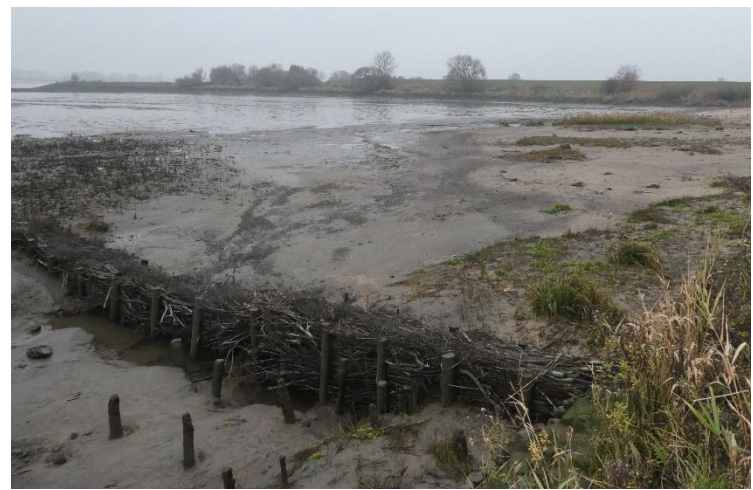
- **Km 27.850** right bank Weser
- **Implementation period:** 2020
- **Contact:** Branch office Farge:
sven.wennekamp@wsv.bund.de
- **Construction design:** Brushwood box to damp a creek running along the revetment

Damping of a creek running between the revetment and a vegetation field. Photo taken shortly after completion of the measure (2020).

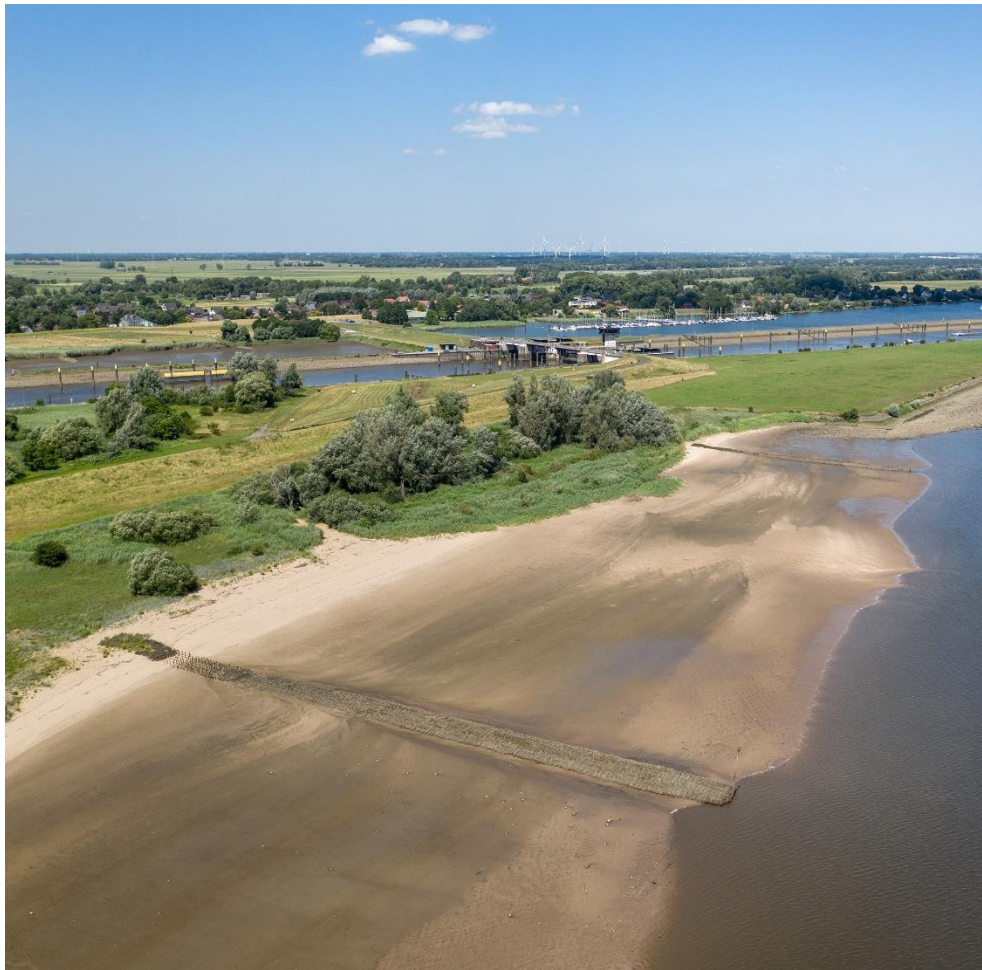
Beach protection with groynes Elsflether Sand

- **Km 28.50-31.40** left bank Weser
- **Implementation period:** n/a
- **Contact:** Branch office Farge:
sven.wennekamp@wsv.bund.de
- **Construction design:** Brushwood groyne made of hardwood fascines tied to stakes acting as beach protection
- Refilling of the groynes is carried out as necessary

Brushwood groynes protecting the beach.

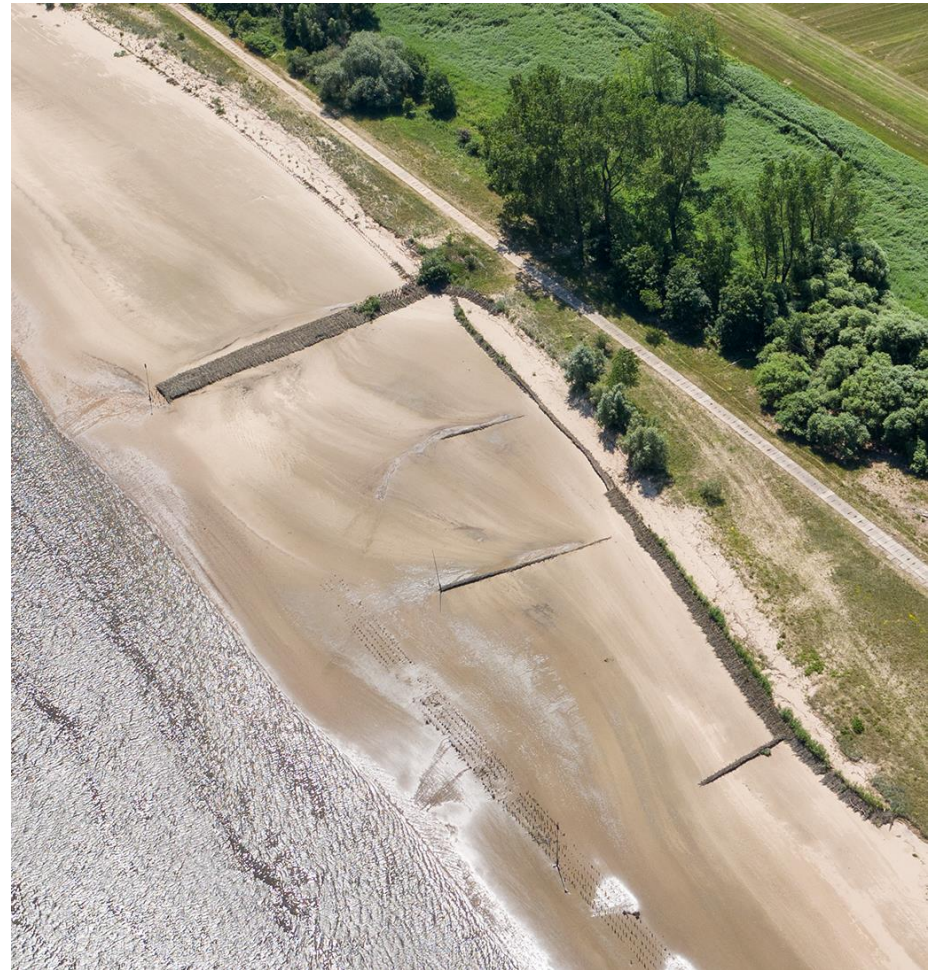
Beach protection with brush mattress Elsflether Sand

- **Km 28.50-31.40** left bank Weser
- **Implementation period:** From 2016-2017
- **Contact:** Branch office Farge:
sven.wennekamp@wsv.bund.de
- **Construction design:** Willow brush mattresses made of hardwood fascines tied to stakes acting as bank protection
- Refilling of the mattresses is carried out as necessary

Longitudinal brush mattress structure installed landward from the groynes.

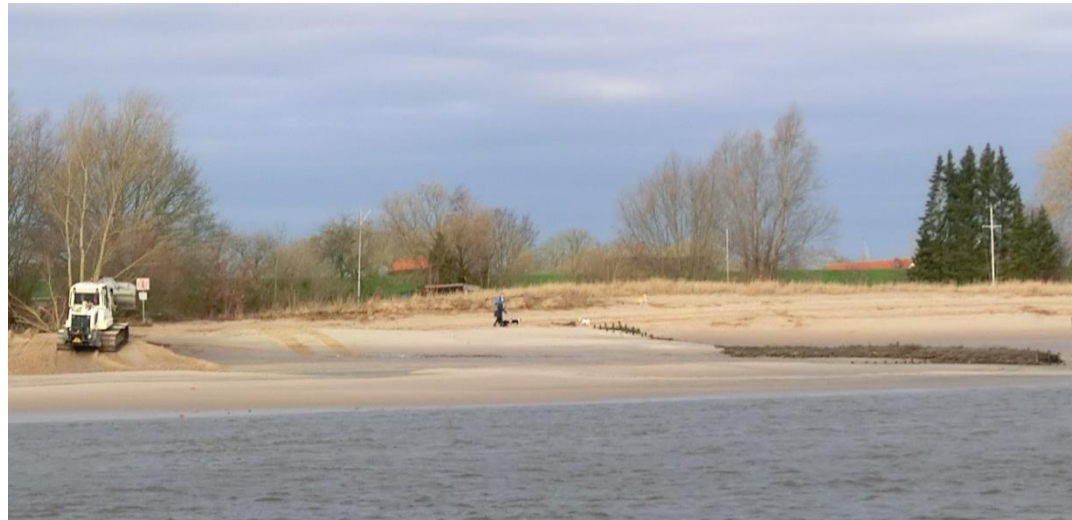
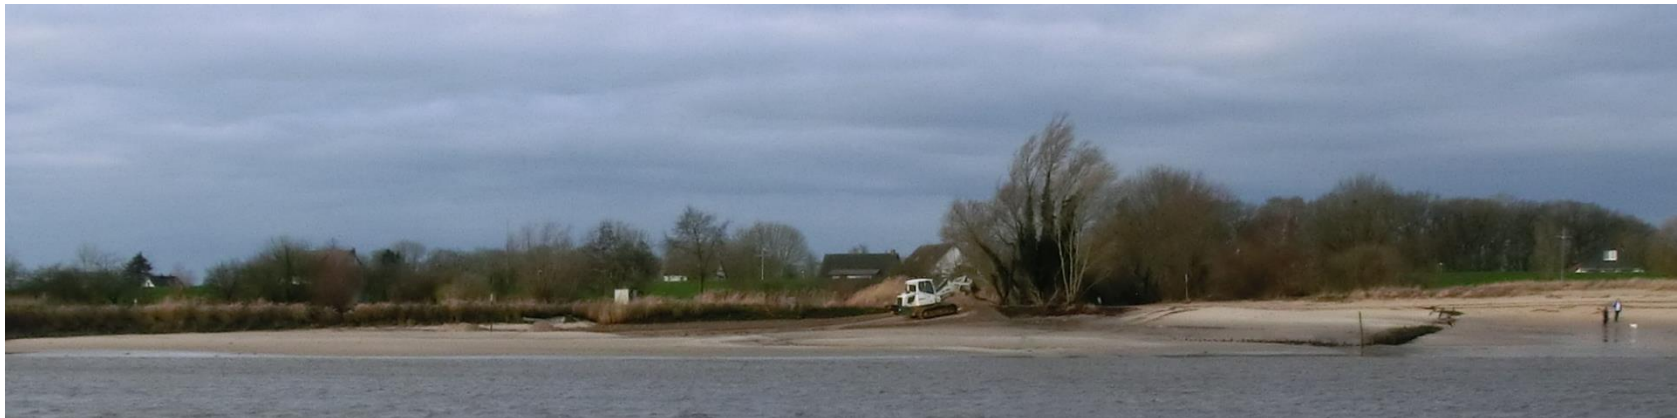
Beach protection with brush mattress Elsfleth marina

- **Km 32.75** left bank Weser
- **Implementation period:** From 2015
- **Contact:** Branch office Farge: sven.wennekamp@wsv.bund.de
- **Construction design:** Dead wood brush mattresses made of hardwood fascines tied to stakes to protect the bank and trap sand at the lock entrance
- Refilling of the mattresses is carried out as necessary

Brush mattresses acting as bank protection and sand trap.

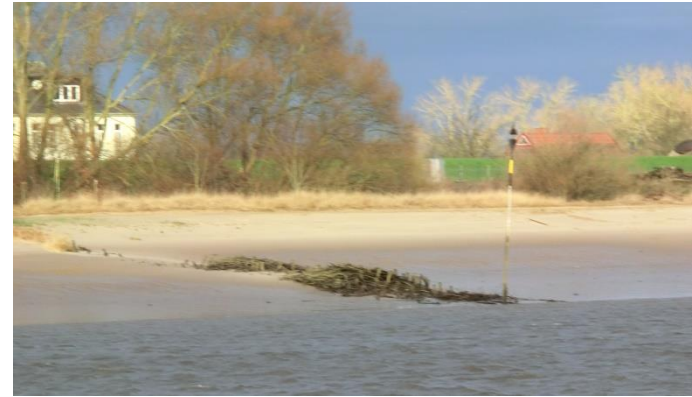
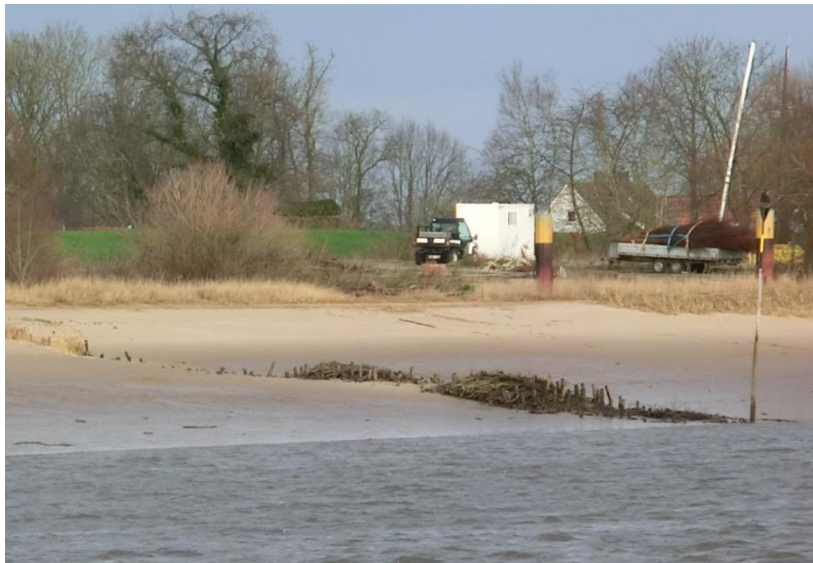
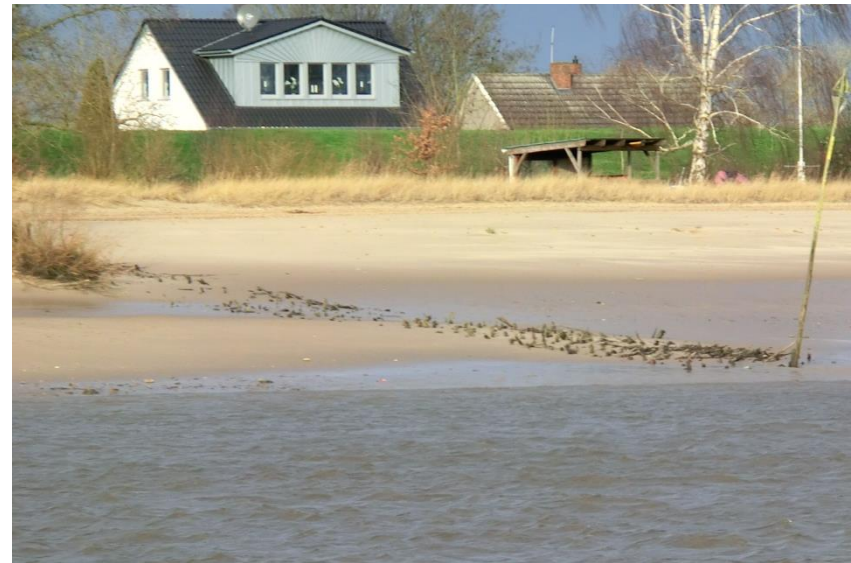
- **Km 33.10-33.25** left bank Weser
- **Implementation period:** n/a
- **Contact:** Branch office Farge: sven.wennekamp@wsv.bund.de
- **Construction design:** Brushwood groyne made of hardwood fascines tied to stakes acting as beach protection
- Refilling of the groynes is carried out as necessary

Brushwood groynes directly adjacent to the Weser dike to protect the beach.

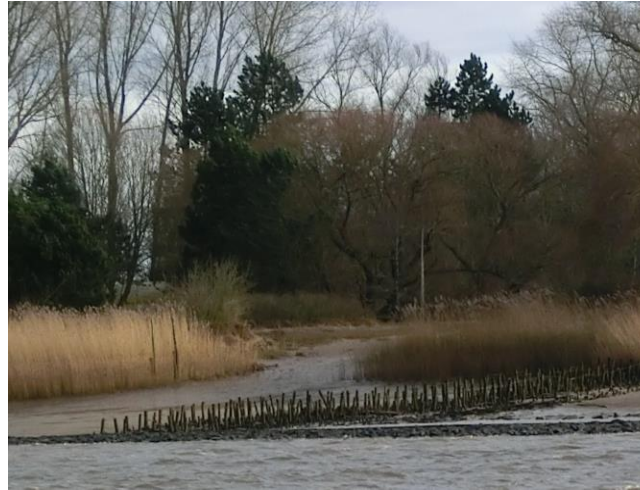
- **Km 33.30-34.25** right bank Weser
- **Implementation period:** n/a
- **Contact:** Branch office Farge: sven.wennekamp@wsv.bund.de
- **Construction design:** Brushwood groynes made of hardwood fascines tied to stakes acting as beach protection
- The groynes have been in place for several decades and are refilled as necessary

Brushwood groynes near Harriersand.

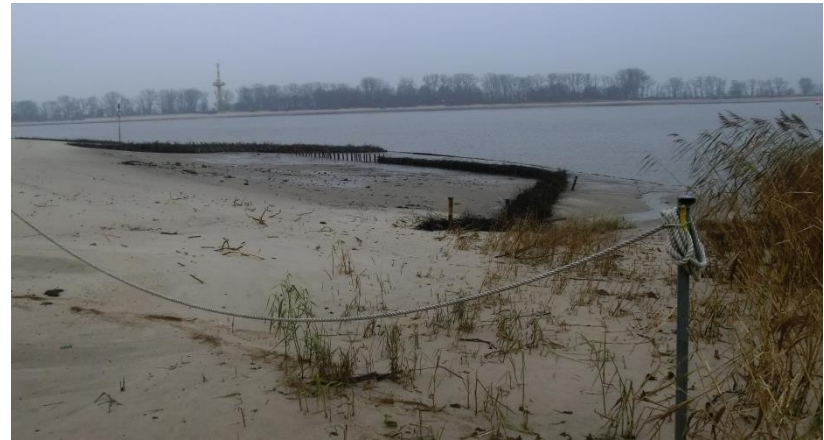
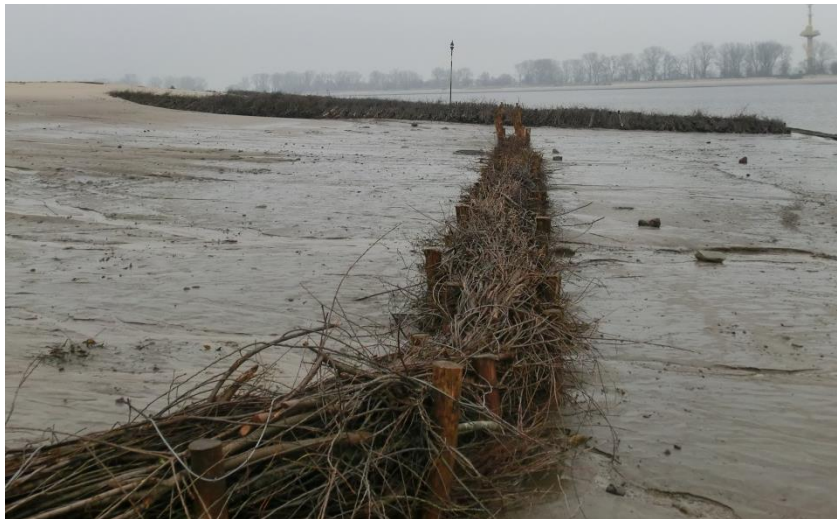
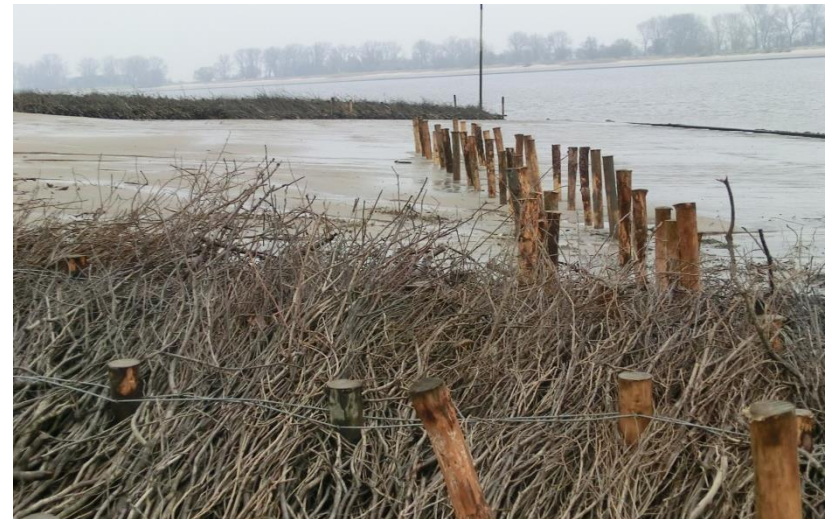
- **Km 36.50-36.60** left bank Weser
- **Implementation period:** n/a
- **Contact:** Branch office Farge: sven.wennekamp@wsv.bund.de
- **Construction design:** Brushwood training wall made of hardwood fascines tied to stakes acting as beach protection
- Refilling of the training wall is carried out as necessary

Training wall made of tied fascines.

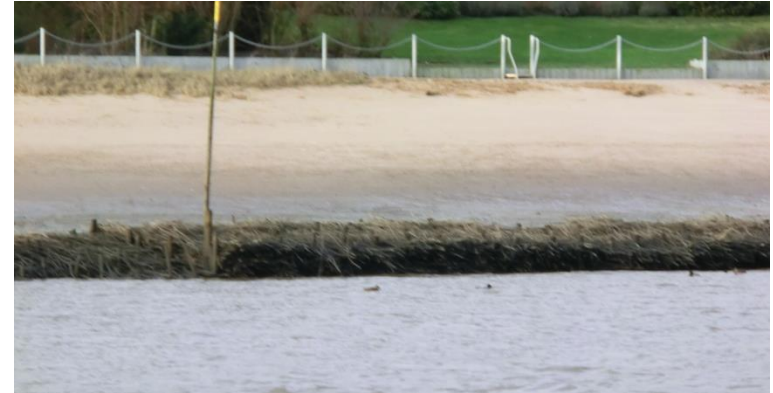
- **Km 38.10-38.20** left bank Weser
- **Implementation period:** 2013
- **Contact:** Branch office Farge:
sven.wennekamp@wsv.bund.de
- **Construction design:** Brushwood training wall made of hardwood fascines tied to stakes acting as beach protection
- Refilling of the training wall is carried out as necessary

Brushwood training wall on the Schierlohstrand.

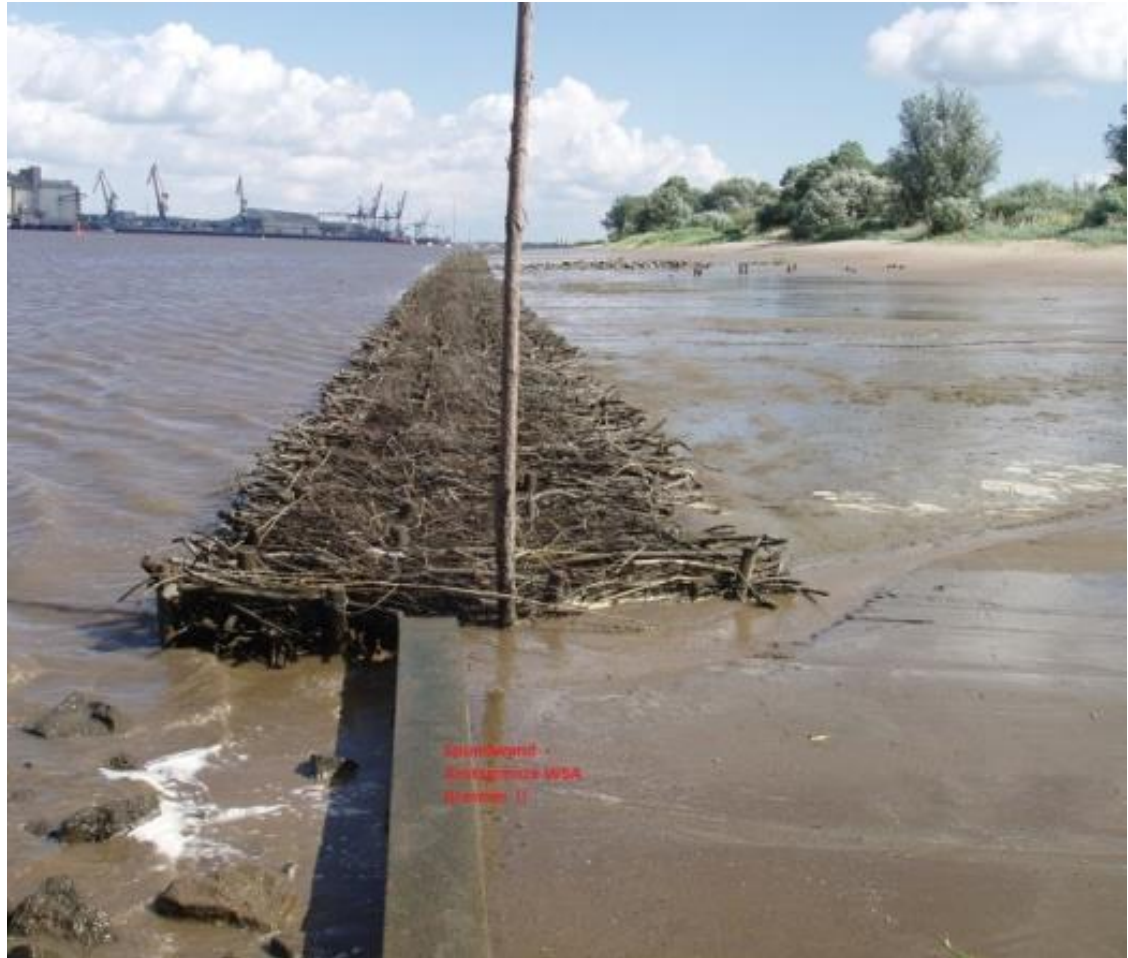
Brushwood training wall Harriersand

- **Km 39.875-40.62** right bank lower Weser
- **Implementation period:** ~2000
- **Contact:** WSA Weser-Jade-Nordsee:
Rainer.hauerken@wsv.bund.de
- **Construction design:** Brushwood training wall made of 4 tied pile rows adjacent to the sheet pile wall of the WSA's office in Bremen.
- Water motion has been reduced and the site has silted-up since (2018).

Brushwood training wall made of 4 tied pile rows adjacent to the sheet pile wall of the WSA's office in Bremen.

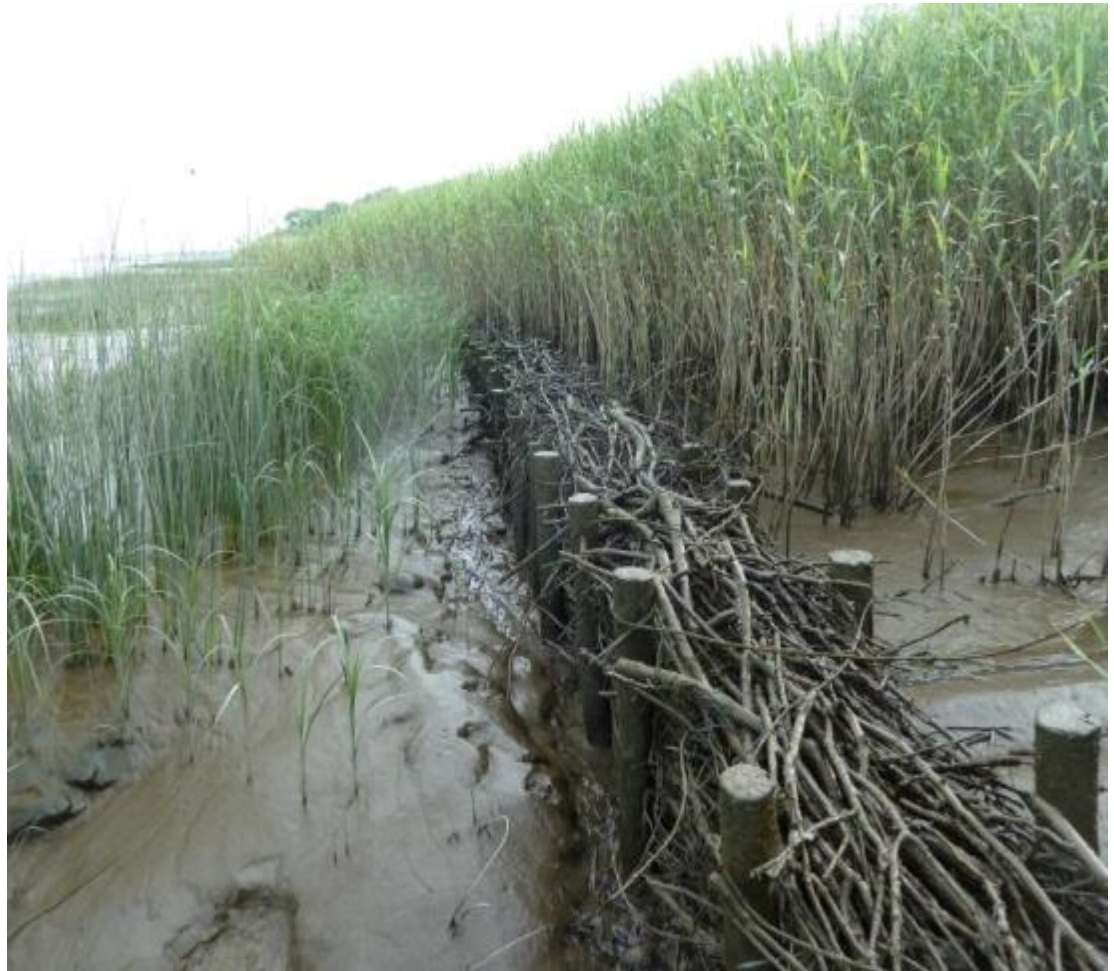
Creek damping lower Weser

- **Km 42.400** right bank lower Weser
- **Implementation period:** ~2008
- **Contact:** WSA Weser-Jade-Nordsee:
Rainer.hauerken@wsv.bund.de
- **Construction design:**
Brushwood box (2 tied pile rows) acting as creek damping to protect the bank and reduce water motion
- Water motion has effectively slowed down. On the landward side of the damping, reeds have developed; rushes are colonising in front of the brushwood box.
- As soon as a complete vegetation cover has established the measure will be deemed to be effective with maintenance being suspended.

Longitudinal brushwood box structure acting as a creek damping to reduce water motion. Riparian vegetation has colonised the site around the structure: reeds on the landward side and rushes on the seaward side.

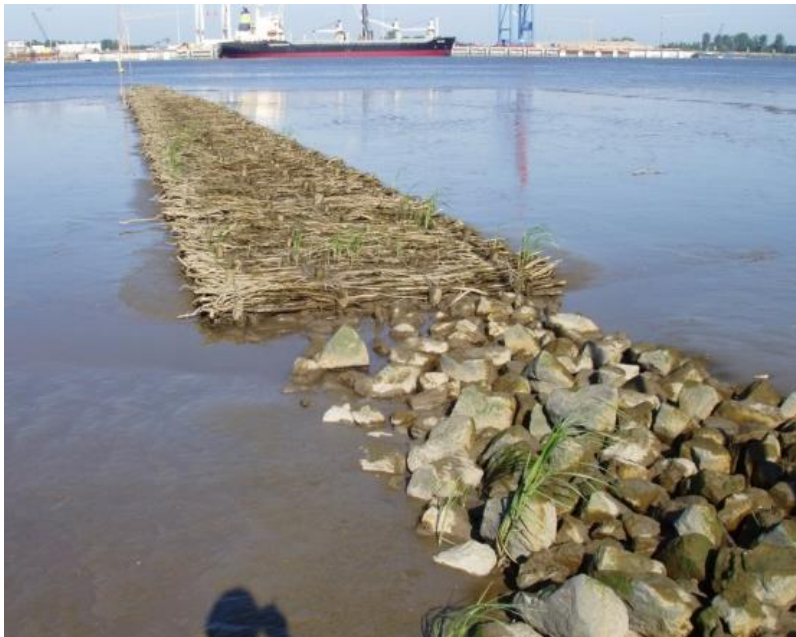
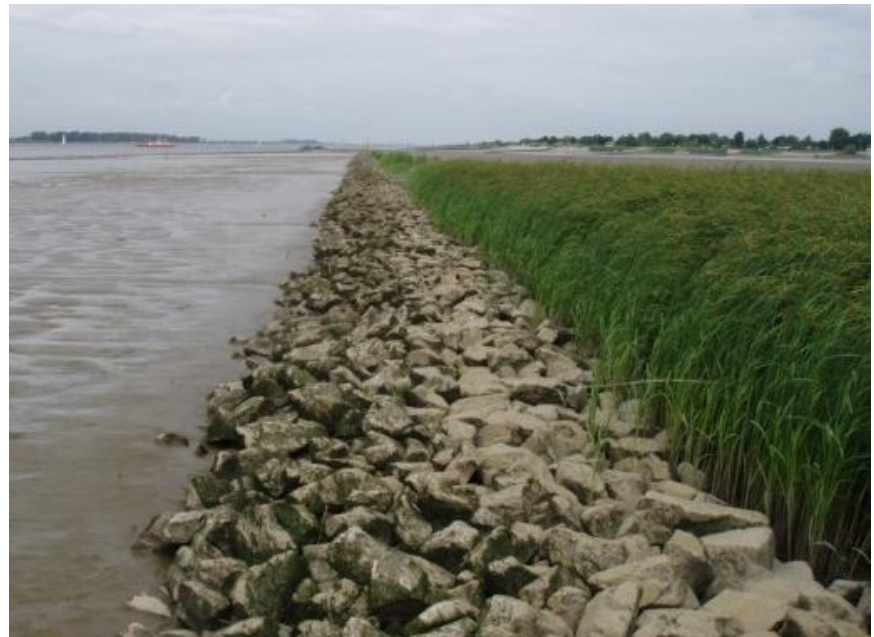
Northern tip Harriersand island

- **Km 43.125-44.050** right bank lower Weser
- **Implementation period:** ~1987 (tip of the island); ~1994 (brushwood groynes)
- **Contact:** WSA Weser-Jade-Nordsee: Rainer.hauerken@wsv.bund.de
- **Construction design:** Transverse fascine structures consisting of heavily silted brushwood groynes (4 tied pile rows) acting as silt traps to reduce local dredging volumes
- 1/3 of the structure is covered by vegetation with the remainder of the site consisting of tidal flats

Fascine structure acting as a silt trap on the northern tip of the Harriersand island.

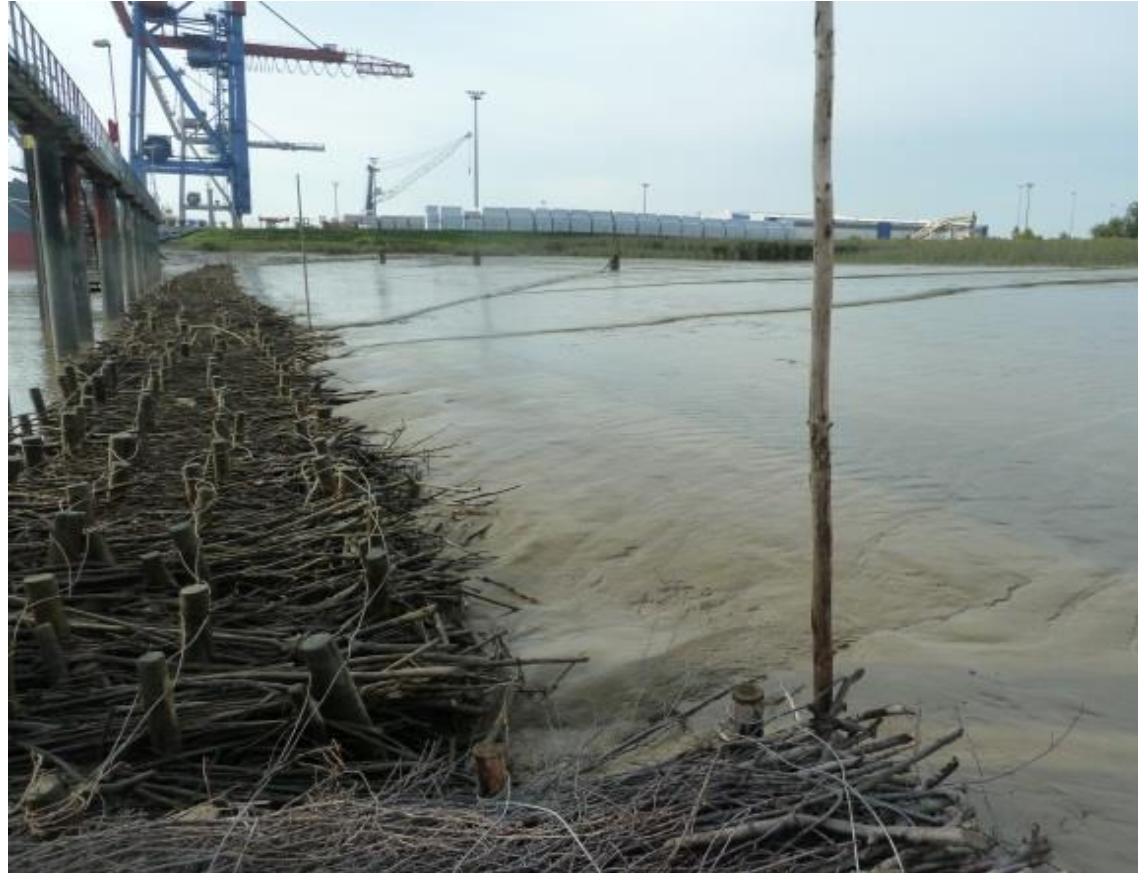
Bank stabilisation lower Weser (Niedersachsenkai)

- **Km 43.300-44.125** left bank lower Weser
- **Implementation period:** ~1995
- **Contact:** WSA Weser-Jade-Nordsee:
Rainer.hauerken@wsv.bund.de
- **Construction design:** Brushwood training wall made of 4 tied pile rows to stabilise the bank and encourage tidal flat sedimentation.
- Split into a northern and southern section. The medium section has been dredged away to make way for the “Niedersachsenkai” pier.

Brushwood training wall made of 4 tied dead wood pile rows.

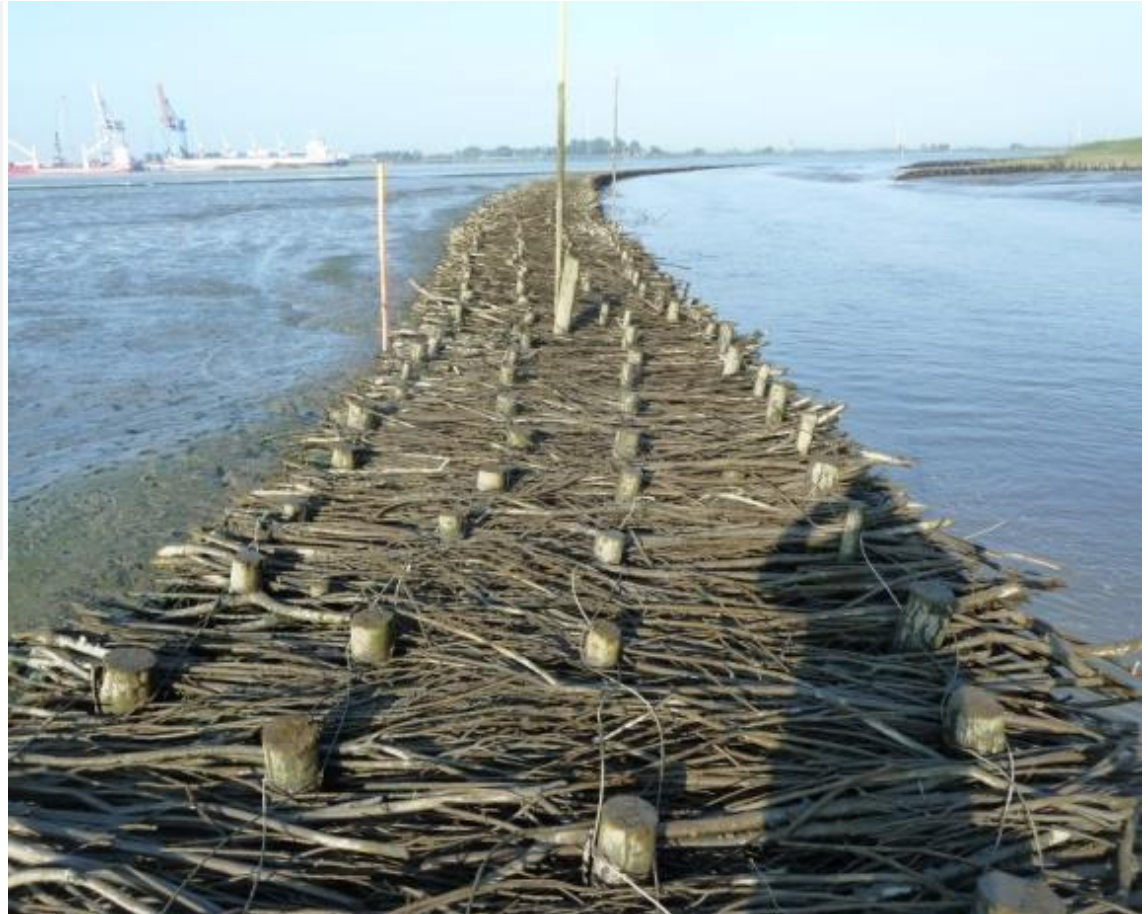
Brushwood training wall Sandstedt

- **Km 43.100-44.100** right bank lower Weser
- **Implementation period:** ~1950
- **Contact:** WSA Weser-Jade-Nordsee:
Rainer.hauerken@wsv.bund.de
- **Construction design:**
Brushwood training wall to ensure and control sluice drainage
- Smooth operation, maintenance carried out in 5-year intervals

Brushwood training wall ensuring and controlling sluice drainage in Sandstedt on the lower Weser.

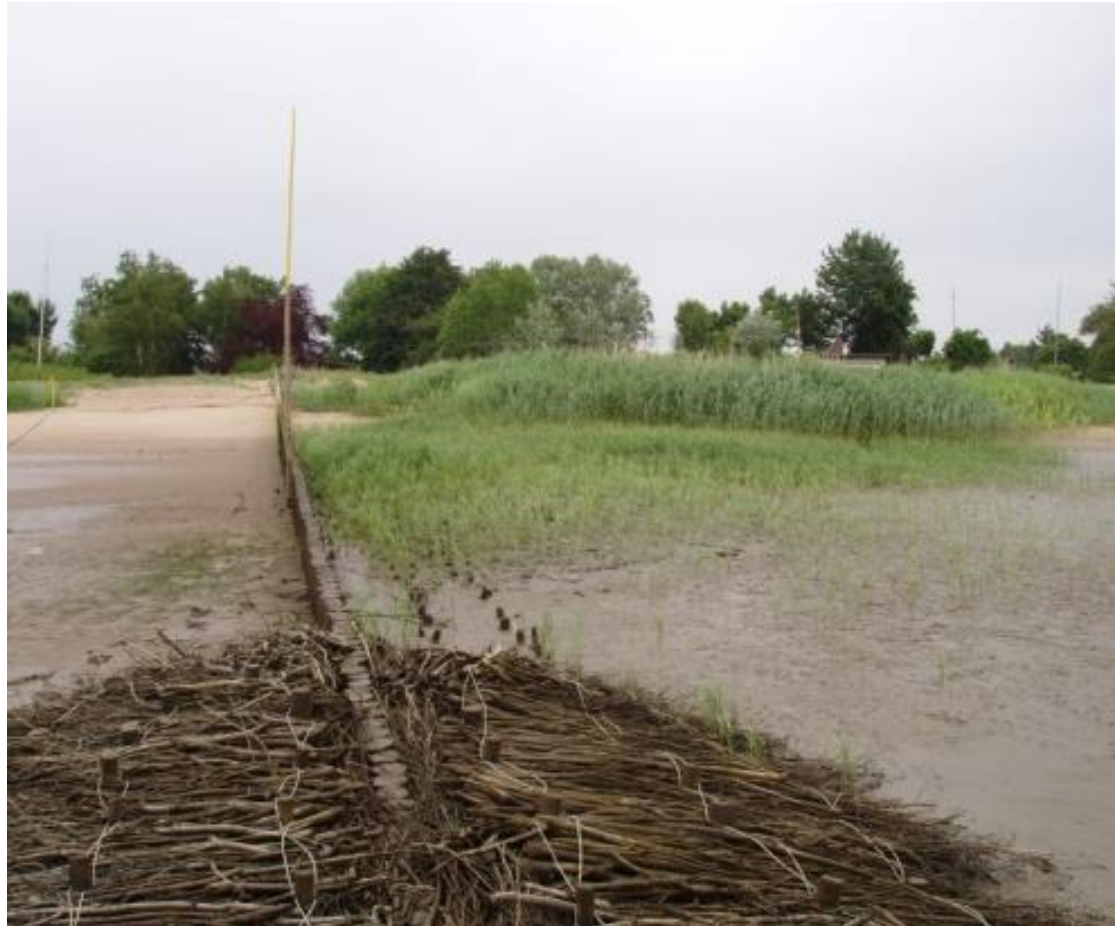
Pile and brushwood groynes Sandstedt

- **Km 44.250-44.500** right bank lower Weser
- **Implementation period:** ~1985 (pure brushwood groynes); from ~1993 (pile groynes)
- **Contact:** WSA Weser-Jade-Nordsee:
Rainer.hauerken@wsv.bund.de
- **Construction design:** 2 brushwood groynes and 6 pile groynes with a brushwood head
- Pile groynes made of pine/larch poles
- Brushwood groynes in the beach area suffered from premature rot
- → danger to beach visitors, prompting replacement by single-row pile groynes

Single-row pile groynes with a brushwood head to protect the bank at Sandstedt beach.

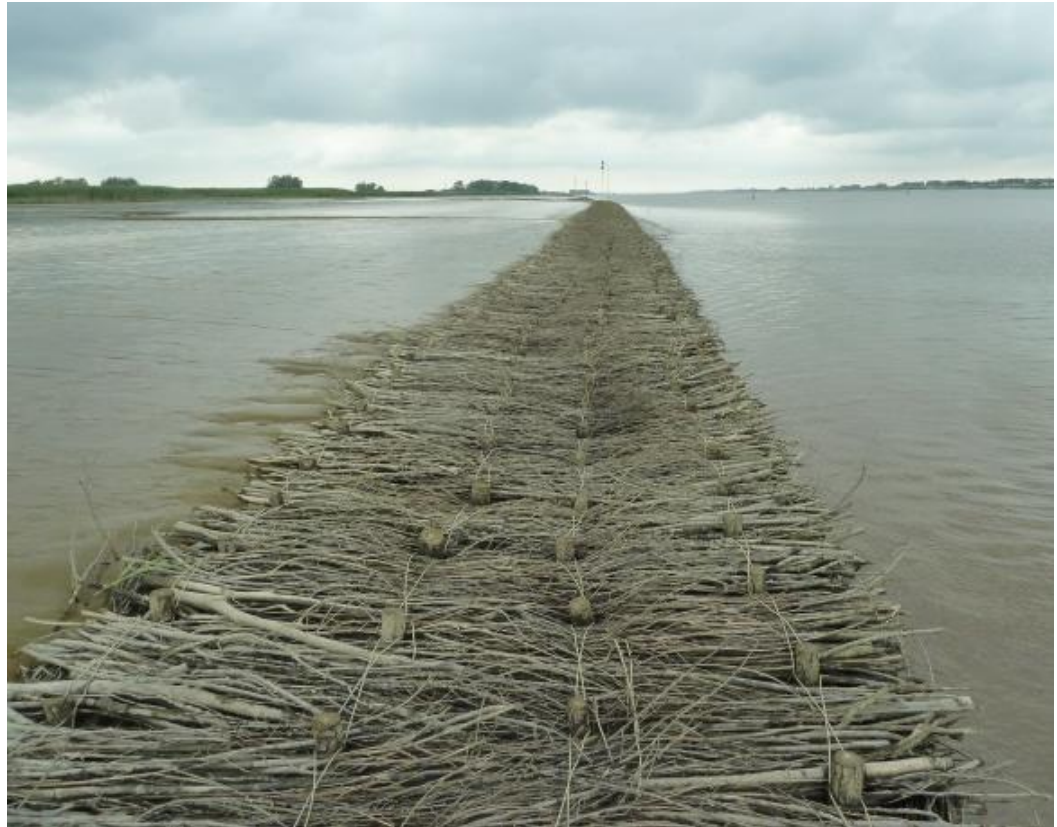
Brushwood training wall for water supply to the Upper Schweiburg

- **Km 44.500-44.800** left bank lower Weser
- **Implementation period:** ~1990-2000
- **Contact:** WSA Weser-Jade-Nordsee: Rainer.hauerken@wsv.bund.de
- **Construction design:** Brushwood training wall made of 4 tied pile rows to support water supply to the Upper Schweiburg, bank stabilisation and tidal flat sedimentation.
- The brushwood training wall has been constructed twice: the first structure was situated 50m further west (landward) and rapidly silted up, albeit without completely meeting the intended purpose.
- The second structure was built at today's position, again to supply more water to the Schweiburg, but proved to be only partially effective for this purpose. Tidal flats have stabilised.

Brushwood training wall made of 4 tied pile rows to supply more water to the Schweiburg and stabilise the bank and tidal flats.

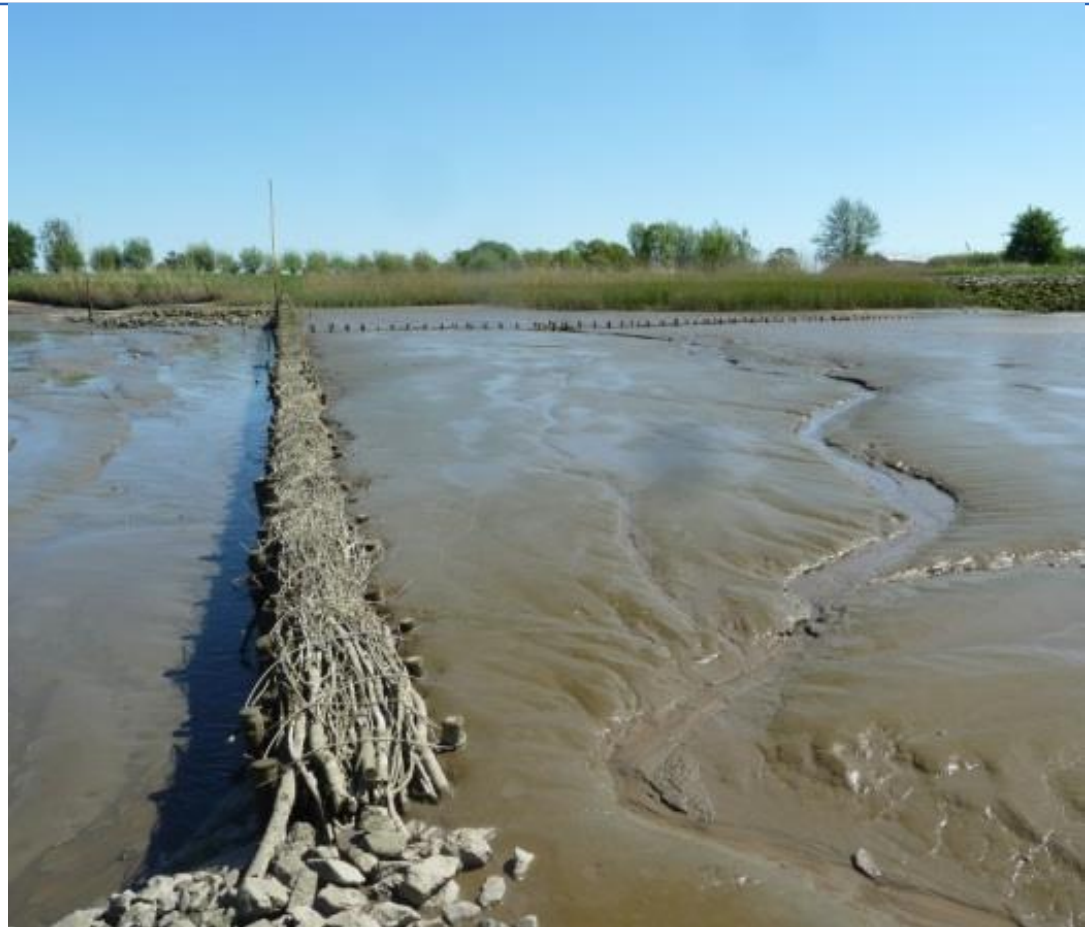
Brushwood box for groyne protection in Rechtenfleth

- **Km 46.625** right bank lower Weser
- **Implementation period:** ~2000-2005
- **Contact:** WSA Weser-Jade-Nordsee:
Rainer.hauerken@wsv.bund.de
- Preliminary inspections carried out by the WSA Bremerhaven and BAW
- **Construction design:** Brushwood box system to protect the groyne root from permanent exposure to scouring and damaging effects.
- Since an armour stone extension of the groyne towards the embankment has not sufficiently reduced the level of hydrodynamics, the brushwood box was built to contain water motion.

Brushwood box system protecting the groyne root.

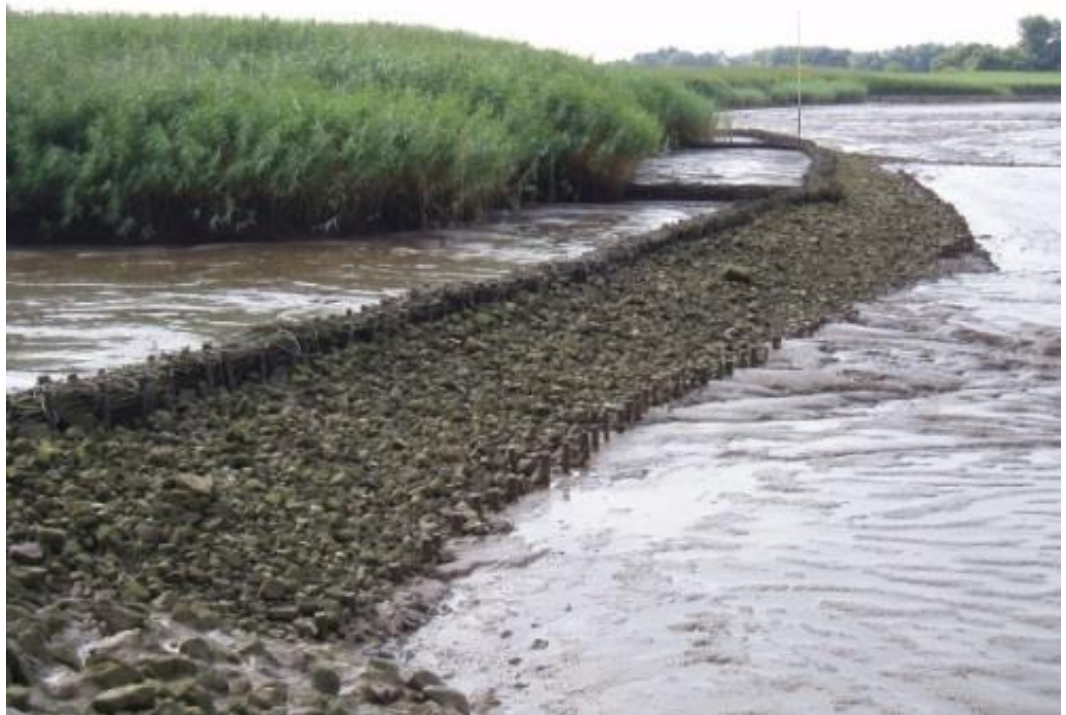
Reduction of water motion Königsbalje

- **Km 47.58-47.875** right bank lower Weser
- **Implementation period:** ~1994
- **Contact:** WSA Weser-Jade-Nordsee: Rainer.hauerken@wsv.bund.de
- **Construction design:** Combined armour stone/dead wood structure: brushwood training wall (2 tied pile rows) with a riprap toe protection to slow down water motion.
- The structure has been installed at a distance of 5m from the bank and is aligned to the bank's natural shape.

Combined structure aligned to the natural shape of the river bank to reduce hydrodynamics.
