Living shoreline techniques for bank protection along estuarine waterways

Collection of measures in tidal areas

25. April 2022

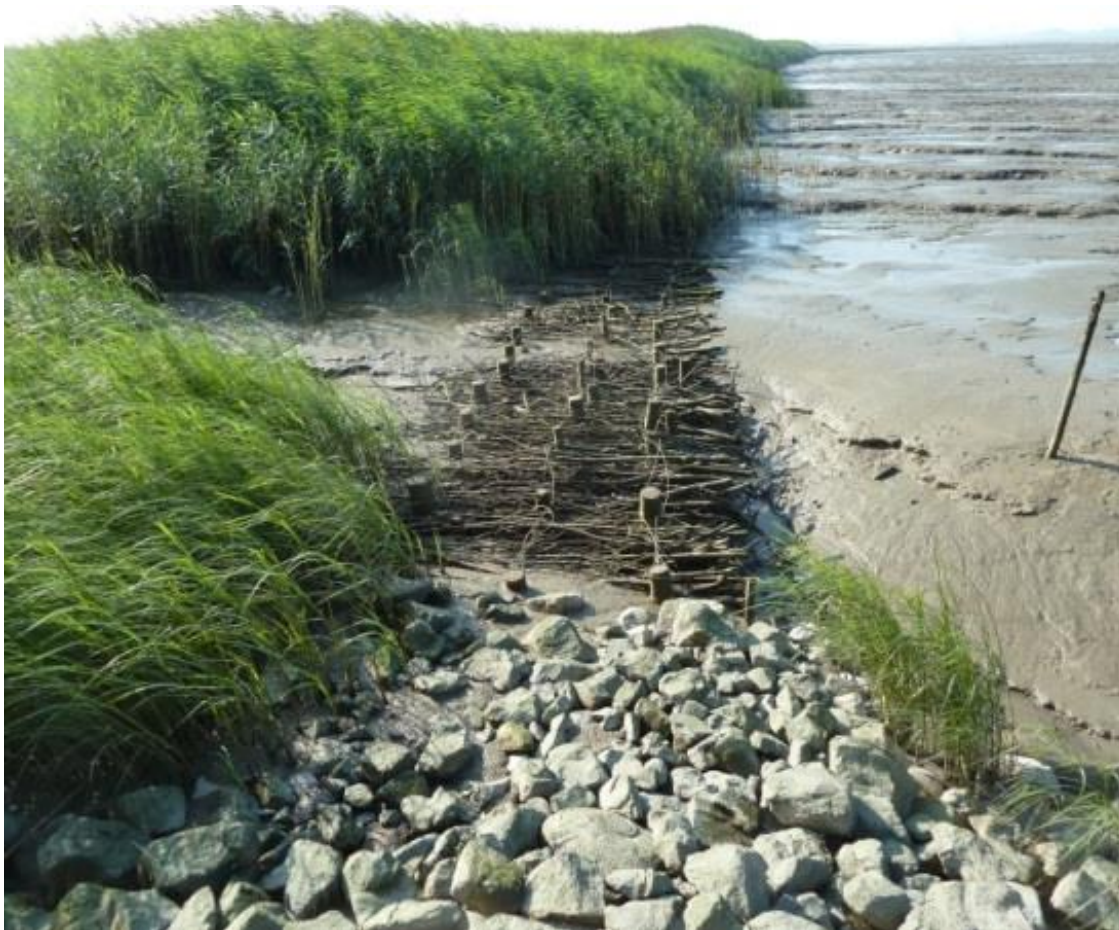
Creek damping lower Weser

- **Km 48.150** right bank lower Weser
- **Implementation period:** ~2008
- **Contact:** WSA Weser-Jade-Nordsee:
Rainer.hauerken@wsv.bund.de
- **Construction design:** Groyne protection consisting of a brushwood mattress made of 4 tied pile rows acting as a deflector for creek damping.
- Water motion has effectively slowed down; maintenance will cease after 2019 since the mission has been accomplished.

Four tied pile rows acting as groyne protection.

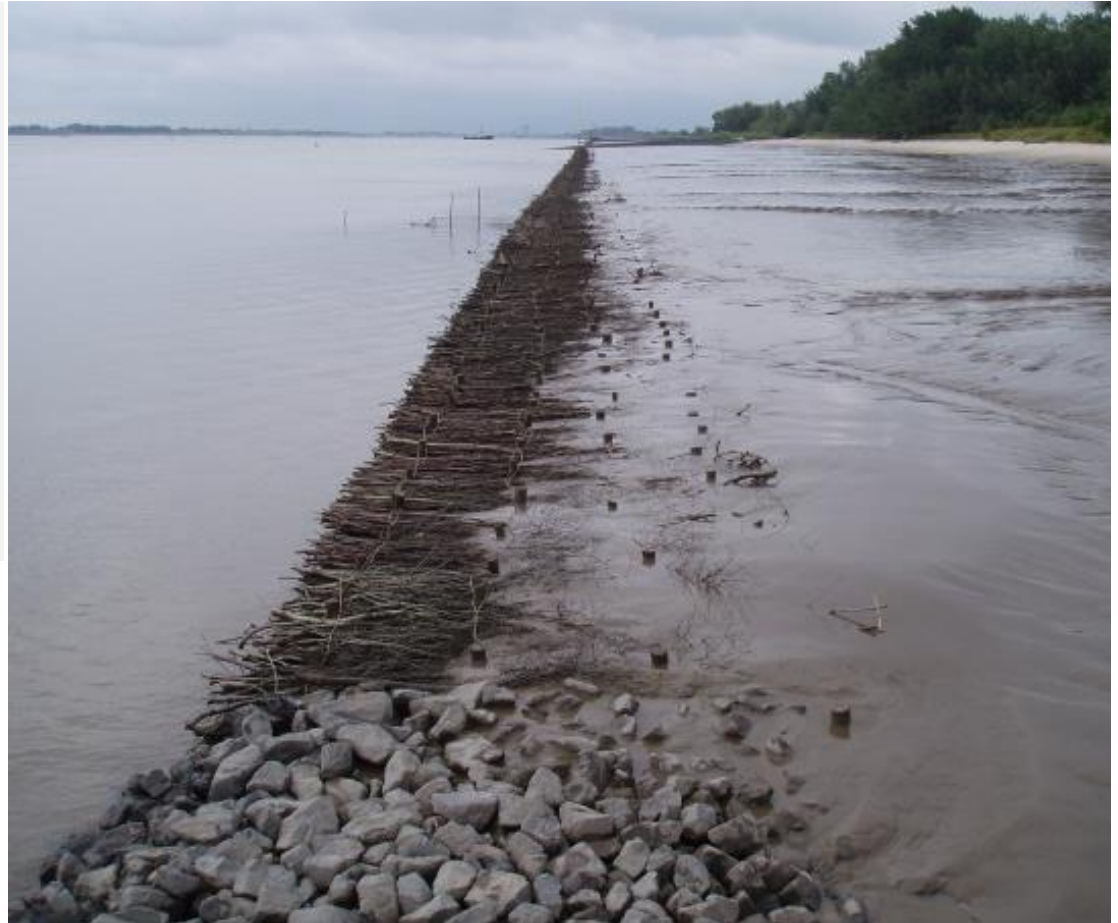
Brushwood training wall Strohauser Plate

- **Km 48.500-50.380** left bank lower Weser
- **Implementation period:** ~2010-2018
- **Contact:** WSA Weser-Jade-Nordsee:
Rainer.hauerken@wsv.bund.de
- **Construction design:**
Brushwood training wall made of 4 tied pile rows (built in 6 construction phases) to stabilise tidal flats.

Brushwood training wall made of 4 tied pile rows stabilising the bank and tidal flats.

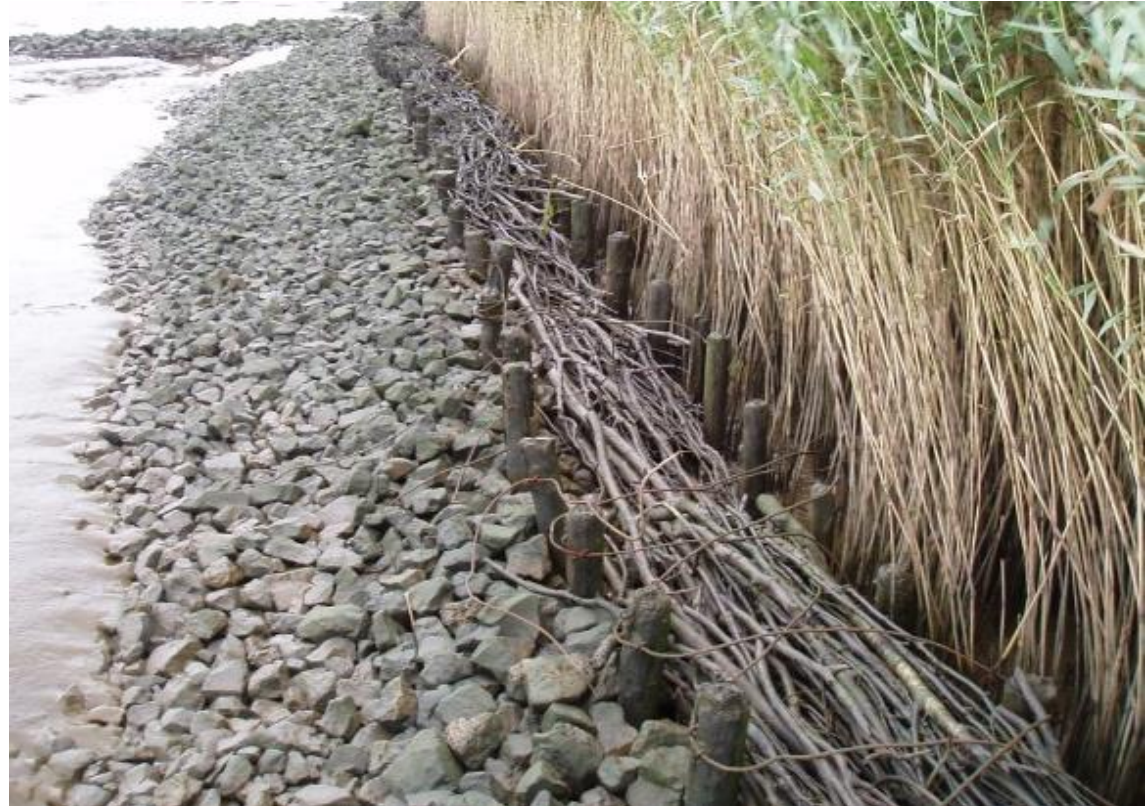
Tidal flat and reed area development lower Weser

- **Km 49.125-50.07** right bank lower Weser
- **Implementation period:** 1992-1998
- **Contact:** WSA Jade-Weser-Nordsee
Rainer.hauerken@wsv.bund.de
- **Construction design:** Combined armour stone (iron silicate slag)/dead wood structure.
- 2 tied pile rows with a riprap toe protection (brushwood box). Steep erosion edges before works started. (Previously built with barges.) The site has flourished requiring only intermittent maintenance.

Combined armour stone/dead wood structure: 2 tied pile rows with a riprap toe protection.

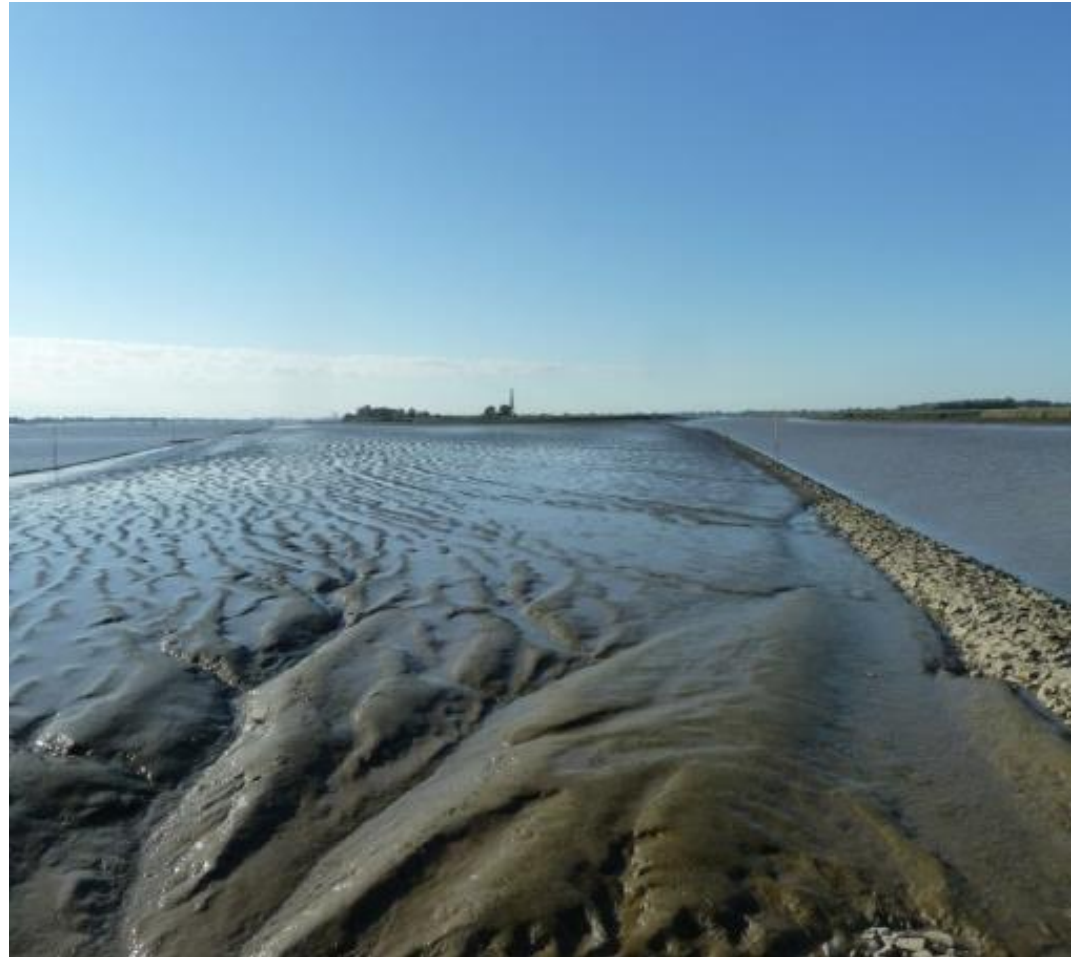
Tip of the Strohauser Plate island

- **Km 50.380-51.640** left bank lower Weser
- **Implementation period:** ~1987 (tip of the island); ~1995 (brushwood groynes)
- **Contact:** WSA Weser-Jade-Nordsee:
Rainer.hauerken@wsv.bund.de
- **Construction design:** Training wall spanning the complete stretch combined with adjacent transverse fascine structures (brushwood groynes) at km 50.700, km 51.000 east and west, km 51.200 east and west, km 51.400.
- The fascine training wall has been overbuilt with iron silicate slag.
- As intended, the area around the tip of the island has become heavily silted up, reducing local dredging volumes.

Heavily silted up transverse fascine structures made of 4 tied pile rows forming a training wall that is overbuilt with slag.

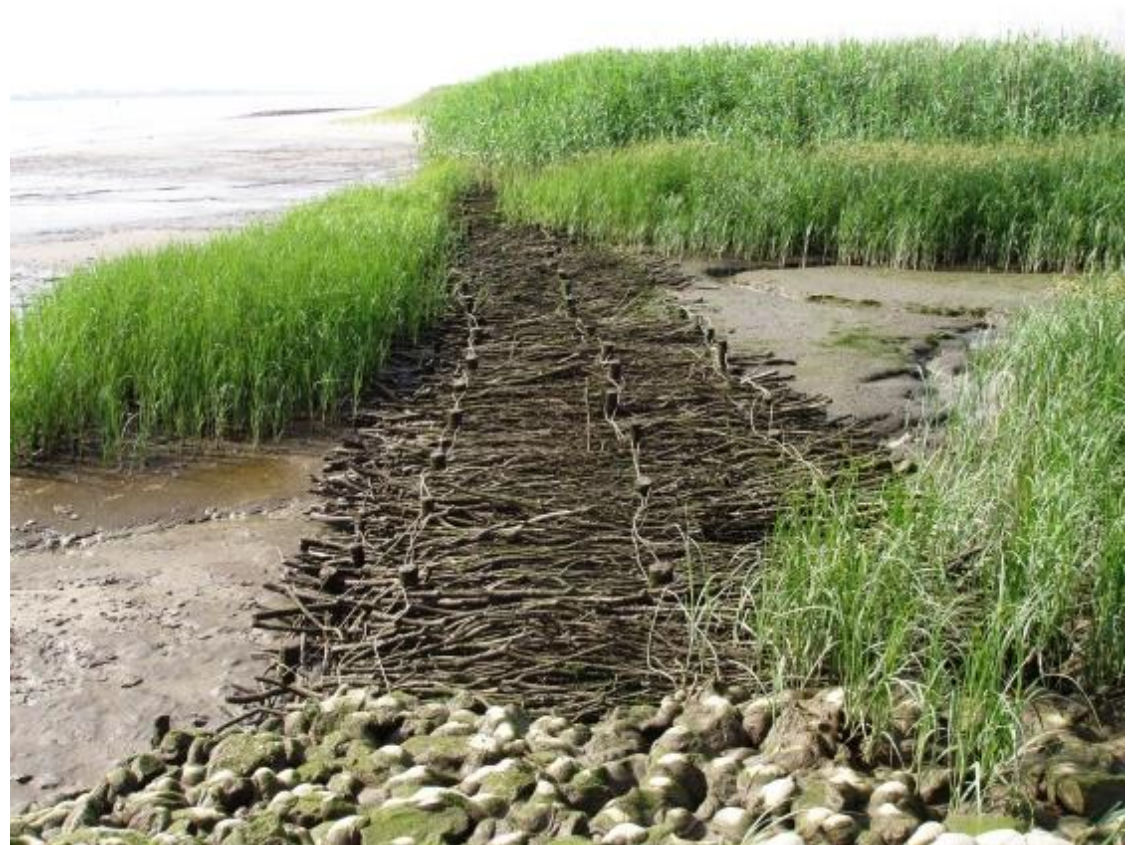
Creek damping lower Weser

- **Km 50.380** left bank lower Weser
- **Implementation period:**
~1993
- **Contact:** WSA Weser-Jade-Nordsee:
Rainer.hauerken@wsv.bund.de
- **Construction design:**
Longitudinal brushwood mattress structure acting as a creek damping to protect the bank and groyne and support reed growth and tidal flat sedimentation.
- Tidal flats and reed vegetation behind the structure have stabilised. Groyne protection and creek deflection are operating effectively.

Longitudinal fascine structure protecting the banks and groyne and supporting tidal flat and reed development.

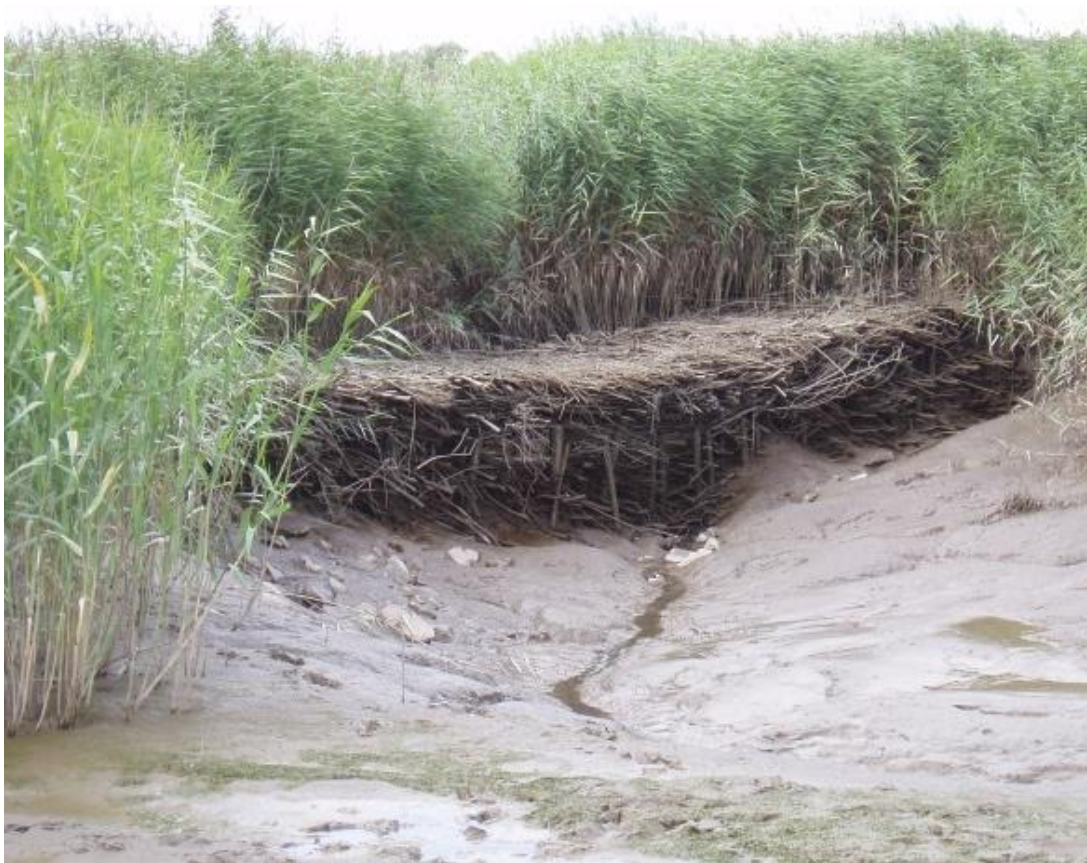
Creek damping lower Weser

- **Km 52.350** left bank lower Weser
- **Implementation period:** ~1999
- **Contact:** WSA Weser-Jade-Nordsee:
Rainer.hauerken@wsv.bund.de
- **Construction design:** Creek damping made of brushwood boxes to stabilise the banks and groyne and to support tidal flat sedimentation and reed growth.
- Reed vegetation behind the brushwood box has recovered well; full groyne protection is operating effectively.
- One more maintenance session scheduled for 2021.

Brushwood box for creek damping.

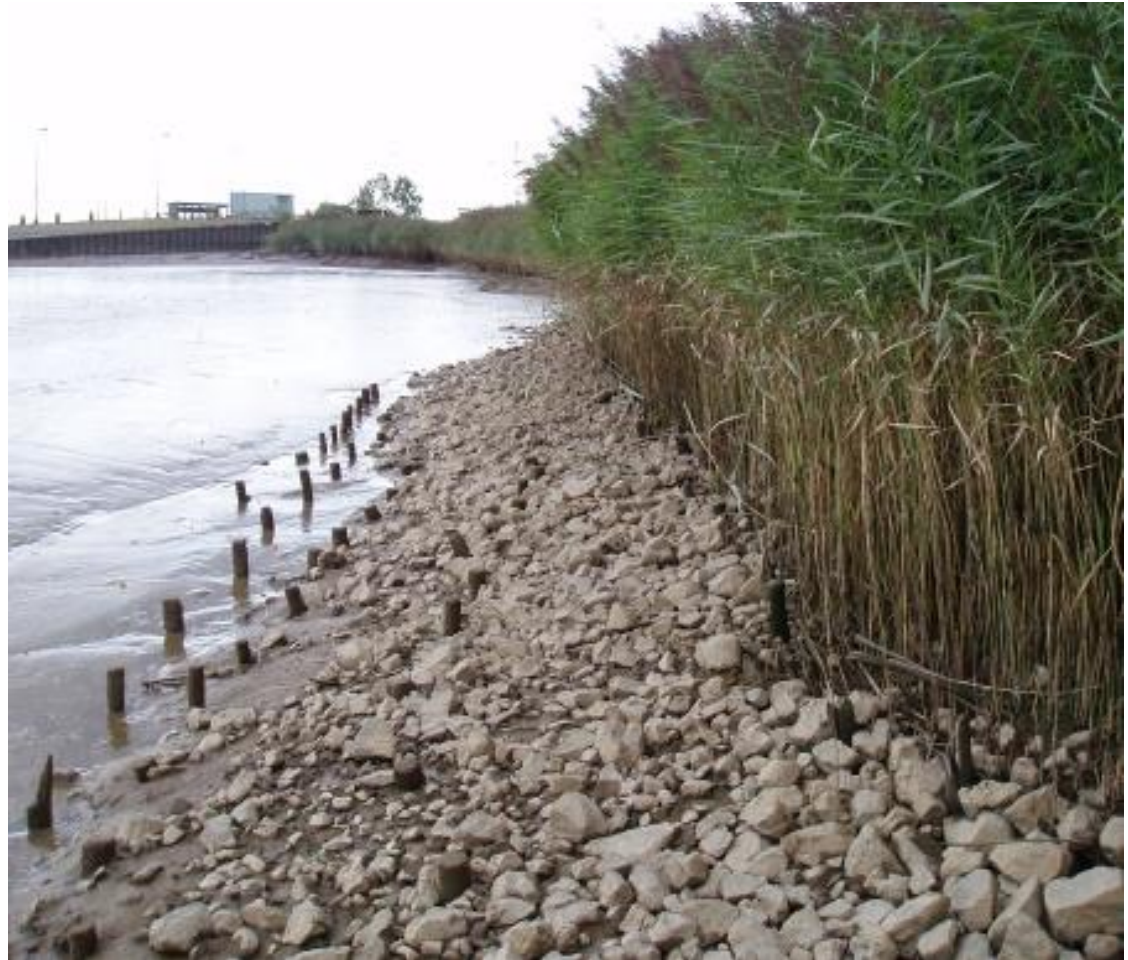
Bank protection former ferry pier Kleinensiel

- **Km 53.500** left bank lower Weser
- **Implementation period:** ~1991
- **Contact:** WSA Weser-Jade-Nordsee:
Rainer.hauerken@wsv.bund.de
- **Construction design:** Solid bank protection made of brushwood boxes with riprap cover.
- Goes back to times of ferry operations exposing the bank to heavy hydraulic loads → bank protection was a must.
- The bank has stabilised, is largely silted up and covered by vegetation, making maintenance superfluous.

Anti-scour brushwood box with riprap cover at the ferry pier.

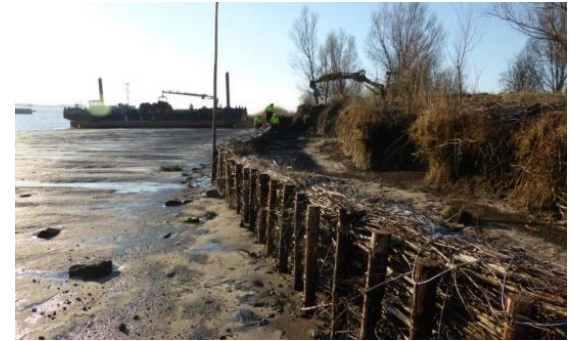
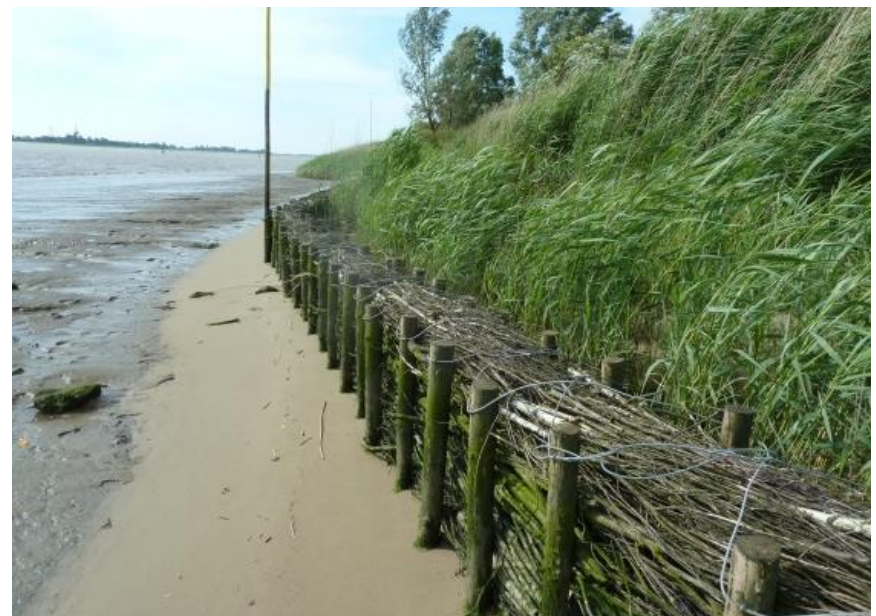
Brushwood box Kleinensieler Plate

- **Km 54.600-54.850** left bank lower Weser
- **Implementation period:** 2018; two more similar construction phases (some 100m long) further north scheduled in 2019 and 2020.
- **Contact:** WSA Weser-Jade-Nordsee
Rainer.hauerken@wsv.bund.de
- **Background:** During the implementation of the compensation scheme “Kleinensieler Plate” backfilling created a steep bank entirely left to nature after completion in 2000. Repeated cases of erosion edges have been observed at the elevation; the crest of the backfill is colonised by shrubs that tumble into the water from time to time due to storms or erosion effects, which impedes transport safety.
- **Construction design:** Parts of the erosion edge are protected by a longitudinal brushwood box structure. Brushwood is set to be refilled in 2020 with no maintenance needs expected afterwards.

Brushwood box protecting an erosion edge and the vegetation established on the bank.

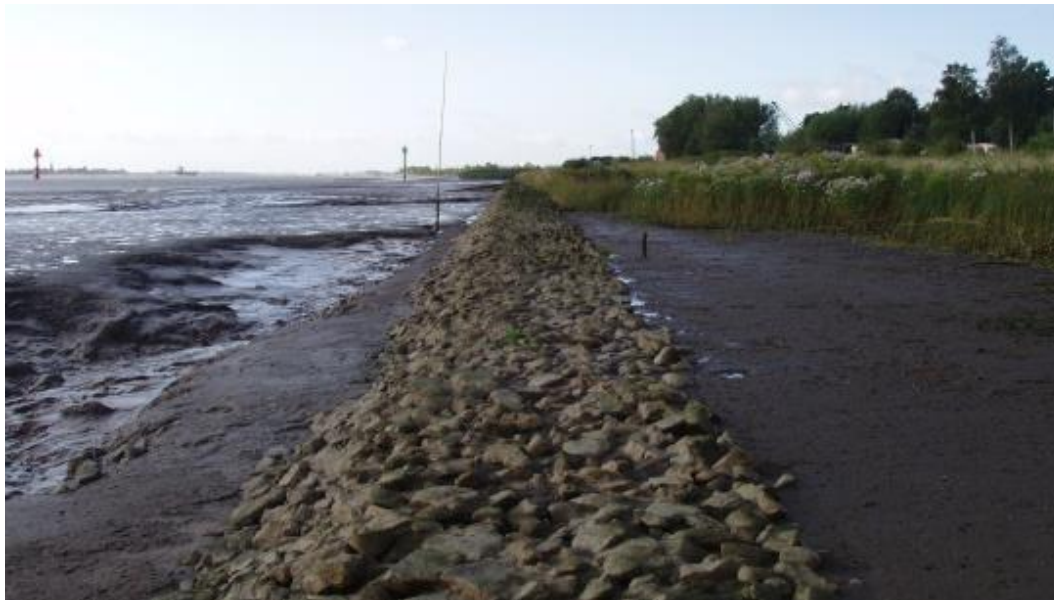
Indirect ecological upgrading of the bank in Großensiel

- **Km 56.100-56.500** left bank lower Weser
- **Implementation period:** ~1990
- **Contact:** WSA Weser-Jade-Nordsee: Rainer.hauerken@wsv.bund.de
- **Construction design:** Longitudinal riprap structure
- Indirect technical-biological bank protection solution: technical structure, albeit aimed at supporting the development of reed and ruderal areas

Technical longitudinal structure serving biological objectives: bank protection as well as reed and ruderal area development.

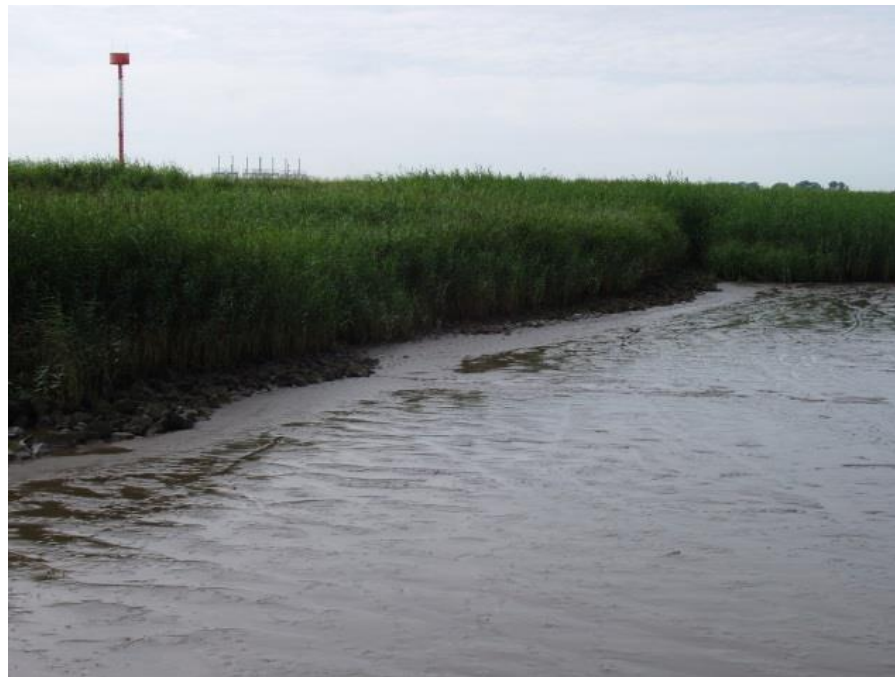
Bank protection Luneplate

- **Km 58.400-58.875** right bank lower Weser
- **Implementation period:** ~2003
- **Contact:** WSA Weser-Jade-Nordsee: Rainer.hauerken@wsv.bund.de
- **Construction design:** Combined armour stone/dead wood structure: brushwood box (2 tied pile rows) and a riprap layer, both completely covered in silt.

Combined structure made of two tied dead wood pile rows and a riprap layer.

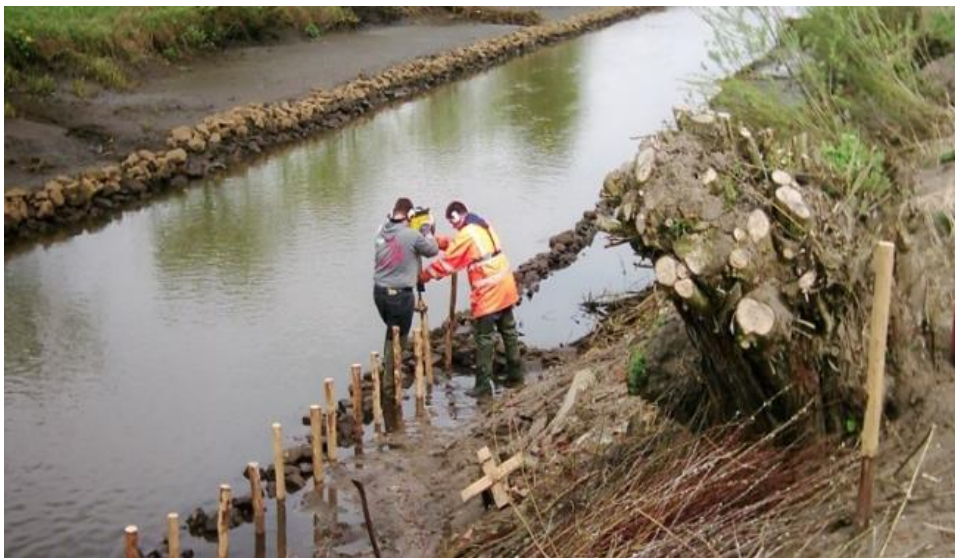
Reinstatement works on the Delme

- **Km 0-0.5** both Delme banks (near km 20.750 of the Ochtum where it is joined by the Delme)
- **Implementation period:** As necessary
- **Contact:** WSA Weser-Jade-Nordsee, branch office Habenhausen: friedrich.hauptmann@wsv.bund.de
- **Construction design:** Embankment protection of a dike without foreland (*Schardeich*) by means of a riprap toe protection capped with willow brush mattresses made of willow cuttings
- Willow rods were available from willow trees growing at the slope crest and were immediately used as live material
- Maintenance obligations go back to the 8m expansion of the Weser (watercourses outside the WSV's scope of responsibility)

Longitudinal structure acting as embankment protection. The revetment is made of a riprap toe protection and a transverse armour stone structure capped with a willow brush mattress with willow cuttings.

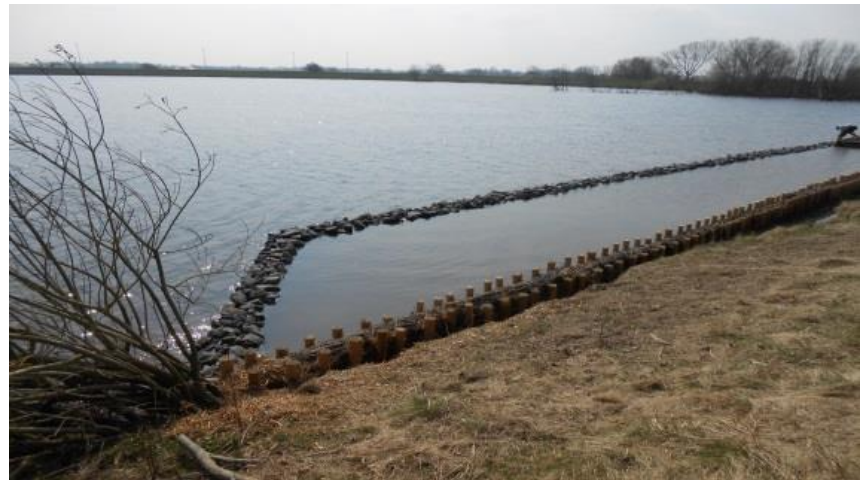
- **Km 11.9-12.0** right bank Hunte
- **Implementation period:** 2018
- **Contact:** WSA Weser-Jade-Nordsee: Dieter.hoeffmann@wsv.bund.de
- **Construction design:** A longitudinal brushwood box structure made of 2 tied pile rows was placed immediately in front of the vulnerable bank. The boxes were filled with straw serving as a filter and capped with fascines.
- A secondary armour stone protection structure was installed in front to absorb wave action. Previous plans envisaged a 2nd pile structure, but appropriate ground fixing proved to be impossible, which gave way to the alternative armour stone solution.
- Since the structure was installed in 2018 only, final conclusions on its impacts would be premature. It is placed on the far side of the navigation channel behind a former land protection dike, where tidal influence is muted.

Compensation measure comprised of longitudinal structures made of double pile rows and riprap.

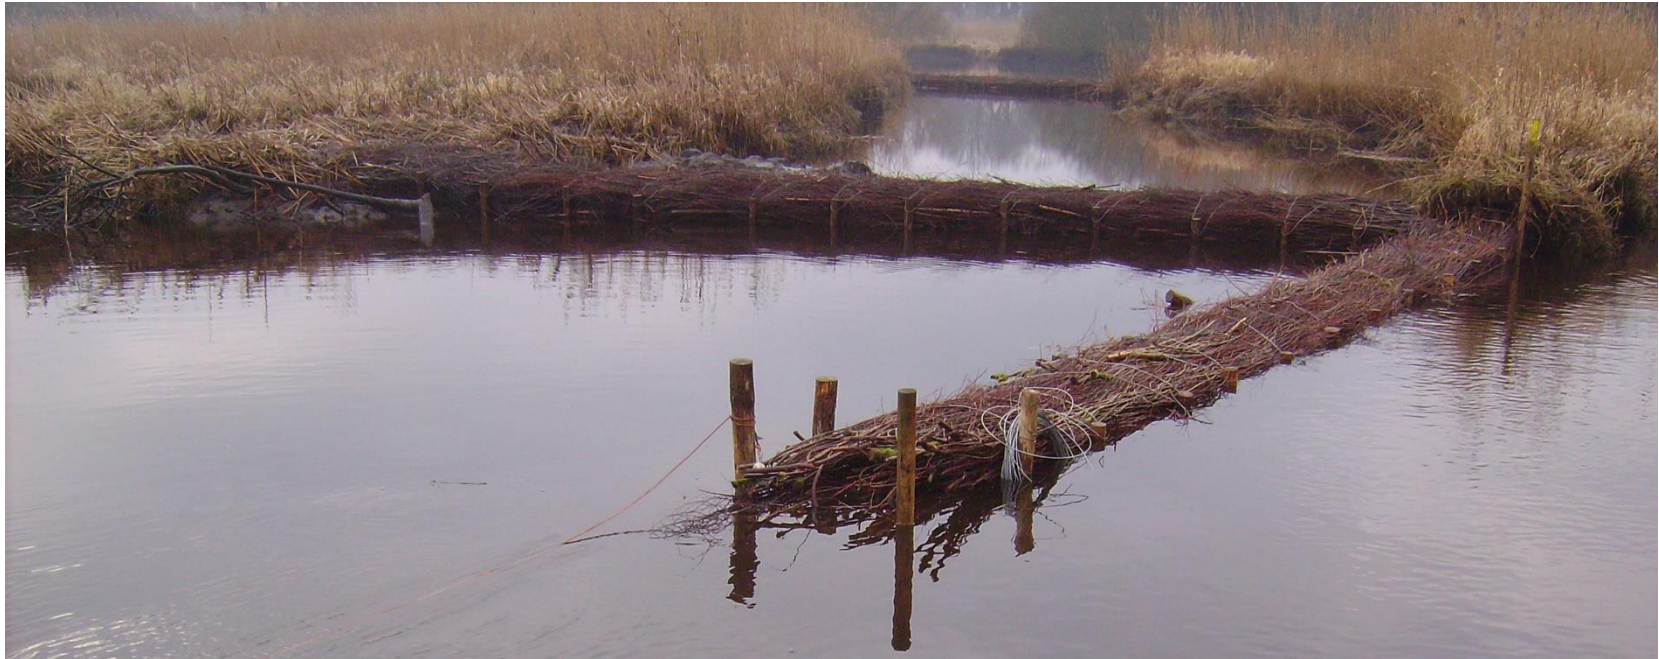
Erosion protection in a bend

- **Km 5.15-5.20** right bank Wümme
- **Implementation period:** 2014-2015 winter season
- **Contact:** Branch office Farge: sven.wennekamp@wsv.bund.de
- **Construction design:** Brushwood box training wall made of hardwood fascines securing a breach in a bend to prevent further abrasion and maintain the natural river course

Protection of a breach in the area around a Wümme bend to preserve the natural river course.

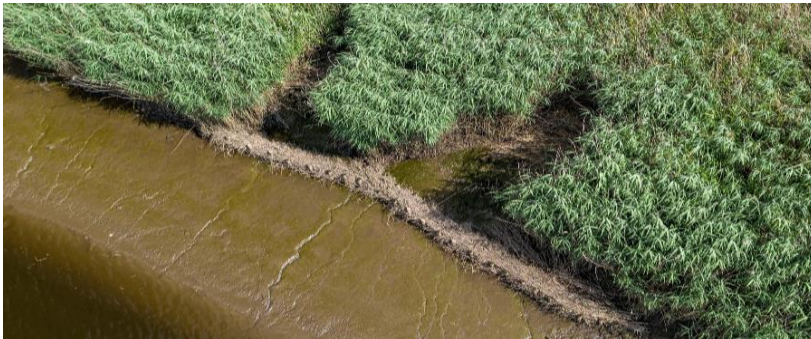
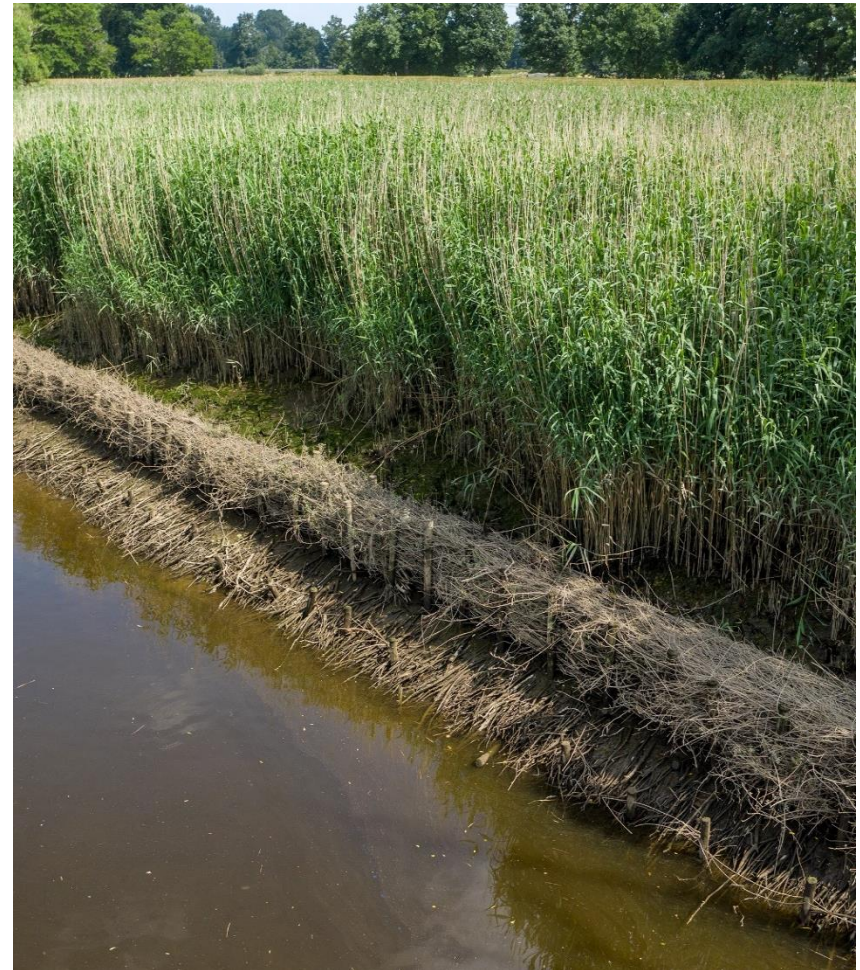
Test track 1 Lesum/Wümme confluence

- **Km 17.31-17.39** left bank Wümme
- **Implementation period:** 2013-2014 winter season
- **Contact:** Branch office Farge:
sven.wennekamp@wsv.bund.de
- Test track 1 under the maintenance plan for the Lesum/Wümme mouth
- **Construction design:** Combined structure of brushwood box (hardwood fascines) and brush mattresses tied to stakes
- Backfilling up to the level of the reed behind the brushwood box plus minor initial planting of reeds
- Purpose: embankment toe and bank protection, scour repair

Test track 1 on the Wümme: combined structure comprised of a brushwood box, a tied brush mattress placed in front and rearward backfilling up to the level of the reed (photos taken in 2020).

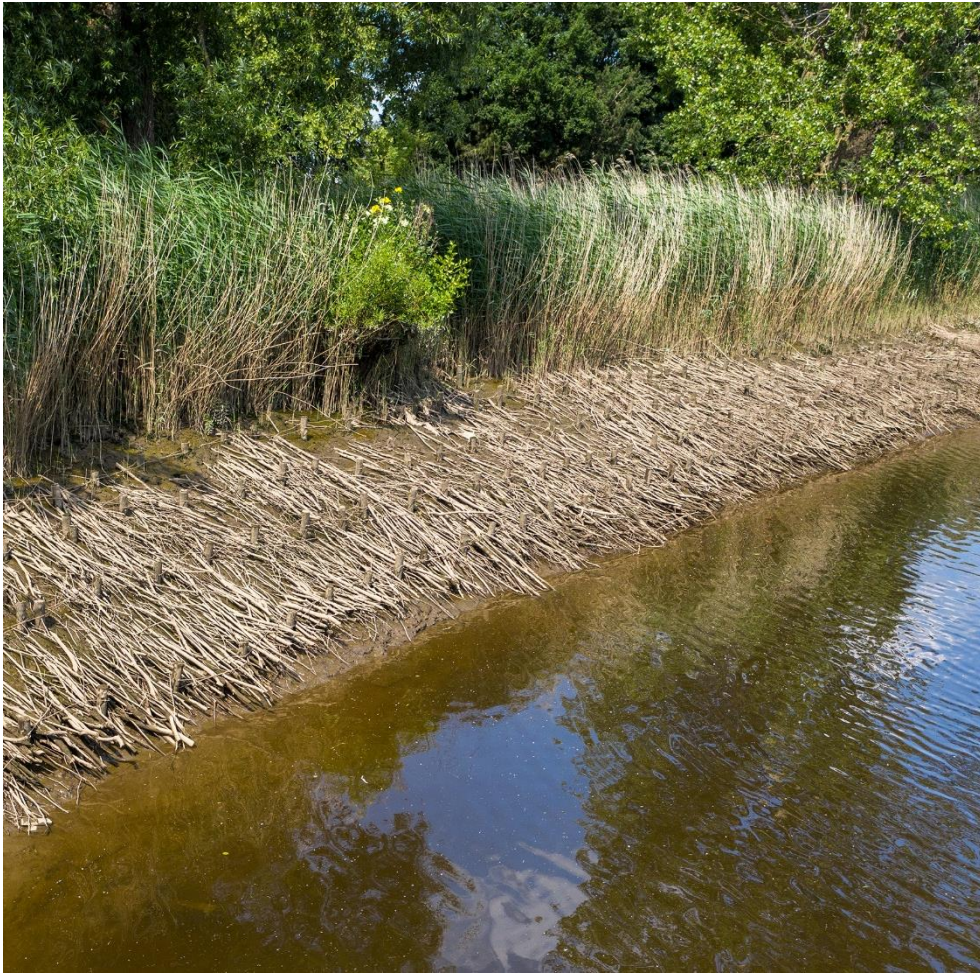
Test track 2 Lesum/Wümme confluence

- **Km 17.00-17.08** right bank Wümme
- **Implementation period:** 2013-2014 winter season
- **Contact:** Branch office Farge: sven.wennekamp@wsv.bund.de
- Test track 2 under the maintenance plan for the Lesum/Wümme mouth
- **Construction design:** Brush mattress made of hardwood fascines tied to stakes acting as embankment toe and bank protection on the outer bank

Test track 2 on the Wümme: dead wood brush mattress protecting the embankment.

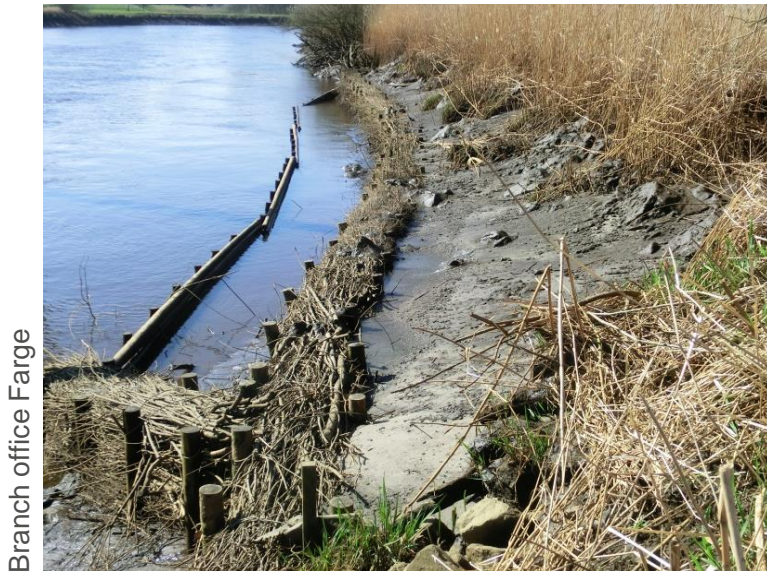
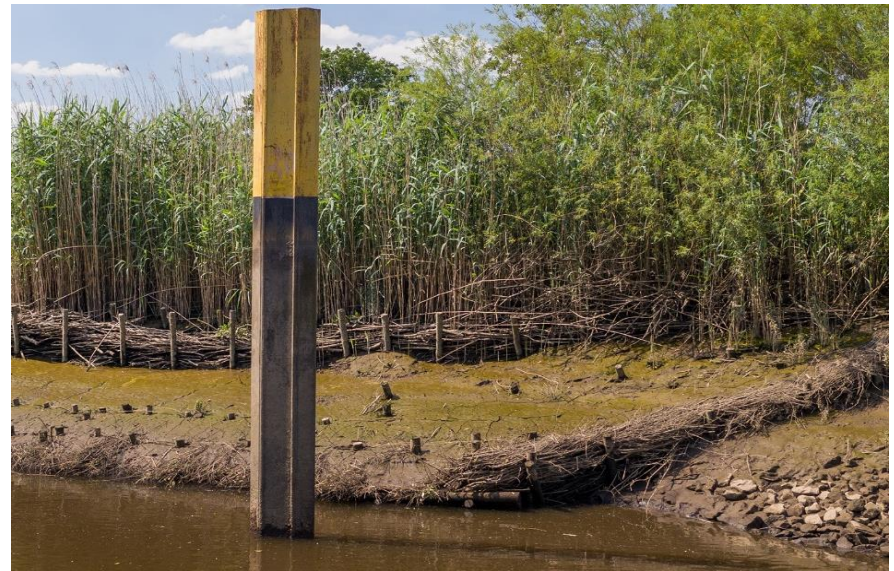
Test track 3 Lesum/Wümme confluence

- **Km 16.18-16.24** right bank Wümme
- **Implementation period:** 2013-2014 winter season
- **Contact:** Branch office Farge: sven.wennekamp@wsv.bund.de
- Test track 3 under the maintenance plan for the Lesum/Wümme mouth
Purpose: embankment toe and bank protection, scour repair
- **Construction design:** Brushwood box made of hardwood fascines and pile wall made of timber poles. Backfilling up to the level of the reed behind the brushwood box plus minor initial planting of reeds
- Intended effect not achieved → structure was unstable in parts and required reworking

Test track 3 on the Wümme: brushwood box behind a pile wall (2014) and status of the adapted measure as of 2020 (right).

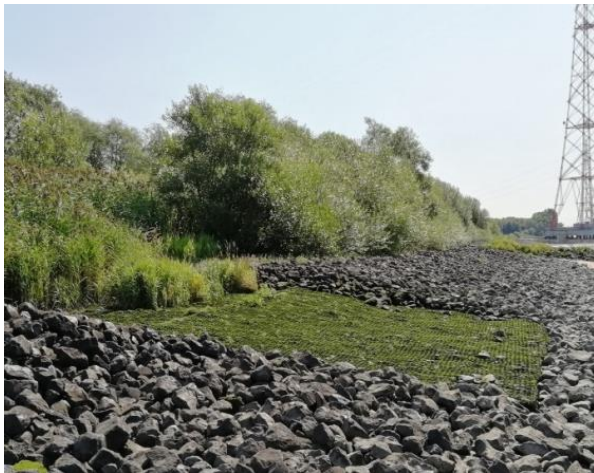
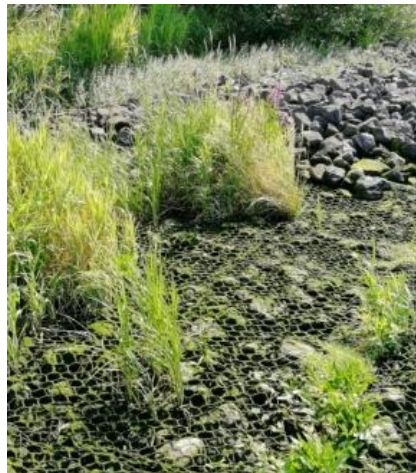
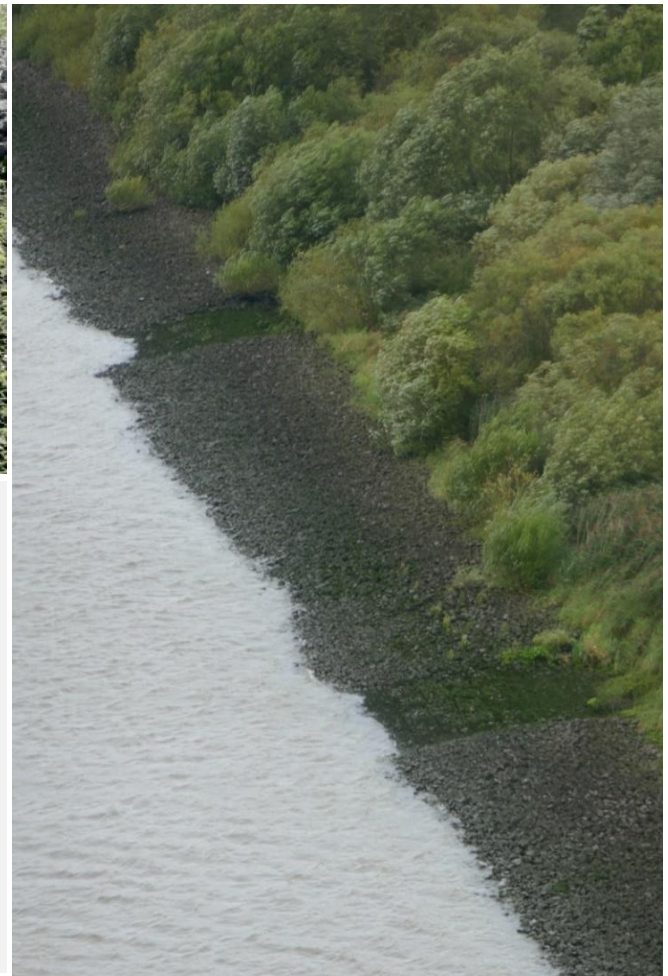
Lowering of revetment Juelssand/Hetlingen

- **Km 650.600-651.200** right bank Elbe
- **Implementation period:** 6 weeks in 2012
- **Contact:** WSA Elbe-Nordsee, Elbe Habitat Foundation, Integrierte Station Untere Elbe
- **Total cost:** ~ €43,000
- **Construction design:** 5 sections of the revetment (total revetment length: 600m) were truncated by 60-80cm to 10m each to allow for overtopping into the hinterland
- Bottom and face of the cut-outs shielded with river mattresses
- 500mt of armour stones have been moved

Local lowering of the revetment and installation of river mattresses to enable vegetation establishment. → Measure FR 4.5 HH/SH under the *Integrated Management Plan (IBP) Weser* (“Restoring banks to a more natural state”)

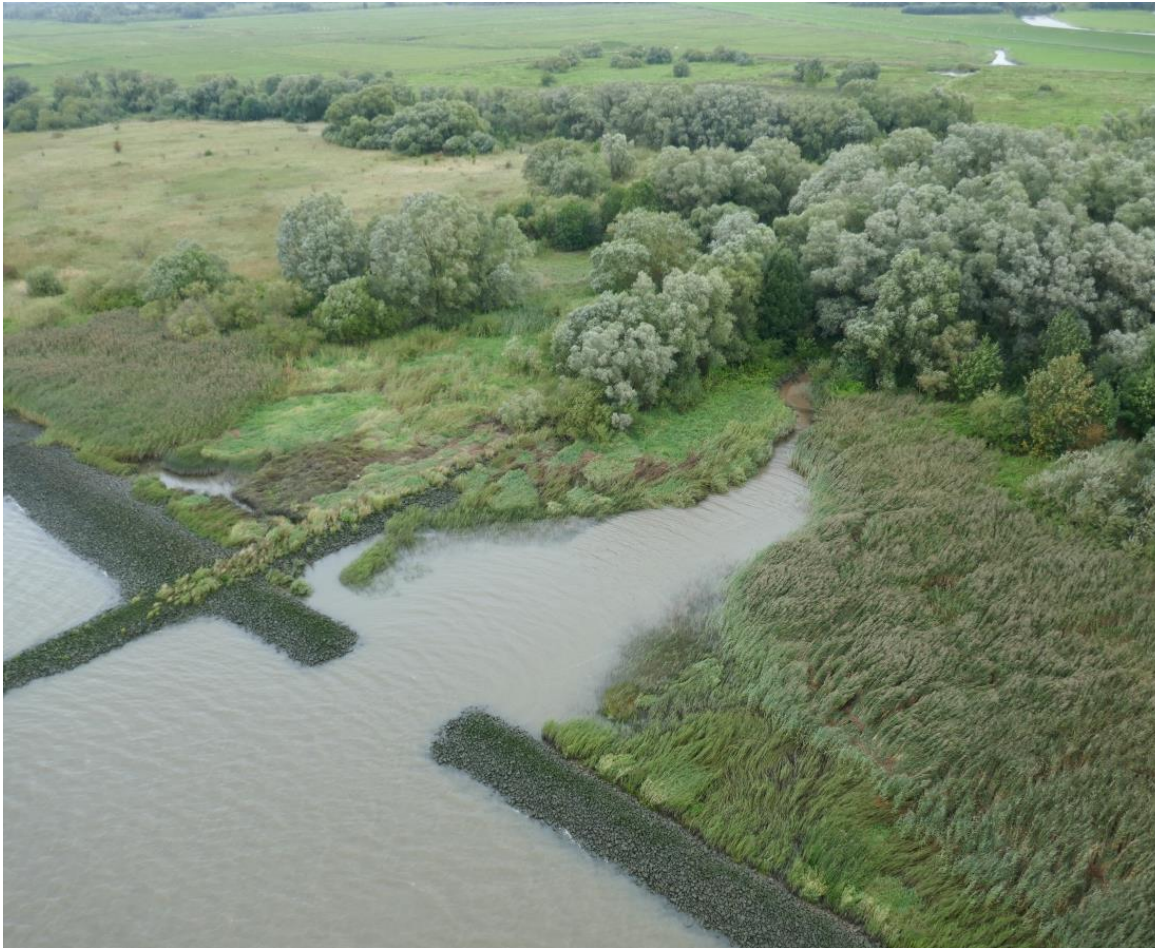
Lowering of revetment Juelssand/Hetlingen

- **Km 650.600** right bank Elbe
- **Implementation period:** 2004
- **Contact:** WSA Elbe-Nordsee, branch office Wedel
- **Construction design:** Lowering one section of the revetment to create improved conditions for the development of estuarine bank dynamics and a natural vegetation zoning in the transition zone between water and land
- Today, a tidal creek with a near-natural bank structure, including sandy tidal flats, reeds and tall forb vegetation, can be found behind the revetment

Tidal creek development enabled by a truncated revetment at km 650.600 of the right Elbe bank.

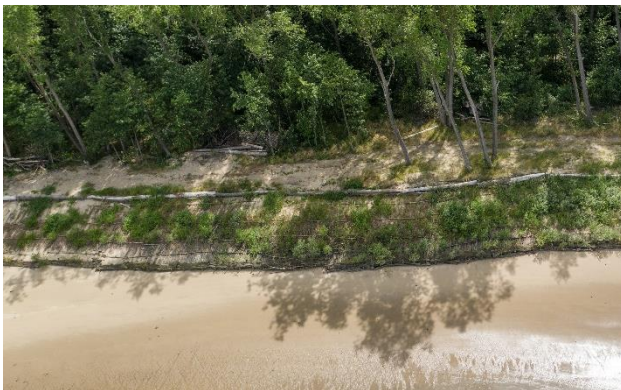
- **Km 642.300-642.700** (main navigation channel) left bank Elbe
- **Implementation period:** 2005-2008; 2015-2019 (continuous)
- **Contact:** Branch office Wedel: john.appel@wsv.bund.de
- **Construction design:** Combination of live material engineering, dead wood and a technical training wall. Willow brush mattresses acting as beach protection, transverse brushwood box structures acting as sediment trap

Combined measure comprised of willow brush mattresses, brushwood groynes and a riprap training wall.

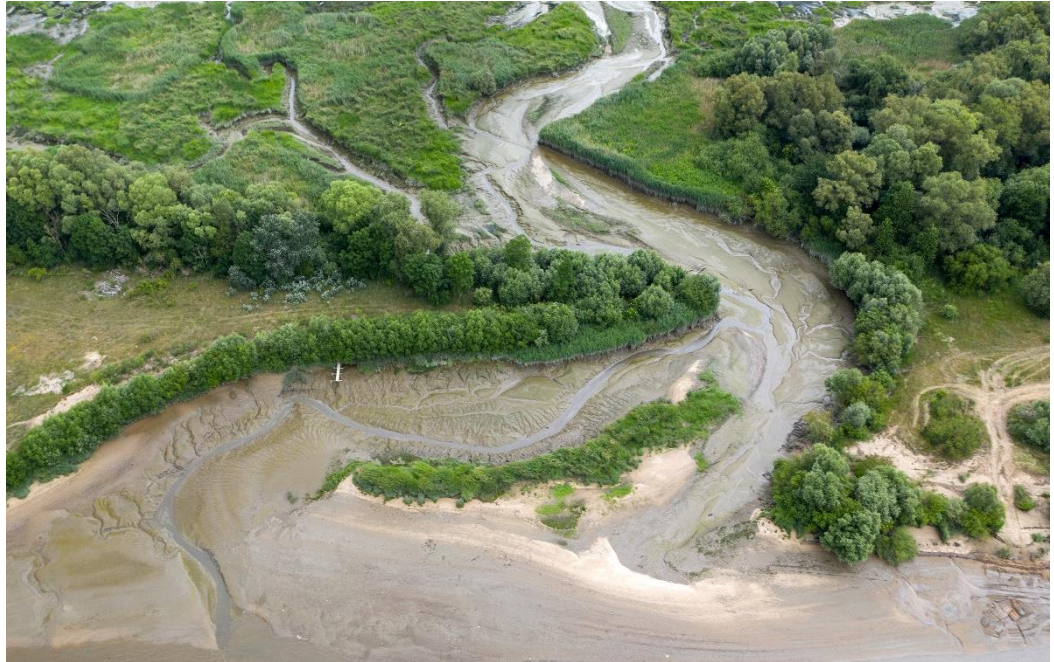
Redesign of the Hanskalbsand bank: combined measure

- **Km 6.700-6.900** Hahnöfer Nebenebbe
- **Implementation period:** 6-8 weeks in every spring season from ~2005
- **Contact:** Branch office Wedel: john.appel@wsv.bund.de
- **Construction design:** Combined measure comprised of willow brush mattresses and willow brushwood rolls protecting a tidal creek and other erosive banks

Willow population established from willow brush mattresses (top right) acting as tidal creek protection and brushwood rolls shielding the bank (bottom).

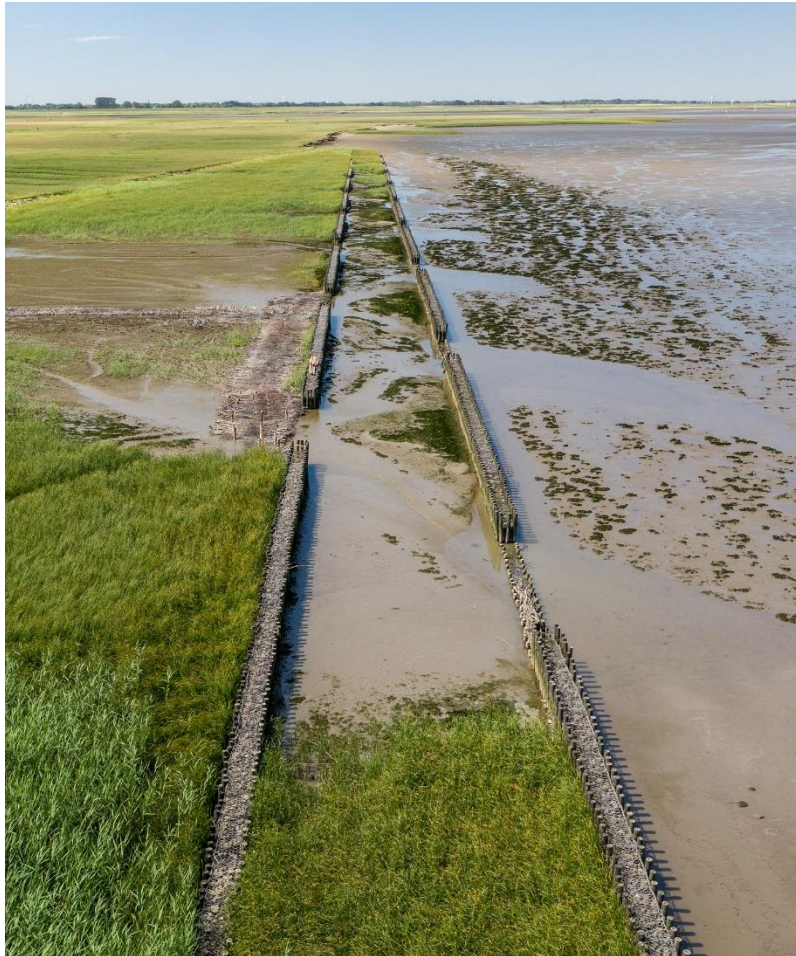
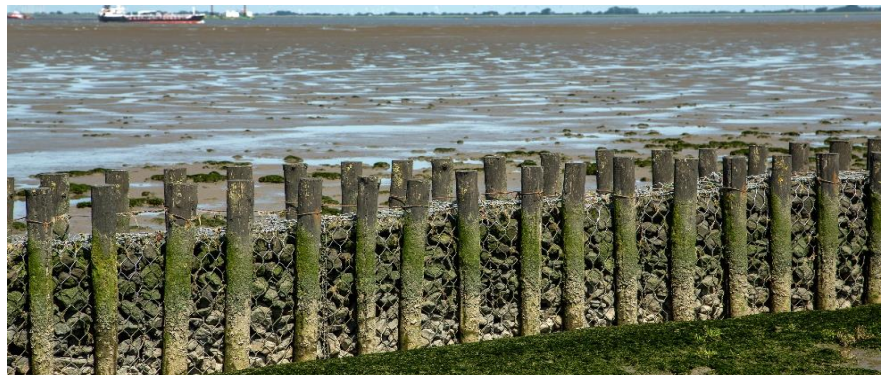
Brushwood box structure at the Hullen

- **Km 703.150-703.770** left bank Elbe
- **Implementation period:** 2003 (with parts being completed in 2014 only), continuous refurbishment from 2013
- **Contact:** WSA Cuxhaven: peter.scholz@wsv.bund.de
- **Construction design:** Brushwood box scheme acting as bank protection
- Bank protection under maintenance agreement, structure partly transferred from the Land of Lower Saxony
- Outlets raised with fascines or coir fascines, replacement of missing piles, restocking of rocks

Brushwood boxes acting as bank protection (photos taken in 2020).
