Living shoreline techniques for bank protection along estuarine waterways

Collection of measures in tidal areas

25. April 2022

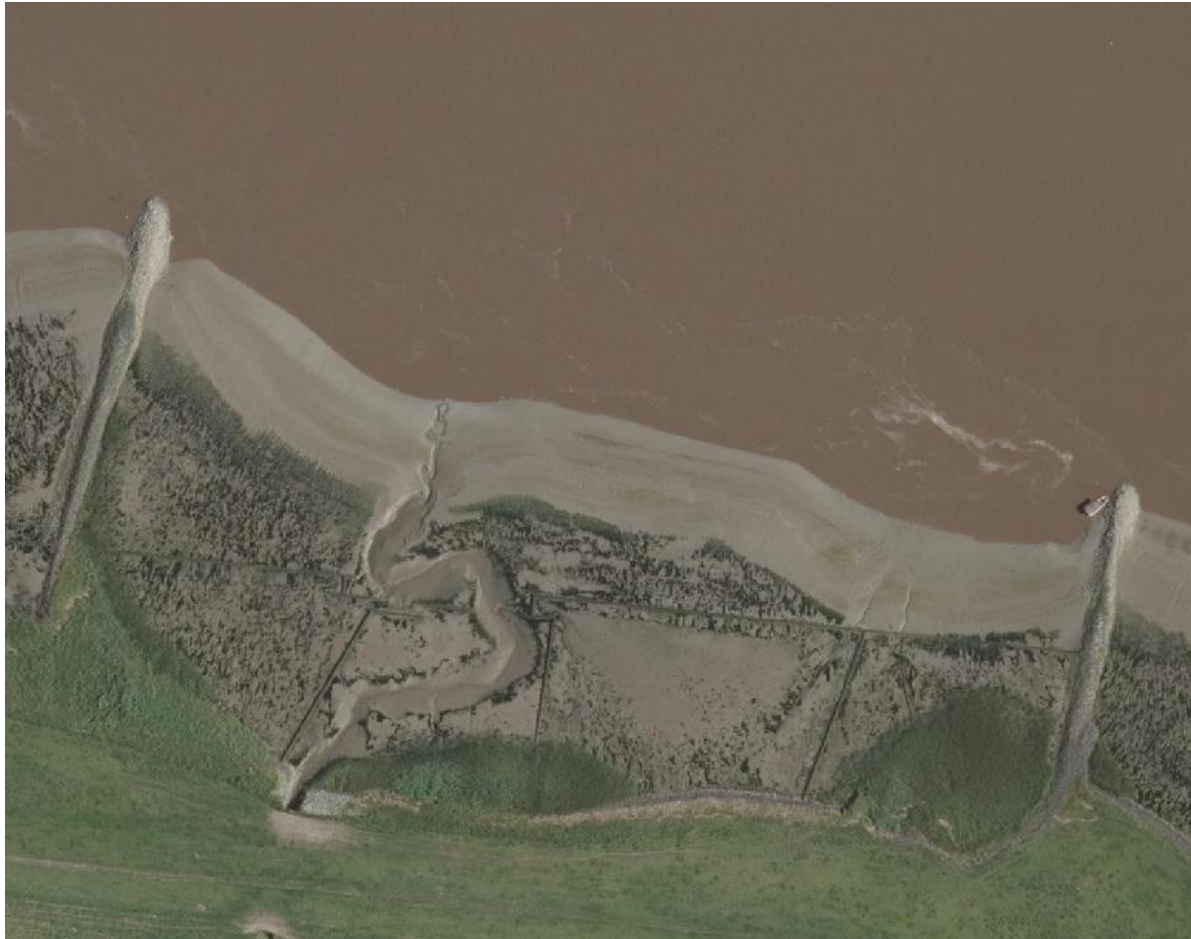
Brushwood box construction between groynes in Belum

- **Km 73.140-73.375** left bank Oste
- **Implementation period:** From September 2011 (continuous maintenance)
- **Contact:** WSA Cuxhaven: peter.scholz@wsv.bund.de
- **Construction design:** Brushwood box scheme acting as bank protection between Belum's groynes no. 9 and no. 11.
- In certain sections missing fascines were replaced by coir fascines. Some fascines go lost in the area every year due to storm tides and floating ice.

Aerial photograph of the brushwood boxes built between groynes no. 9 and 11.

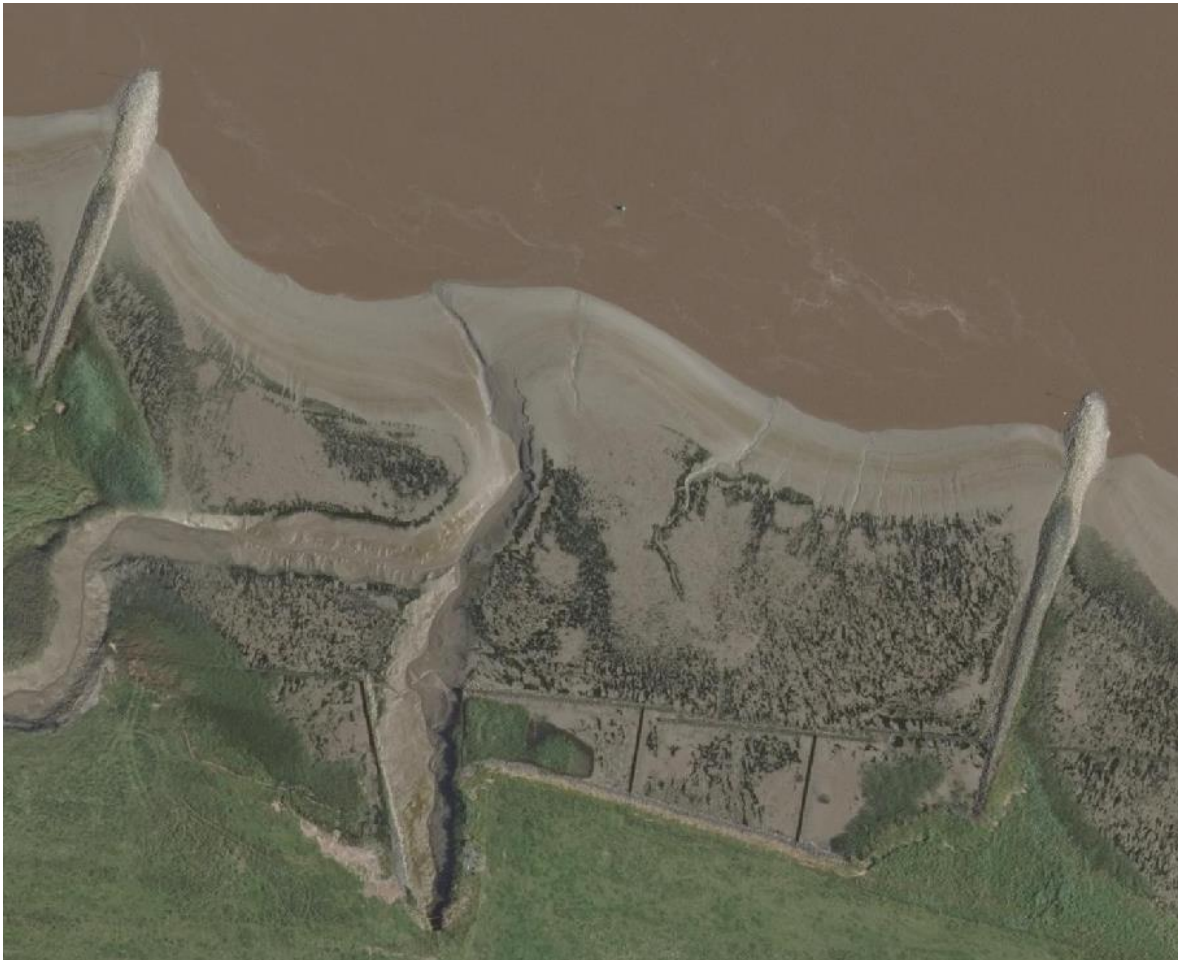
Brushwood box construction between groynes in Belum

- **Km 73.375-73.610** left bank Oste
- **Implementation period:** From June 2013 (continuous maintenance)
- **Contact:** WSA Cuxhaven: peter.scholz@wsv.bund.de
- **Construction design:** Brushwood box scheme acting as bank protection between Belum's groynes no. 7 and no. 9.
- In certain sections missing fascines were replaced by coir fascines. Some fascines go lost in the area every year due to storm tides and floating ice.

Aerial photograph of the brushwood boxes built between groynes no. 7 and 9.

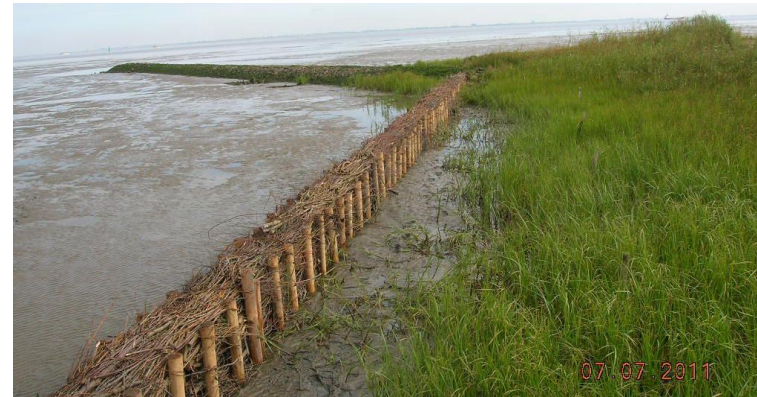
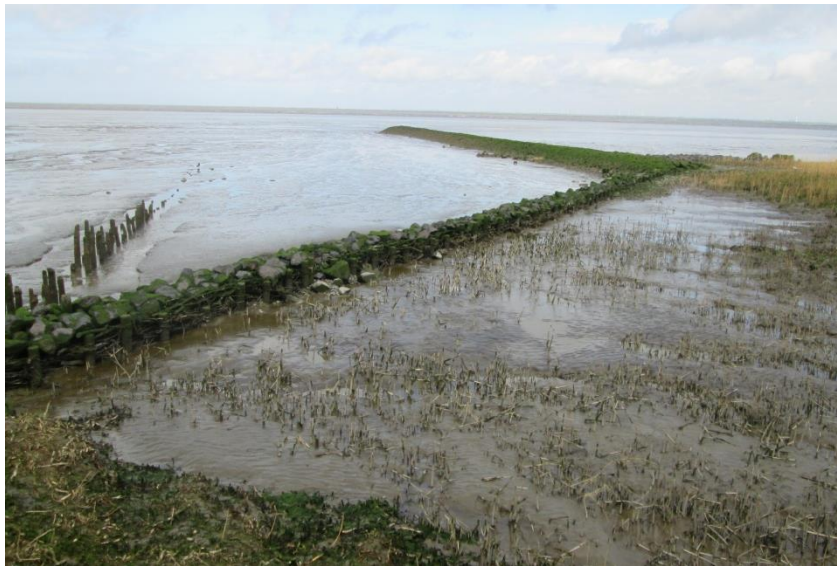
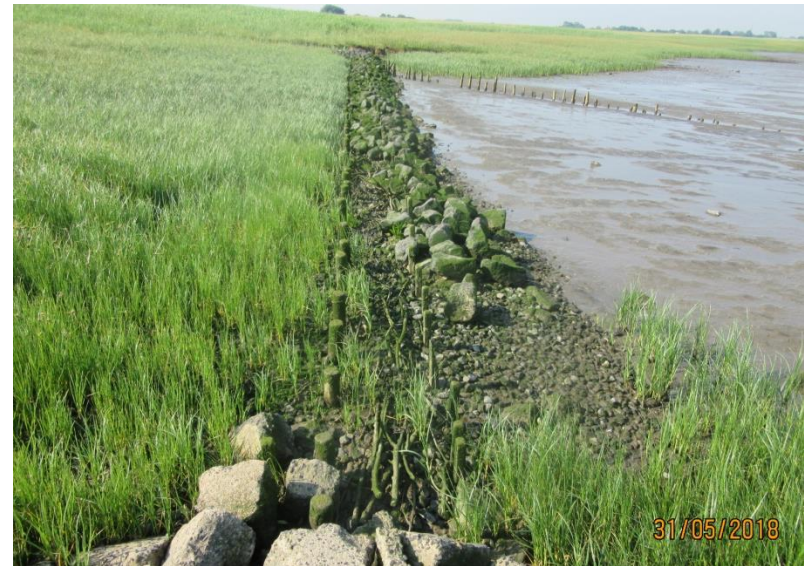
- **Km 709.780-709.800** left bank Elbe
- **Implementation period:** February 2011-August 2018
- **Contact:** WSA Cuxhaven: peter.scholz@wsv.bund.de
- **Construction design:** Protection of the groyne root with brushwood boxes
- Brushwood boxes were reinforced with a riprap toe protection during stage 2 and completely overbuilt with riprap during stage 3.

Protection of the groyne root with measures ranging from brushwood boxes built in 2011 (top) to a complete riprap superstructure (bottom).

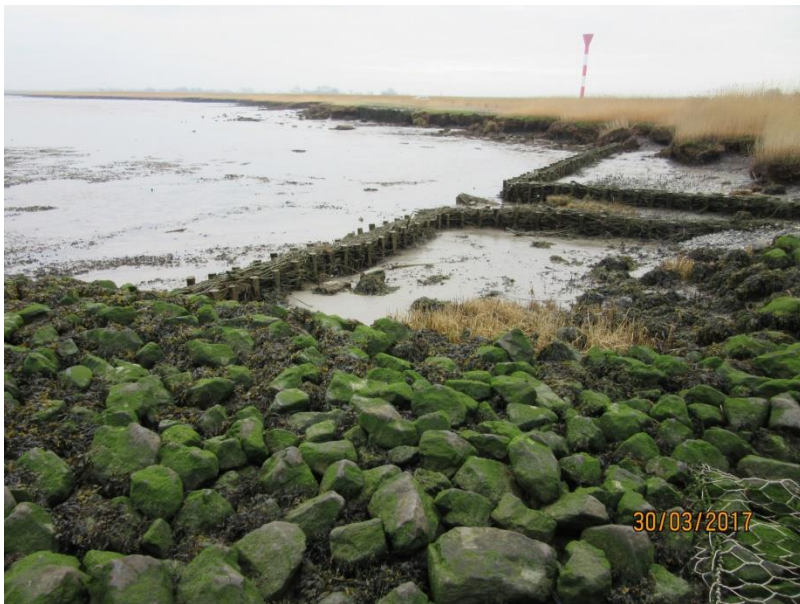
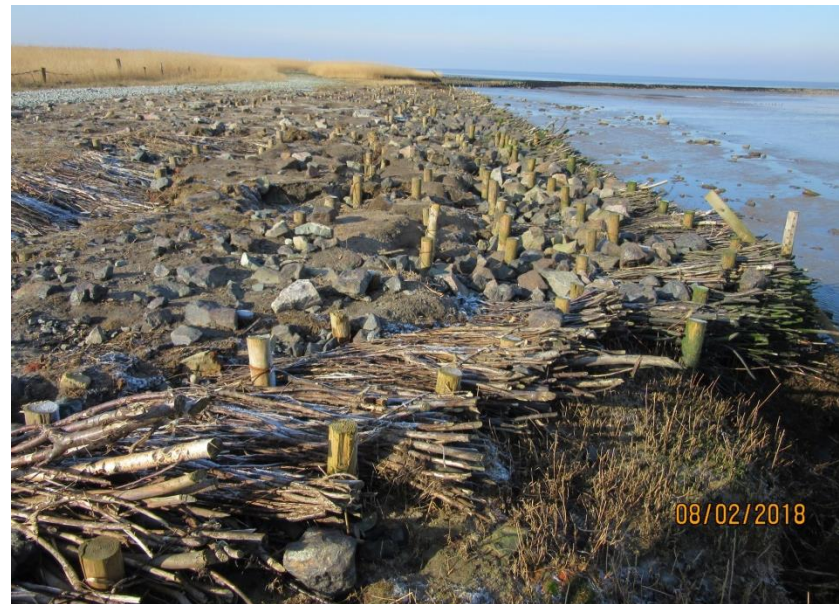
- **Km 712.460-712.580** left bank Elbe
- **Implementation:** Continuously from spring 2017
- **Contact:** WSA Cuxhaven: peter.scholz@wsv.bund.de
- **Construction design:** Rearward protection of the groyne root with brushwood boxes and fascine work (brushwood mattresses)
- Construction phase I with vegetation coir rolls failed: no vegetal cover developed, 75% of fill material got lost

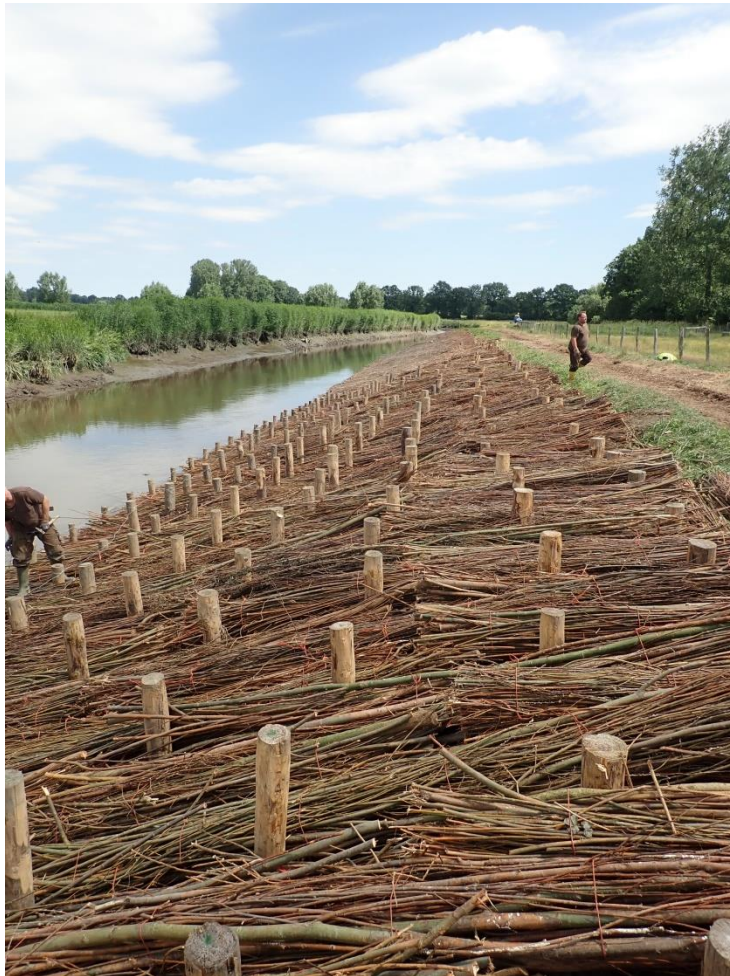
Protection of dikes without foreland on the Pinnau

- **Km 6.750-7.000** left bank Pinnau
- **Implementation period:** 29 May - 4 July 2018
- **Contact:** WSA Elbe-Nordsee:
caroline.feldmann@wsv.bund.de; external contractor: BSD
- **Construction design:** Bank maintenance of dikes without foreland (*Schardeiche*) with brushwood mattresses made of willow fascines from the preceding pruning season, arranged in a cross pattern.
- Cross profiles are measured on an annual basis for documentation purposes.

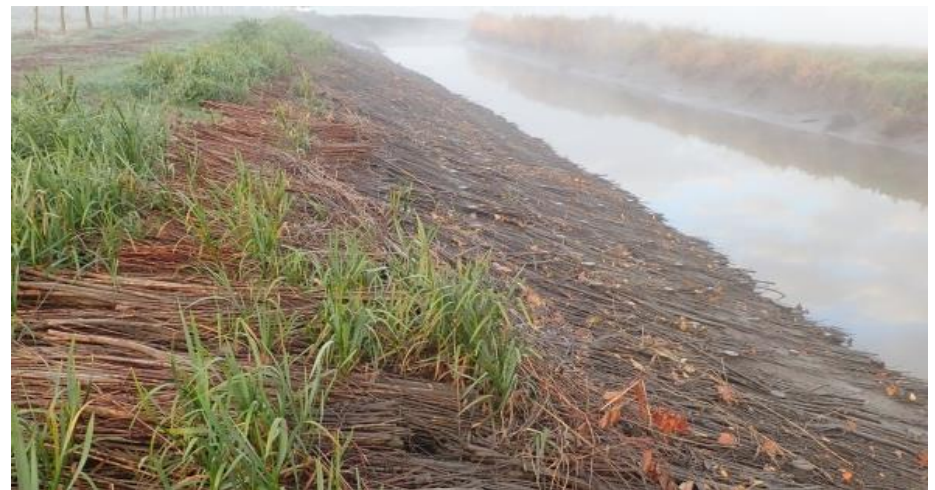
Brushwood mattresses supporting bank maintenance of dikes without foreland at the time of installation (left) and 4 weeks later (right).

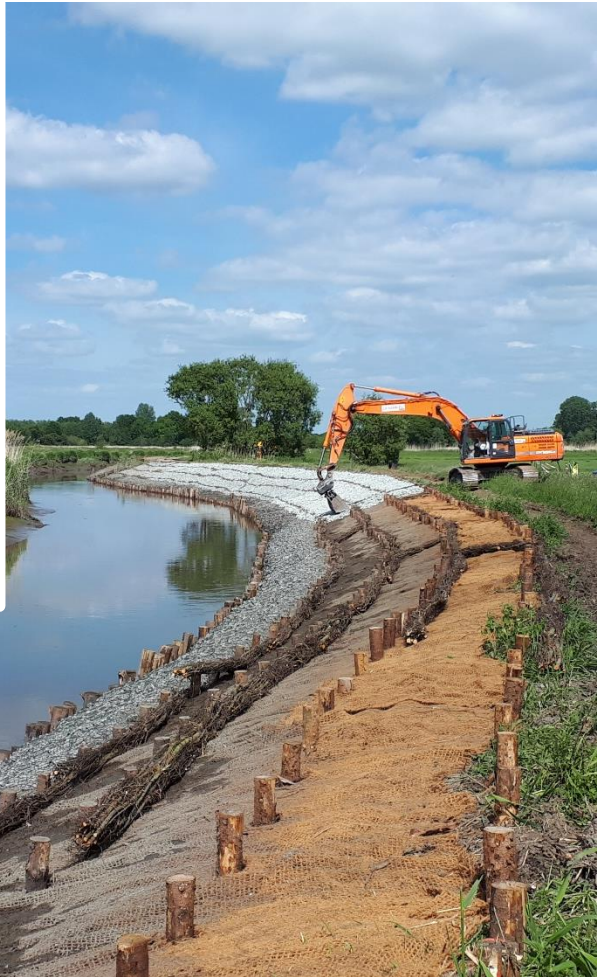
- **Km 7.340-7.500** left bank Pinnau
- **Implementation period:** May to June 2020
- **Contact:** WSA Elbe-Nordsee: caroline.feldmann@wsv.bund.de
- **Construction design:** Position stability of the revetment is ensured by fascine enclosure, rapid silting and growth of the new reed vegetation, rooting encouraged by coir mesh matting
- Measure initiated for embankment protection purposes

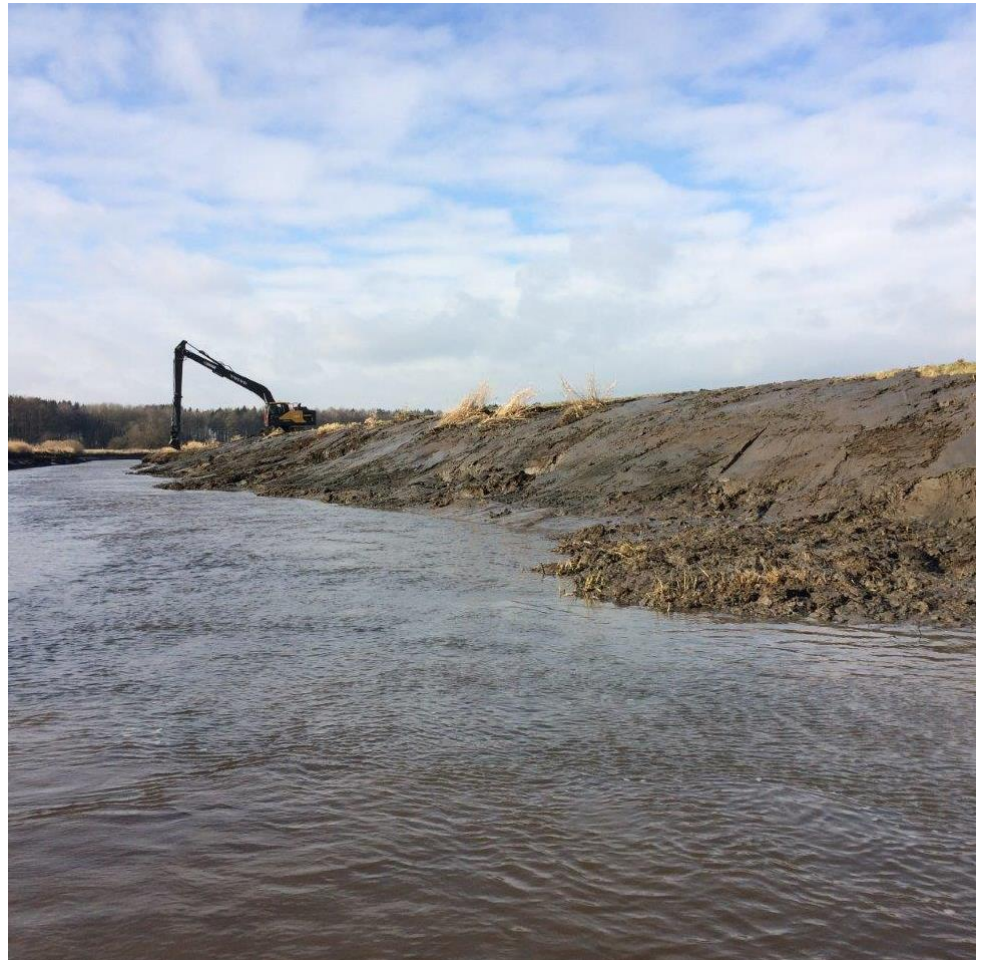
- **Km 7.500-8.080** right bank Pinnau
- **Implementation period:** Calendar week 7, 2019
- **Contact:** WSA Elbe-Nordsee: caroline.feldmann@wsv.bund.de
- **Construction design:** In order to rectify scour damage and bank collapses at dikes without foreland (*Schardeiche*), digging works were carried out under a pilot scheme to have the soil (cohesive, densely rooted) that had slipped into the Pinnau aligned the to the surrounding embankment and to examine the position stability of the dumped soil on the new embankment profile. Reed vegetation recolonised quickly.
- Continued severe flooding in the winter of 2019-2020, however, caused the cohesive material to become sodden and slump again before the new plants' root penetration provided sufficient protection.

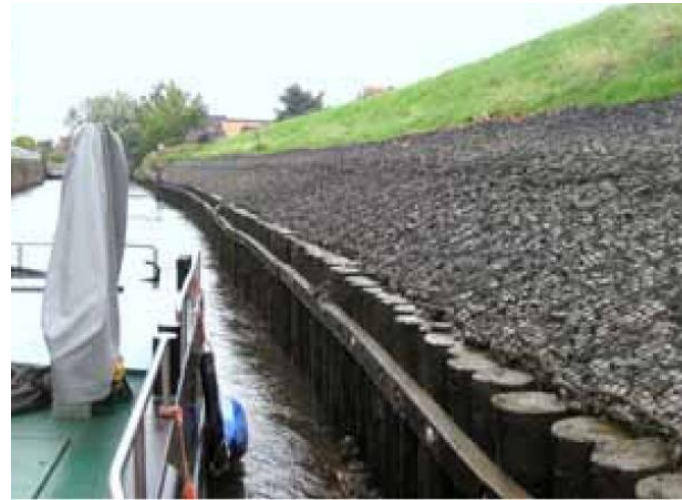
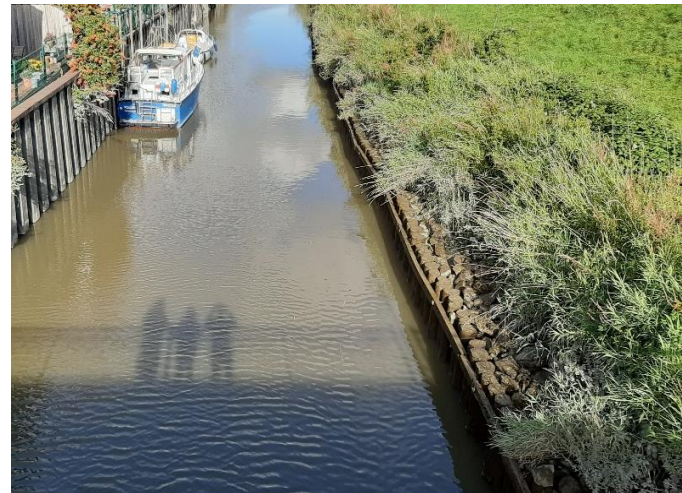
- **Contact:** Branch office Stade: caroline.feldmann@wsv.bund.de
- **Construction design:** In the winter of 2010-2011, severe longitudinal cracks in the embankment and subsidences along the embankment toe were discovered. As a response, a combined technical-biological bank protection scheme was put in place.

- In some sections pile walls (pine wood) were installed to protect the embankment toe.
- The steep embankment with a slope of 1:2 was shielded with stone mattresses, that have proven their worth.

- A strip of 1m in width situated above the stone mattresses is also exposed to hydraulic loads in times of flooding. Therefore, it was covered with pre-grown, natural fibre based grass mattresses reinforced with an additional armouring (“composite”) (contractor: BGS Ingenieurbiologie und Ökologie GmbH). The use of grass mattresses requires a certain degree of predictability of the construction schedule since delays entail major maintenance efforts in terms of rolling out and irrigating the mats.

Top: protective pile wall after installation (2012); bottom: status of the works as of October 2020

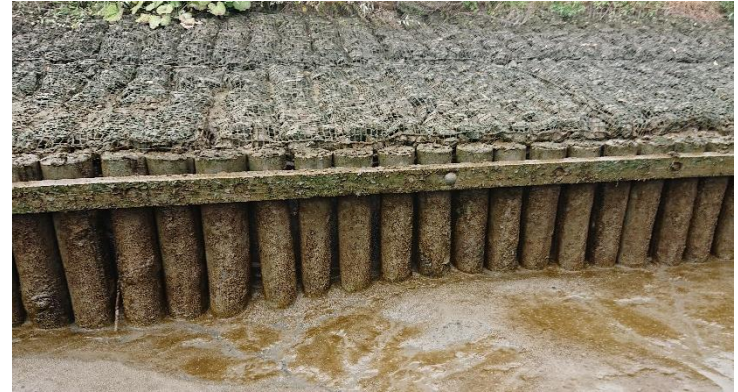
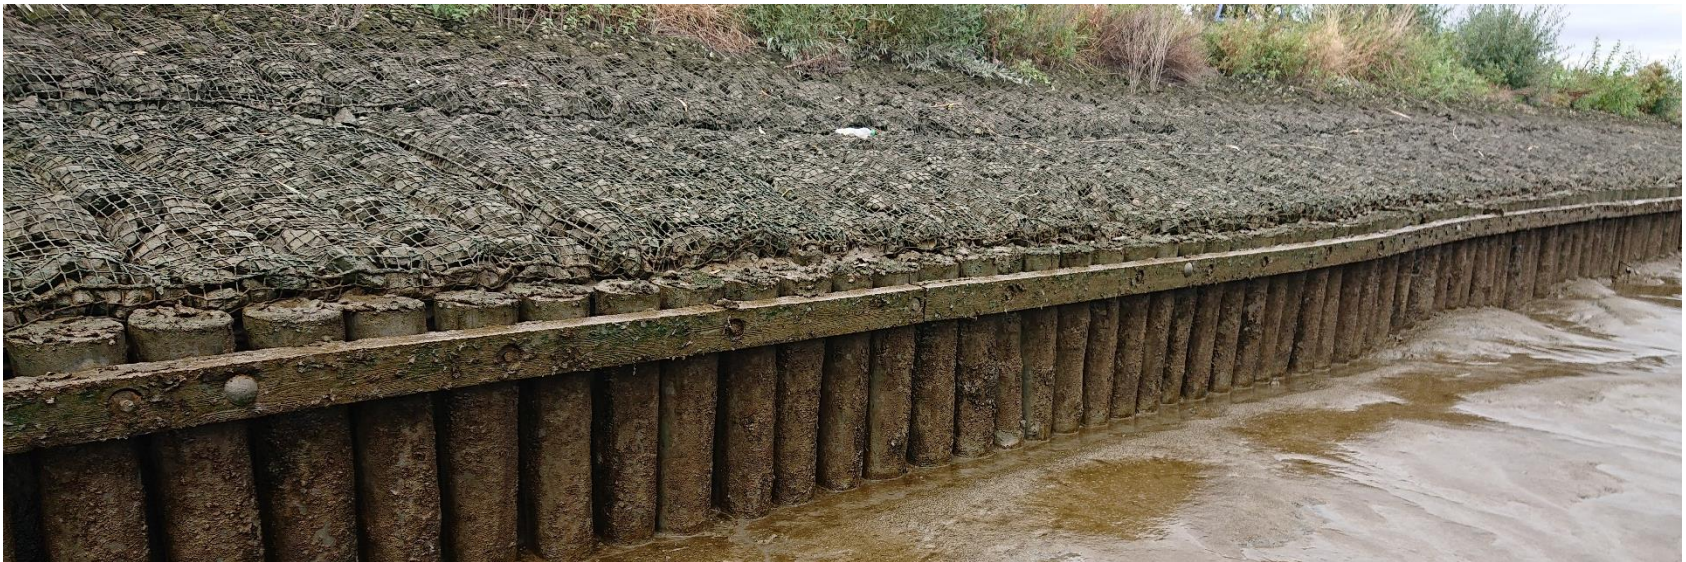
- **Km 2.410-2.550** right bank Bützflether Süderelbe
- **Implementation period:** 100 days of work
- **Contact:** Branch office Stade:
christopher.edler@wsv.bund.de
- **Construction design:** Toe protection consisting of a pile wall made of driven spruce piles plus stone mattresses
- Purpose of the measure: remediation of bank collapses caused by wash and wake

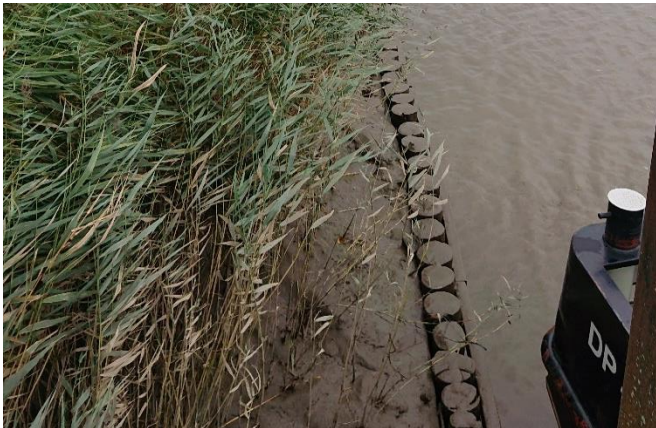
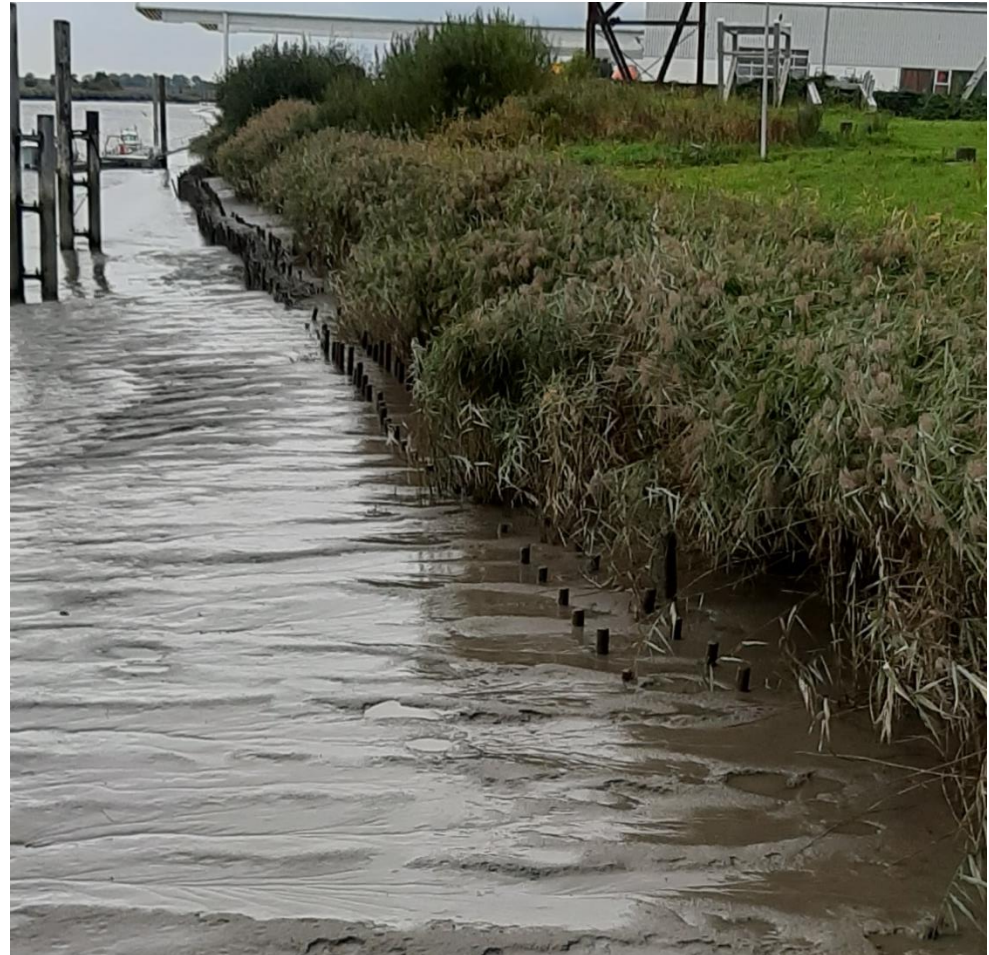
- **Km 5.220-5.350** left bank Ruthenstrom
- **Implementation period:** 15 days of work
- **Contact:** Branch office Stade: christopher.edler@wsv.bund.de
- **Construction design:** Brushwood box with willow fascines to protect bank from further collapse
- Purpose of the measure: remediation of bank collapses caused by wash and wake

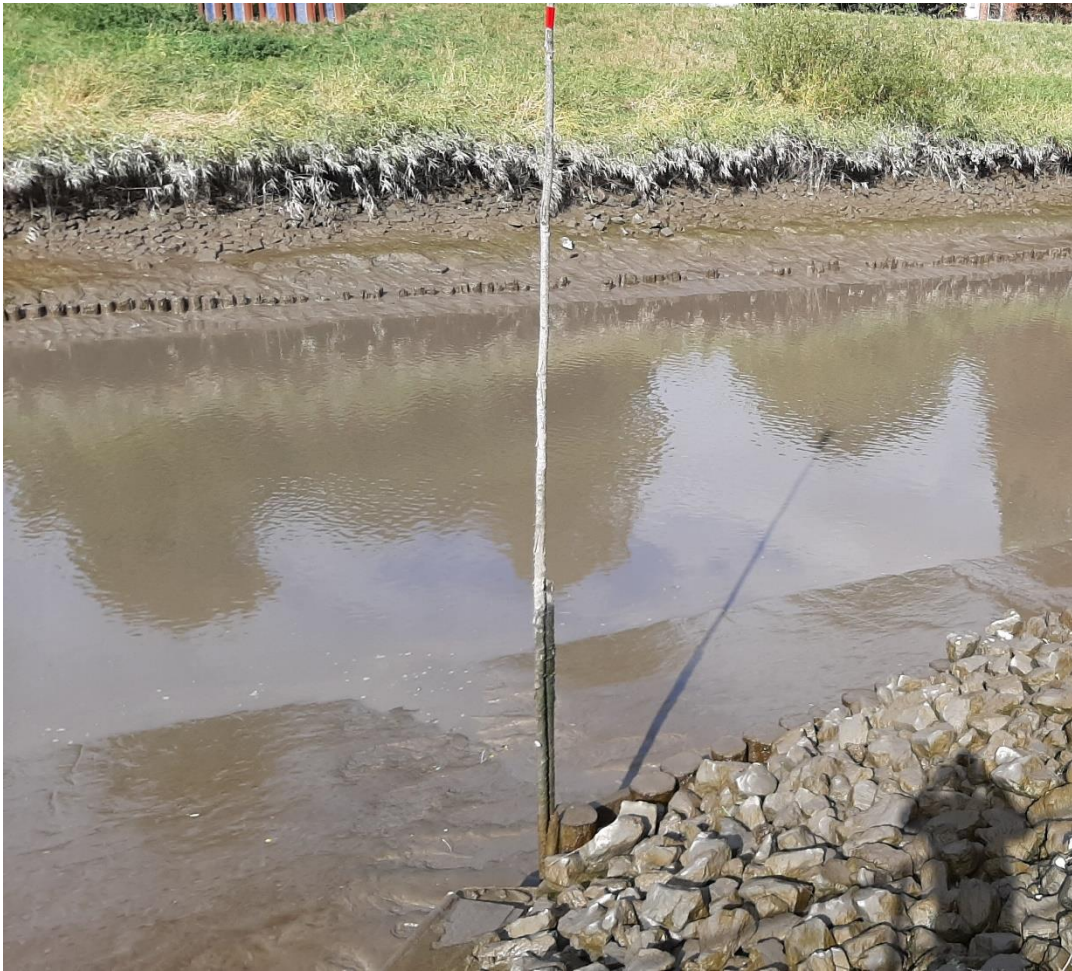
- **Km 0.470-0.560** right bank Schwinge
- **Implementation period:** 25 days of work
- **Contact:** Branch office Stade: christopher.edler@wsv.bund.de
- **Construction design:** Toe protection consisting of a pile wall made of driven spruce piles plus riprap and natural vegetation
- **Purpose of the measure:** remediation of bank collapses caused by wash and wake

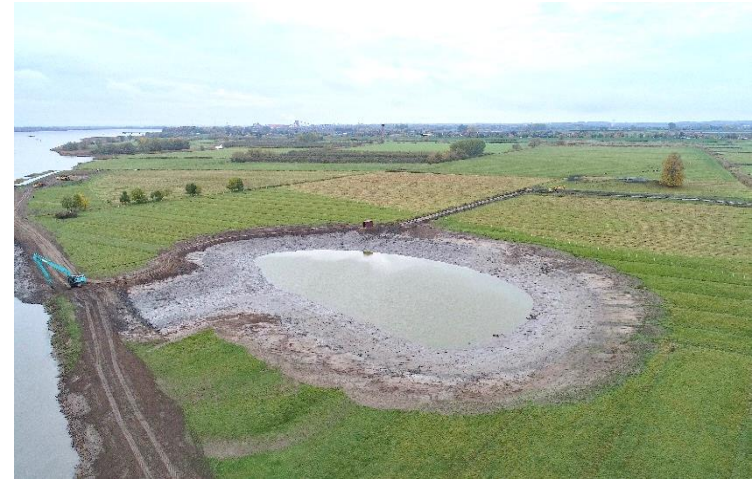
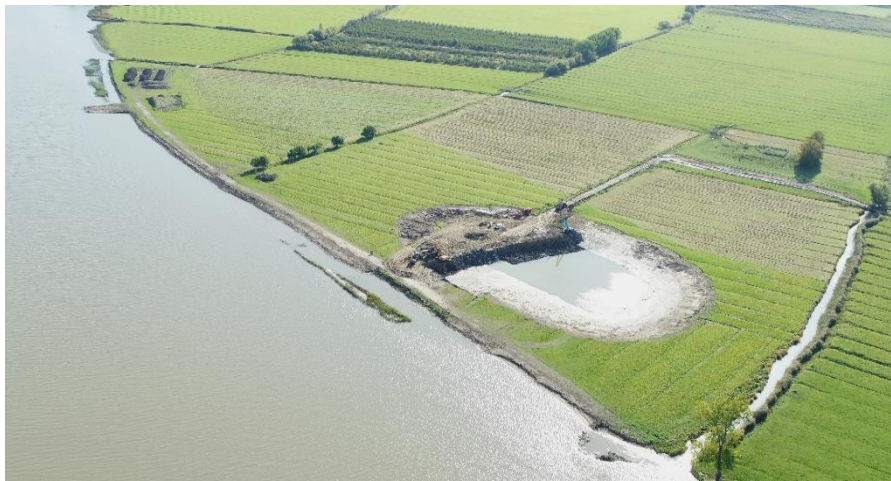
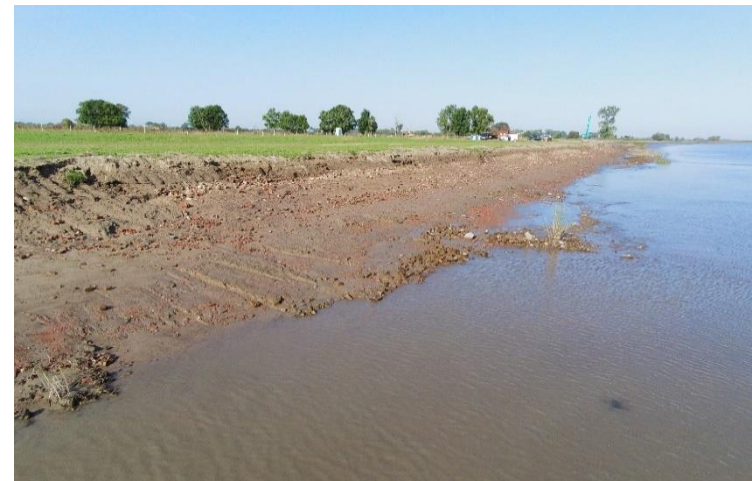
- **Km 0,3-0,9** left Bank Schwarztonnensander Nebenelbe
- **Implementation period:** 2020
- **Contact:** Branch office Wedel:
astrid.roeder@wsv.bund.de
- **Construction design:** Removal of about 640 m of revetment and four partially deteriorated groynes
- Shoreline flattening and removal of riprap bank protections to promote typical estuarine bank dynamics and shallow water areas, as well as the promotion of tidal flat and reed development.

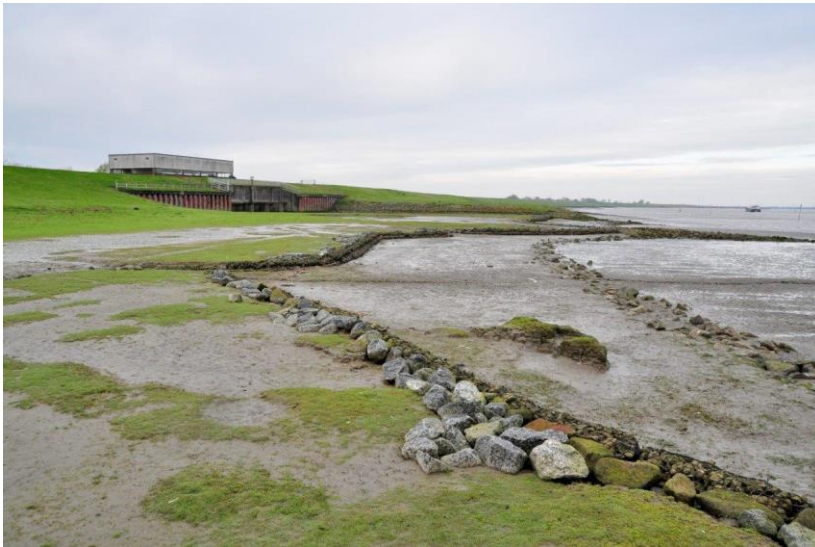
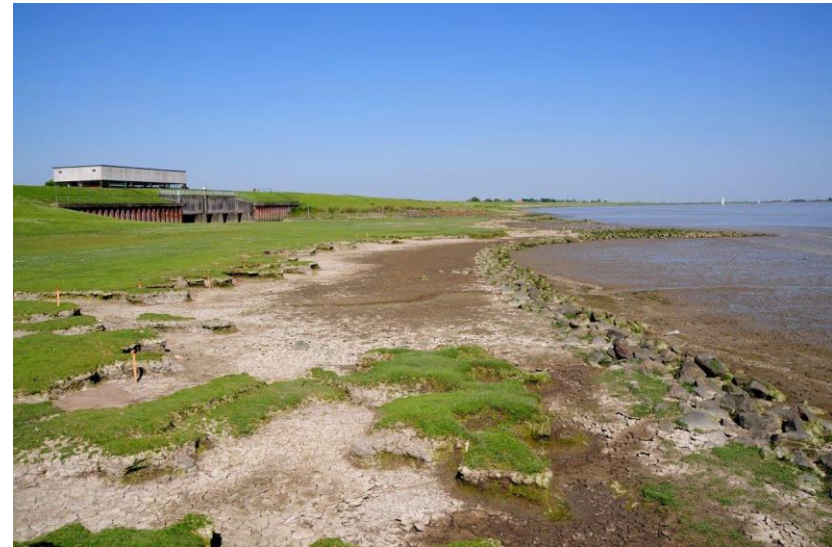
- Km 27.2-27.4 left bank Ems
- **Implementation period:** 9 days of work (7-15 August 2015)
- **Contact:** WSA Ems-Nordsee: Friedhelm.Roeloffzen@wsv.bund.de
- **Construction design:** Rock rolls at the revetment top occasioned by 2014 embankment inspection.

Protection of the erosion edge with rock rolls.

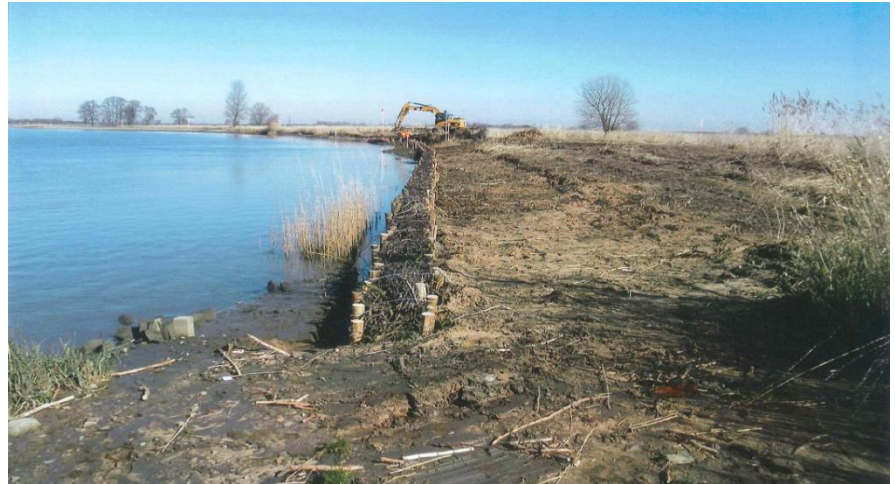
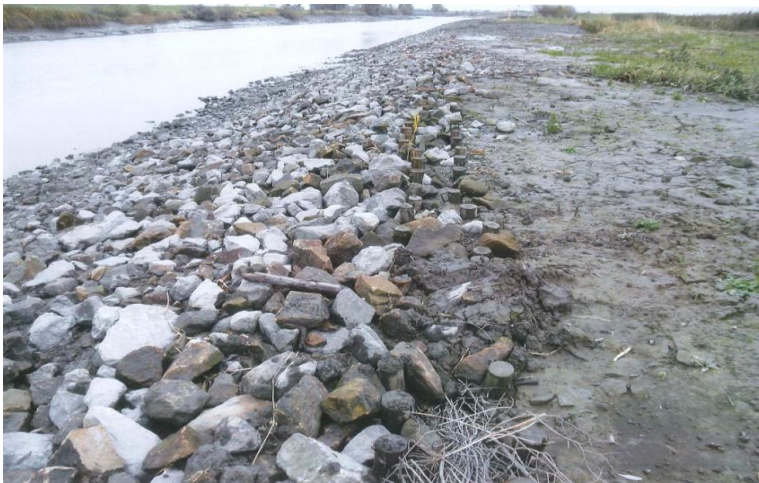
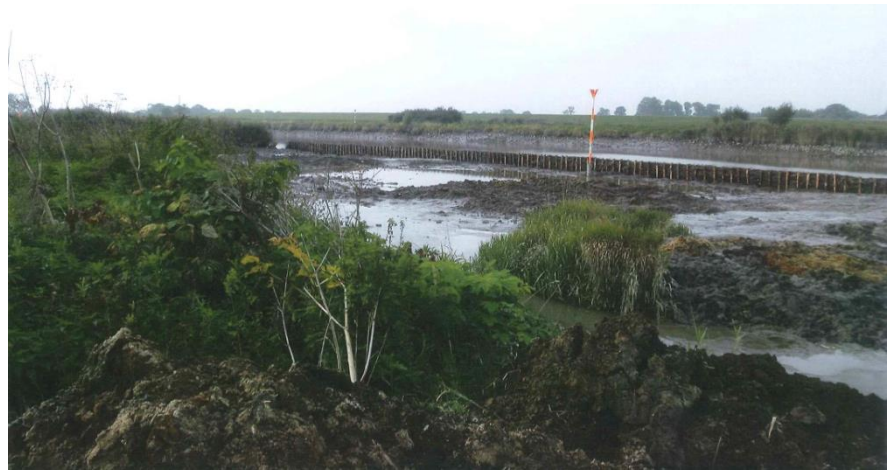
- **Km 218.3-219.8** right bank DEC
- **Implementation period:** 2010-2016
- **Contact:** WSA Ems-Nordsee: hans-hermann.schmitz@wsv.bund.de
- **Construction design:** Rectification of erosion damage at the slope crest of the revetment near the summer dike. Brushwood boxes were installed in several sections to protect the revetment.
