Brushwood boxes at Hullen, Section B

Measure-ID Estuary Waterway Chainage Bank side Elb703li\_01\_01 Elbe Lower Elbe (0701) Km 703.15 - 703.515 Left

# Nature-Based Solutions for Bank -Protection along Estuarian Waterways

Fact Sheets

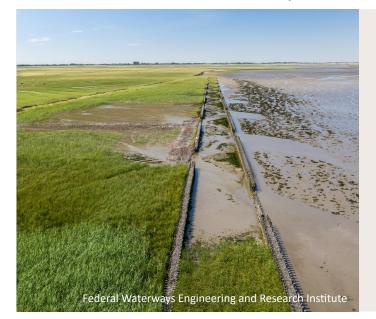
**Dead wood protection measure** Double pile row

Bank protection: bank erosion with erosion edge reaching up to vegetation border; sediment trap

**Development and maintenance of measure** The measure was installed by the Lower Saxony Water Management, Coastal and Nature Protection Agency (NLWKN). The measure's development can be assessed as positive since sediment buildup is good and vegetation has spread. The objective of bank protection has been achieved. The maintenance interval required for the measure is 1-2 years; the replacement interval is > 10 years.
