## Brushwood training wall Warflether Sand

Bundesanstalt für Wasserbau

Measure-ID	Uwe024li_01_01
Estuary	Weser
Waterway	Lower Weser (5298)
Chainage	Km 23.5 - 24.9
Bank side	Left

Brushwood training wall

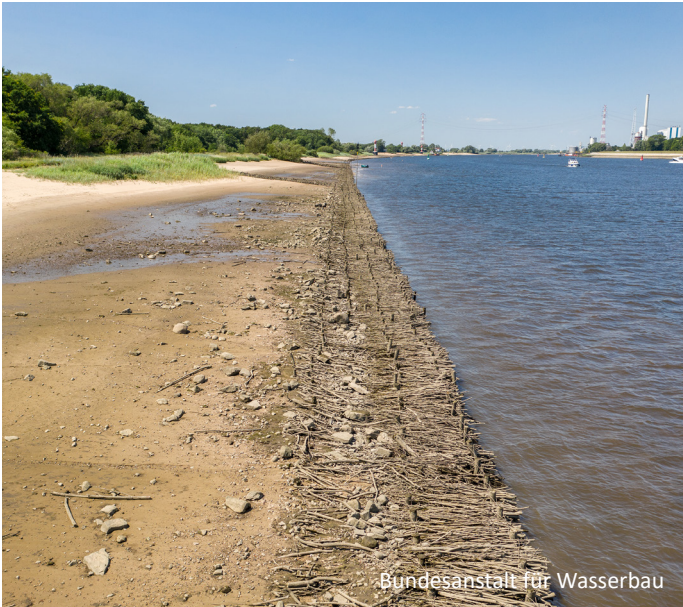
7,670.40 m<sup>3</sup> of brushwood: length = 1,400 m, width = 3.20 m, height of the structure = 0.20-1.60 m

The bank protection has been in place for several decades and its year of installation is unknown. In 2020 general repair work was carried out. After 3-5 years the area needs to be reworked. In order to restore 10-15 m of the training wall, 6-8 persons per day are required to work under tidal conditions. Ongoing maintenance of the structure is necessary to ensure lasting protection of the nature-based bank design. The maintenance interval required is 3-5 years; the replacement interval is also 3-5 years.
