Federal Waterways Engineering and Research Institute & Federal Institute of Hydrology

Nature-based solutions for bank protection in estuarine waterways

Collection of measures in tidal areas

30.04.2026
Version: 4

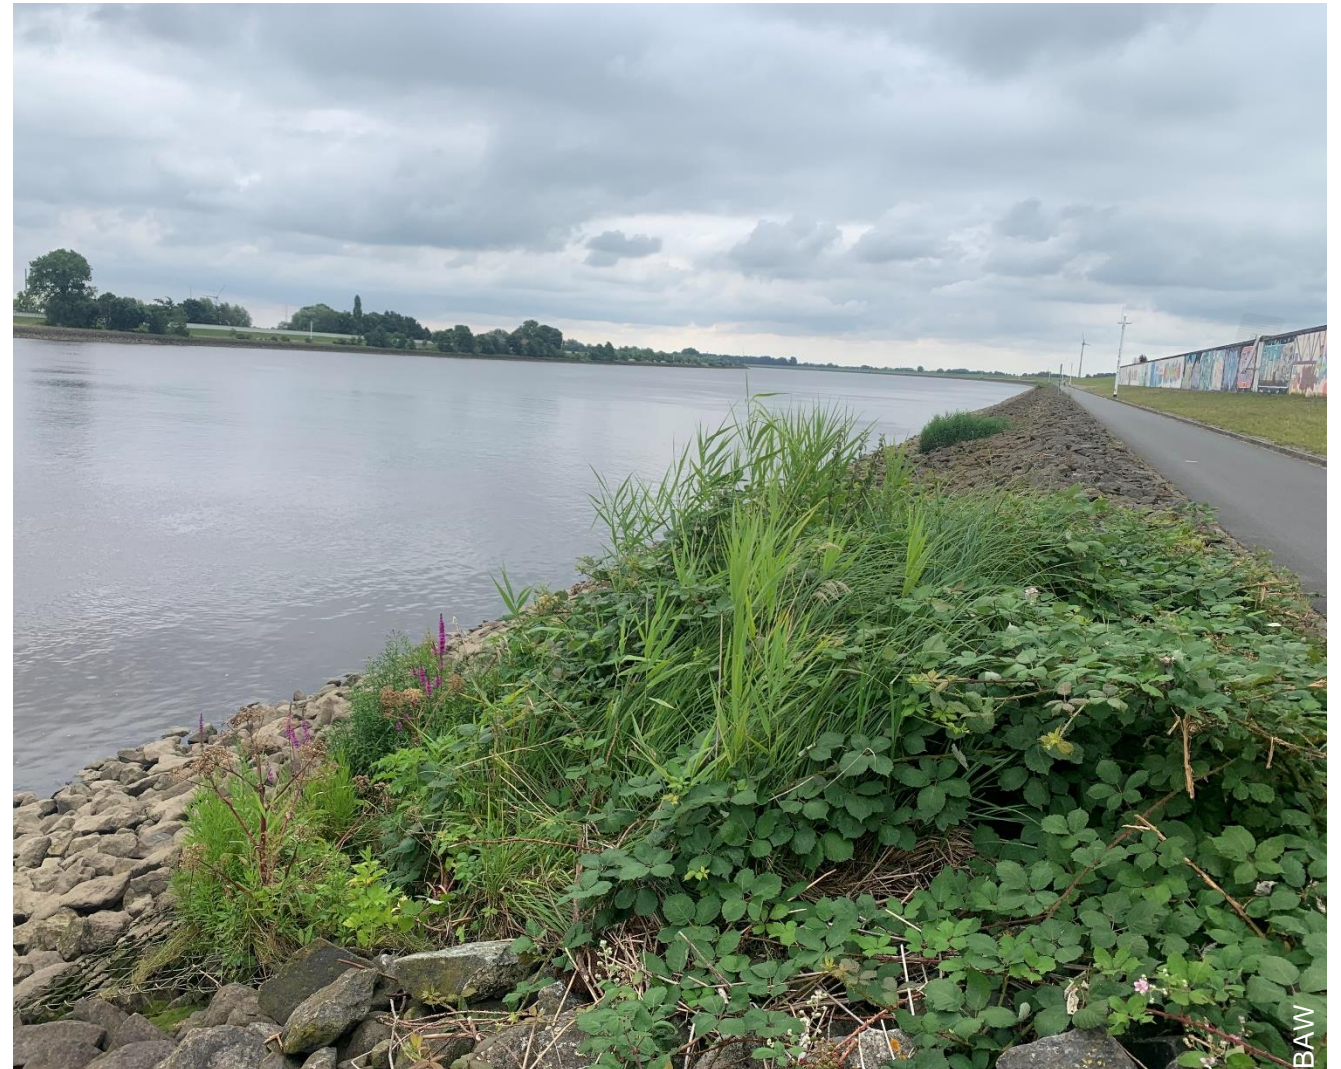
Vegetation boxes Lemwerder

- **Km 11,7-17,0** left bank Lower Weser
- **Implementation:** 2015 - 2016
- **Contact:** WSA Weser-Jade-Nordsee: abz-habenhansen@wsv.bund.de
- **Construction design:** During the construction of the new revetment, several vegetation islands made of gabion boxes were integrated into the revetment at intervals of approximately 320 m. The boxes are 4 m x 5 m in size and were installed in the area around mean high tide and higher, so that they are only flooded at higher water levels. The gabion boxes were filled by hand with LMB_{10/60} class stones (aiming for a void ratio of approximately 30%) The vegetation bales from the bank and reed zone were placed in the voids between the stones or after removing individual stones from the filled gabion boxes and weighted down with additional stones. The remaining gaps were filled with a pumpable soil-bentonite mixture.

- **Development:** The vegetation has developed well and various plant species can be found within the vegetation boxes. No major maintenance work has been necessary to date. Occasionally, blackberry plants are removed as they are an invasive species.

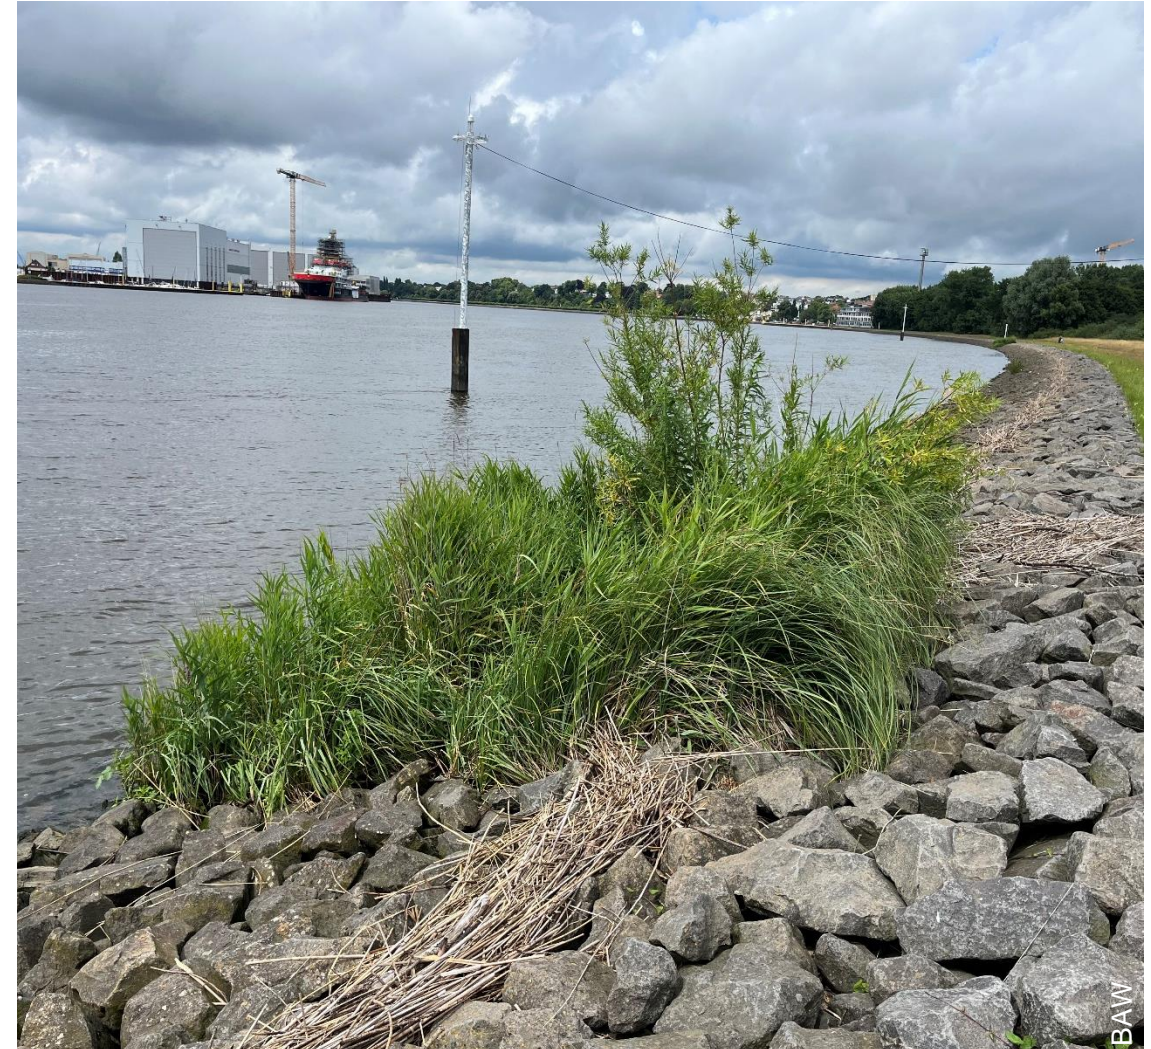
Vegetation boxes Schönebeker Sand

- **Km 15,875-17,325** right bank Lower Weser
- **Implementation:** 2018-2019
- **Contact:** WSA Weser-Jade-Nordsee: abz-habenhausen@wsv.bund.de
- **Construction design:** During the construction of the new revetment, several vegetation islands made of gabion boxes were integrated into the revetment at intervals of approximately 250 m. The boxes are 4 m x 5 m in size and were installed in the area around mean high tide and higher, so that they are only flooded at higher water levels. The gabion boxes were filled by hand with LMB_{10/60} class stones (aiming for a void ratio of approximately 30%) The 2-year-old and older vegetation bales from the riparian and reed zone were placed in the cavities between the stones or after removing individual stones from the filled gabion boxes and weighted down with additional stones. The remaining gaps were filled with a pumpable soil-bentonite mixture.

- **Development:** The vegetation has developed well and today, in addition to various reeds and other plants, willows can also be found in the vegetation boxes. No major maintenance work has been necessary to date. Occasionally, blackberry plants are removed as they are an invasive species.

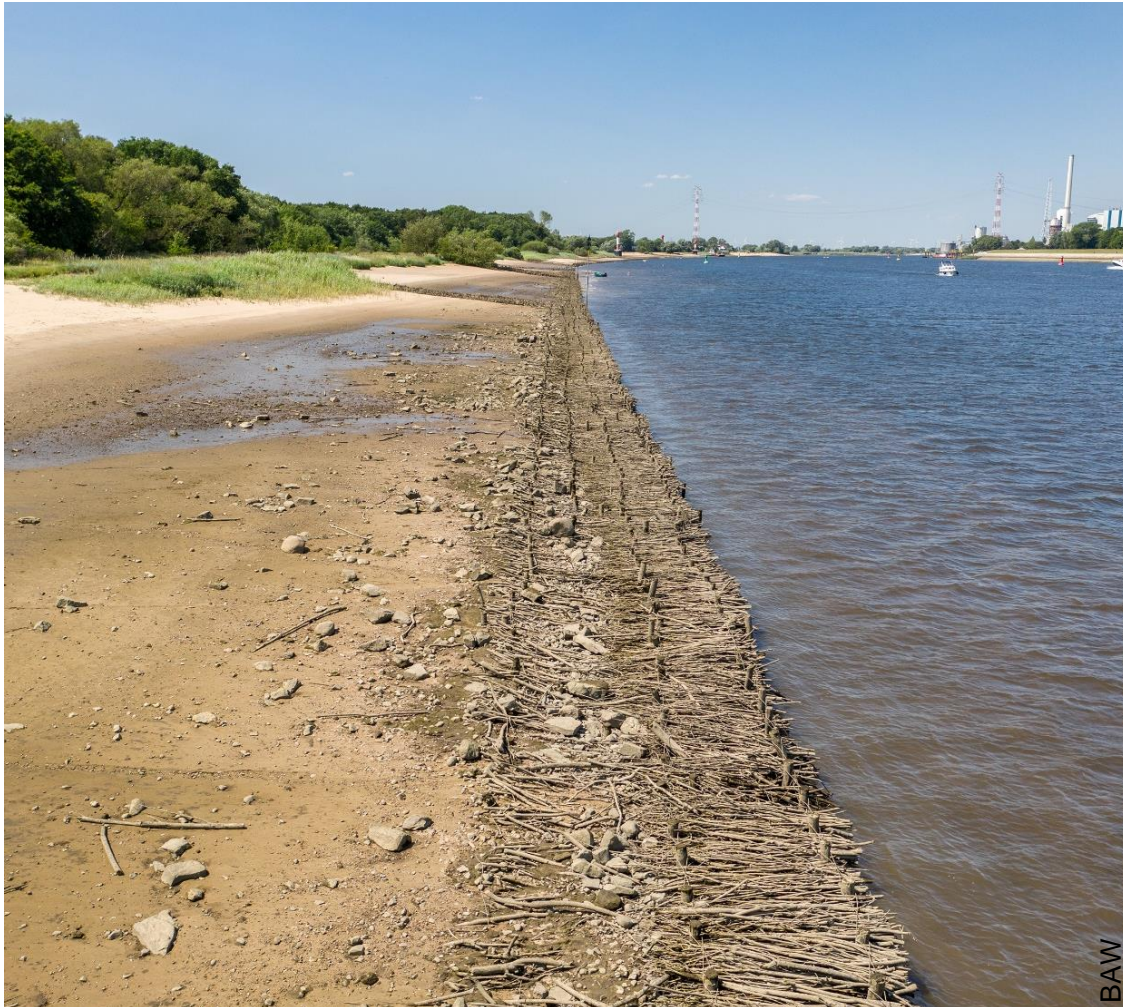
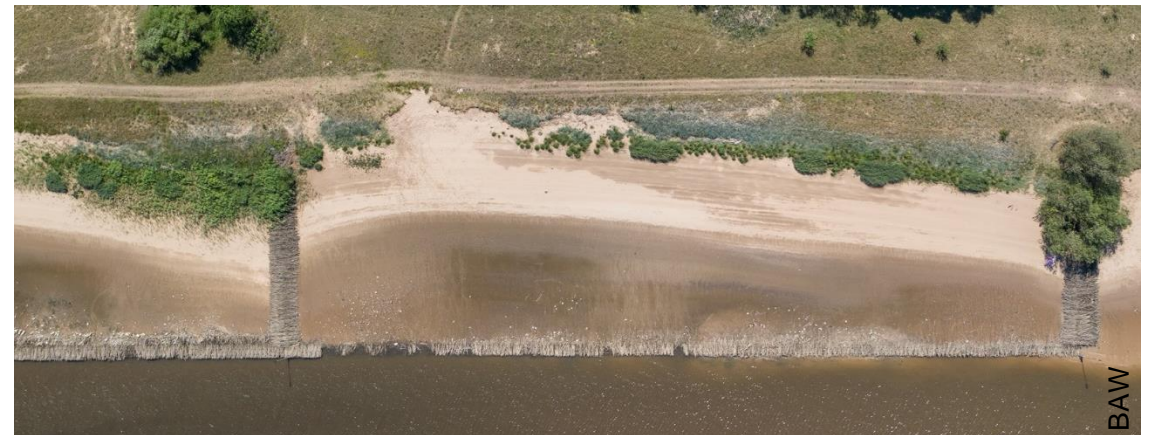
Brushwood training wall at Warflether Sand

- **Km 23,50-24,90** left bank Weser
- **Implementation:** unknown, last maintenance in 2020
- **Contact:** WSA Weser-Jade-Nordsee: abz-farge@wsv.bund.de
- **Construction design:** Brushwood training wall (longitudinal structure consisting of tied fascines) made of hardwood fascines to protect the beach
- **Development:** The training wall is fulfilling its purpose and is maintained in sections. The next maintenance is planned for 2026.

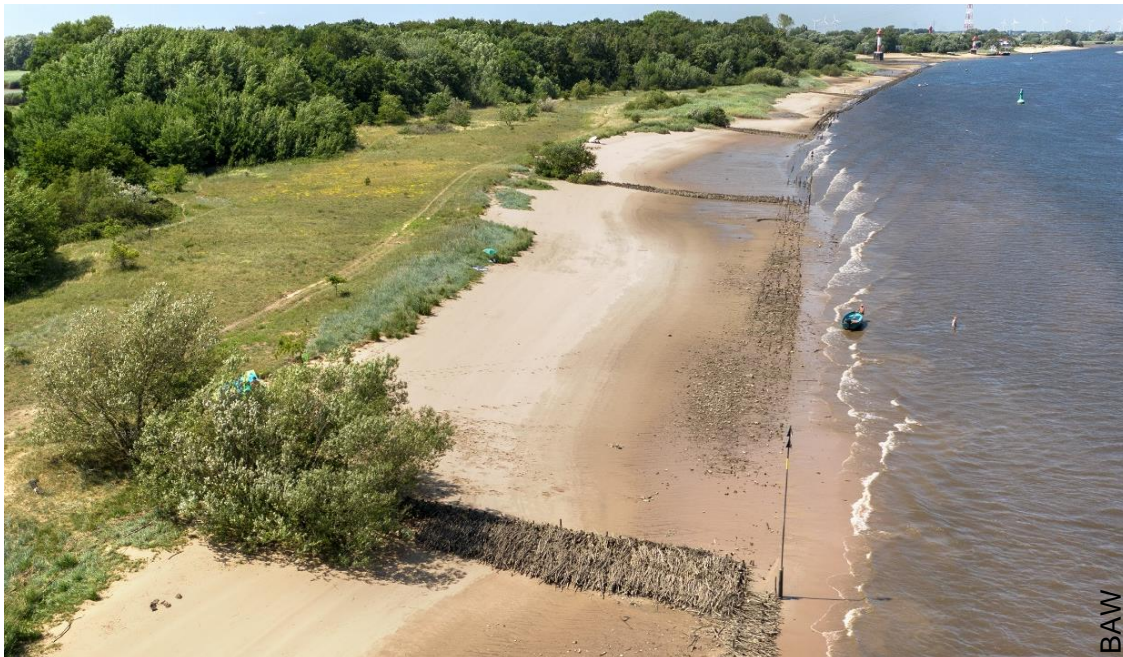
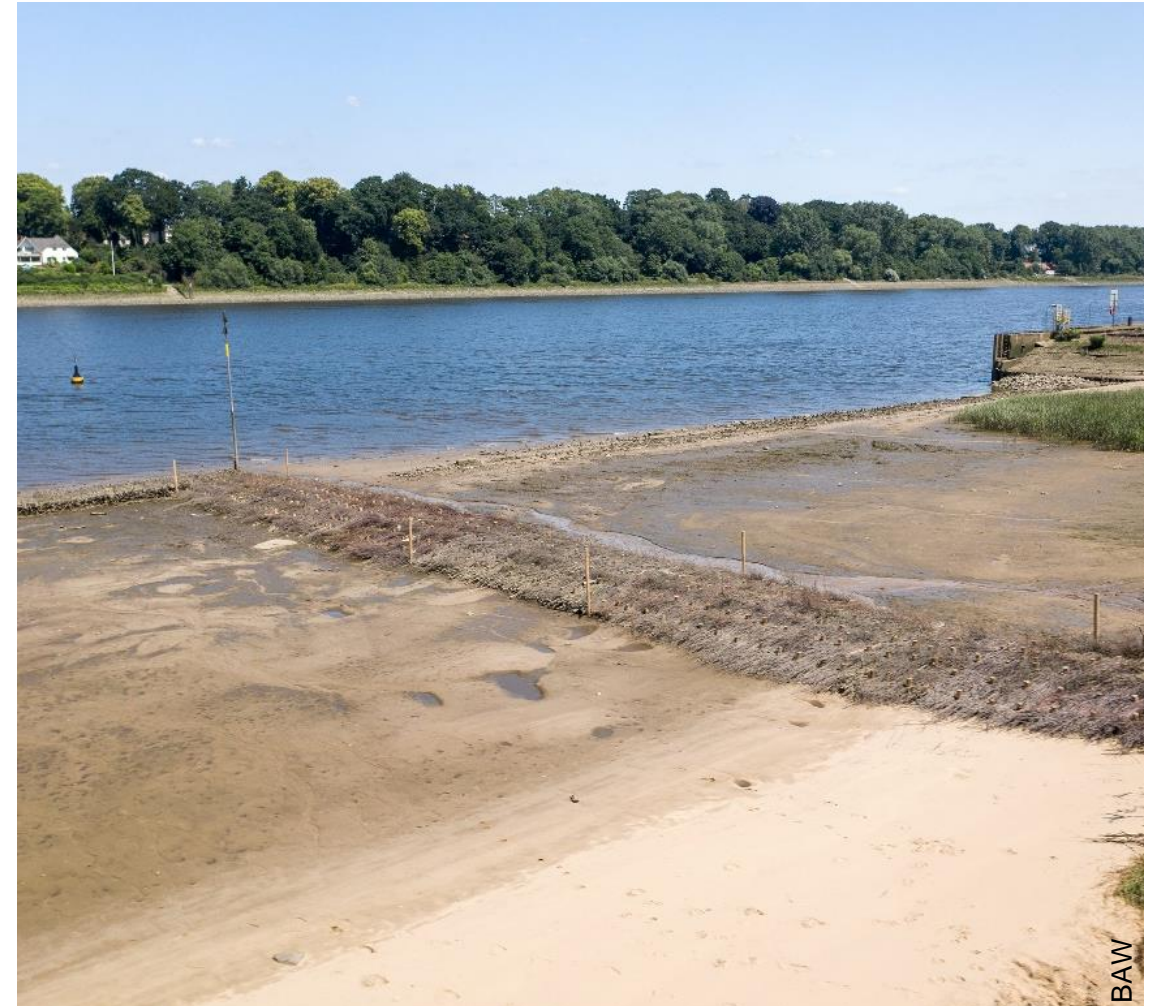
Brushwood groynes at Warflether Sand

- **Km 23,50-24,90** left bank Lower Weser
- **Implementation:** unknown, last maintenance in 2020
- **Contact:** WSA Weser-Jade-Nordsee: abz-farge@wsv.bund.de
- **Construction design:** Brushwood groynes made of hardwood fascines tied to piles
- **Development:** The groynes are fulfilling their purpose and are maintained as needed. The next maintenance is planned for 2026.

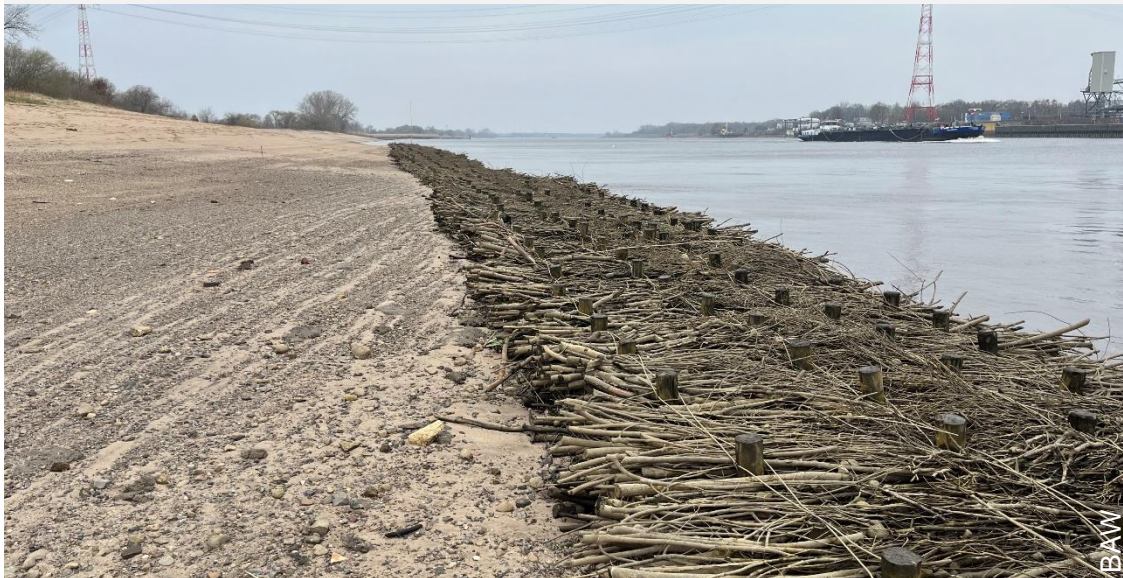
- **Km 25,00-25,50** left bank Lower Weser
- **Implementation:** unknown, last maintenance in 2025
- **Contact:** WSA Weser-Jade-Nordsee: abz-farge@wsv.bund.de
- **Construction design:** Brushwood training wall made of hardwood fascines for beach protection in two sections; gap at the ferry terminal Berne at km 25,35-25,45
- **Development:** The training wall is fulfilling its purpose and is maintained as needed; last maintenance was conducted in 2025.

Brushwood training wall in section 2 at km 25,45-25,95 in March 2026.

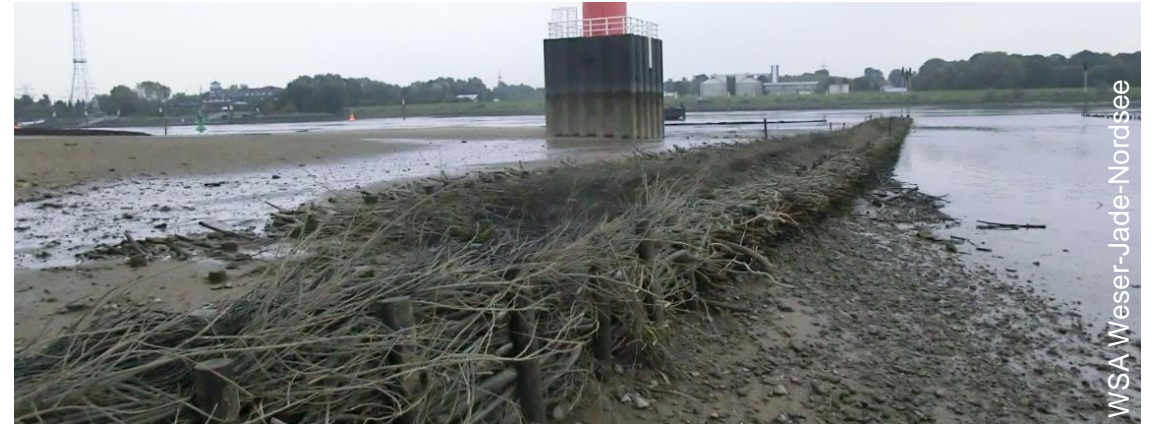
Brushwood training wall in section 1 at the harbour entrance at km 25,0 in 2014.

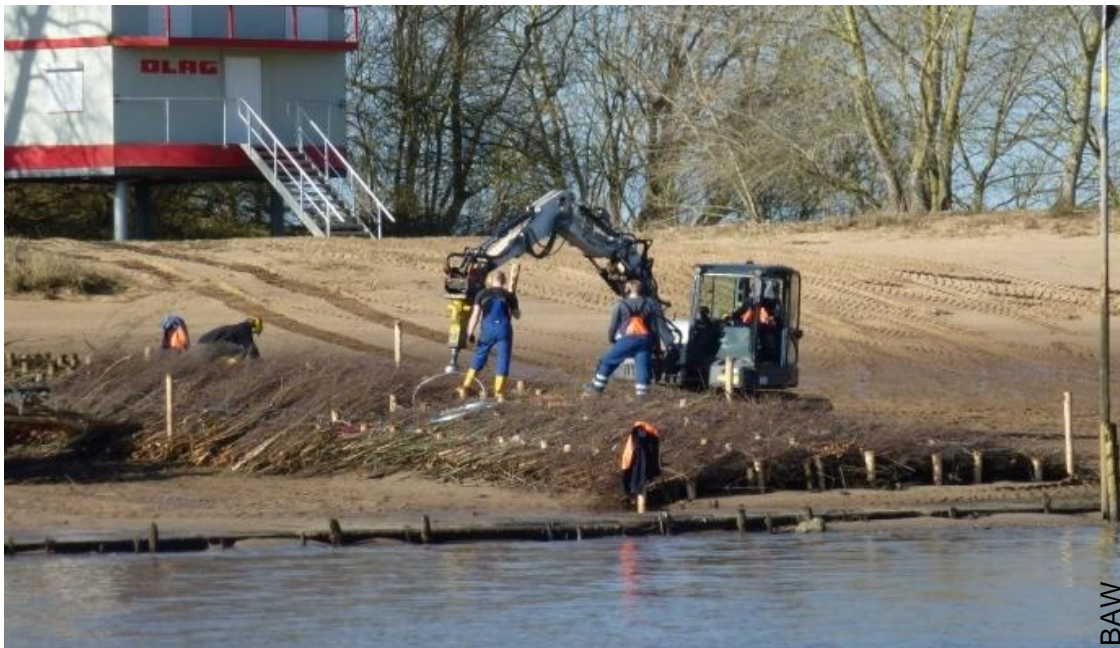
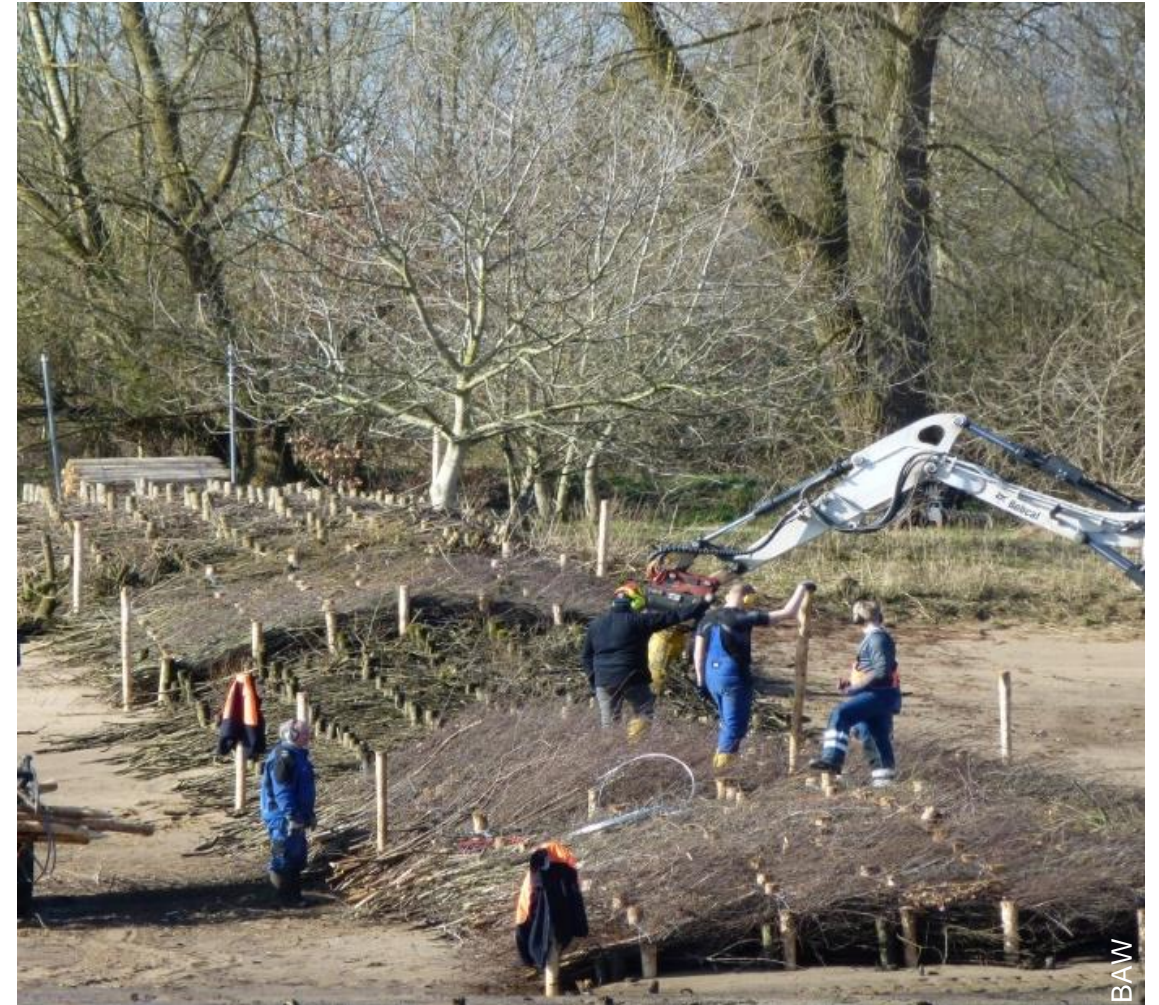
Brushwood groynes at Juliusplate

- **Km 25,00-25,50** left bank Lower Weser
- **Implementation:** unknown, last maintenance in 2020
- **Contact:** WSA Weser-Jade-Nordsee: abz-farge@wsv.bund.de
- **Construction design:** Brushwood groynes made of hardwood fascines to protect the beach
- **Development:** The groynes are fulfilling their purpose and are maintained as needed. The next maintenance is planned for 2026.

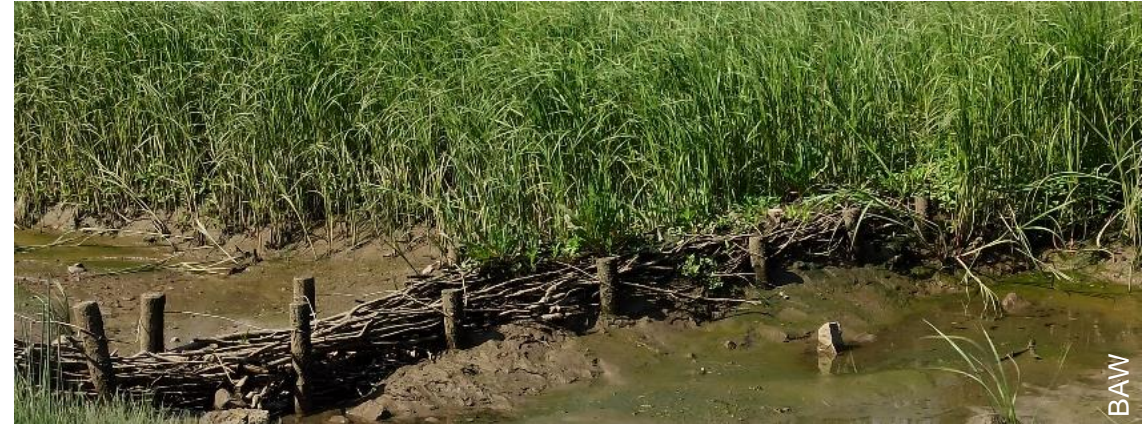
- **Km 27,850** right bank Lower Weser
- **Implementation:** November 2020, last maintenance in December 2023
- **Contact:** WSA Weser-Jade-Nordsee: abz-farge@wsv.bund.de
- **Construction design:** Brushwood box to damp a tidal creek running alongside the revetment.
- **Development:** The brushwood box is fulfilling its purpose. The next maintenance is planned for 2026.

Brushwood box before maintenance in June 2023 .

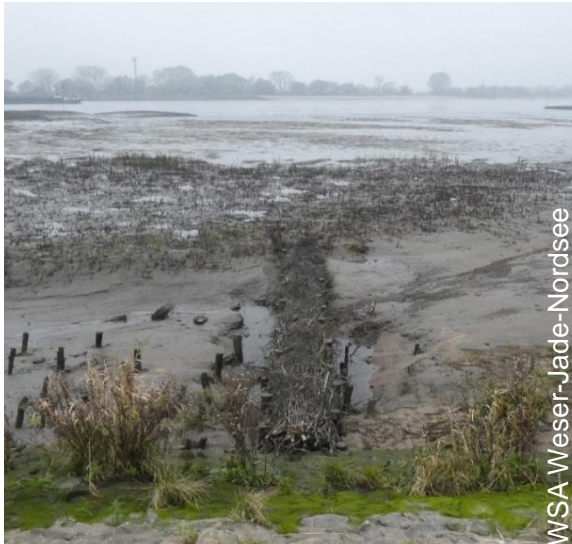
Brushwood box after construction in November 2020.

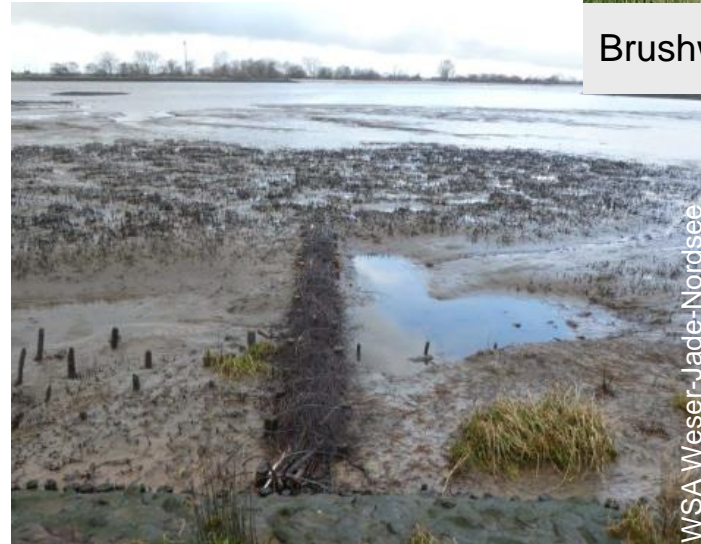
Brushwood box shortly after maintenance in January 2024.

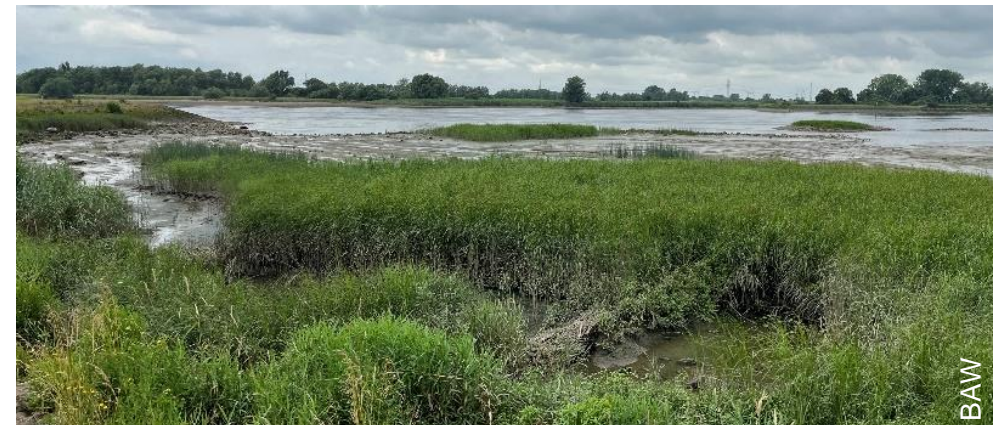
Brushwood box in July 2025.

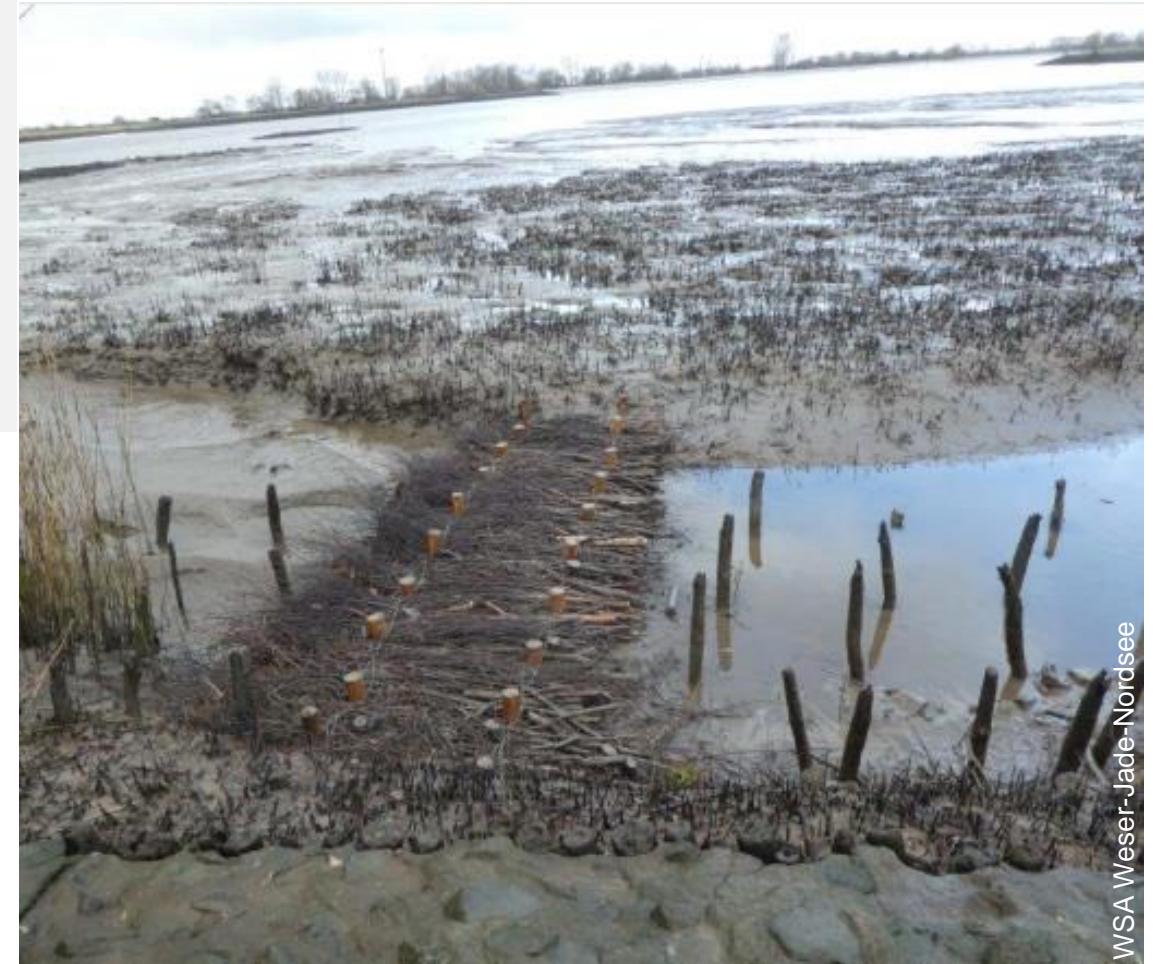
- **Km 27,850** right bank Lower Weser
- **Implementation:** December 2023
- **Contact:** WSA Weser-Jade-Nordsee: abz-farge@wsv.bund.de
- **Construction design:** Dead wood measure made of brushwood fascines laid on the ground in the direction of flow. The fascines are secured with piles and wire.
- **Development:** The measure was constructed in addition to another brushwood box to damp the tidal creek running alongside the revetment. It is fulfilling its purpose.

Final measure in January 2024.

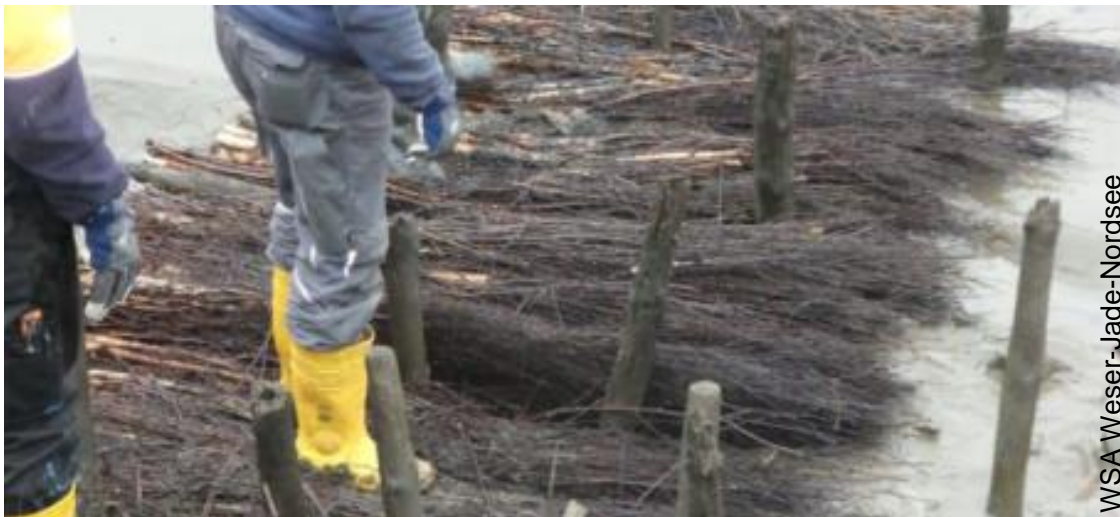
Construction of the measure in 2023

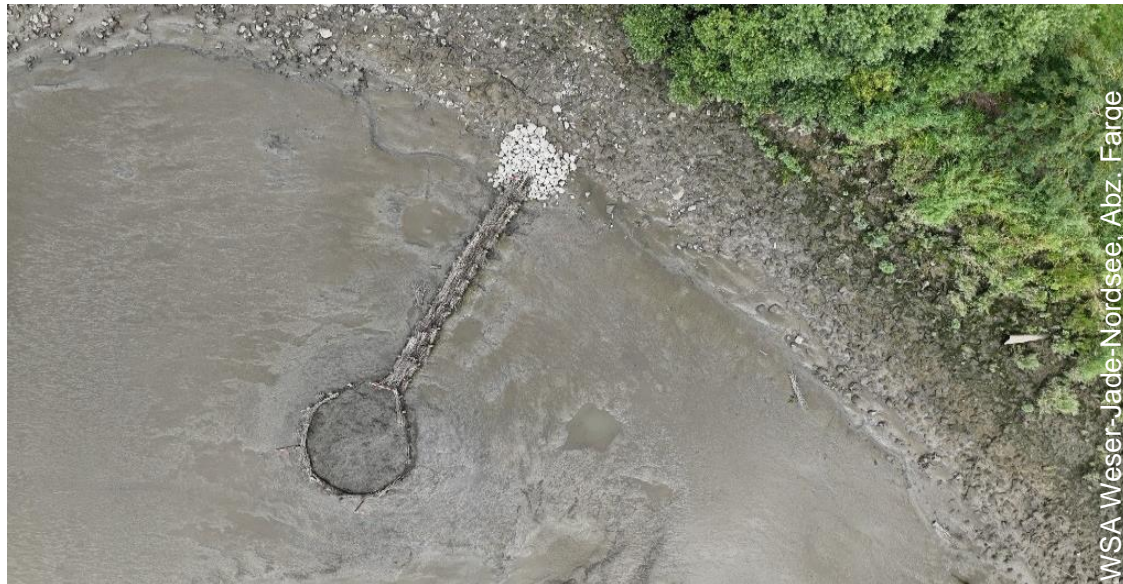
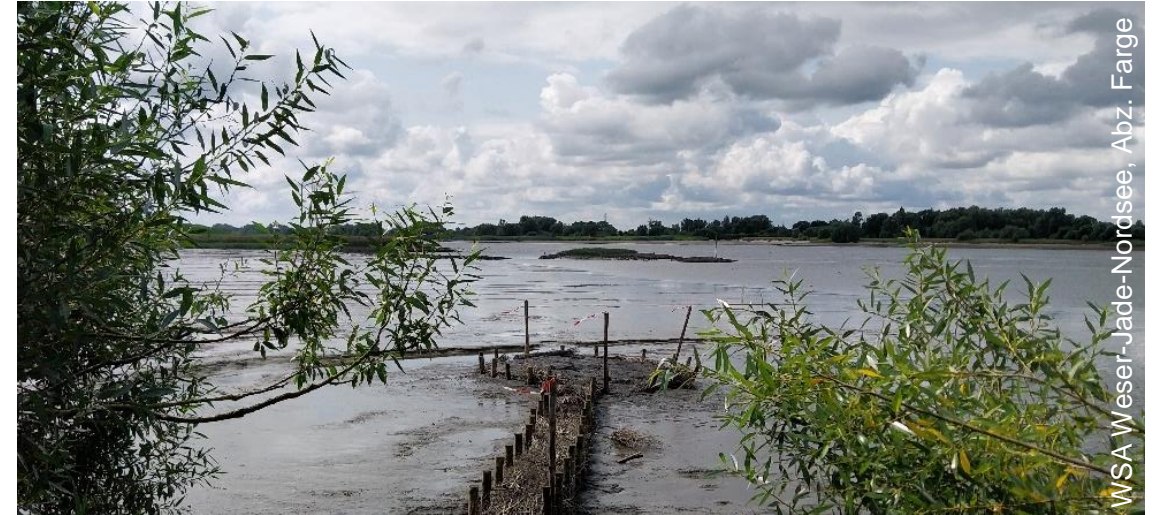
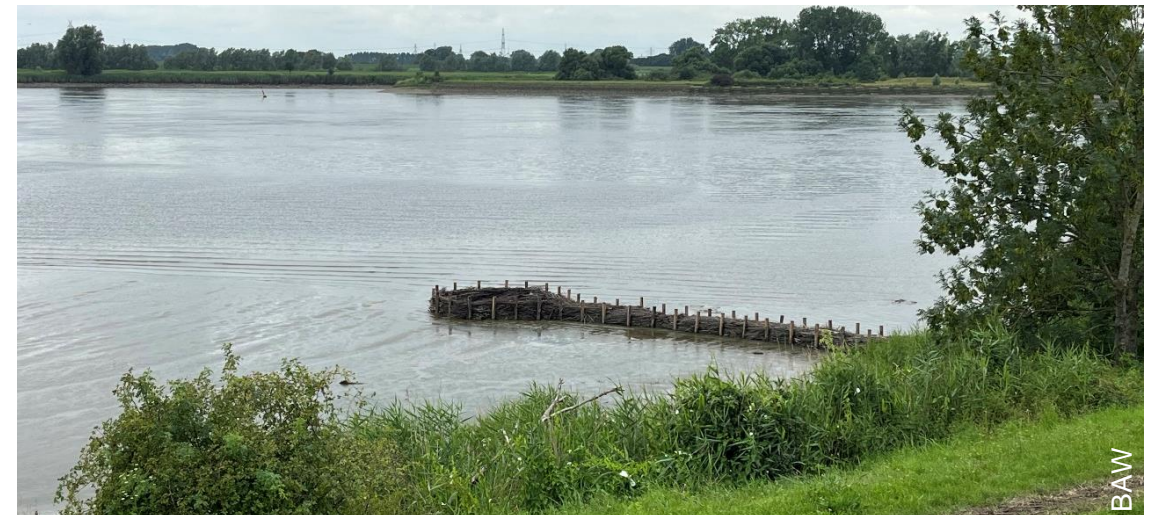
Brushwood box at Bunker Bay - Northern bank

- **Km 27,850** right bank Lower Weser
- **Implementation:** July 2025
- **Contact:** WSA Weser-Jade-Nordsee: abz-farge@wsv.bund.de
- **Construction design:** Brushwood box to damp a tidal creek, running along the revetment at the northern bank of the Bunker Bay. The brushwood box was supplemented by a 'groyne head', which is at least halfway filled with sediment in order to create colonisation areas for site-typical vegetation.
- **Development:** No statements on development available yet.

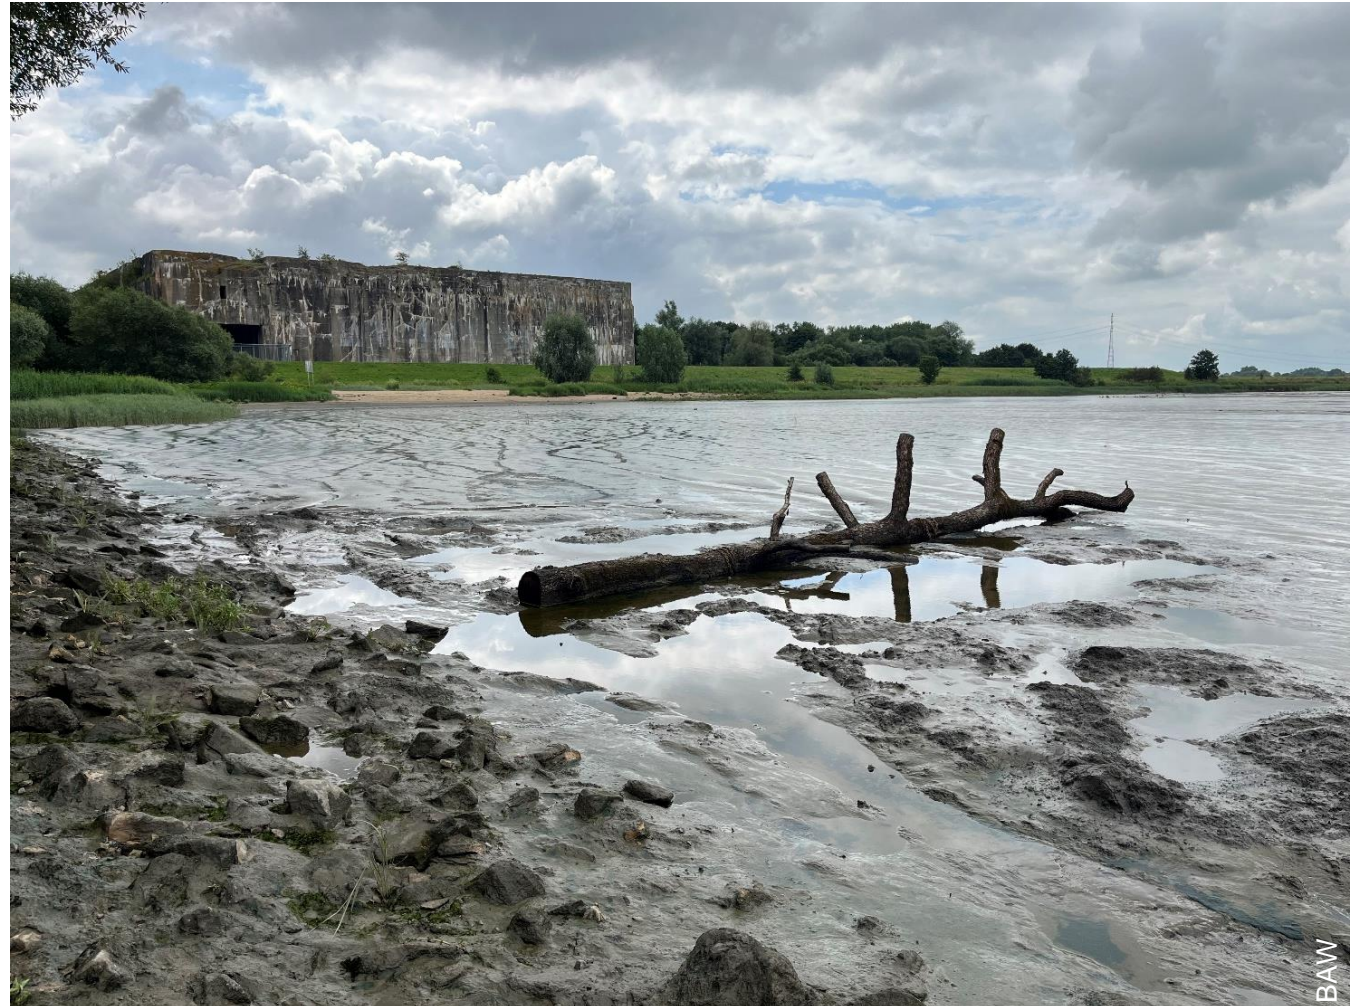
Living tree for bank protection at Bunker Bay - Northern bank

- **Km 27,850** right bank Lower Weser
- **Implementation:** July 2025
- **Contact:** WSA Weser-Jade-Nordsee: abz-farge@wsv.bund.de
- **Construction design:** Living willow tree to damp a tidal creek and to create structural diversity in the riparian zone.
- **Development:** It is still unclear whether the tree will sprout. The crown had to be severely pruned for transport.

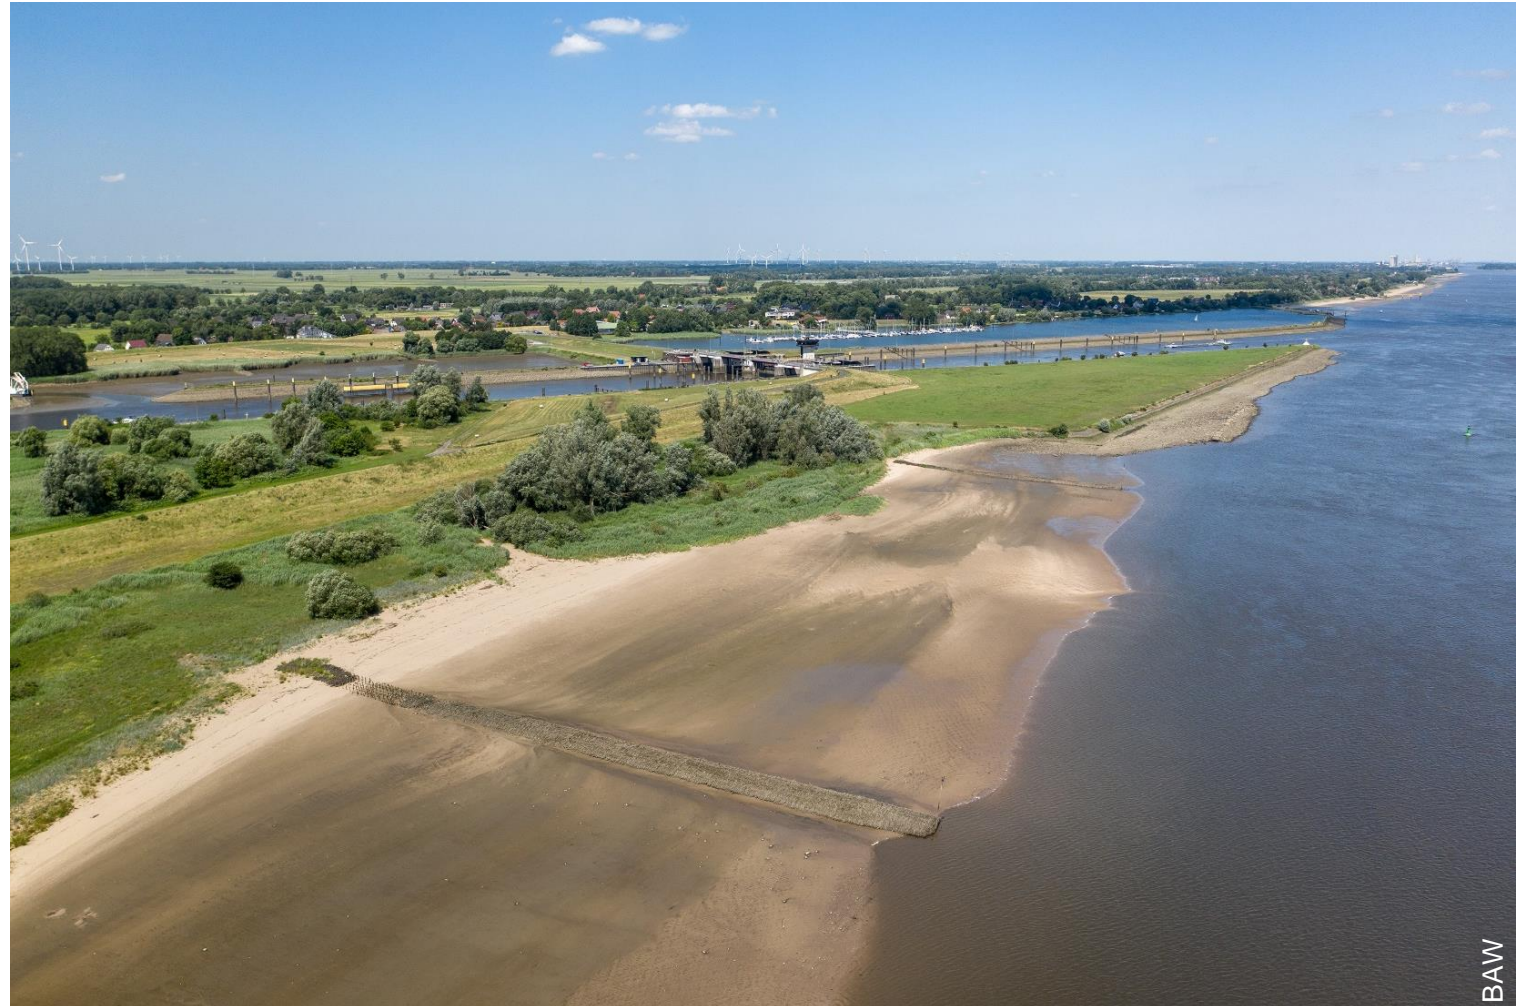
Brushwood groynes Elsflether Sand

- **Km 28,50-31,40** left bank Lower Weser
- **Implementation:** unknown
- **Contact:** WSA Weser-Jade-Nordsee: abzfarge@wsv.bund.de
- **Construction design:** Brushwood groynes made of hardwood fascines for beach protection
- **Development:** The groynes are fulfilling their purpose and are maintained as needed. However, no repairs are currently planned as the section of beach is stable.

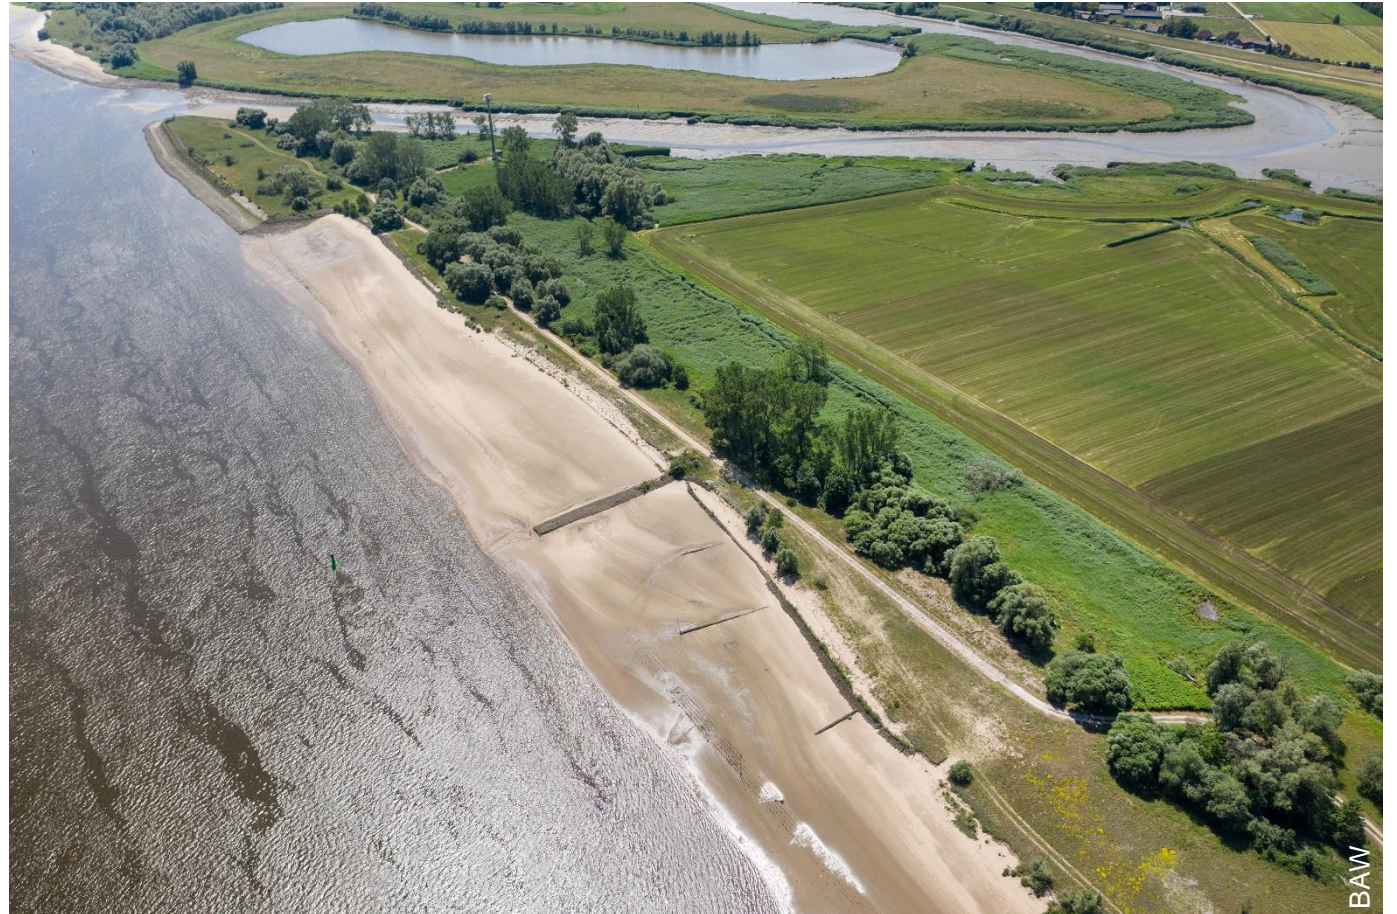
Brushwood mattress at Elsflether Sand

- **Km 28,50-31,40** left bank Lower Weser
- **Implementation:** ab 2016/2017
- **Contact:** WSA Weser-Jade-Nordsee: abz-farge@wsv.bund.de
- **Construction design:** Willow brushwood mattress for bank protection and to stabilize sand nourishments. Additionally, initial plantings with willow cuttings were placed around mean high water.
- **Development:** The brushwood mattress is fulfilling its purpose and is maintained as needed. However, no repairs are currently planned, as the section of beach was replenished in 2022.

Brushwood mattress for bank protection placed at the height of the groyne root.

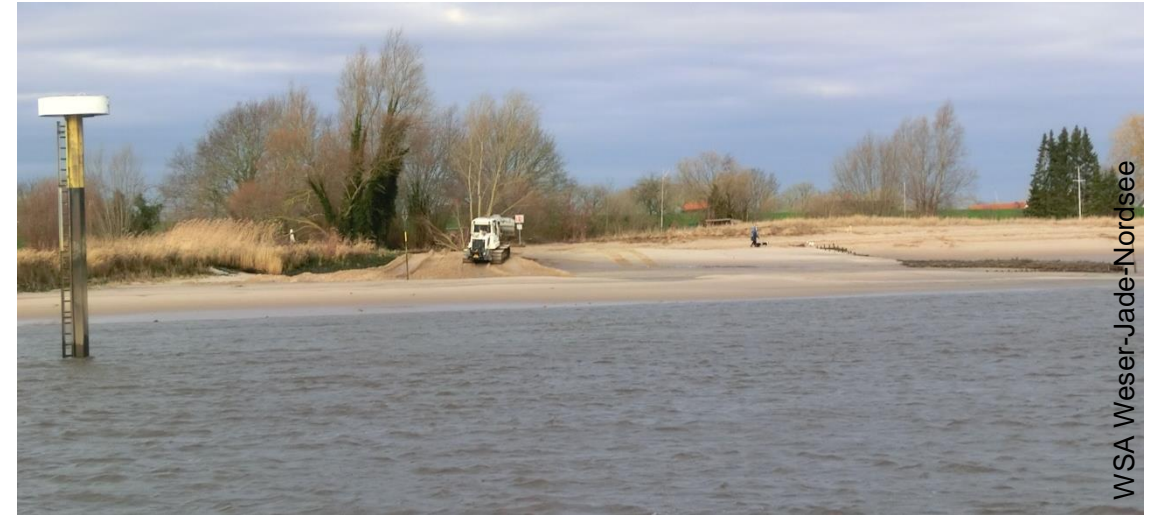
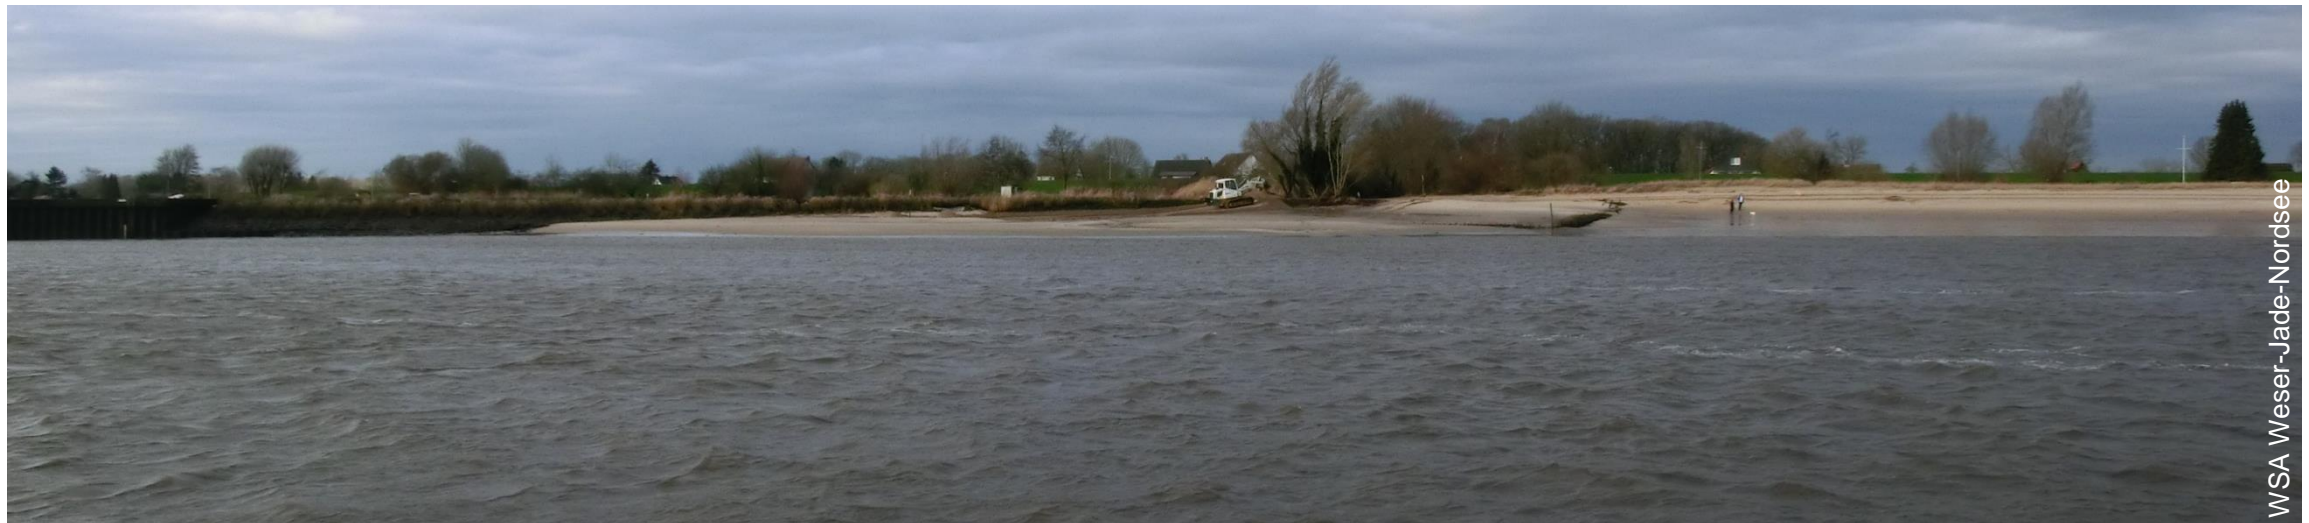
Brushwood mattress at Yacht harbour Elsfleth

- **Km 32,75** left bank Lower Weser
- **Implementation:** 2015
- **Contact:** WSA Weser-Jade-Nordsee: abz-farge@wsv.bund.de
- **Construction design:** Brushwood mattress made out of hardwood for bank protection and to trap sediment at the lock entrance.
- **Development:** The brushwood mattress is maintained as needed.
