Federal Waterways Engineering and Research Institute & Federal Institute of Hydrology

Nature-based solutions for bank protection in estuarine waterways

Collection of measures in tidal areas

30.04.2026
Version: 4

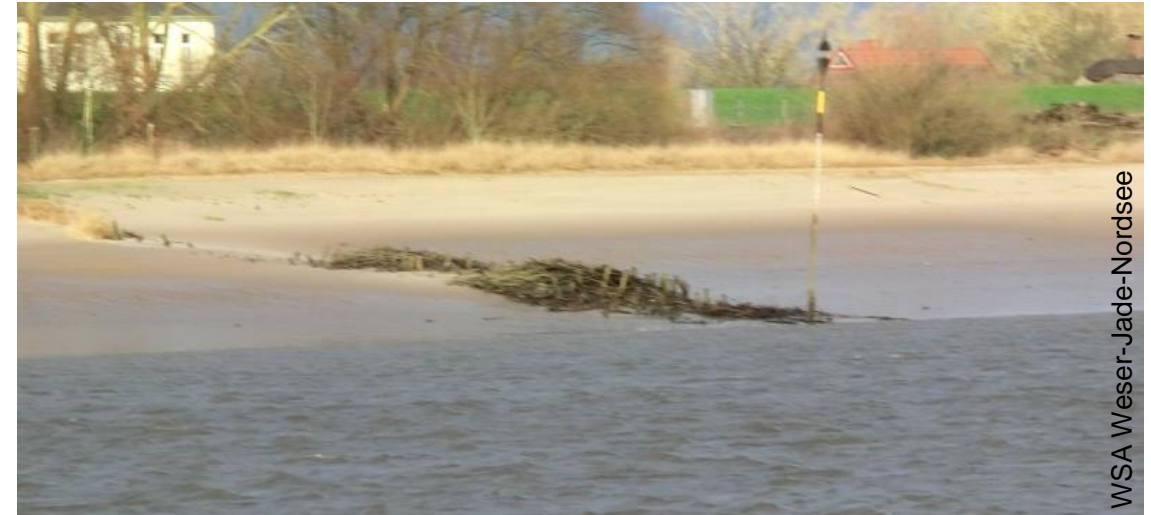
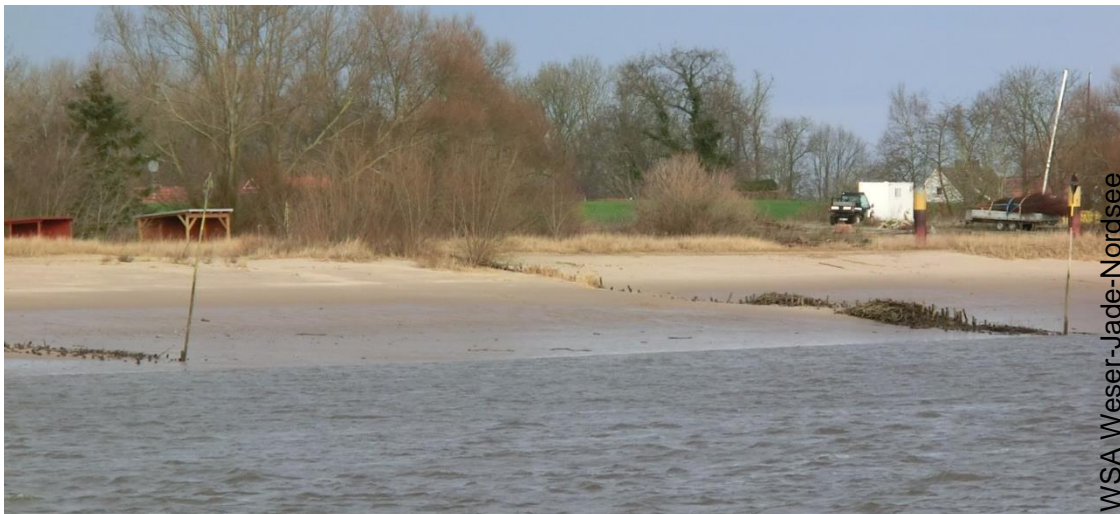
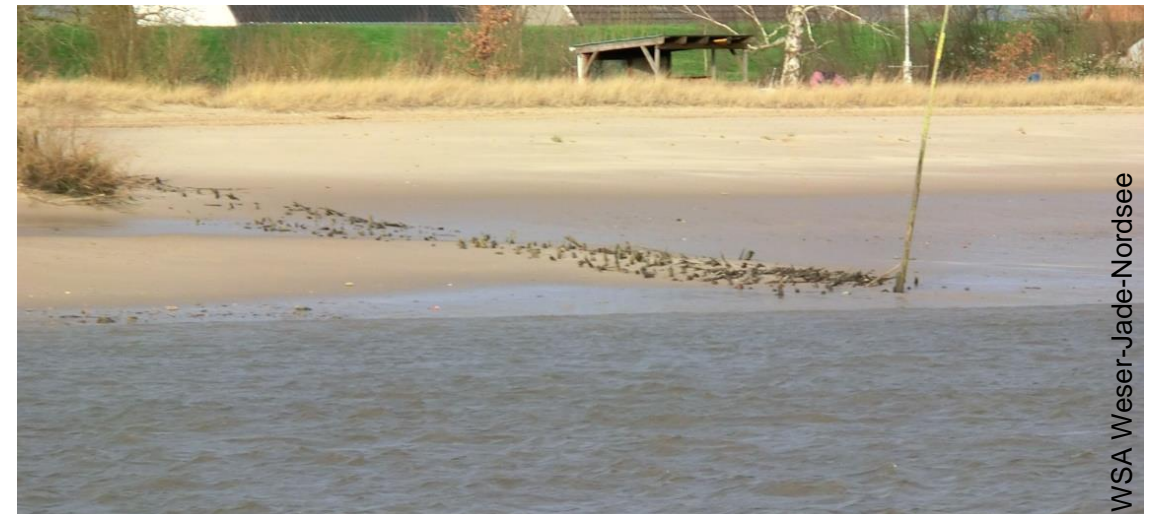
- **Km 33,10-33,25** left bank Lower Weser
- **Implementation:** unknown
- **Contact:** WSA Weser-Jade-Nordsee: abz-farge@wsv.bund.de
- **Construction design:** Brushwood groynes for beach protection made out of hardwood fascines and located directly at the Weser dyke
- **Development:** The groynes are maintained as needed.

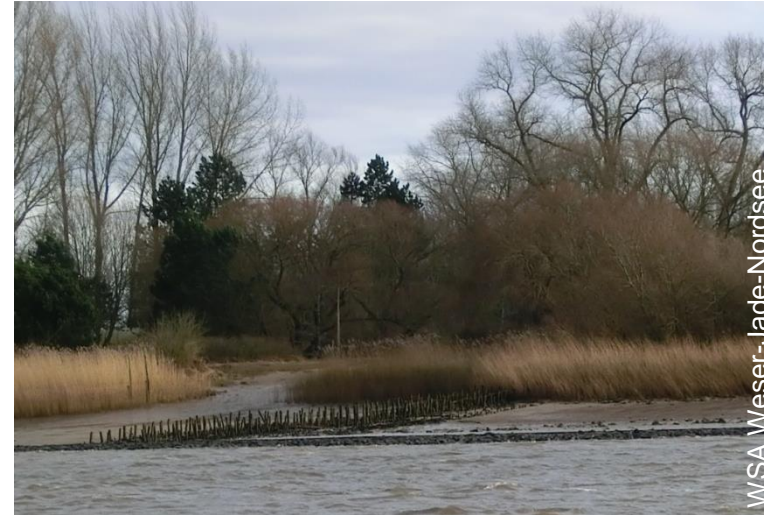
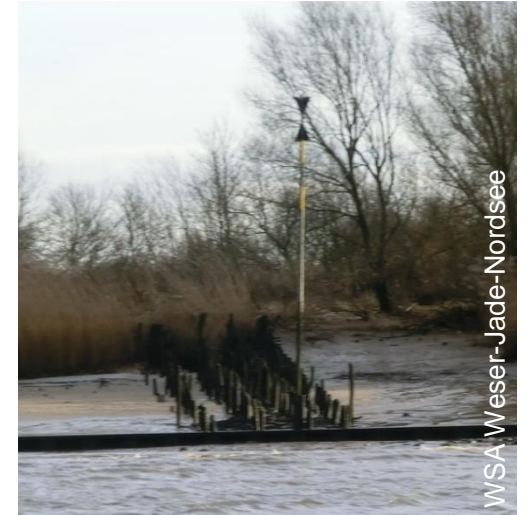
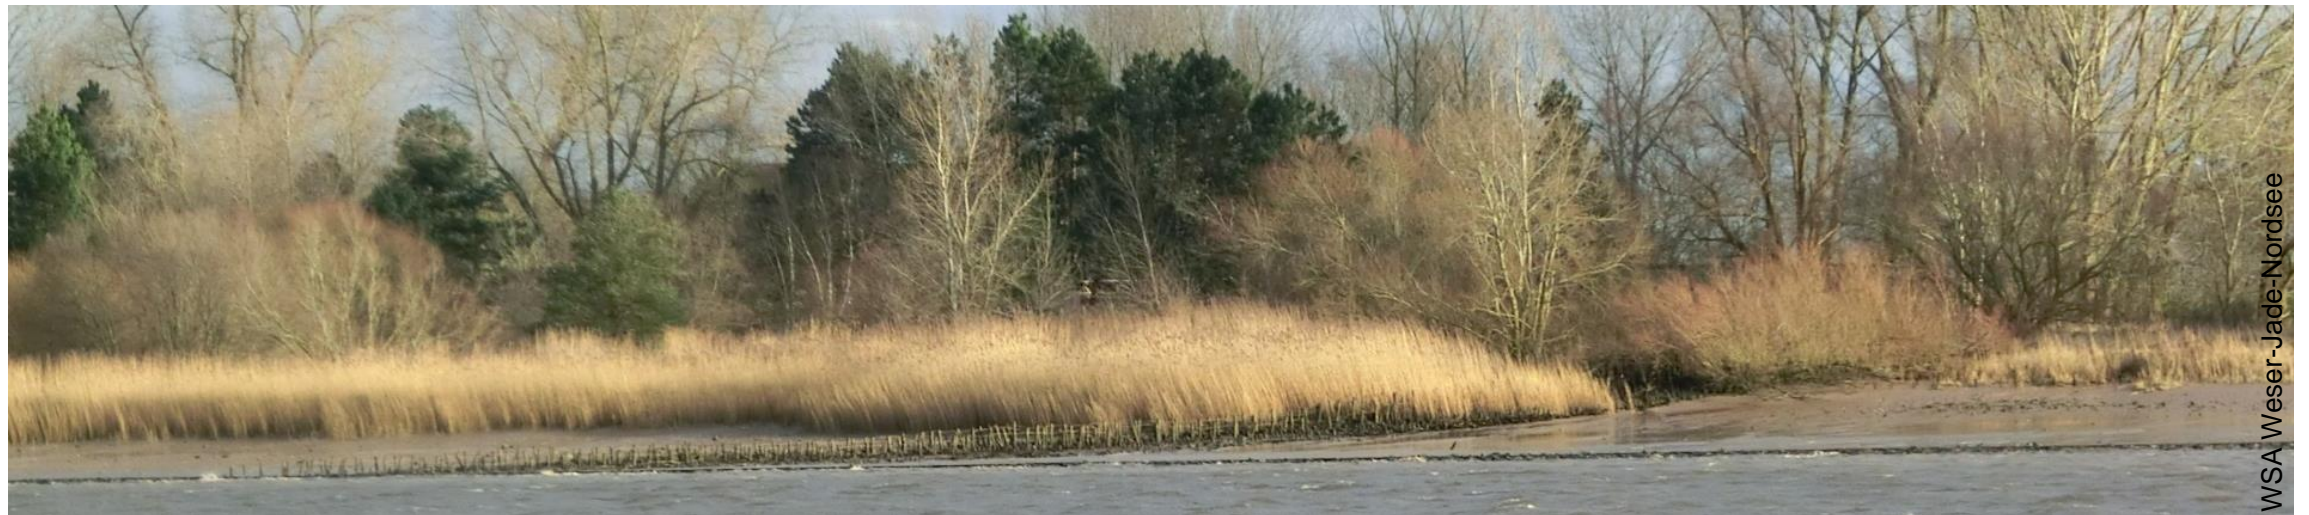
Brushwood groynes at Harriersand

- **Km 33,30-34,25** right bank Lower Weser
- **Implementation:** unknown
- **Contact:** WSA Weser-Jade-Nordsee: abz-farge@wsv.bund.de
- **Construction design:** Brushwood groynes made out of hardwood fascines tied to piles for beach protection
- **Development:** The groynes are several decades old and have not been maintained for some time due to staff shortages. However, the bank and the surrounding area remain stable.

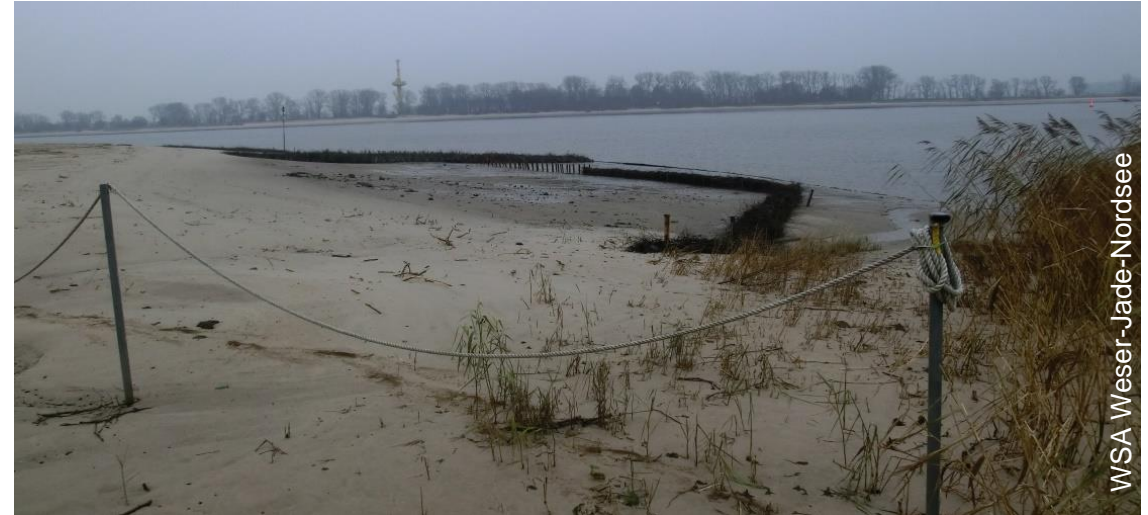
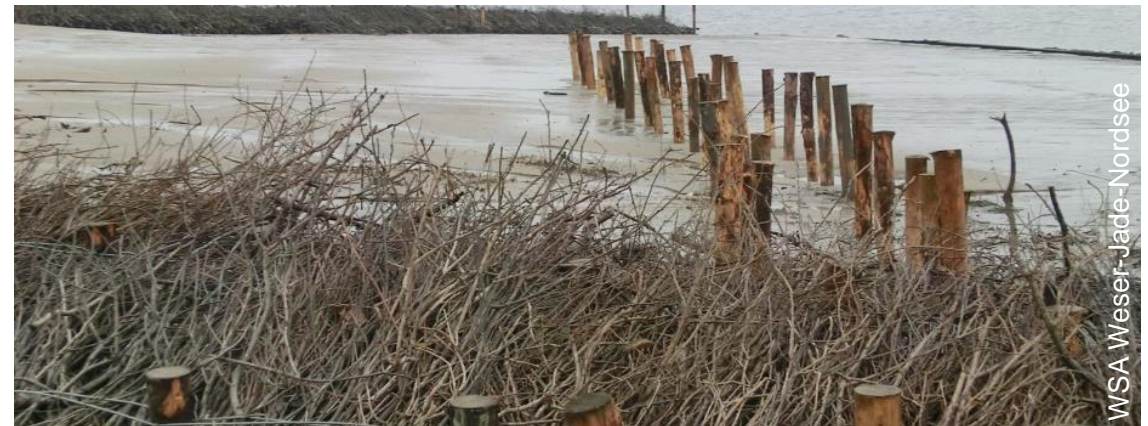
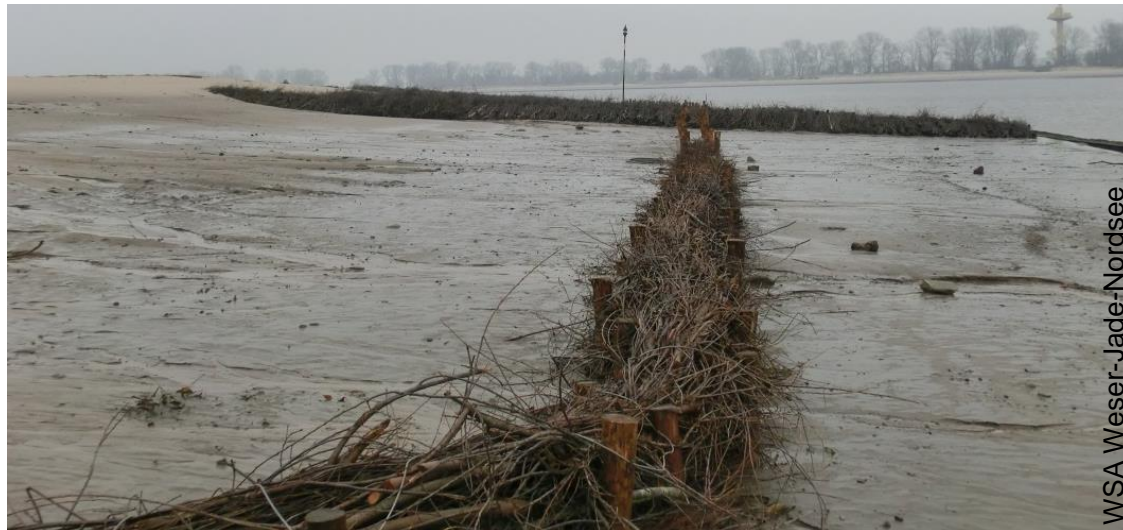
Brushwood training wall at Käseburger Siel

- **Km 36,50-36,60** left bank Lower Weser
- **Implementation:** 2013
- **Contact:** WSA Weser-Jade-Nordsee: abz-farge@wsv.bund.de
- **Construction design:** Brushwood training wall for beach protection made of hardwood fascines
- **Development:** The brushwood training wall is fulfilling its purpose and is maintained as needed. The measure was last maintained in 2025.

Brushwood training wall during construction in 2013.

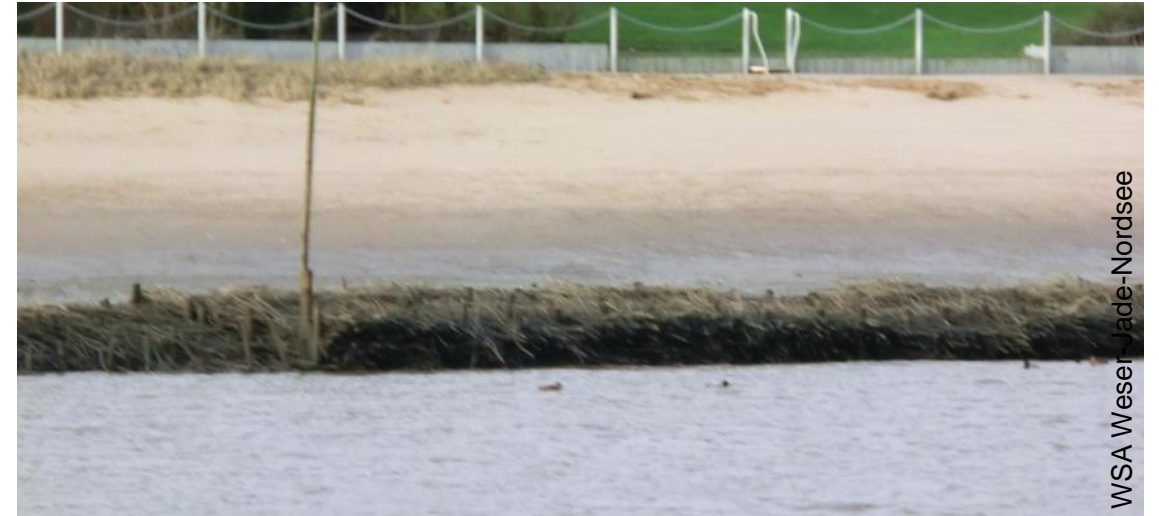
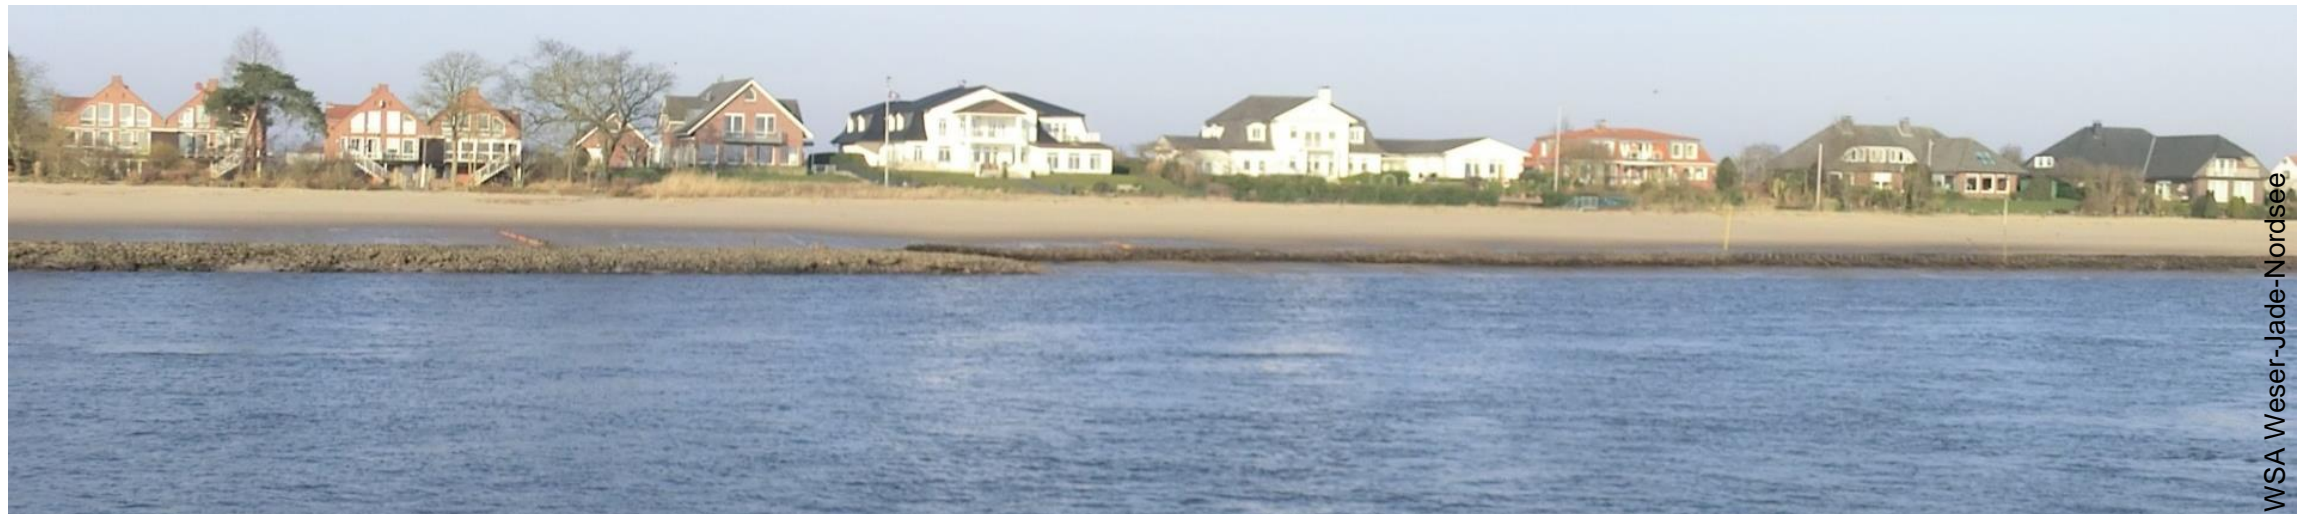
Brushwood training wall at Schierlohstrand

- **Km 38,10-38,20** left bank Lower Weser
- **Implementation:** 2013
- **Contact:** WSA Weser-Jade-Nordsee: abz-farge@wsv.bund.de
- **Construction design:** Brushwood trainings wall for beach protection made of hardwood fascines
- **Development:** The brushwood training wall is maintained as needed. Currently no maintenance is planned.

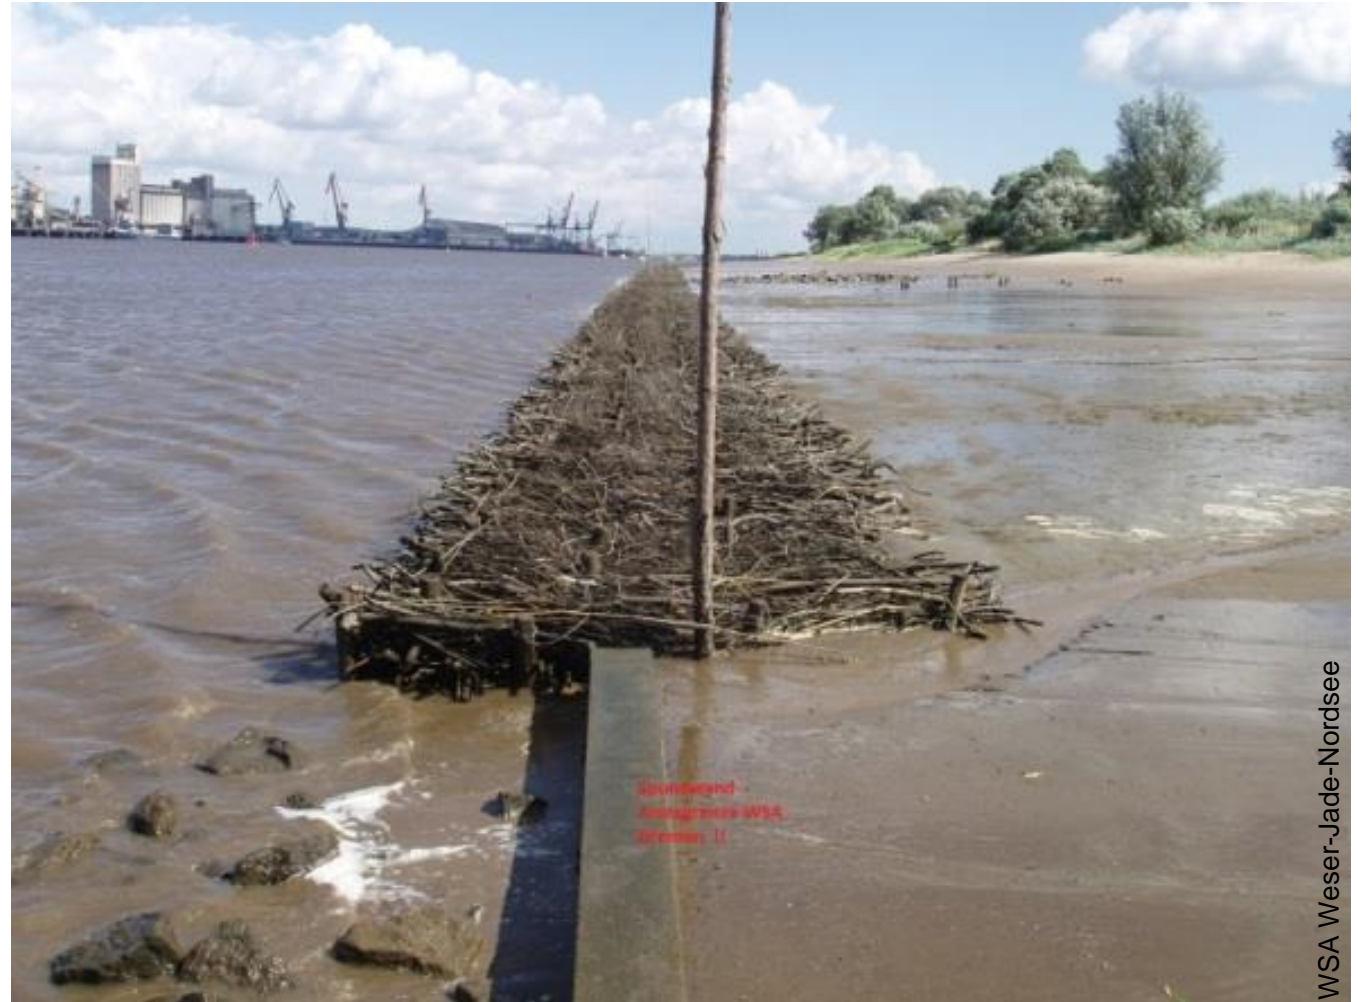
Brushwood training wall at Harriersand

- **Km 39,875-40,62** right bank Lower Weser
- **Implementation:** approx. 2000, last maintenance in 2024-2025
- **Contact:** WSA Weser-Jade-Nordsee: steffen.buchner@wsv.bund.de
- **Construction design:** Brushwood training wall made of brushwood fascines tied to 4 pile rows. The measure is directly connected to a sheet pile wall.
- **Development:** The training wall is fulfilling its purpose and the area has silted up. Last maintenance has been conducted in 2024/2025.

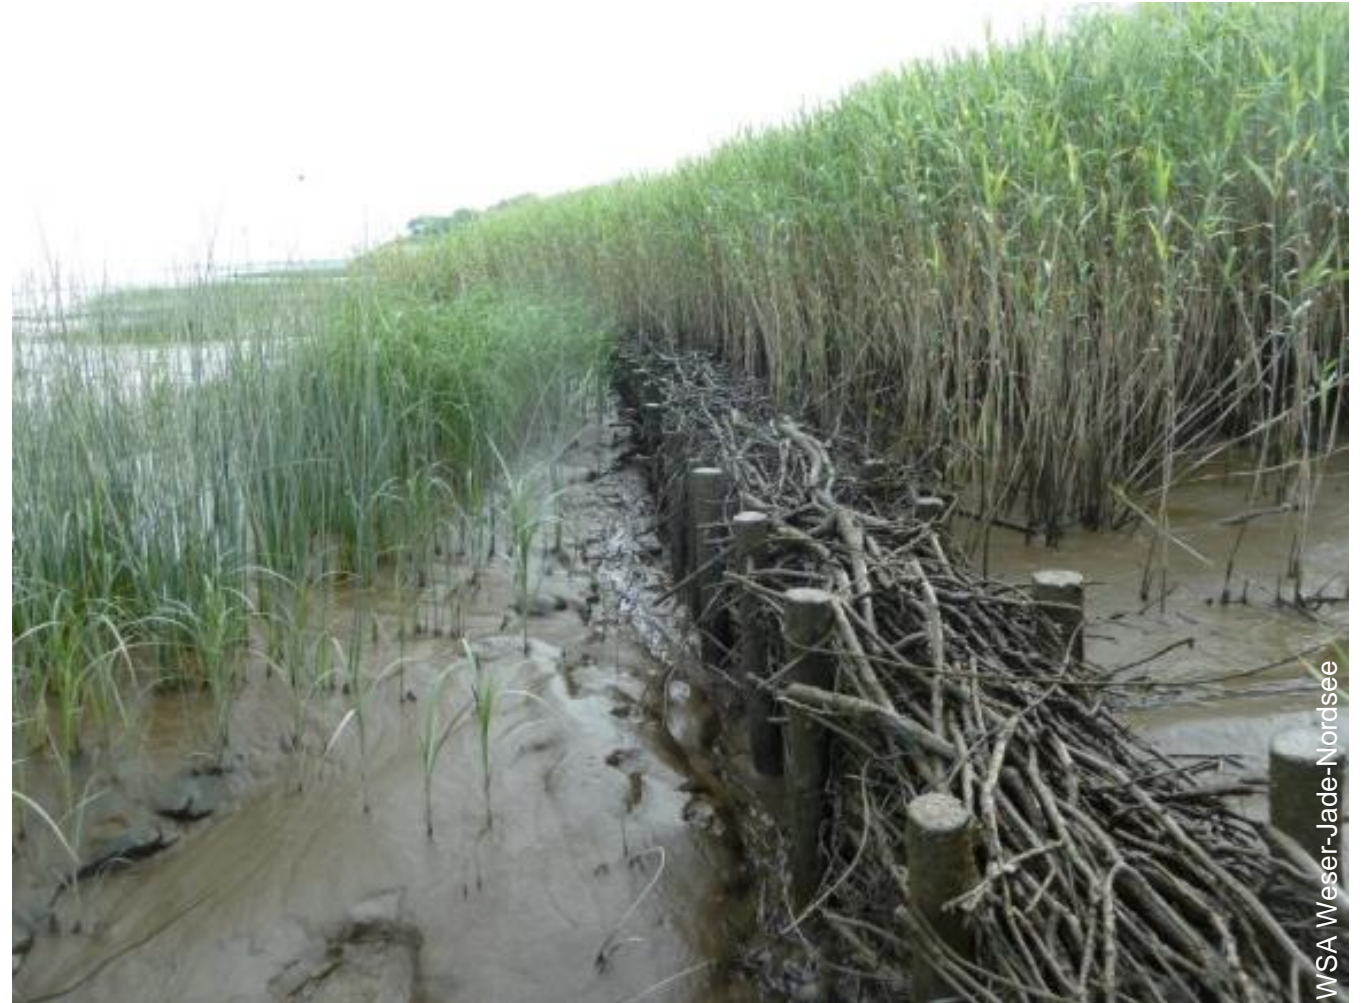
- **Km 42,400** right bank Lower Weser
- **Implementation:** approx. 2008
- **Contact:** WSA Weser-Jade-Nordsee:
steffen.buchner@wsv.bund.de
- **Construction design:** Brushwood box to damp a tidal creek for bank protection
- **Development:** The area has calmed. Reeds have established on the landward site of the measure, and rushes are settling in front of the brushwood box. The area is completely overgrown and the measure is no longer being maintained.

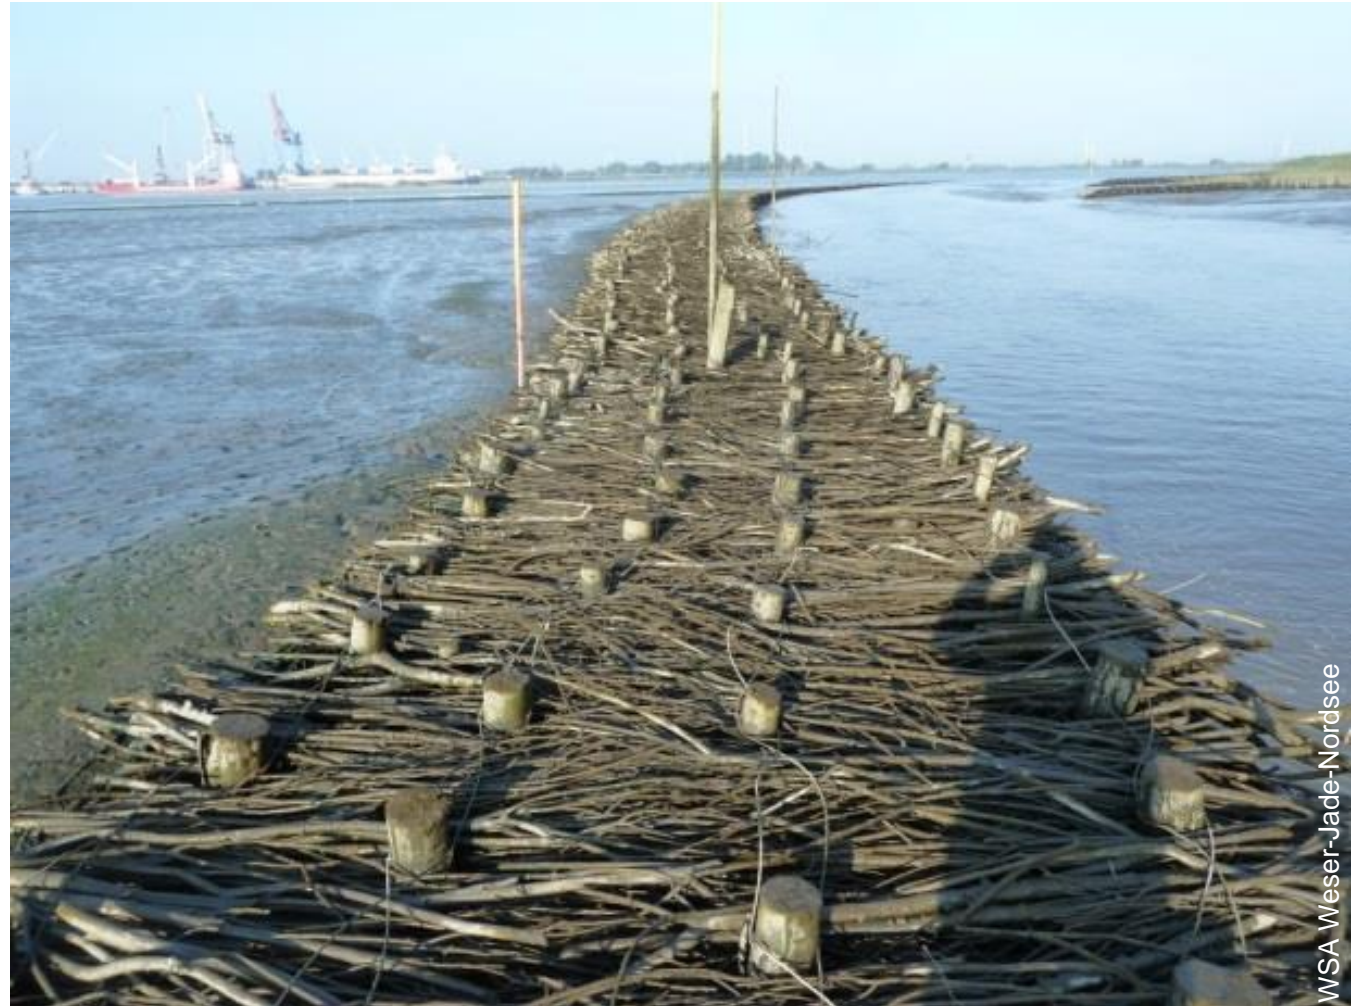
Brushwood training wall at Sandstedt

- **Km 43,100- 44,100** right bank Lower Weser
- **Implementation:** approx. 1950, last maintained in 2018
- **Contact:** WSA Weser-Jade-Nordsee:
steffen.buchner@wsv.bund.de
- **Construction design:** Brushwood training wall to ensure and control sluice drainage
- **Development:** The measure is successful and is maintained regularly. Last maintenance was conducted in 2018 and next maintenance is planned for 2026.

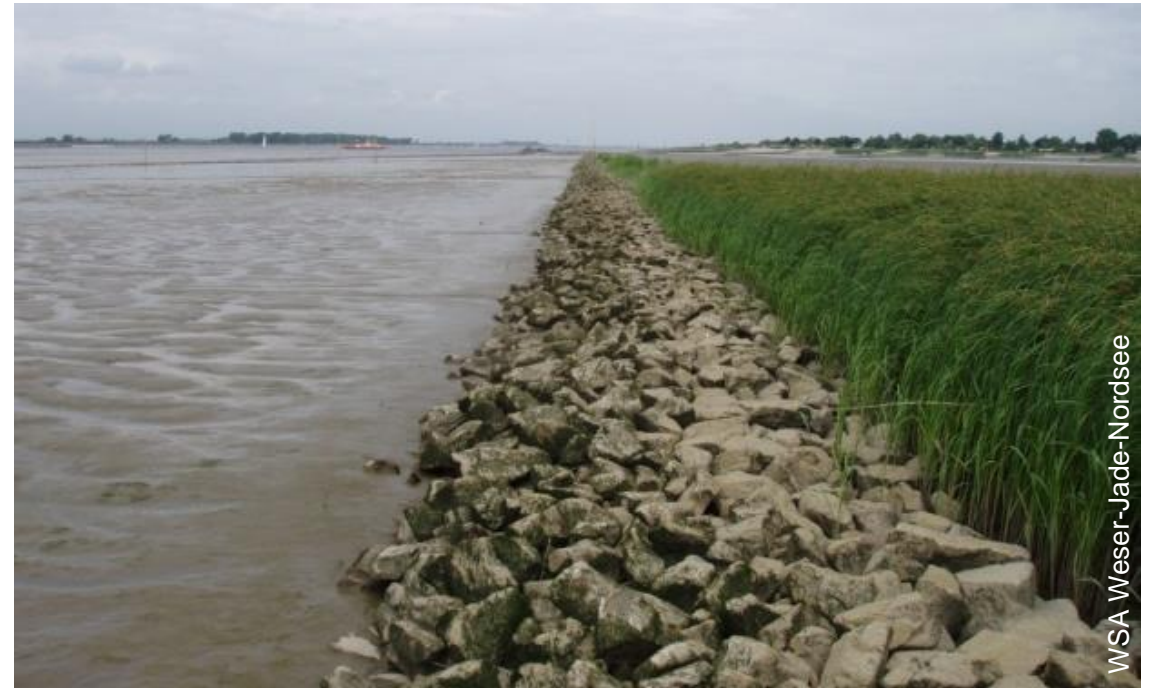
Brushwood groynes at northern tip of Harriersand Island

- **Km 43,125-44,050** right bank Lower Weser
- **Implementation:** approx. 1987 (island tip), approx. 1994 (brushwood groynes)
- **Contact:** WSA Weser-Jade-Nordsee: steffen.buchner@wsv.bund.de
- **Construction design:** Brushwood groynes acting as silt traps to reduce local dredging volumes. The fascine material is tied to four pile rows with wire.
- **Development:** The brushwood groynes are covered with silt, so no maintenance is necessary. Approximately one-third of the structure is overgrown with vegetation. The area is stable and no maintenance is planned for the future.

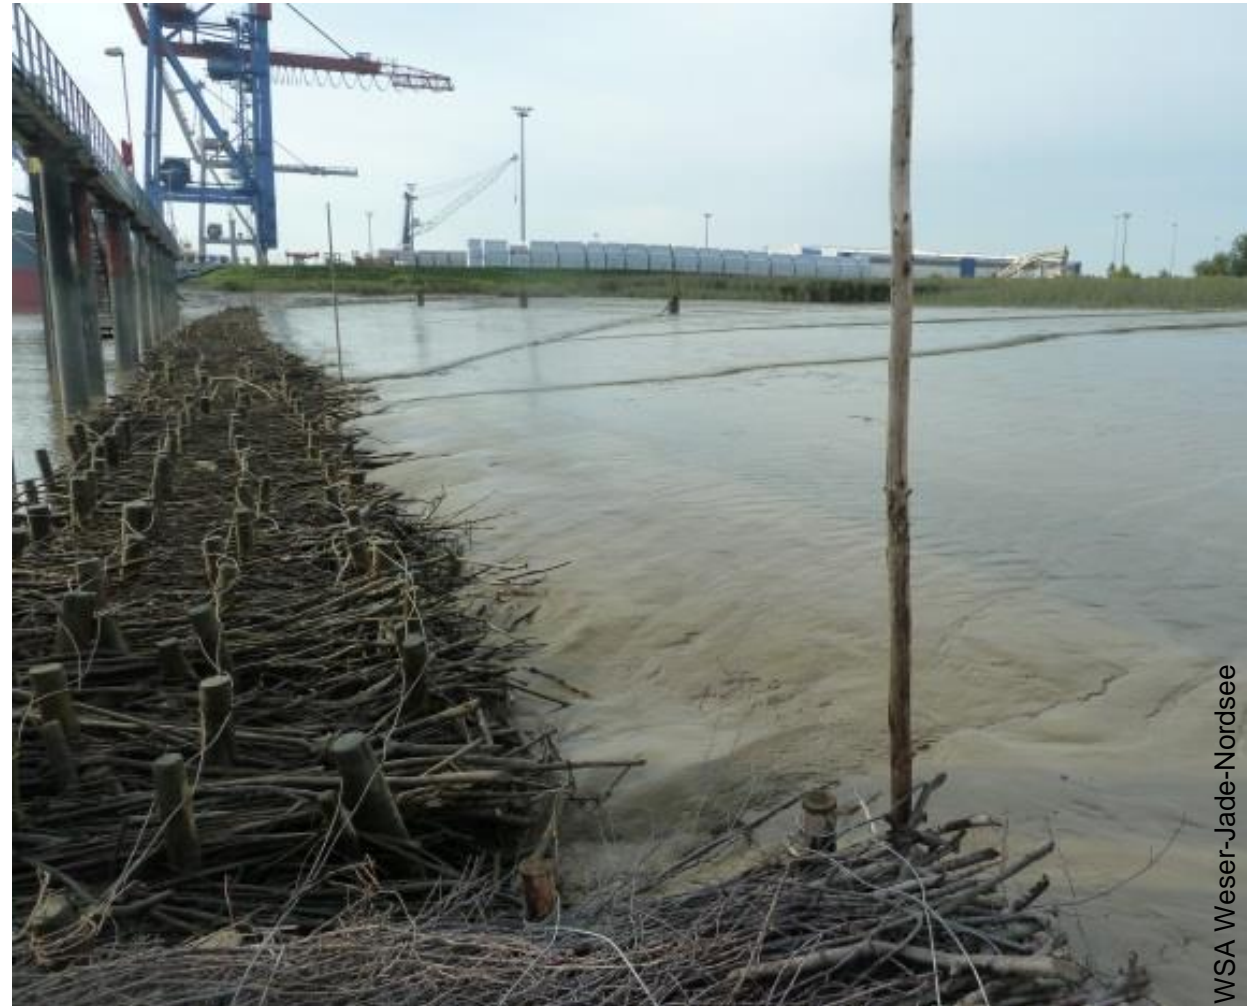
Brushwood training wall at Niedersachsenkai

- **Km 43,300-44,125** left bank Lower Weser
- **Implementation:** approx. 1995, last maintenance in 2021
- **Contact:** WSA Weser-Jade-Nordsee:
steffen.buchner@wsv.bund.de
- **Construction design:** Brushwood training wall made of 4 tied pile rows to stabilise the bank and encourage tidal flat development. The training wall is split into a northern and southern section. The medium section has been dredged away to make way for the “Niedersachsenkai” pier.
- **Development:** The brushwood training wall was built over as part of the expansion of Brake's northern harbour. Currently, only an approx. 120 m long section of the training wall remains at km 43.300 left bank. The purpose as bank protection was successful and the training wall is maintained every 6 years, with the next maintenance planned for 2026/2027.

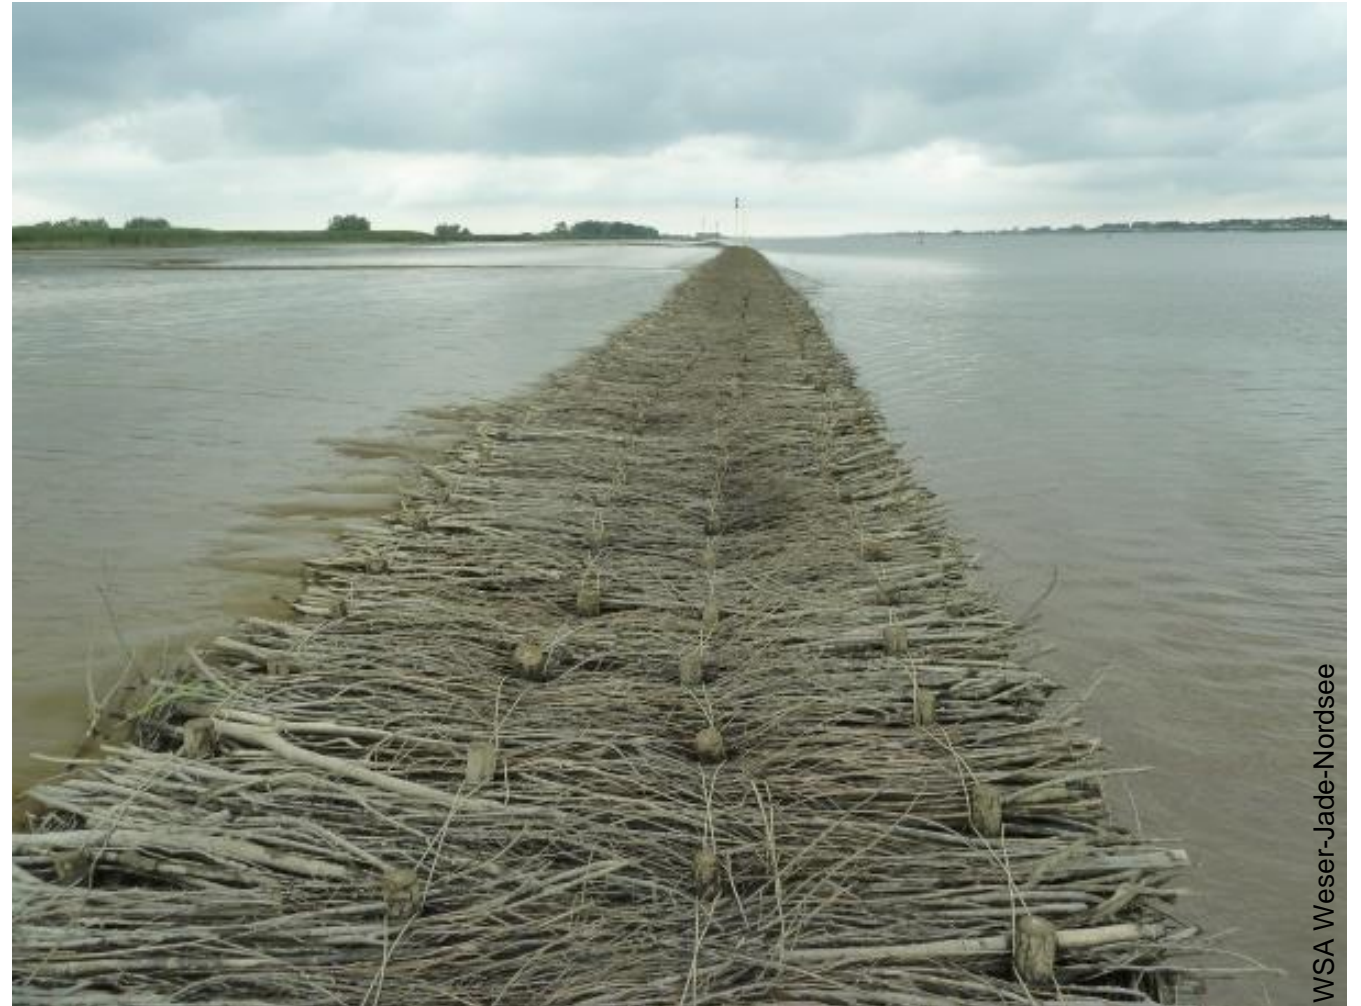
Brushwood training wall - Supply to the Upper Schweiburg

- **Km 44,500-44,800** left bank Lower Weser
- **Implementation:** approx. 1990-2000, last maintenance in 2023/2024
- **Contact:** WSA Weser-Jade-Nordsee: steffen.buchner@wsv.bund.de
- **Construction design:** Brushwood training wall made of 4 tied pile rows to support water supply to the Upper Schweiburg, bank stabilisation and tidal flat sedimentation.
- **Development:** The brushwood training wall has been constructed twice: the first structure was situated 50 m further west (landward) and rapidly silted up, albeit without completely meeting the intended purpose. The second structure was built at today's position, again to supply more water to the Schweiburg, but proved to be only partially effective for this purpose. Tidal flats have stabilised. The next maintenance is planned for 2027/2028.

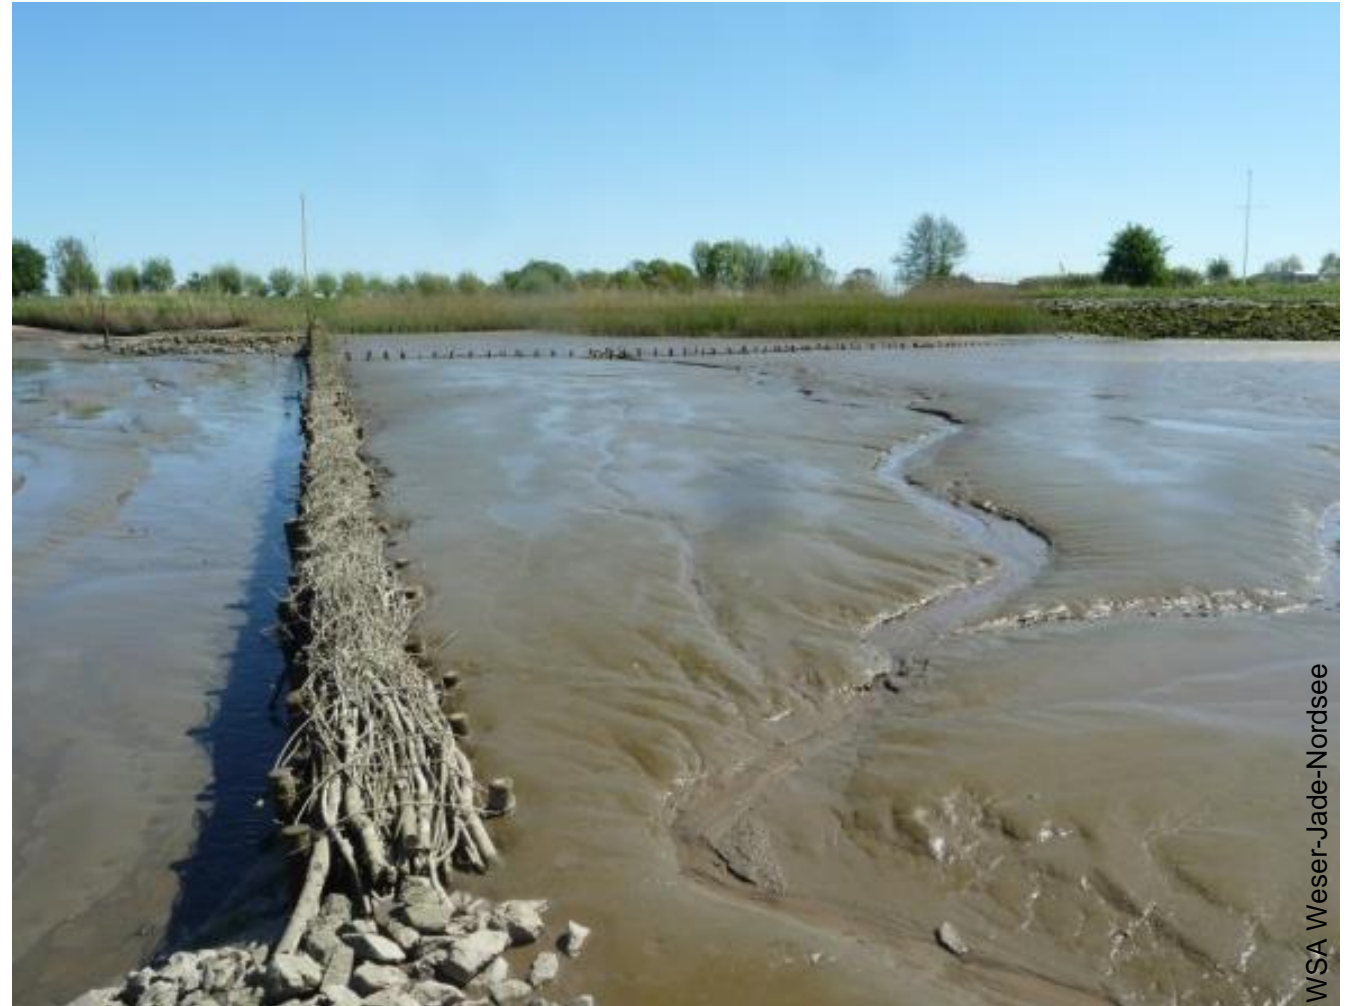
Brushwood boxes for protection of a groyne root at Rechtenfleth

- **Km 46,625** right bank Lower Weser
- **Implementation:** approx. 2000-2005, last maintenance in 2017
- **Contact:** WSA Weser-Jade-Nordsee:
steffen.buchner@wsv.bund.de
- **Construction design:** Brushwood box system to protect the groyne root from permanent exposure to scouring and damaging effects. Since an armour stone extension of the groyne towards the embankment has not sufficiently reduced the level of hydrodynamics, the brushwood box was built to contain water motion.
- **Development:** The area has silted up as desired and has developed positively. Maintenance is currently not necessary and is not planned.

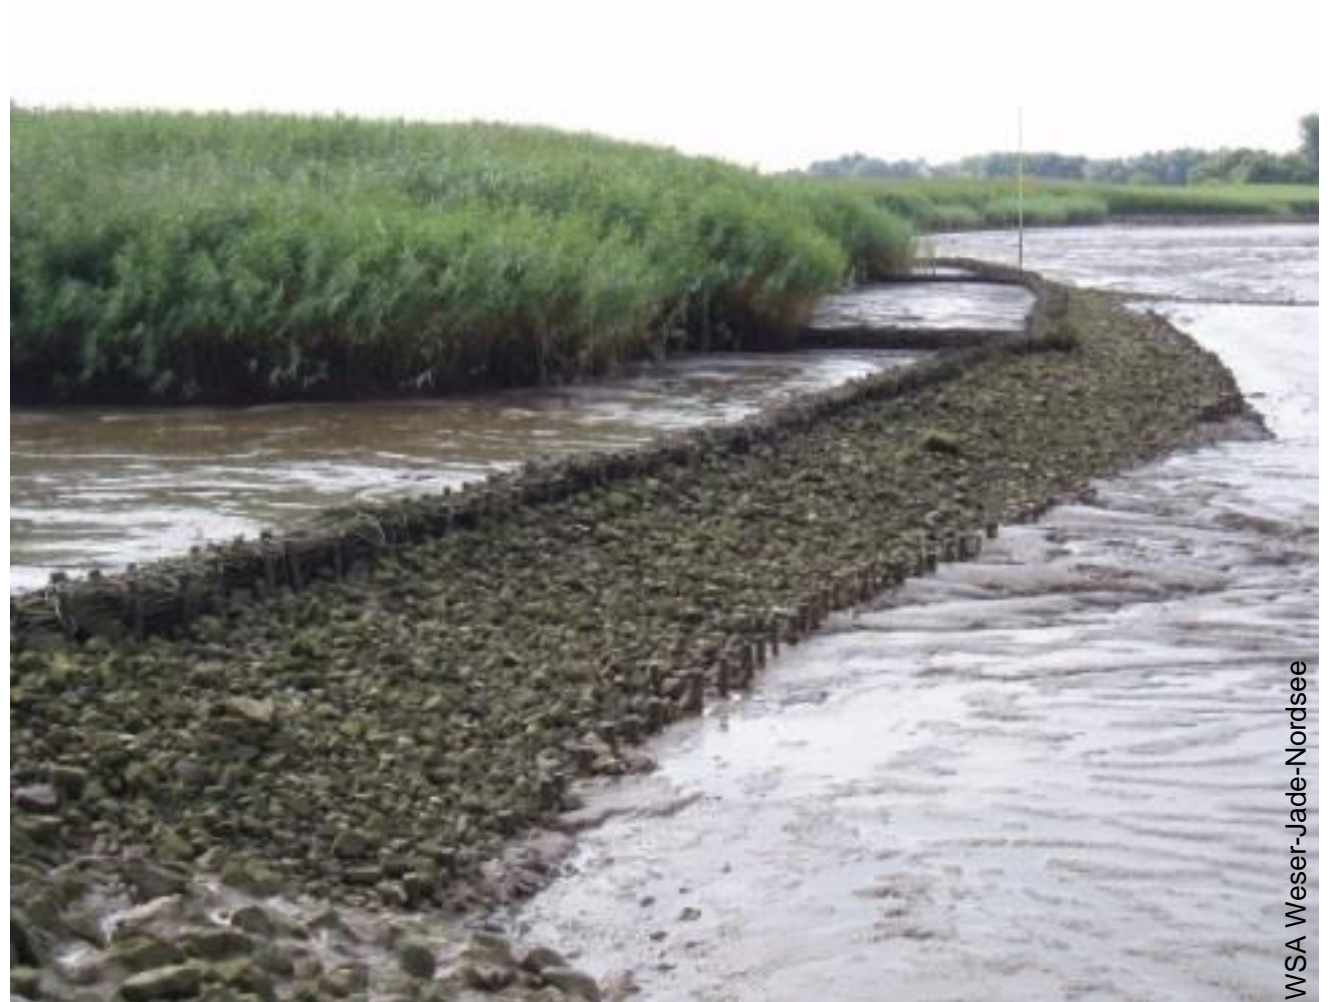
Reduction of water motion at Königsbalje

- **Km 47,58-47,875** right bank Lower Weser
- **Implementation:** approx. 1994, last maintenance in 2021
- **Contact:** WSA Weser-Jade-Nordsee:
steffen.buchner@wsv.bund.de
- **Construction design:** Combined armour stone/dead wood structure: brushwood training wall (2 tied pile rows) with a riprap toe protection to slow down water motion. The structure has been installed at a distance of 5 m from the bank and is aligned to the bank's natural shape.
- **Development:** The measure is fulfilling its purpose. In 2021, an additional deflector was installed as part of maintenance work. There is currently no further need for maintenance.

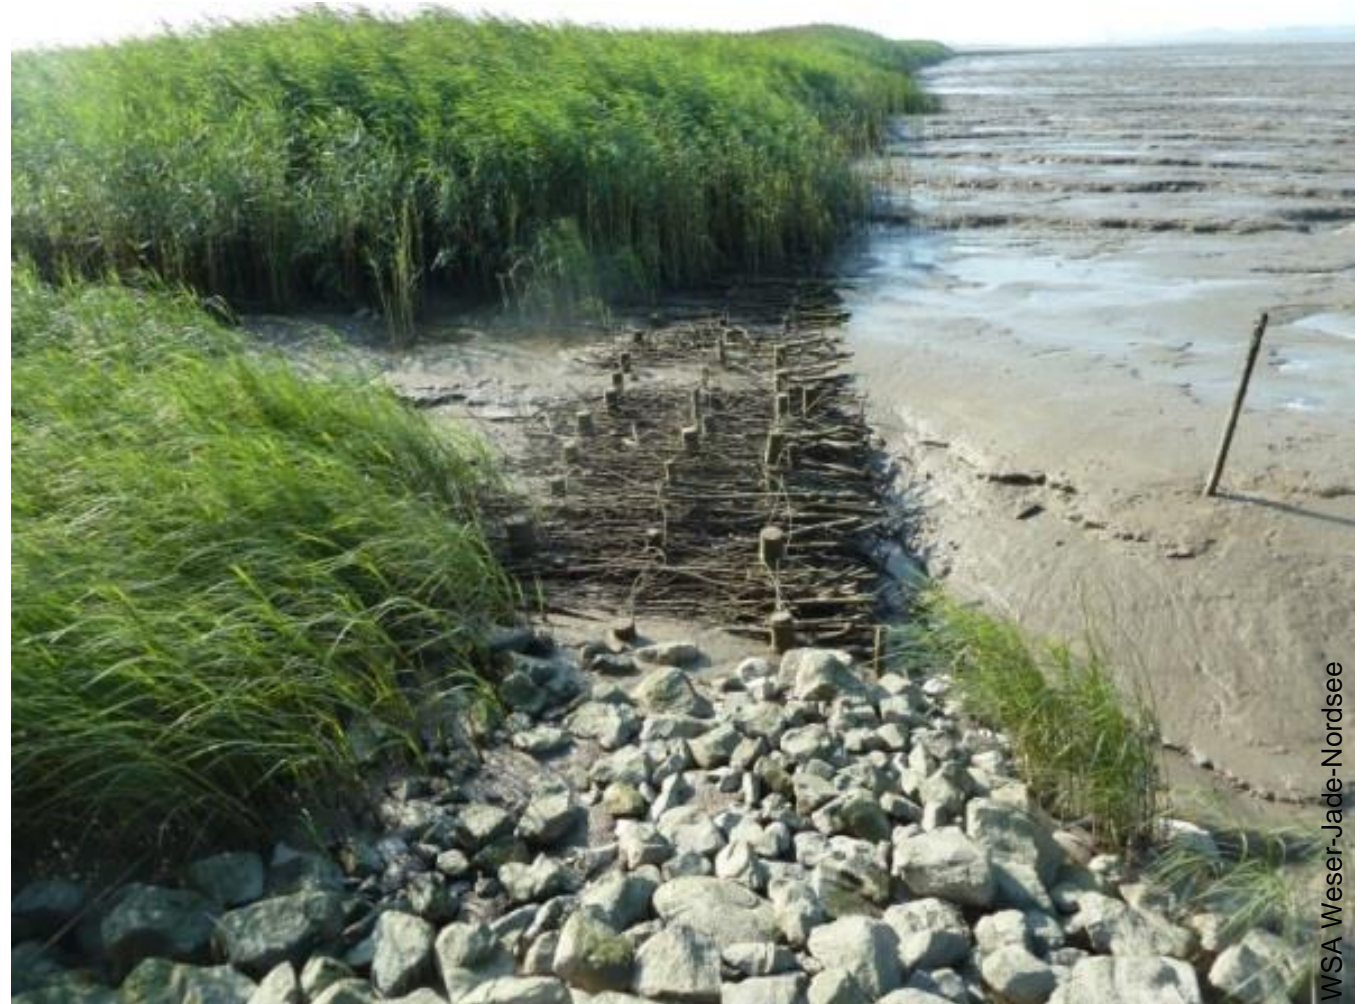
Brushwood measure to damp a tidal creek

- **Km 48,150** right bank Lower Weser
- **Implementation:** approx. 2008, 2019
- **Contact:** WSA Weser-Jade-Nordsee: steffen.buchner@wsv.bund.de
- **Construction design:** Dead wood measure to damp a tidal creek and protect a groyne. The structure is made of brushwood fascines laid on the ground in the direction of tidal creek flow. The fascines are secured to four pile rows with wire.
- **Development:** Water motion in the area has effectively slowed down and was maintained for the last time in 2019. Since then, the measure has served its purpose, so no further maintenance is necessary.

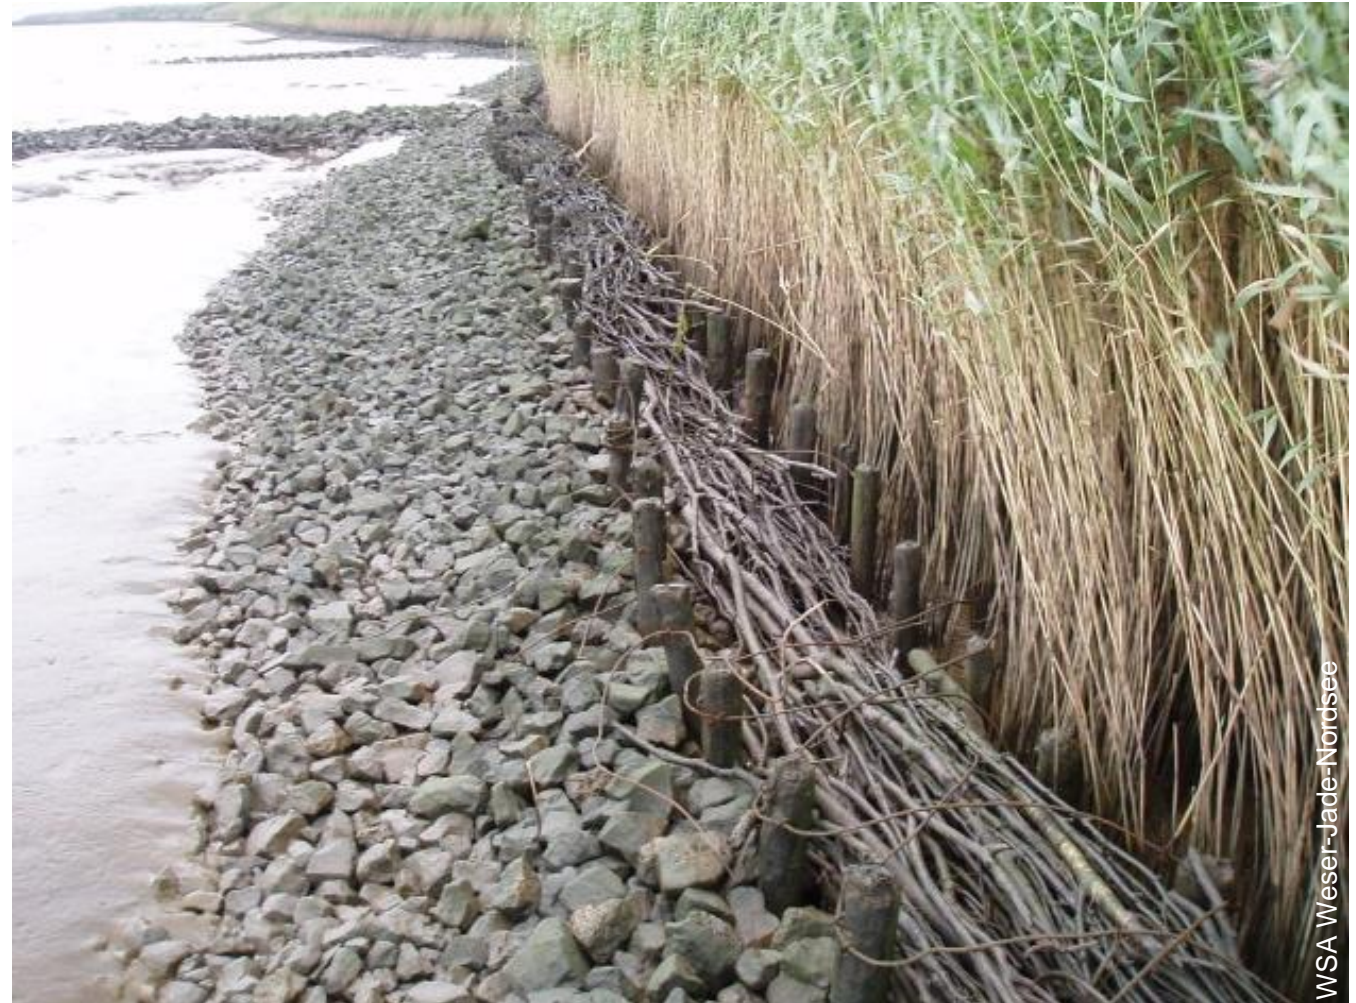
Brushwood box with riprap toe protection

- **Km 49,125-50,07** right bank Lower Weser
- **Implementation:** 1992-1998, last maintenance in 2017
- **Contact:** WSA Weser-Jade-Nordsee: steffen.buchner@wsv.bund.de
- **Construction design:** Brushwood box with a riprap toe protection (iron silicate slag)
- **Development:** Prior to building of the brushwood box steep erosion edges were present. Now, the area is developing well and the measure is occasionally maintained as needed.
