Federal Waterways Engineering and Research Institute & Federal Institute of Hydrology

Nature-based solutions for bank protection in estuarine waterways

Collection of measures in tidal areas

30.04.2026
Version: 4

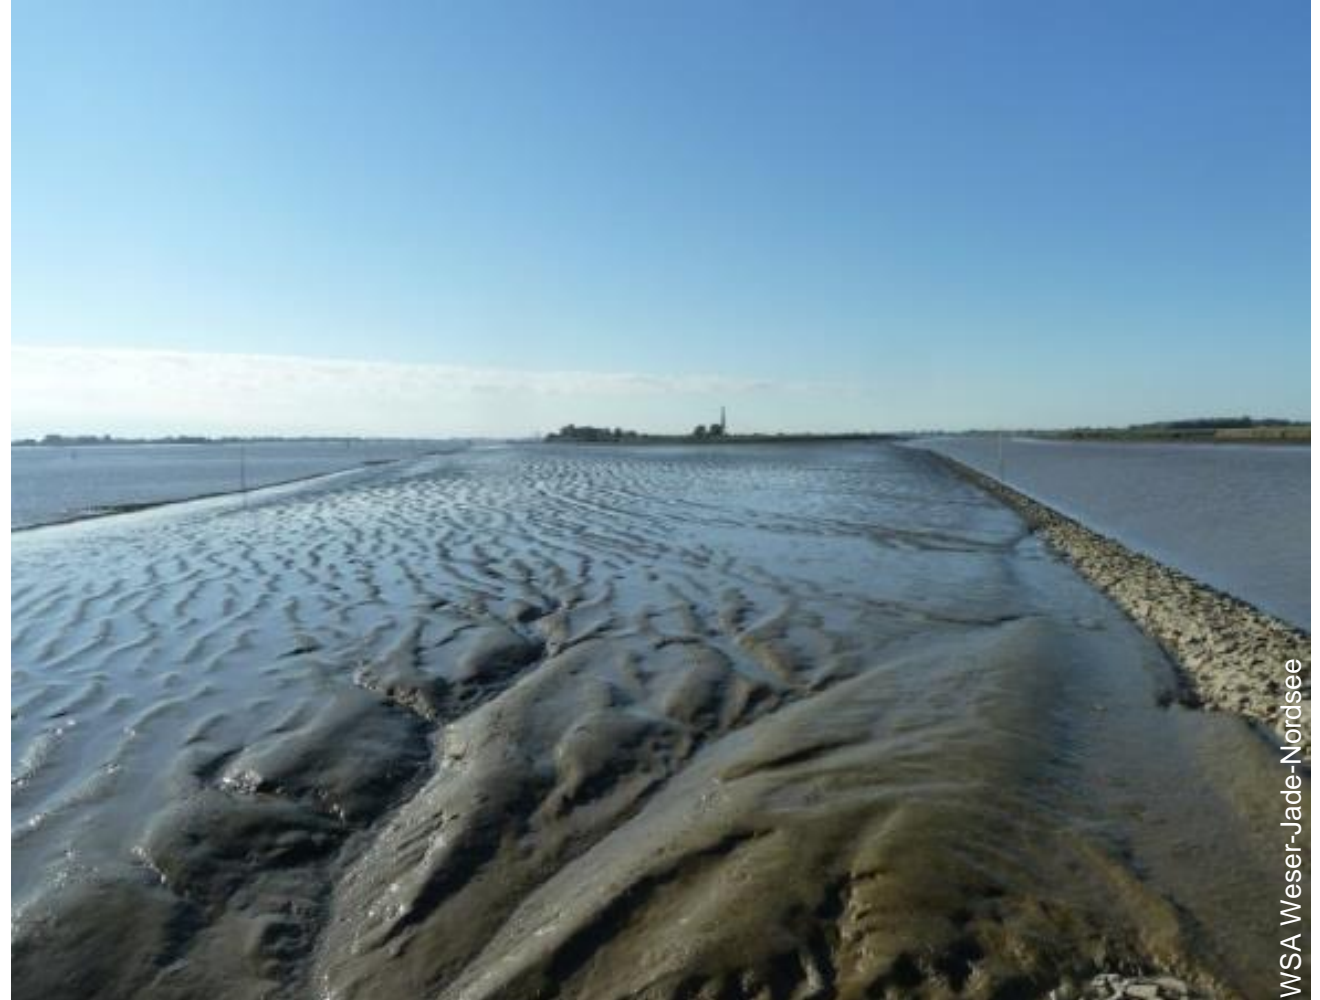
Protection of the tip of the Strohauser Plate Island

- **Km 50,380-51,640** left bank Lower Weser
- **Implementation:** approx. 1987 (tip of the island), approx. 1995 (brushwood groynes)
- **Contact:** WSA Weser-Jade-Nordsee:
steffen.buchner@wsv.bund.de
- **Construction design:** Training wall along the entire stretch and adjacent transverse brushwood groynes at km 50.700, km 51.000 east and west, km 51.200 east and west, km 51.400. The original brushwood training wall was covered with iron silicate slag.
- **Development:** As intended, the area around the tip of the island has become heavily silted up, reducing local dredging volumes. There is currently no need for maintenance; however, the measure is being monitored on an ongoing basis.

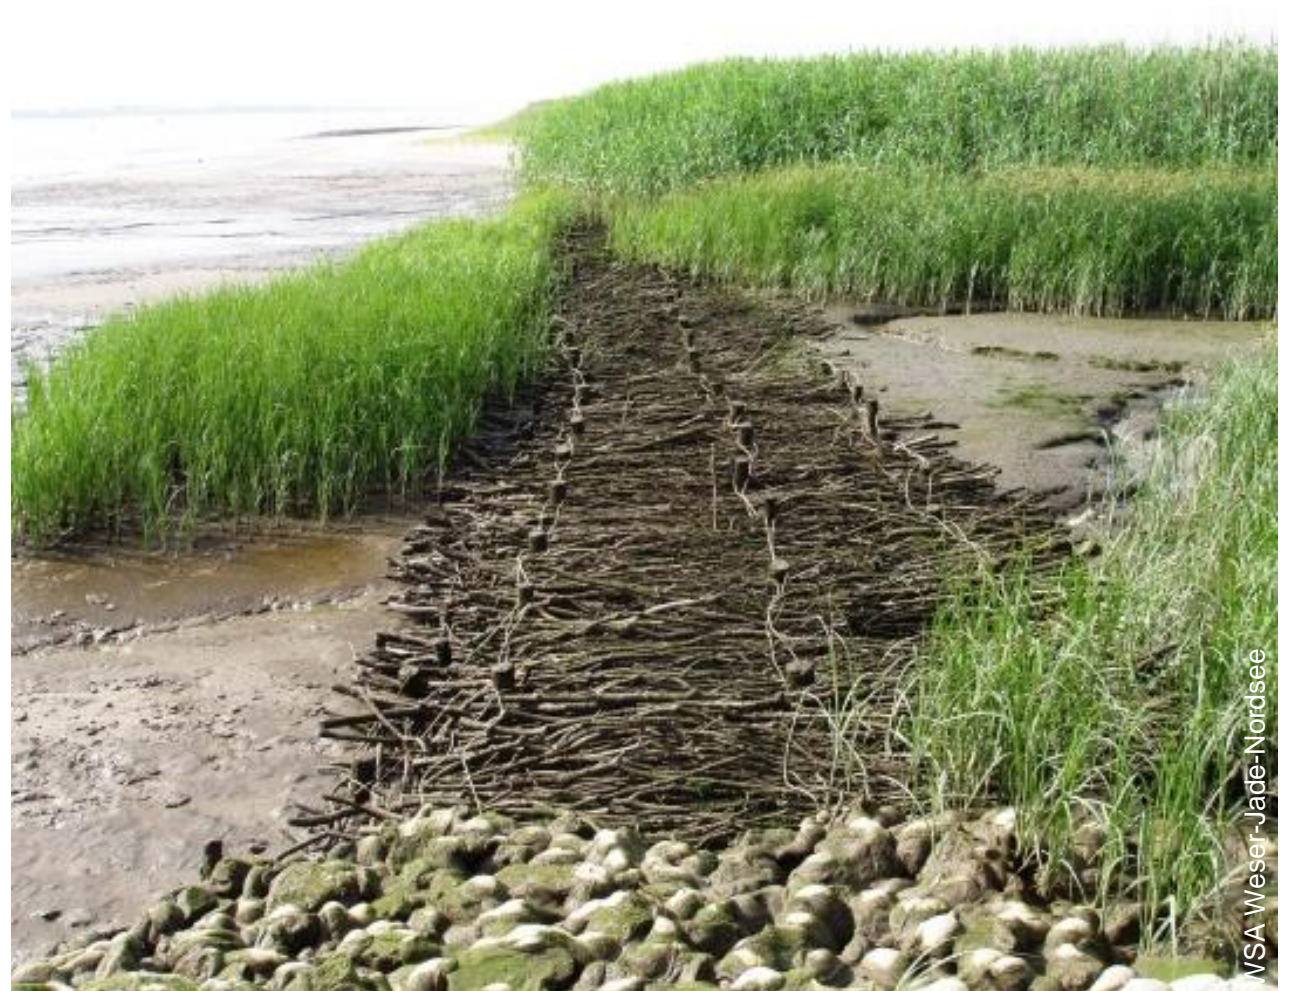
Brushwood mattress to damp a tidal creek

- **Km 50,380** left bank Lower Weser
- **Implementation:** approx. 1993
- **Contact:** WSA Weser-Jade-Nordsee:
steffen.buchner@wsv.bund.de
- **Construction design:** Longitudinal brushwood mattress structure to damp a tidal creek in order to protect the bank and groyne and support reed growth and tidal flat sedimentation.
- **Development:** The mudflats and reeds behind the structure have stabilised. The groyne is secured and the tidal creek has been diverted. No maintenance is currently necessary as the area is silted up and stable.

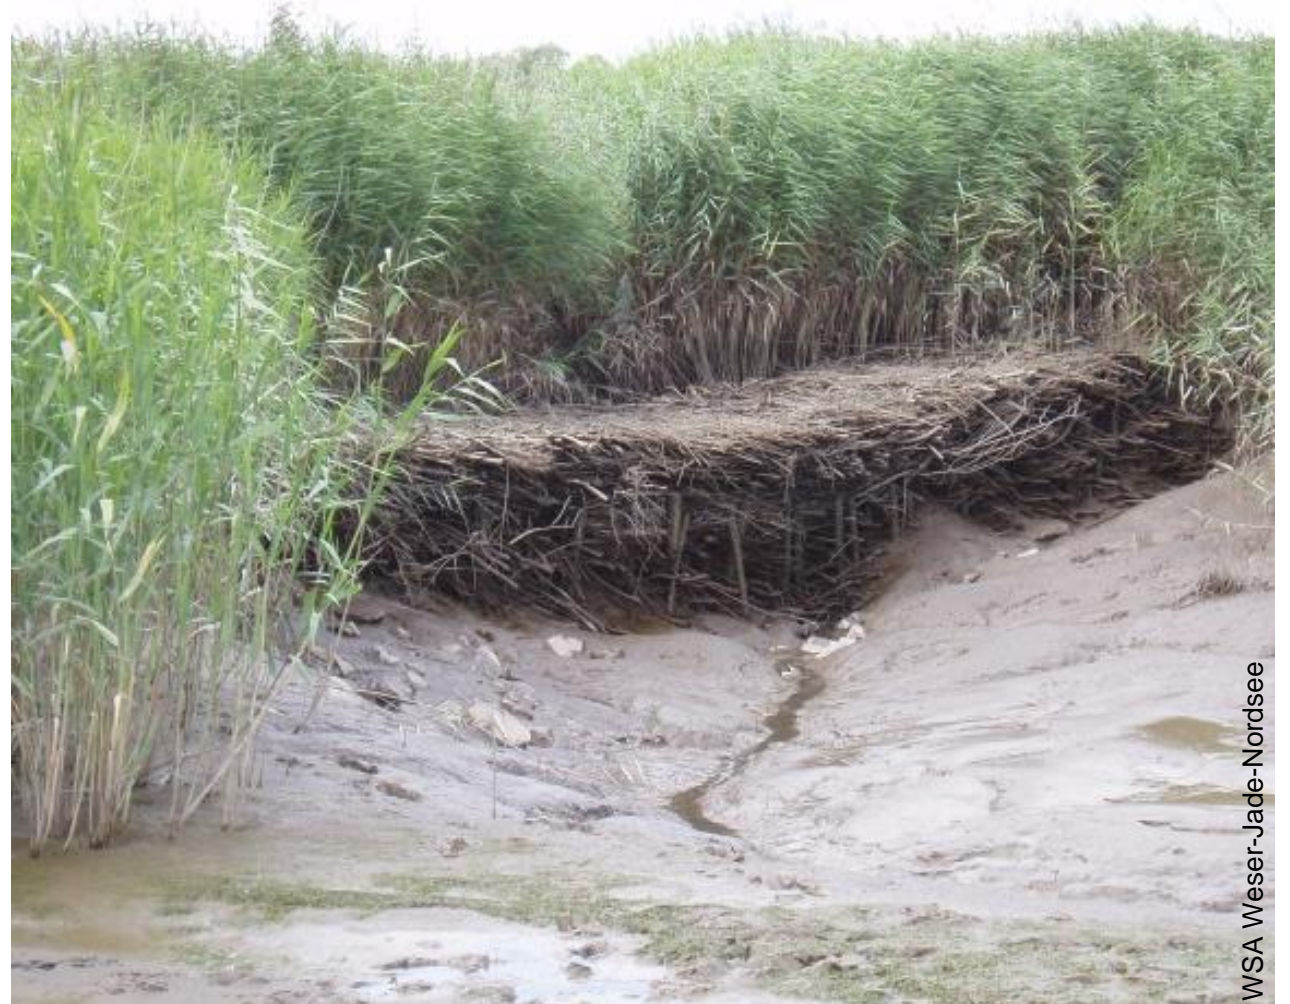
- **Km 52,350** left bank Lower Weser
- **Implementation:** approx. 1999, last maintenance in approx. 2021
- **Contact:** WSA Weser-Jade-Nordsee: steffen.buchner@wsv.bund.de
- **Construction design:** Brushwood box to damp a tidal creek in order to protect the bank and groyne and support reed growth and tidal flat sedimentation.
- **Development:** The reed bed behind the brushwood box has stabilised well and the groyne is completely secured. The structure was last maintained around 2021.

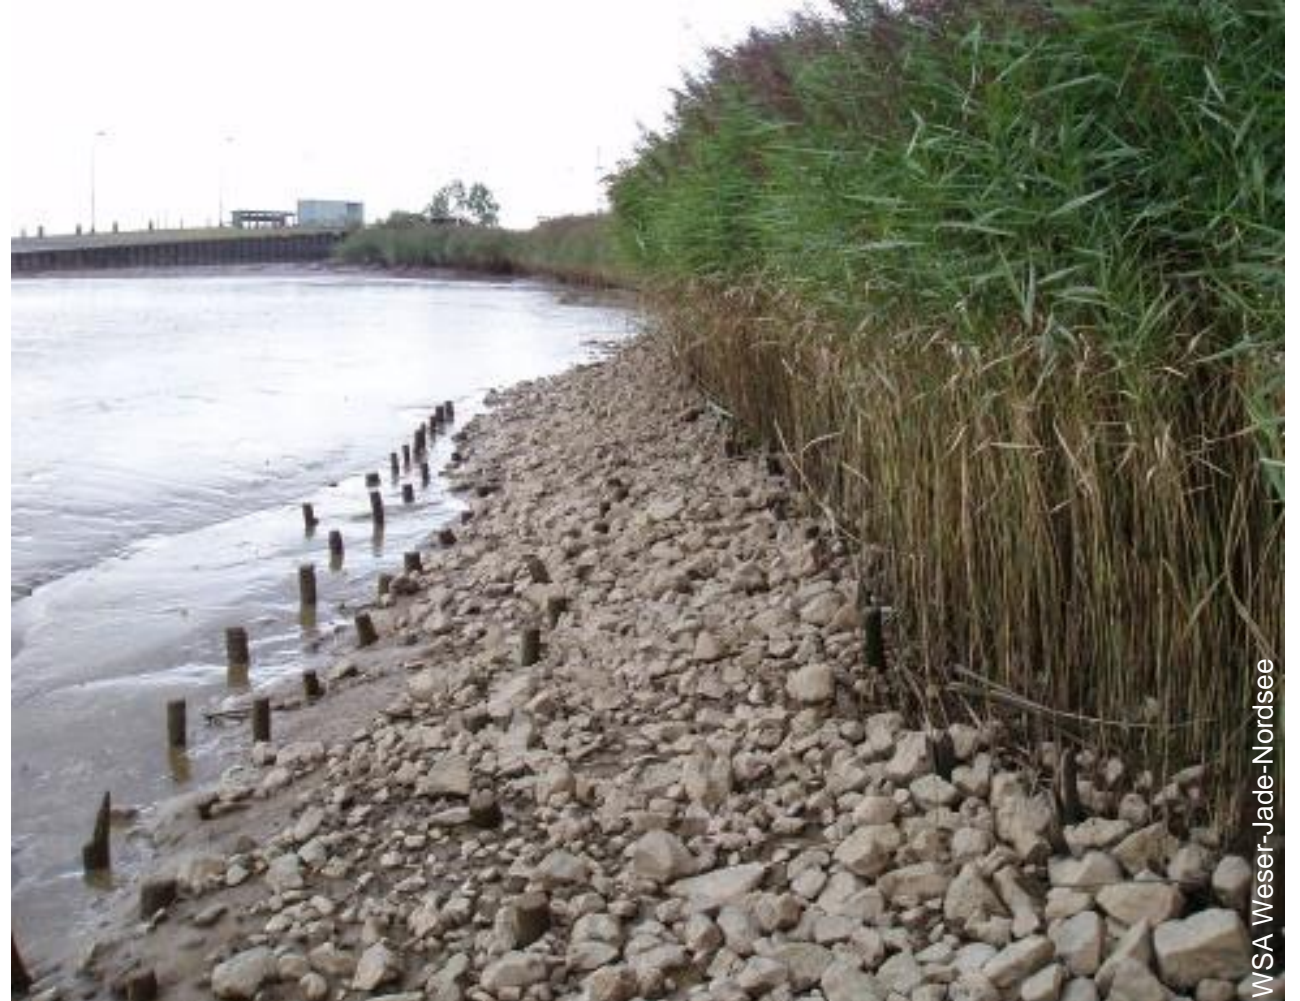
Bank protection of former ferry landing site at Kleinensiel

- **Km 53,500** left bank Lower Weser
- **Implementation:** approx. 1991
- **Contact:** WSA Weser-Jade-Nordsee:
steffen.buchner@wsv.bund.de
- **Construction design:** Solid bank protection made of brushwood boxes with riprap cover as scour protection at the ferry landing site
- **Development:** The bank protection dates back to the time when the ferry was still in operation and high loads were exerted on the bank, making bank protection necessary. The bank has stabilised, is largely silted up and overgrown, so that maintenance is no longer necessary.

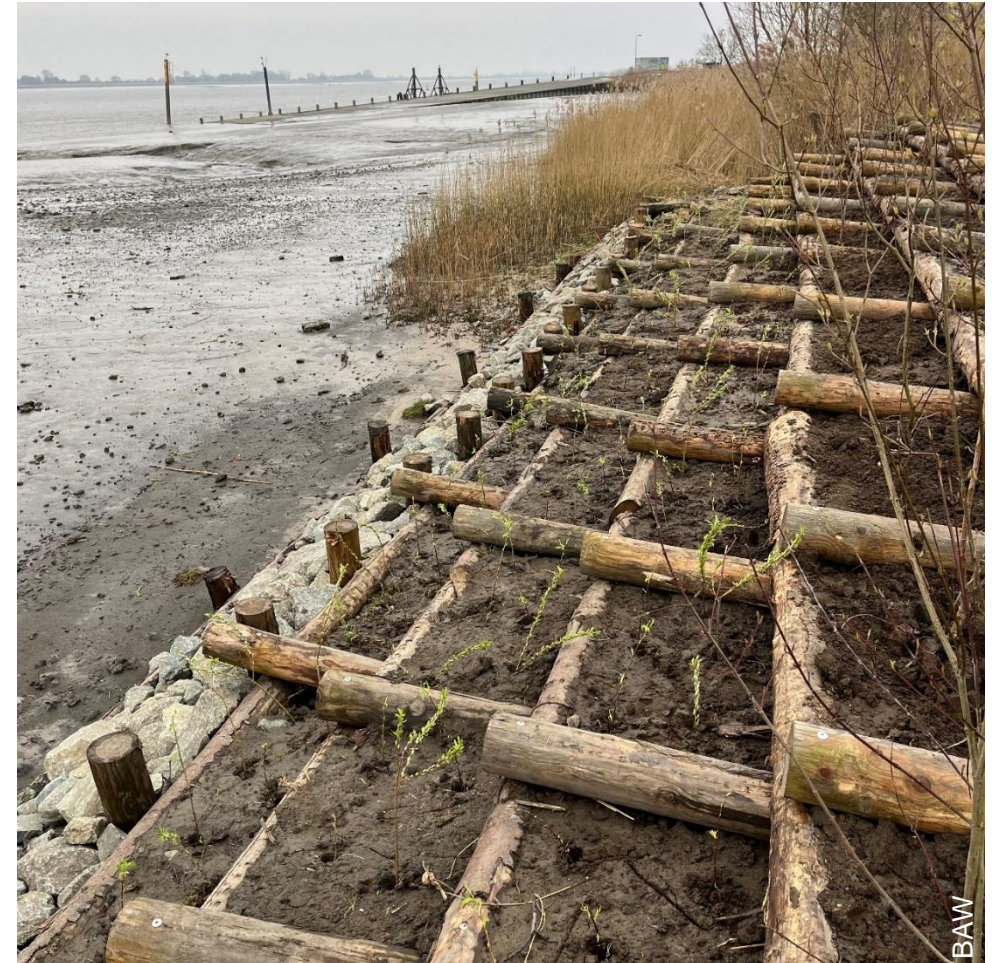
Living crib wall at Kleinensiel

- **Km 53,550-53,600** left bank Lower Weser
- **Implementation:** March 2026
- **Contact:** WSA Weser-Jade-Nordsee: steffen.buchner@wsv.bund.de
- **Construction design:** Living crib wall with willow cuttings and initial plantings of *Cornus sanguinea* and *Crataegus*
- **Development:** The measure is intended to stabilize an erosion edge of approximately 2 m height. It was constructed as a pilot site and monitored through regular site inspections. It is as yet unclear whether the soil introduced will survive the initial phase until the plants have established roots or whether it will be washed away. Immediately after construction, there was already some slight washout of the soil material at higher water levels, so that some soil material was replenished. The development of the measure is being continuously monitored.

Finished crib wall with initial plantings in March 2026.

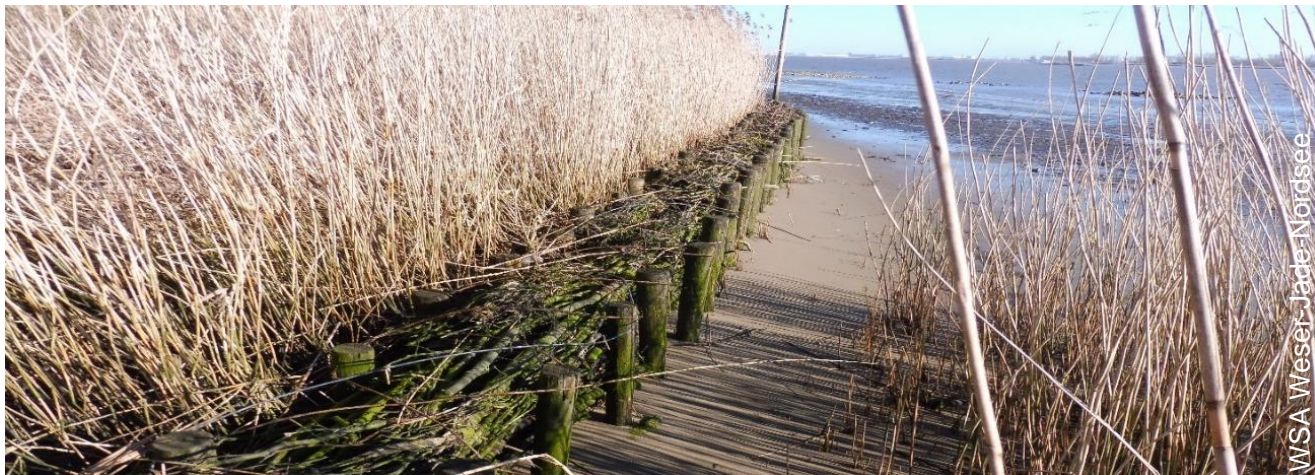
Brushwood boxes to stabilize an erosion edge at “Kleinensieler Plate“

- **Km 54,850-55,000** left bank Lower Weser
- **Implementation:** 2019/2020, last maintained in 09/2025-04/2026
- **Contact:** WSA Weser-Jade-Nordsee: steffen.buchner@wsv.bund.de

- **Construction design:** Brushwood box to stabilize an erosion edge
- **Development:** During the implementation of the compensation scheme “Kleinensieler Plate” soil filling created a steep bank entirely left to nature after completion in 2000. Due to the raised embankment, erosion edges continue to form, some of which are secured by brushwood boxes. During construction several excavator shovel loads of soil containing rhizomes were deposited in the area between the brushwood box and the erosion edge to encourage vegetation growth. The structure is fulfilling its purpose. Bank erosion has been stopped and a vegetation belt approximately 5-10 m wide has established between the brushwood box and the erosion edge.

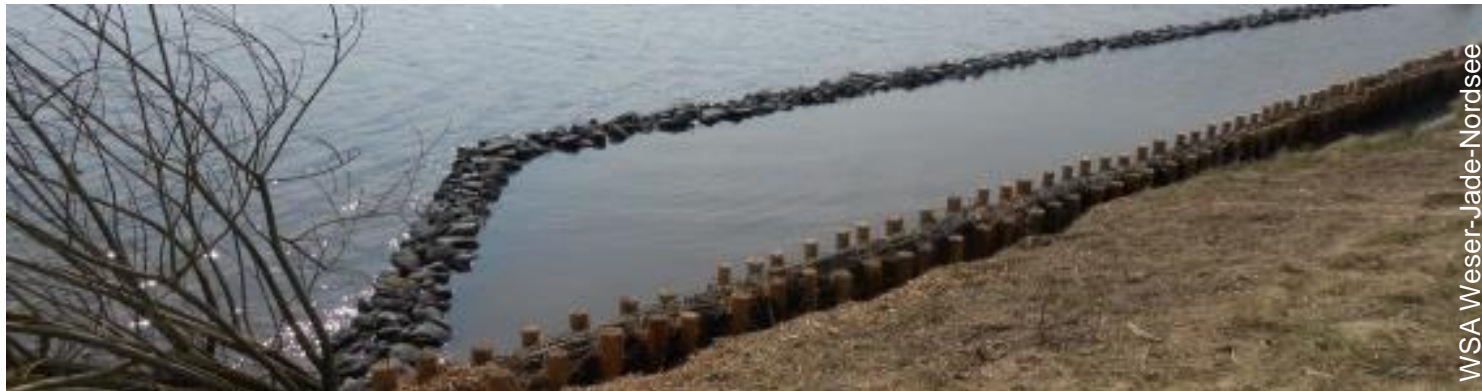
Compensation scheme Hunte expansion Hollersiel

- **Km 11,9-12,0** right bank Hunte
- **Implementation:** 2018
- **Contact:** WSA Weser-Jade-Nordsee: Dieter.hoeffmann@wsv.bund.de
- **Construction design:** A brushwood box consisting of two rows of wire-bound piles, filled with fascines and a straw filter, was placed directly in front of the erosive bank. A secondary protective structure made of riprap was constructed in front of it to shield against wave impact. The original plan called for a second pile structure, which could not be installed and was therefore replaced with stones. The structure is located away from the navigation channel behind a former dyke and is subject only to moderate tidal influence.

- **Development:** Since construction, there has been neither a deterioration nor an improvement in the erosion. The bank is stable, and most of the fascine material is no longer present (see photo on the right). The measure has not been maintained to date. Since the area is stable, no maintenance is planned for the future.

Finished measure immediately after construction in 2018.

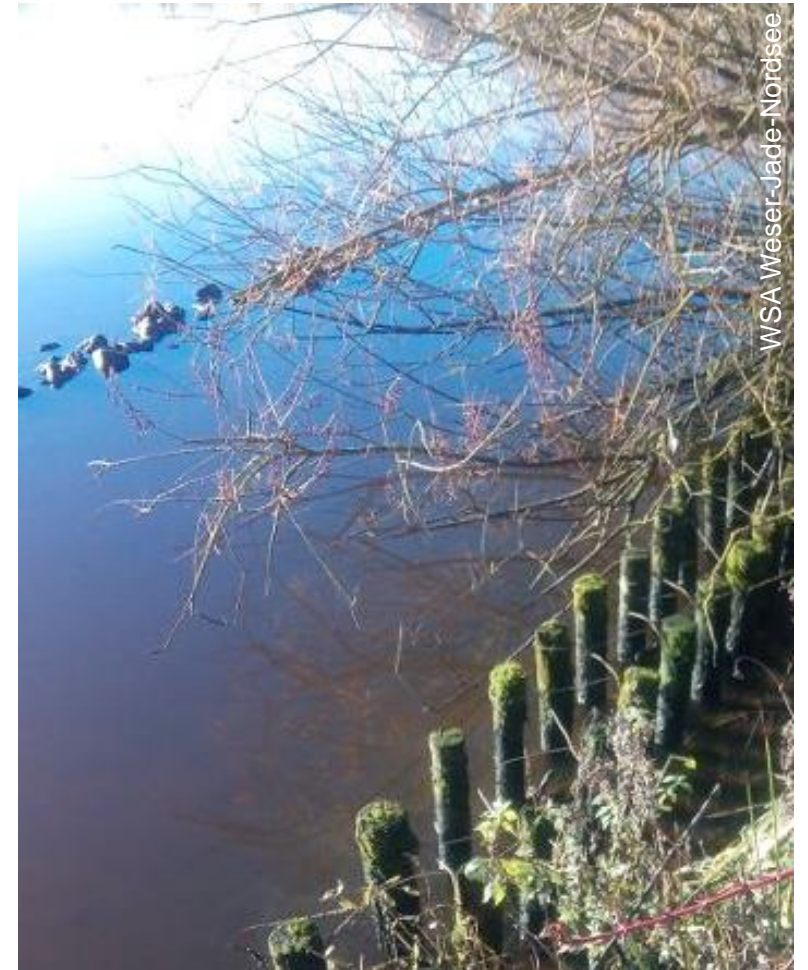
Measure in November 2025.

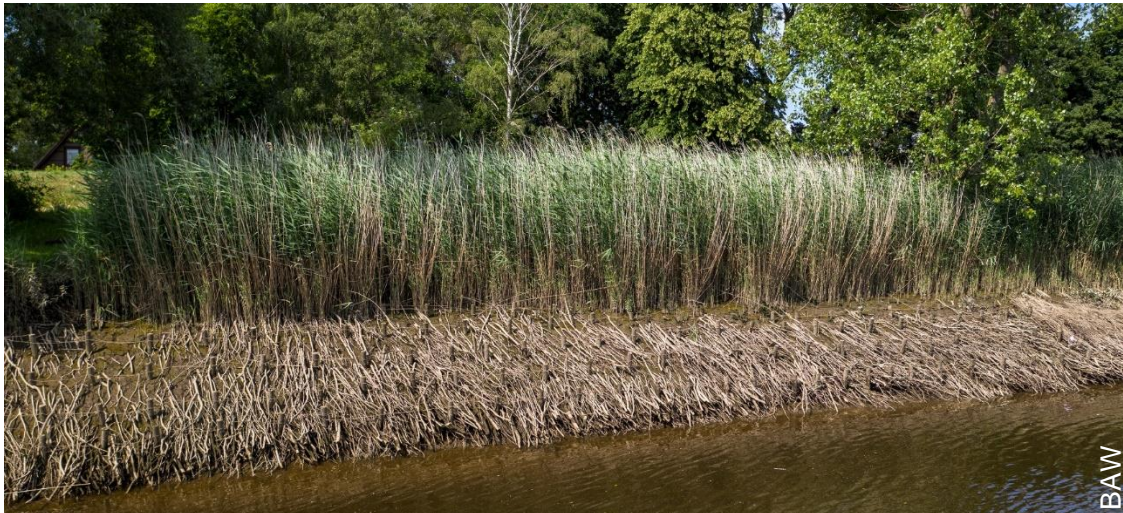
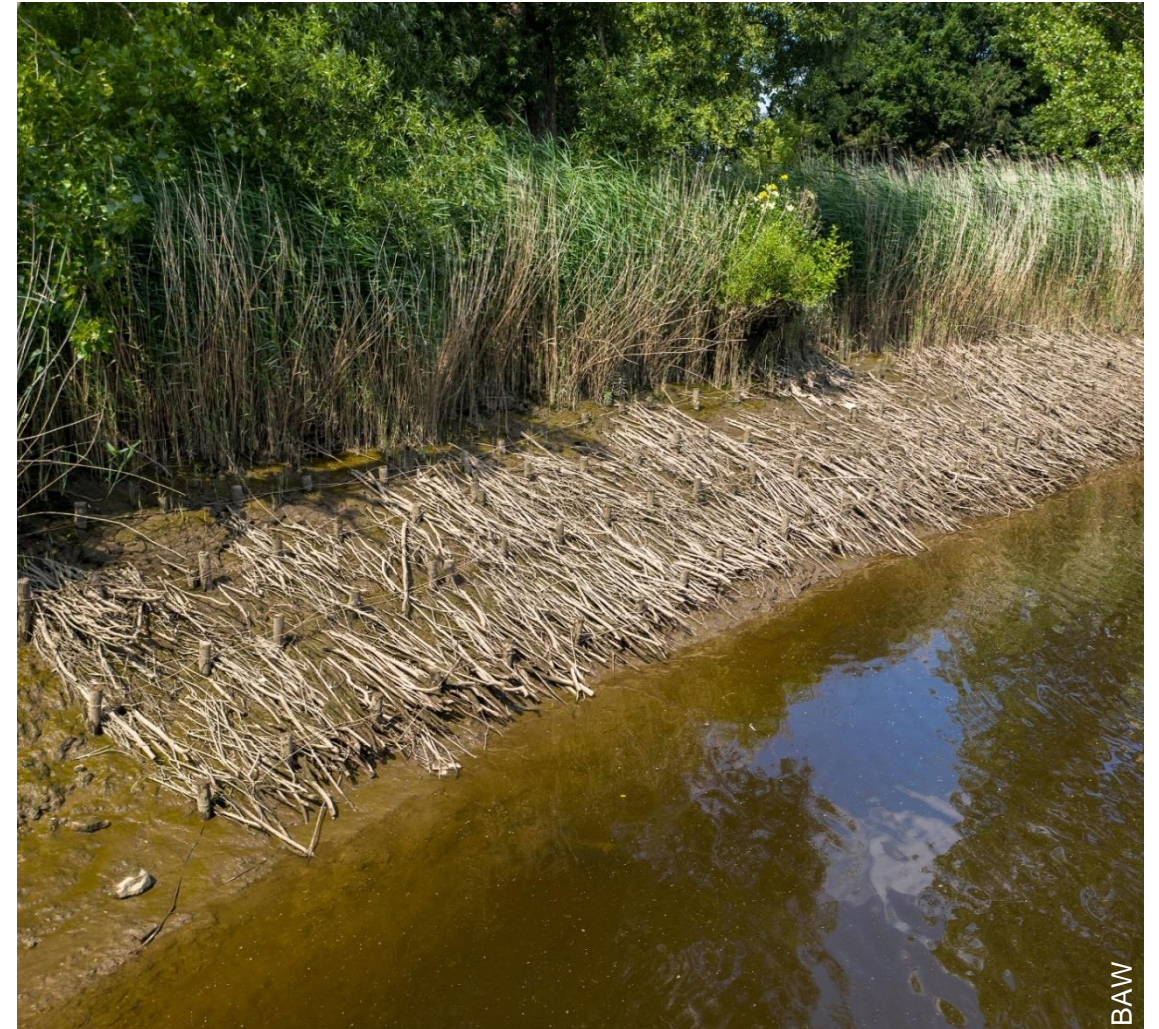
Wümme pilot site 2

- **Km 17,00-17,08** right bank Wümme
- **Implementation:** Winter 2013/2014, last maintenance in 2020
- **Contact:** WSA Weser-Jade-Nordsee: abz-farge@wsv.bund.de
- **Construction design:** Brushwood mattress made out of hardwood fascines for dyke toe and bank protection
- **Development:** The measure is the pilot site 2 under the maintenance plan for the Lesum/Wümme. It was implemented for bank and dike protection and to prevent scouring. The project is fulfilling its purpose, and no repairs are currently planned.

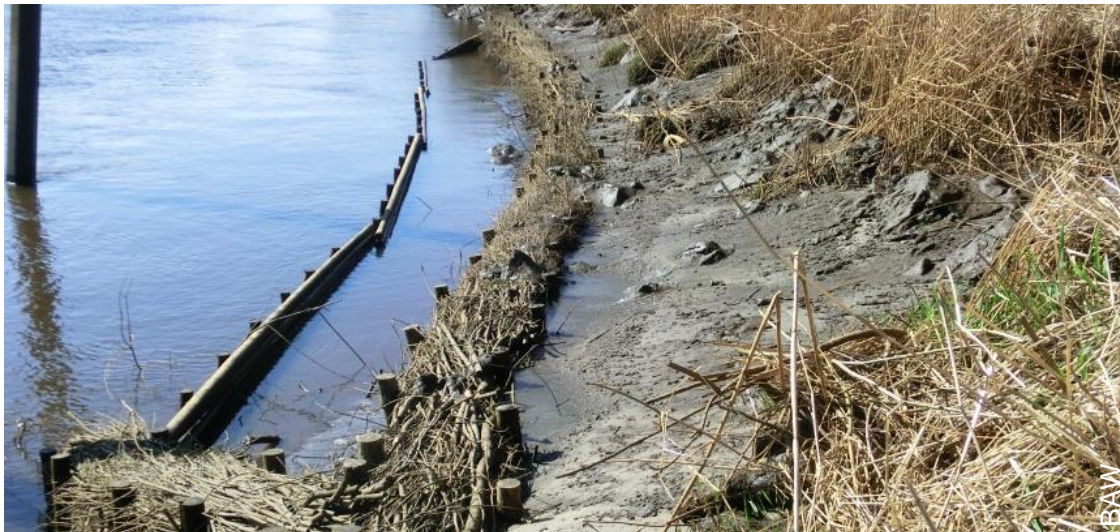
- **Km 16,18-16,24** right bank Wümme
- **Implementation:** Winter 2013/2014, last maintenance in 2020
- **Contact:** WSA Weser-Jade-Nordsee: abz-farge@wsv.bund.de
- **Construction design:** Brushwood box filled with hardwood fascines and a pile wall. Backfilling up to the level of the reed behind the brushwood box and minor initial planting of reeds.
- **Development:** The measure is the pilot site 2 under the maintenance plan for the Lesum/Wümme. It was implemented for bank and dike protection and to prevent scouring. The construction design used on this pilot site has not proven effective, and the section will therefore no longer be repaired. The structure was only partially stable, and the pile wall did not achieve the desired effect. The design was modified by replacing the pile wall with a brushwood box.

Pilot site 3 at the Wümme: Brushwood box with behind a pile wall in 2014.

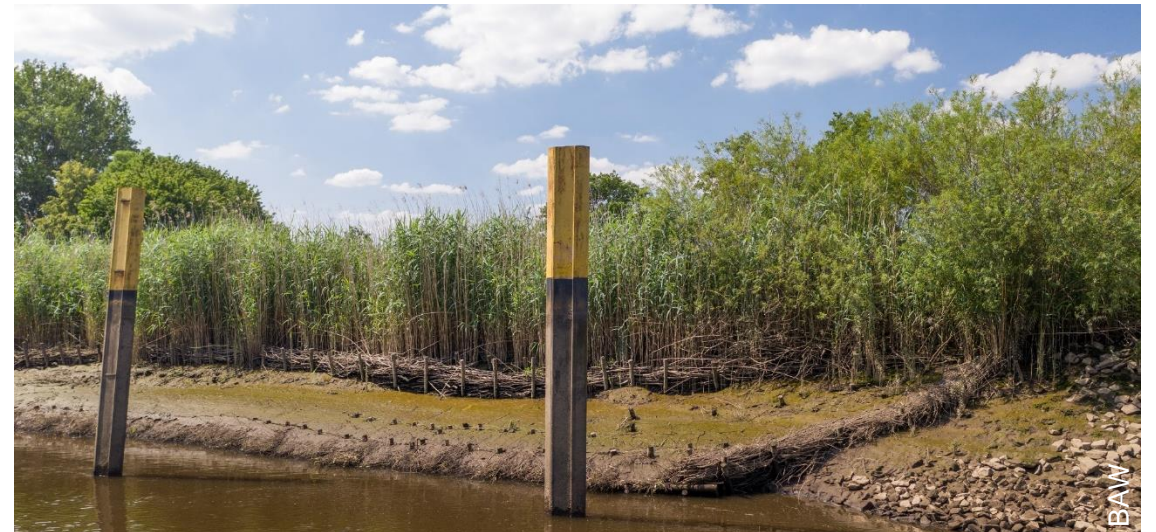
Modified measure in 2020.

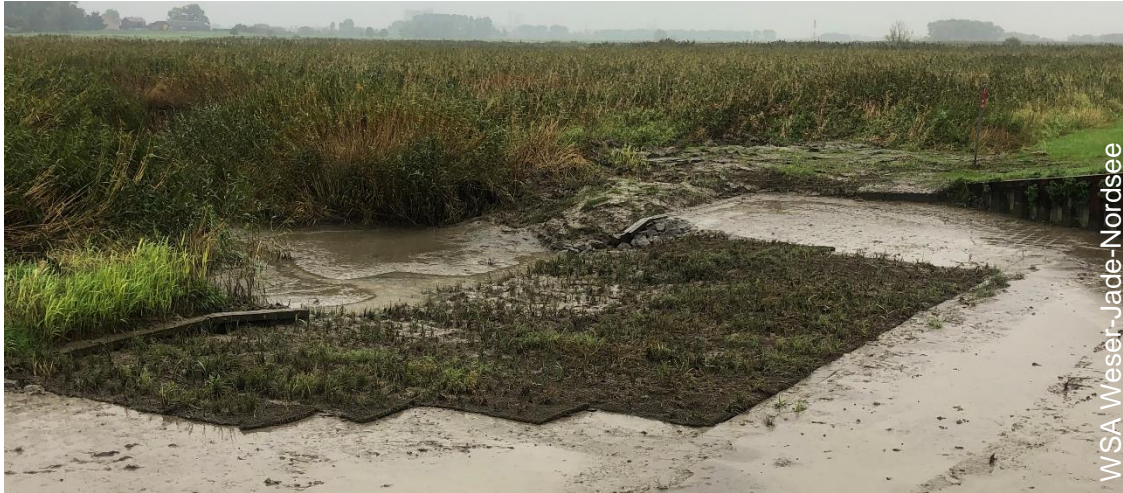
- **Construction design:** The goal of the project was to protect the outlet area of the Verlaat from scouring. The previous paving and the wooden sheet pile wall were not restored. To mitigate hydrodynamic stress, the slope was reprofiled, the scour hole was filled with sand as a water-conducting layer, covered with a geotextile, and stone mattresses were laid out over the entire area. Coconut fibre mats enriched with seeds (a native reed mixture) were laid down and interwoven with the stone mattresses. Additional stability is expected to result from the roots growing through the stone mattresses.

Measure immediately after construction (08.10.2020)

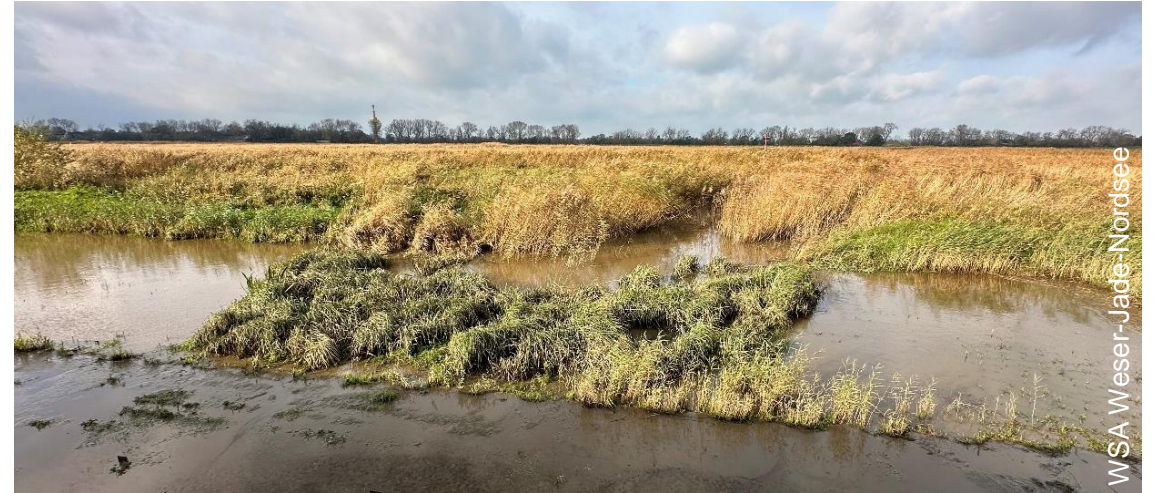
- **Development:** The vegetation has quickly established and spread and has withstood storm surges. During the annual inspection, no defects or recurring areas of damage have been identified to date, so no further action has been required. The material is maintenance-free and requires neither regular upkeep nor maintenance measures such as repairs or follow-up treatments.

Measure on 08.11.2023

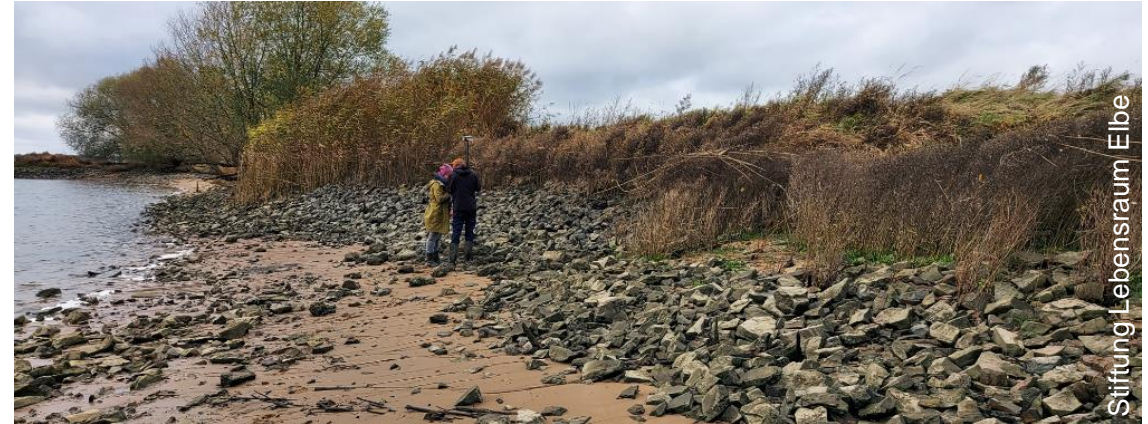
Before

- **Km 589,000 – 591,000** right bank Elbe
- **Implementation:** 2024
- **Contact:** Stiftung Lebensraum Elbe, WSA Elbe-Nordsee
- **Construction design:** Lowering the revetment to 1 m above sea level to encourage natural bank dynamics, vegetation establishment, the formation of tidal creeks and the development of sandy bank areas.
- **Development:** A more natural bank has been created, and so far no maintenance work has been required. The protection provided by the groyne remains in place.

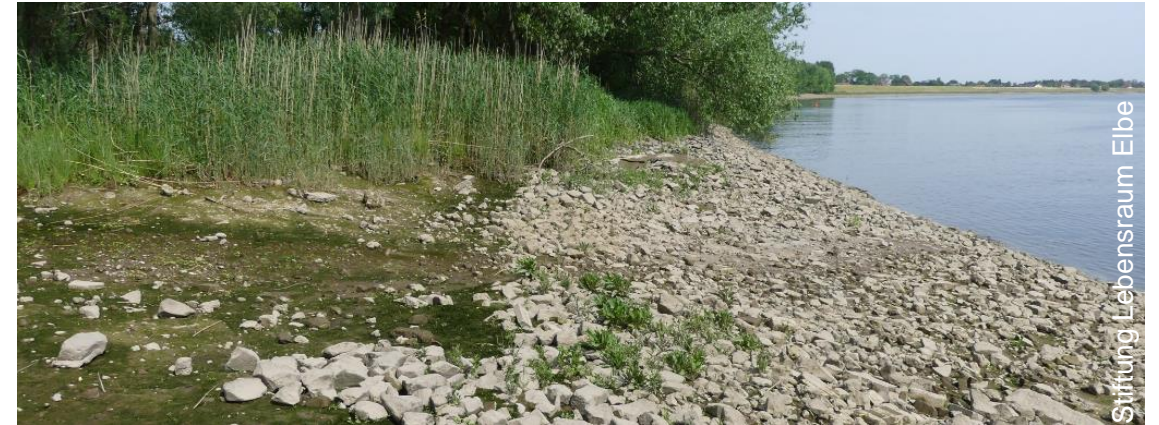
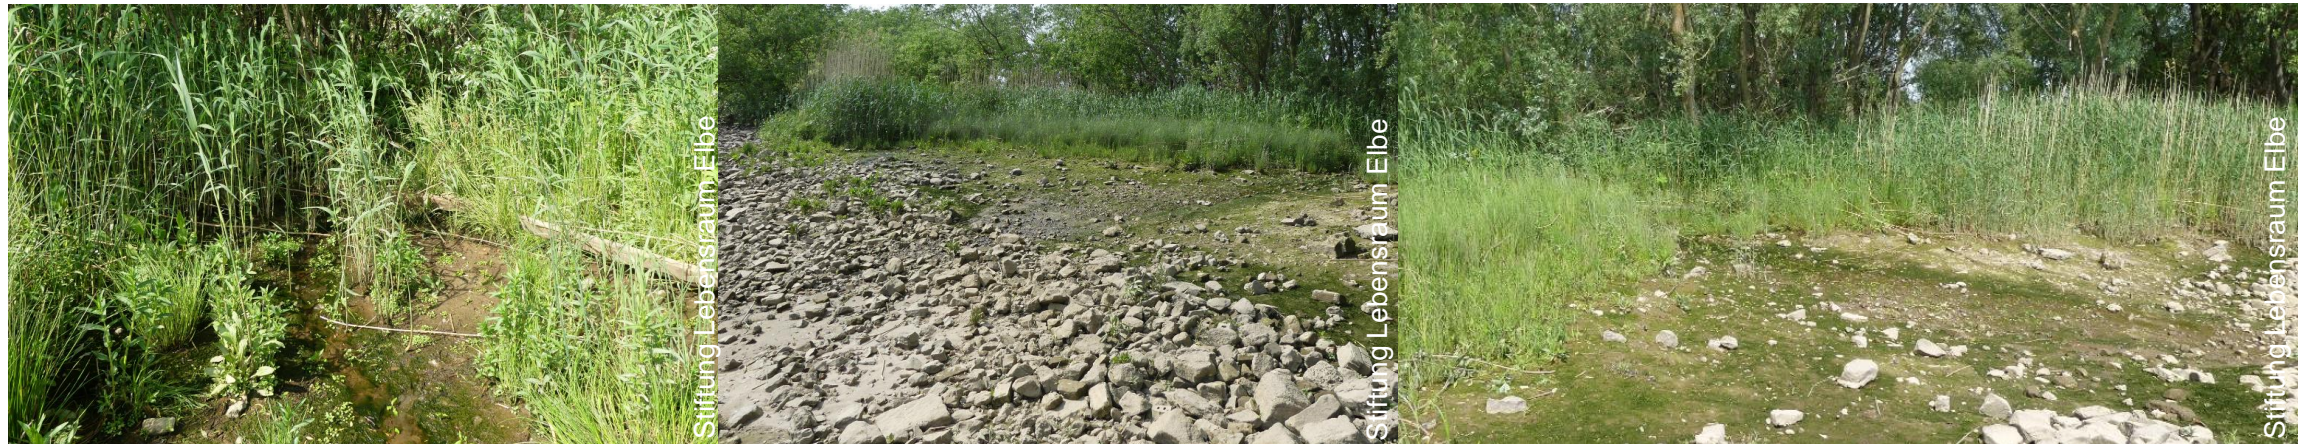
- **Km 603,000-603,000** right bank Elbe
- **Implementation:** November 2019
- **Contact:** Stiftung Lebensraum Elbe, WSA Elbe-Nordsee
- **Construction design:** Lowering the revetment of around 1.5 m along 30 m to allow natural bank development.
- **Development:** A more natural bank has been created, and so far no maintenance work has been required.

Summer 2022, 3rd year after implementation.

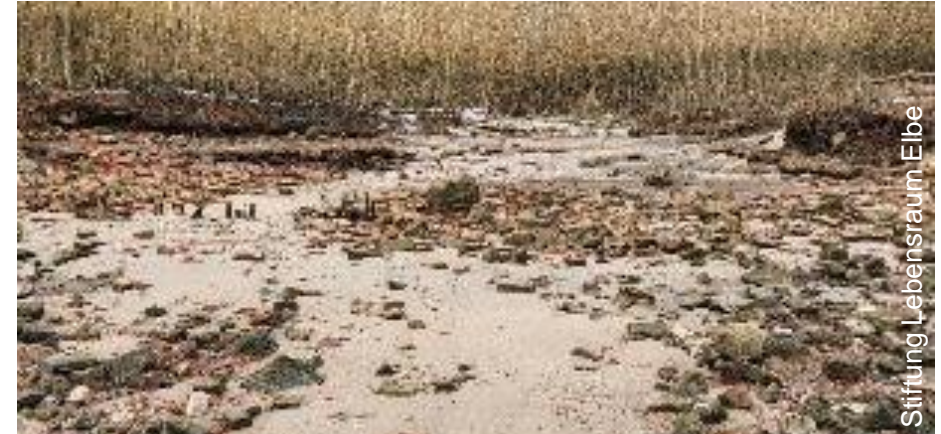
Norderelbe, February 2025. First tidal creek structures visible; season Prielstrukturen sichtbar; due to the time of year, no primary vegetation is visible yet.

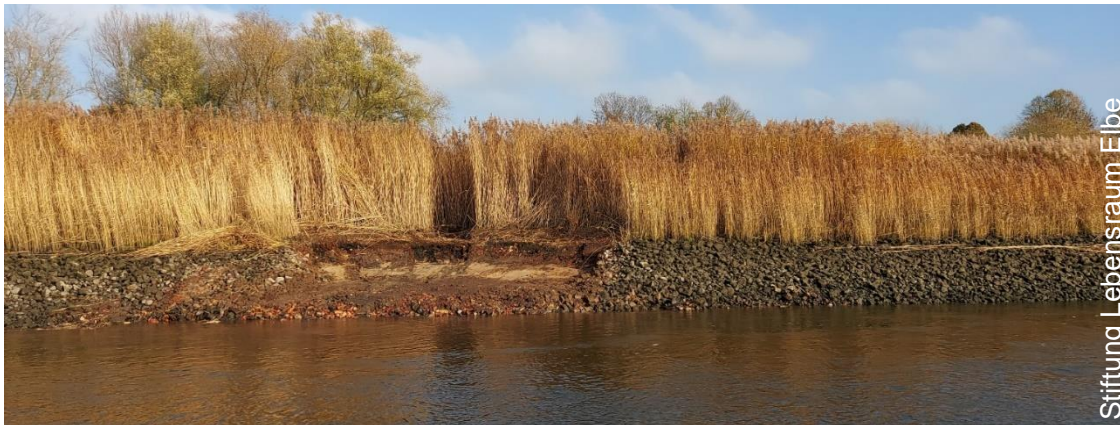
- **Km 609,000 – 612,000** left and right bank of Süder- und Norderelbe (Southern and Northern Elbe) at „Bunthäuser Spitze“
- **Implementation:** November 2022
- **Contact:** Hamburg Port Authority, Stiftung Lebensraum Elbe
- **Construction design:** Removal of riprap and lowering the revetment by around 1-1.5 m in six 10 m wide sections. The goal of this measure is to promote the development of tidal creeks and increase structural diversity behind the lowered revetments, as well as to encourage the growth of primary vegetation in the bank area.
- **Development:** So far, no changes to the remaining revetment have been observed, so no maintenance is necessary. Minor changes, such as the formation of tidal creeks and the leveling of the relief in the adjacent areas, have been observed. In addition, initial growth of primary vegetation and algae has begun.

After lowering of the revetment.

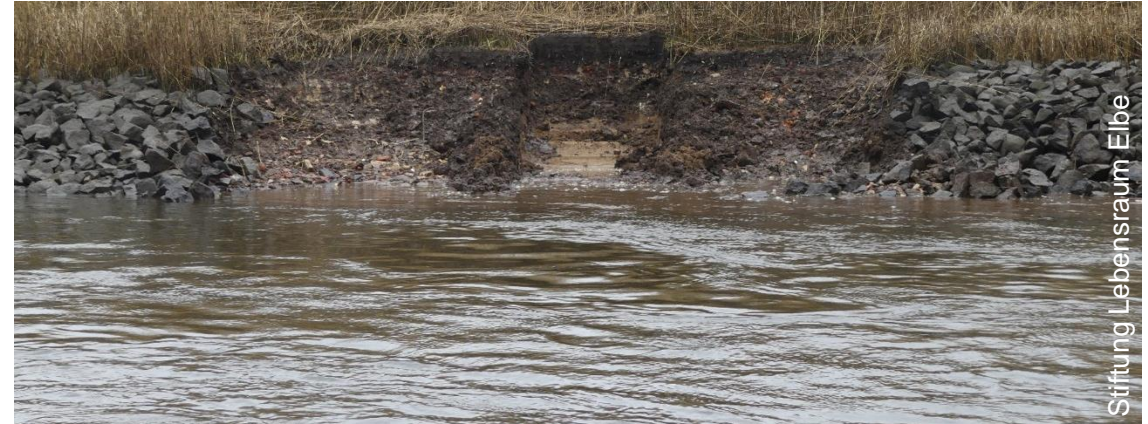
- **Km 613,000 – 615,000** left bank Süderelbe (Southern Elbe)
- **Implementation:** 2018-2019
- **Contact:** Hamburg Port Authority, Stiftung Lebensraum Elbe
- **Construction design:** Lowering of the revetment by approximately 1 m over a width of approximately 10 m. The aim of this measure is to encourage the development of tidal creeks and increase structural diversity behind the lowered sections of the revetment, as well as to encourage the growth of primary vegetation on the exposed bank areas.
- **Development:** First tidal creek structures are visible, and in some places initial growth of algae and primary vegetation can be observed. Hardly any changes were observed in the adjacent riprap revetment, so no maintenance has yet been necessary. A relatively large amount of the underlying revetment has been exposed within the lowered area.

After implementation.

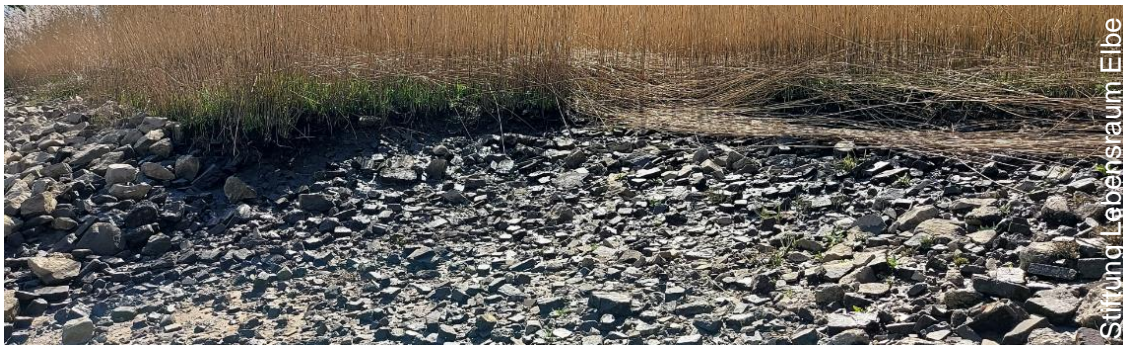
Measure at the beginning of 2023. Many of the underlying stones have been uncovered.

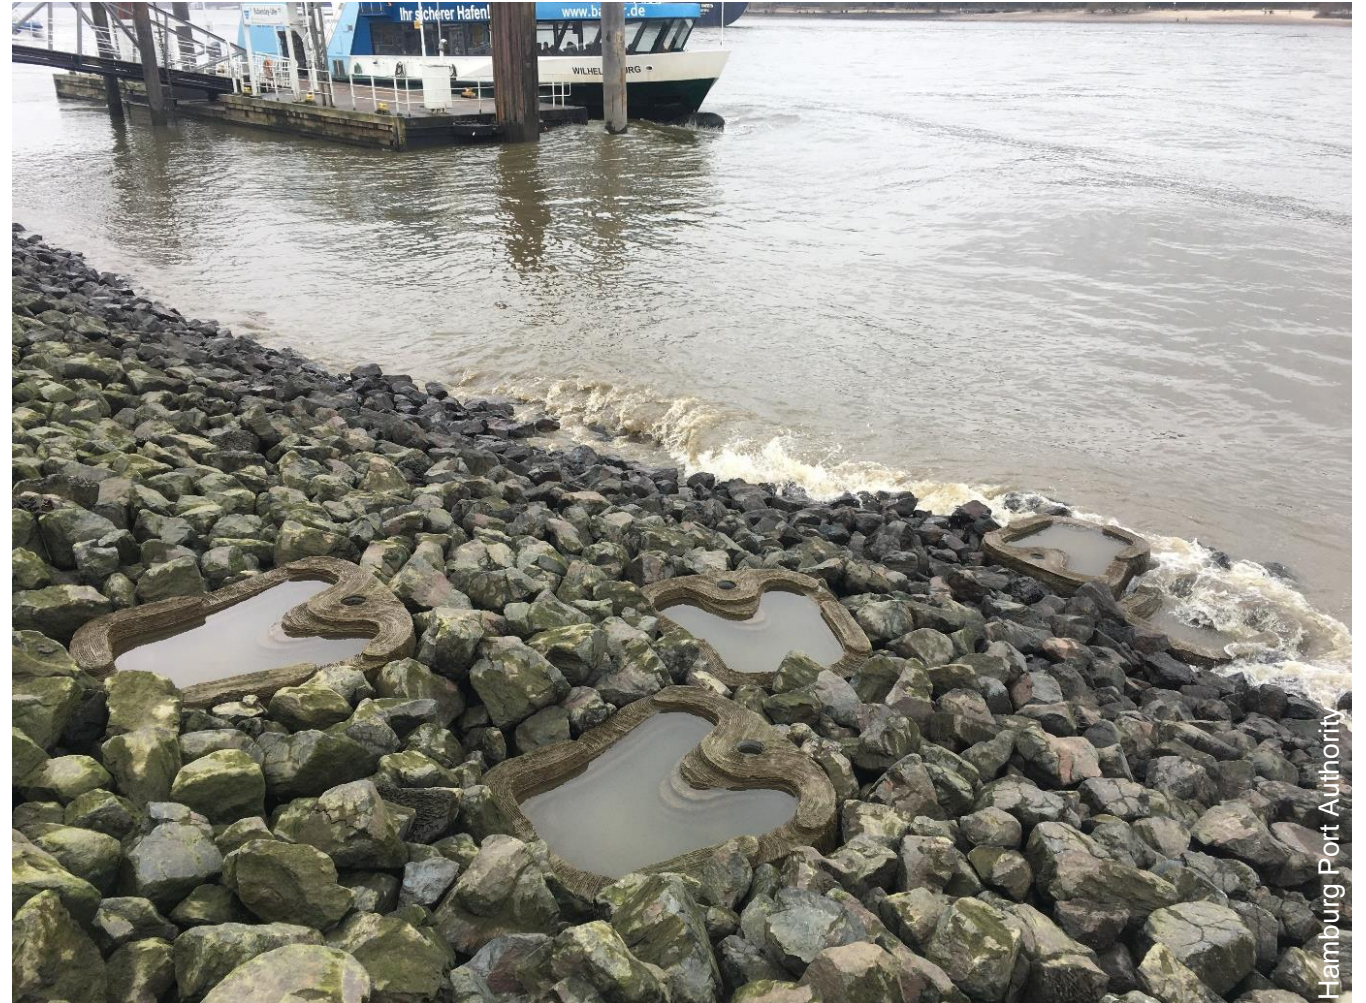
- Km 628,500 left bank Elbe
- **Implementation:** September 2019
- **Contact** Hamburg Port Authority
- **Construction design:** Improvement of the structural diversity of the bank areas and underwater habitats through the integration of five tide pools made of bioactive concrete into the revetment.
- **Development:** Monitoring has shown that the pools have resulted in a more structured community of phyto- and macrozoobenthos compared to riprap structures without pools.

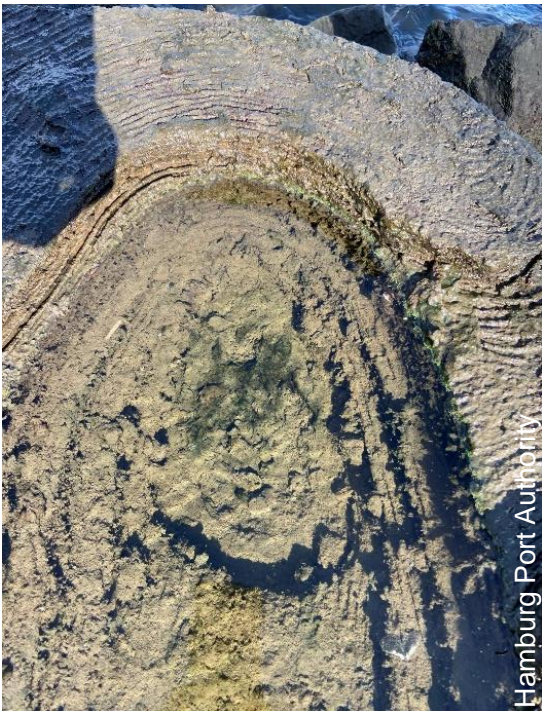
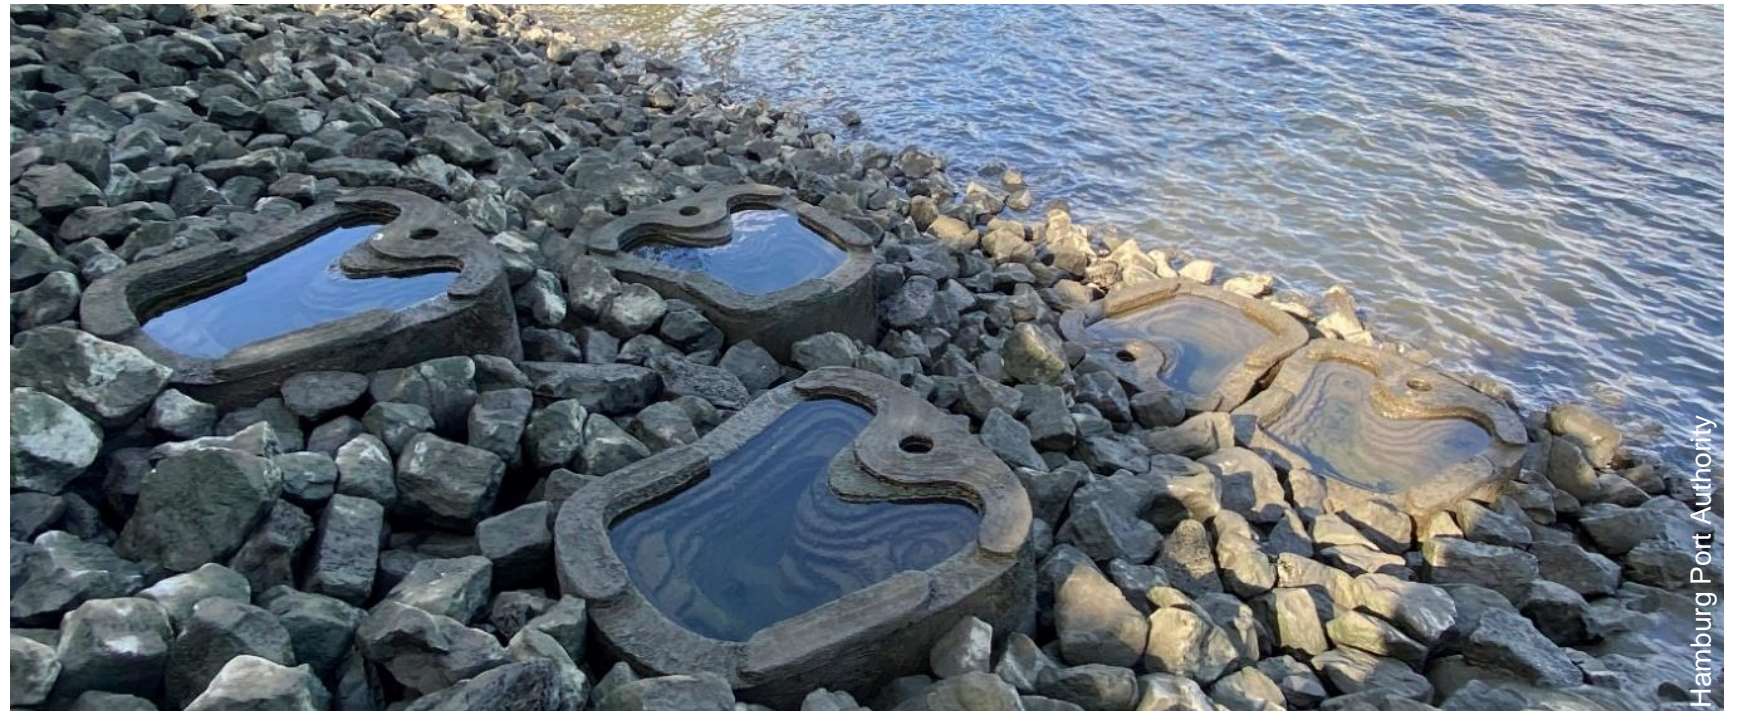
Tide pools at “Genter Ufer“

- **Km 629,500** left bank Elbe
- **Implementation:** April 2020
- **Contact** Hamburg Port Authority
- **Construction design:** Improvement of the structural diversity of the bank areas and underwater habitats through the integration of five tide pools made of bioactive concrete into the revetment.
- **Development:** Monitoring has shown that the pools have resulted in a more structured community of phyto- and macrozoobenthos compared to riprap structures without pools.
