Federal Waterways Engineering and Research Institute & Federal Institute of Hydrology

Nature-based solutions for bank protection in estuarine waterways

Collection of measures in tidal areas

30.04.2026
Version: 4

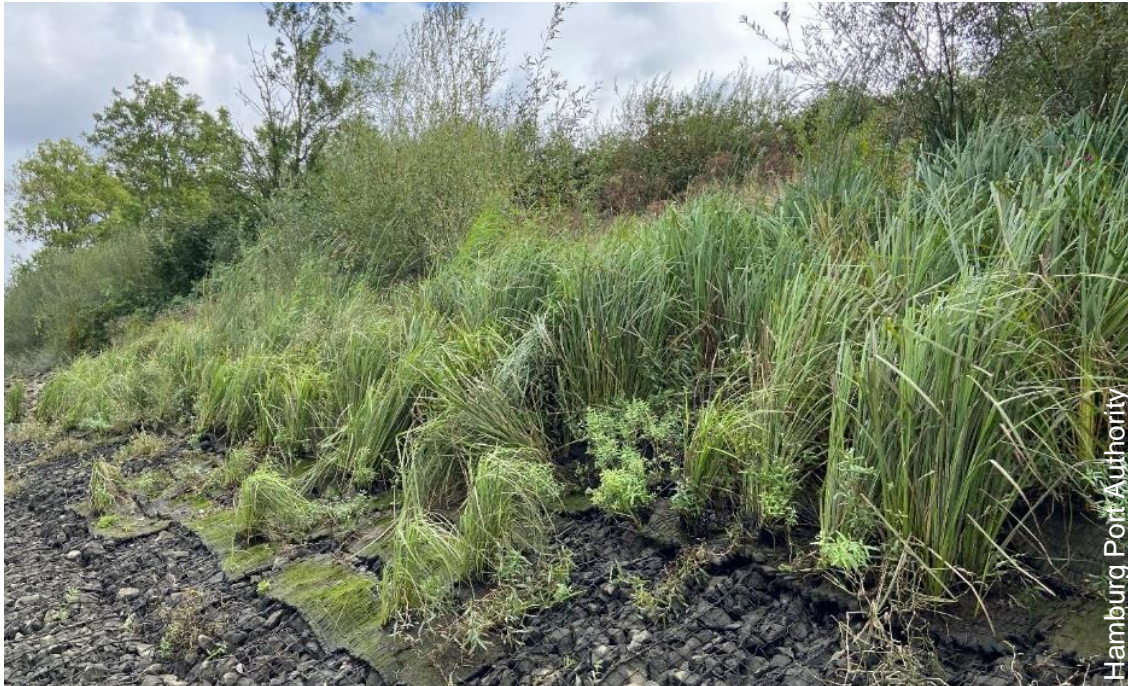
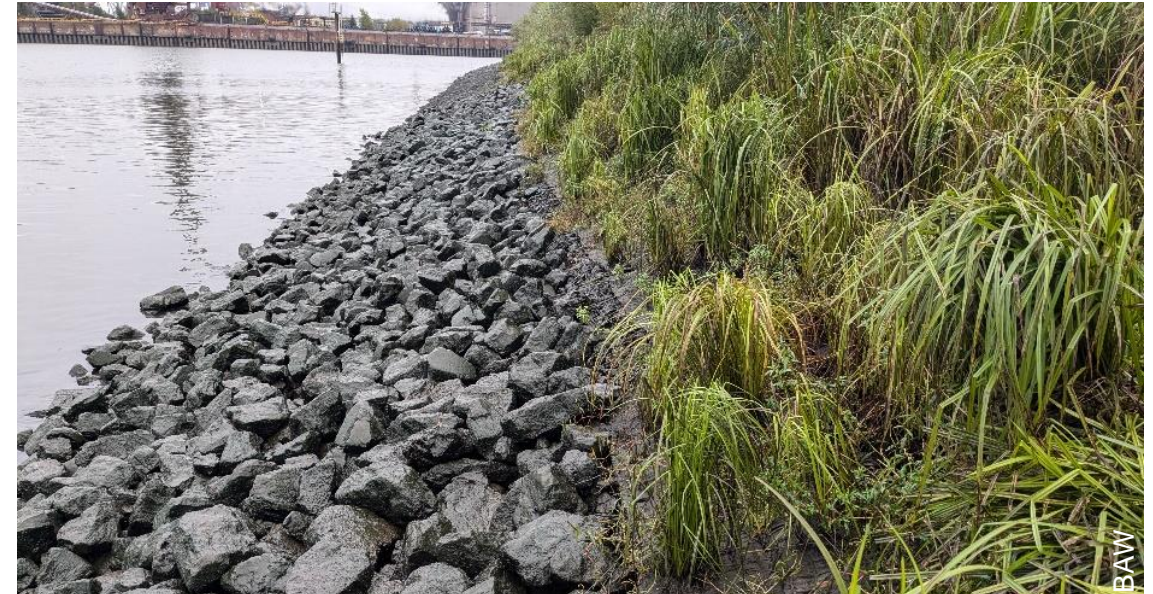
Vegetated revetment at “Genter Ufer“

- **Km 629,500** left bank Elbe
- **Implementation:** Juni - Juli 2020 (gabion mattresses); Mai – Juli 2021 (vegetation mats)
- **Contact** Hamburg Port Authority
- **Construction design:** Replacement of the existing riprap with gabion mattresses, onto which planted (pre-cultivated) vegetation mats were placed.
- **Development:** Growth of the reed bed was observed between 0.9 and 1 m above mean high water. Regular maintenance is necessary to prevent the introduction and spread of invasive species.

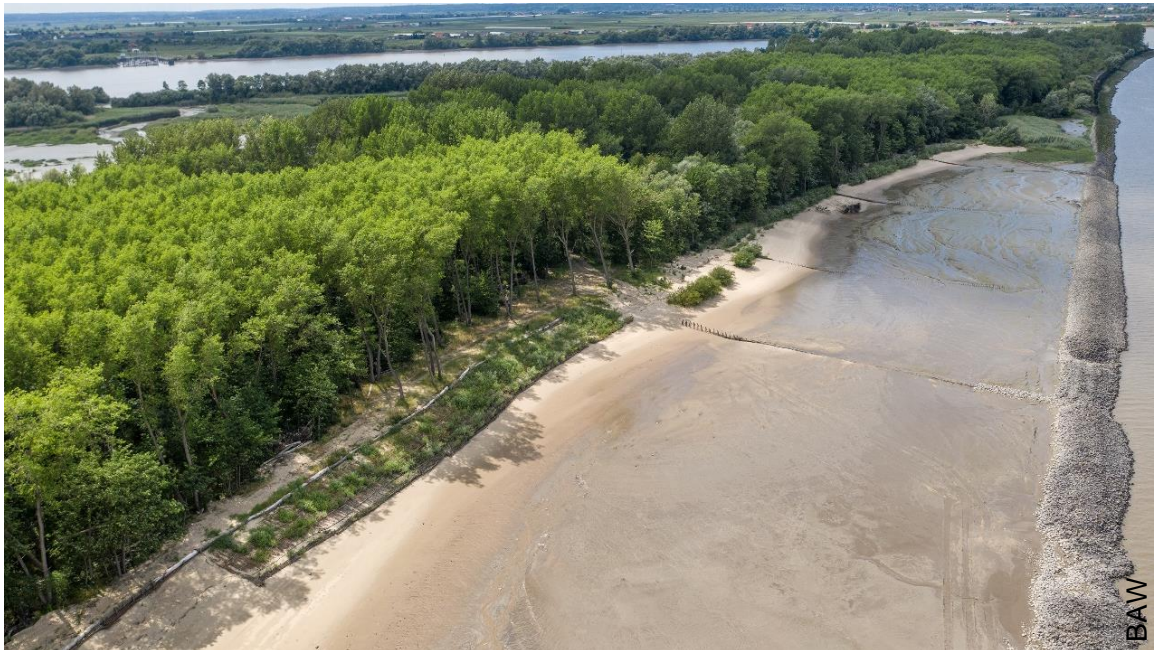
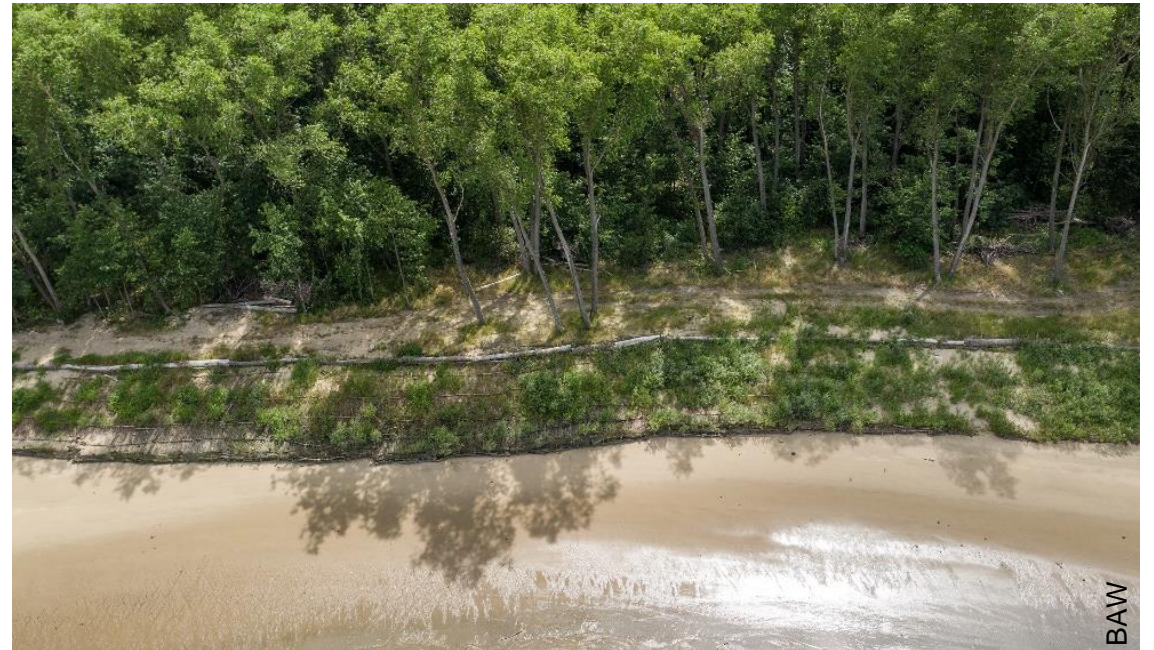
Willow mattresses for beach protection on Elbe island Hanskalbsand

- Km 642,300-642,700 left bank Elbe
- **Implementation:** 2017-2023
- **Contact:** WSA Elbe-Nordsee: abz-wedel@wsv.bund.de
- **Construction design:** Several sections of willow mattresses around 1 m above mean high water to protect the beach and prevent bank erosion. Toe protection of the willow mattresses consists of sproutable and non-sproutable fascine rolls.
- **Development:** The willows have established successfully and are pruned regularly. The next pruning is scheduled for 2026.

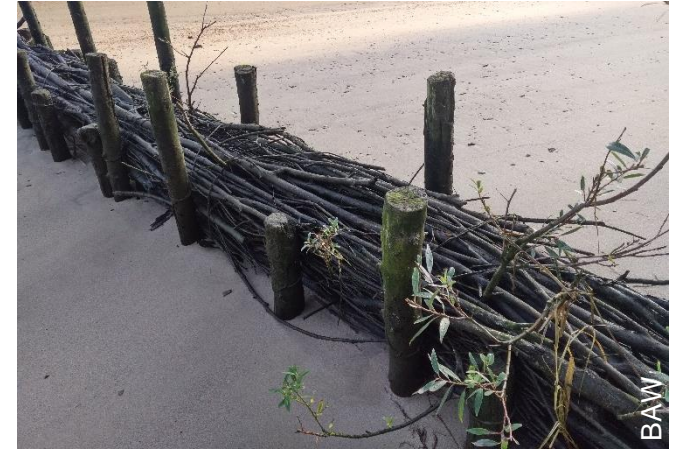
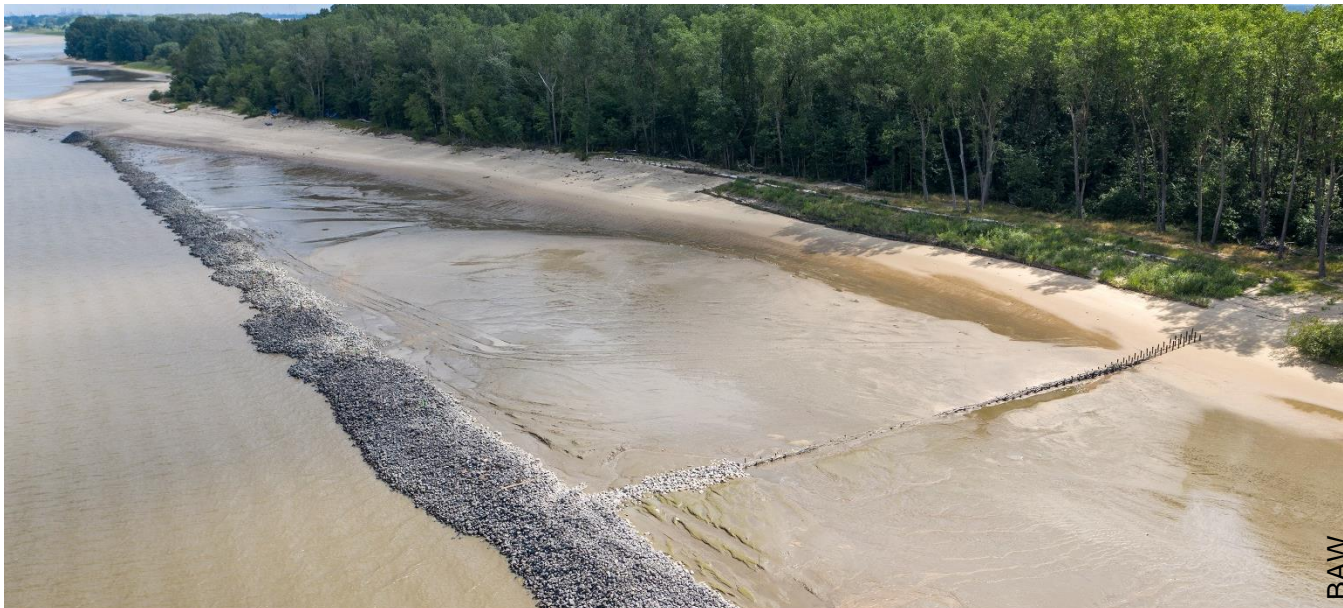
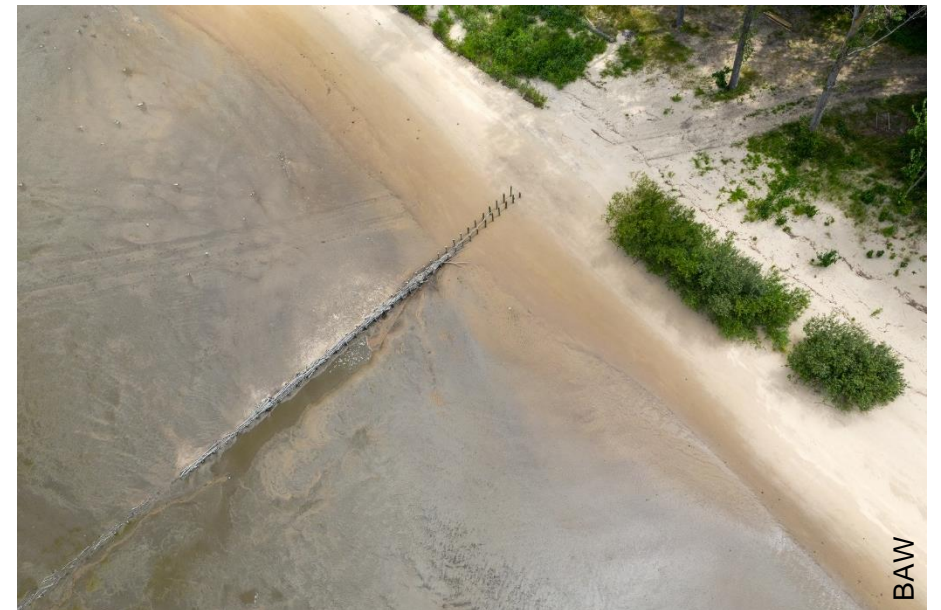
Brushwood box groynes at the Elbe Island Hanskalbsand – facing the navigation channel

- Km 642,300-642,700 left bank Elbe
- **Implementation:** ab 1995
- **Contact:** WSA Elbe-Nordsee: abz-wedel@wsv.bund.de
- **Construction design:** Groynes made out of brushwood boxes to prevent scouring and to block the flow of water behind the riprap training wall after flooding, in order to promote sedimentation.
- **Development:** The brushwood box groynes were designed to reduce the current in a tidal creek running behind the training wall and to allow sedimentation to occur. They are fulfilling this purpose. The brushwood boxes are maintained on an irregular basis, whenever materials from willow pruning and human resources for implementation are available.

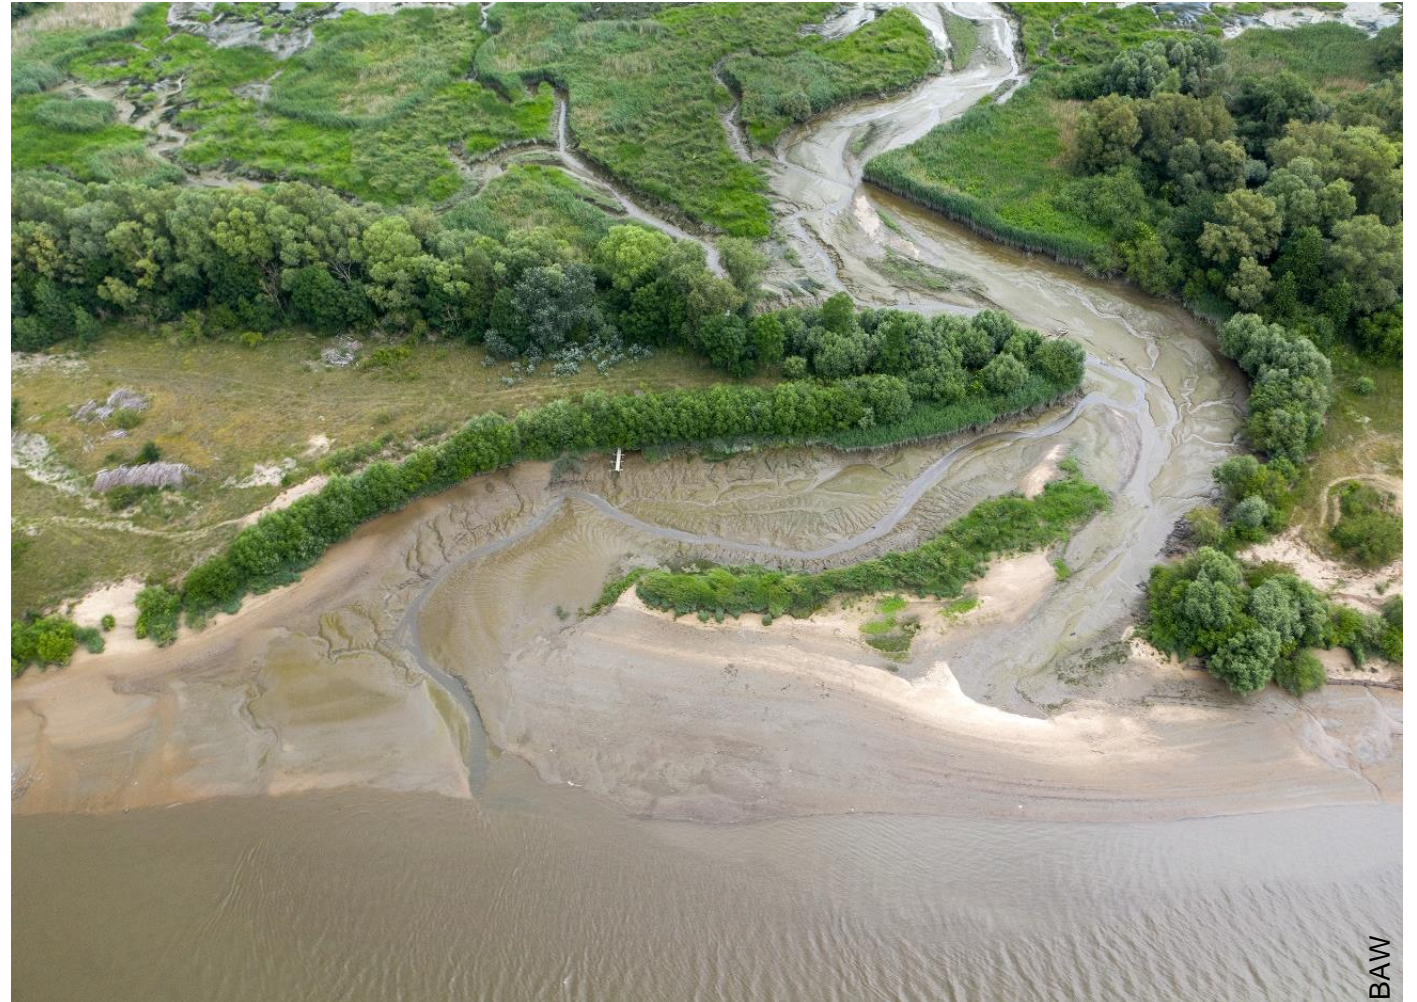
Willow mattresses for tidal creek protection on Elbe island Hanskalbsand

- **Km 6,700-7,000 right bank** Hahnöfer Nebenelbe
- **Implementation:** 2005, 2008, 2016/2017
- **Contact:** WSA Elbe-Nordsee: abz-wedel@wsv.bund.de
- **Construction design:** Pilot site in two sections with willow mattresses to protect a tidal creek and other erosive banks.

- **Development:** Long-term monitoring of the experiment in the first section showed that the willow shoots did not sprout permanently until approximately 1 m above mean high water. Based on these results, another section near the tidal channel mouth was secured in 2008. This was expanded in 2016/2017 to also secure the higher-lying bank areas with a willow mattress. The measure is fulfilling its purpose, and a robust willow stand has formed. Damage from wildlife browsing can be observed. The willow mattresses are maintained irregularly through pruning every 4-5 years and, as needed, selective replanting using cuttings. The next pruning of the willows is planned for 2026.

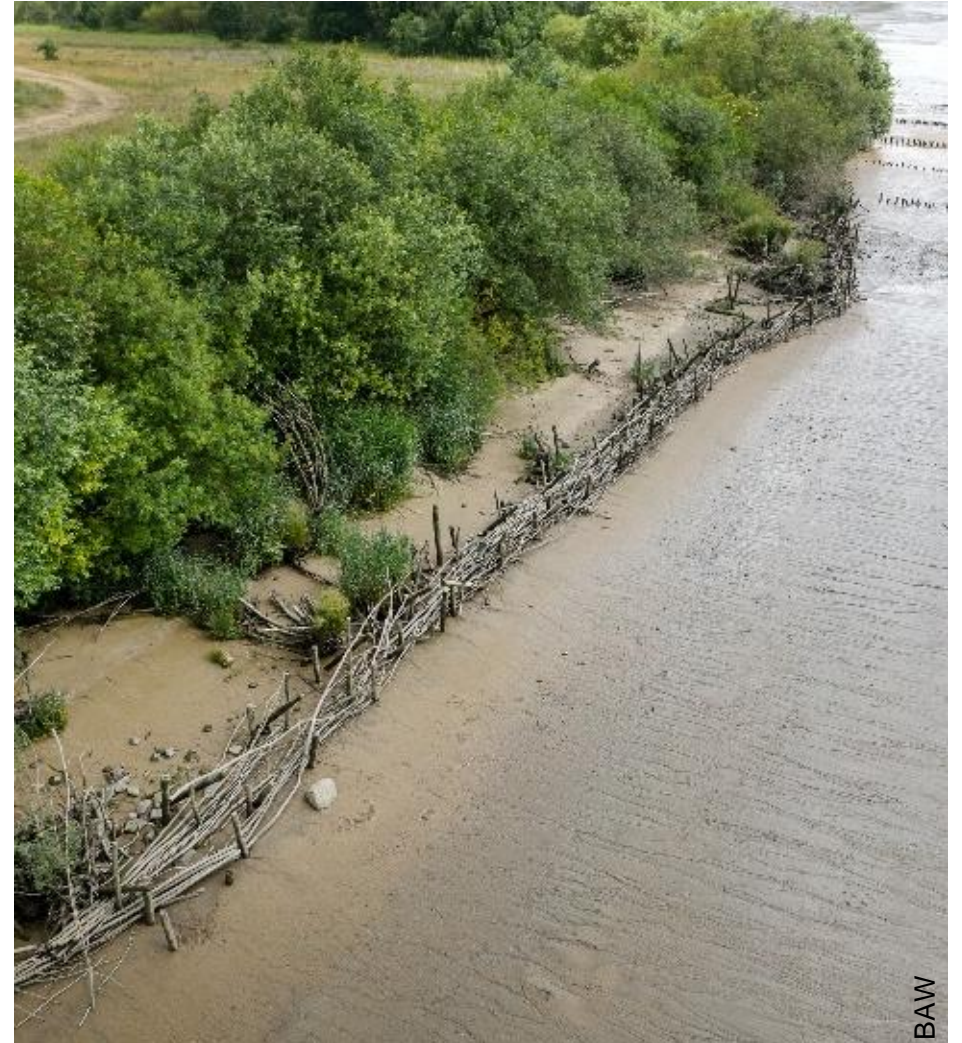
Willow mattress with fascine toe protection on Elbe island Hanskalbsand – Hahnöfer Nebenelbe

- **Km 6,700-6,900** Hahnöfer Nebenelbe
- **Implementation:** 2015/2016
- **Contact:** WSA Elbe-Nordsee: abz-wedel@wsv.bund.de
- **Construction design:** Willow mattress with a toe protection using fascine rolls and a filter of double-layered coconut fiber mats to prevent bank erosion caused by a storm surge.
- **Development:** The willow mattress has successfully taken root, and the measure is fulfilling its stabilizing purpose. Damage caused by a series of storms in 2021 was repaired by planting willow cuttings as reinforcements and renewing the toe protection. The condition has remained stable since then.

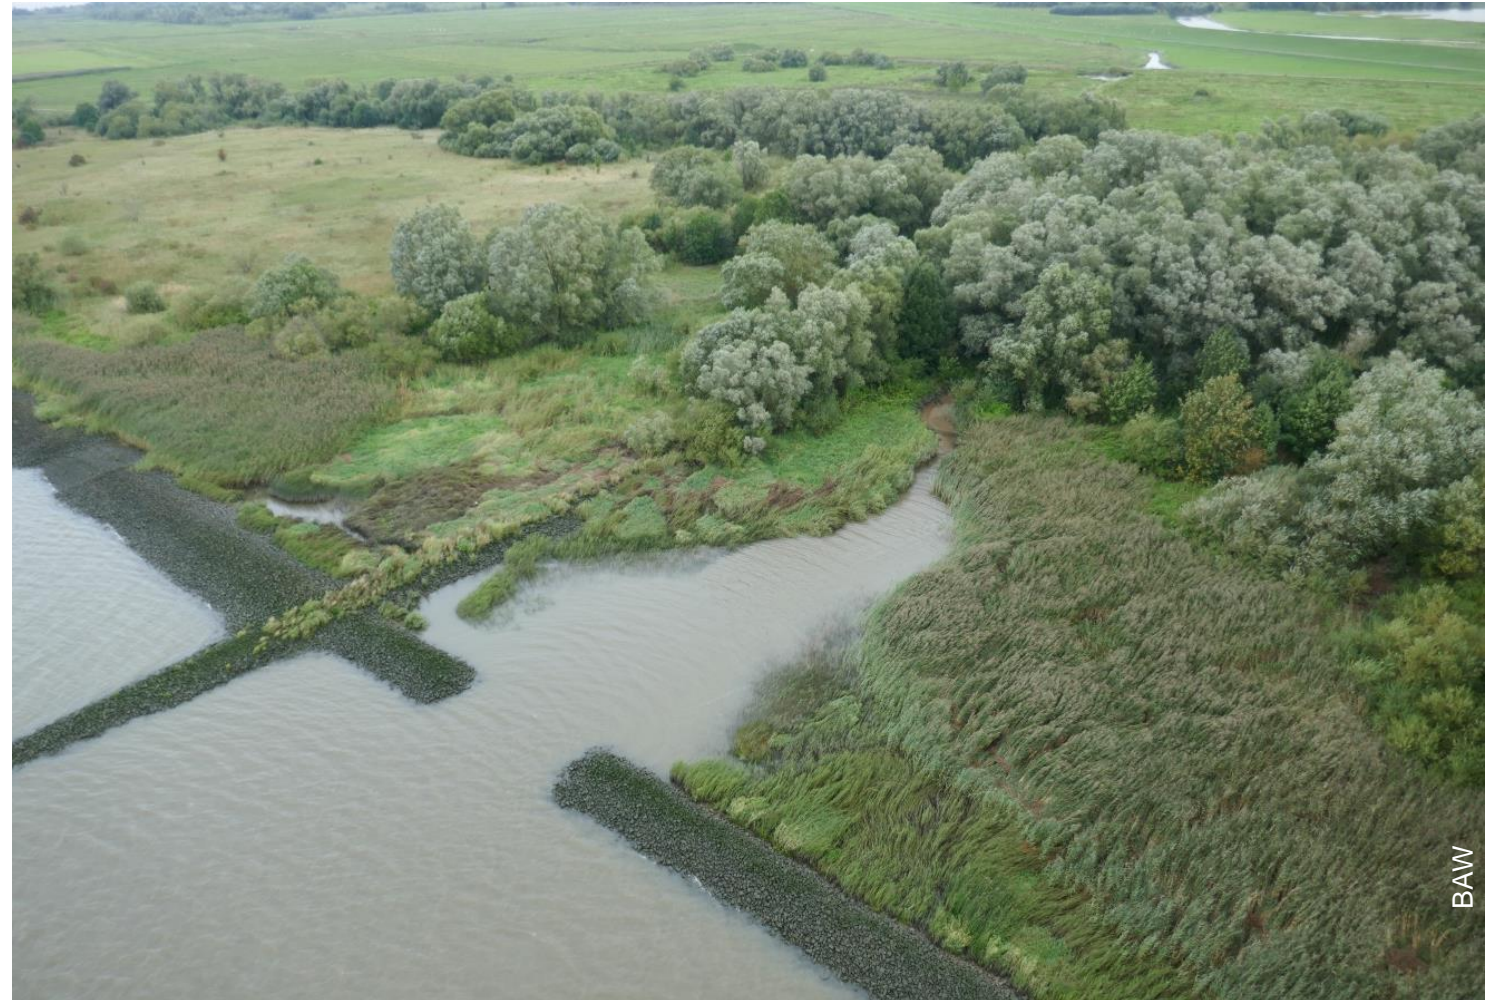
Lowering of the revetment at Juelssand

- **Km 650,600** right bank Elbe
- **Implementation:** 2004
- **Contact:** WSA Elbe-Nordsee: abzwedel@wsv.bund.de
- **Construction design:** Lowering of the revetment in one section to improve conditions for the development of estuary-typical bank dynamics, and the establishment of natural vegetation zones in the transition zone between land and water.
Development: The area has developed positively. Behind it now lies a tidal creek with a near-natural bank featuring sandy mudflats, reeds, and tall grasses.

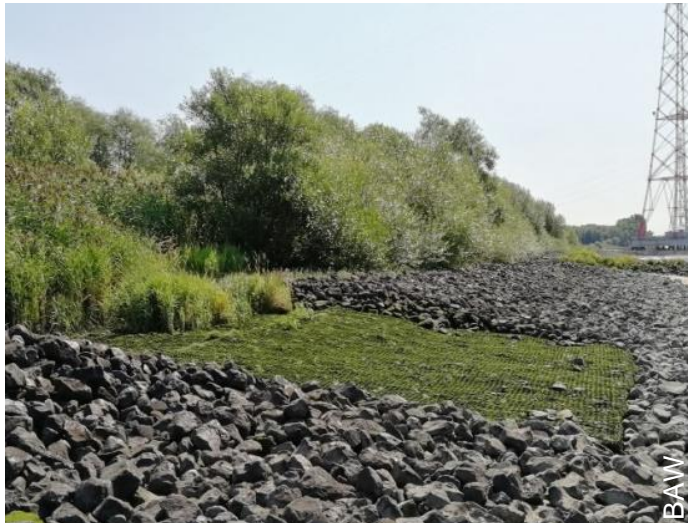
- **Km 650,600-651,200** right bank Elbe
- **Implementation:** 6 weeks in 2012
- **Contact:** WSA Elbe-Nordsee: abz-wedel@wsv.bund.de, Stiftung Lebensraum Elbe, Integrierte Station Unterelbe
- **Construction design:** Five 10 m wide sections of revetment (total length approx. 600 m) were each lowered by 60-80 cm to allow water to flow over the revetment and into the hinterland area (500 tons of riprap moved). The base and sides of the lowered area were secured with gabion mattresses.
- **Development:** Vegetation has spread within the lowered areas. The wire mesh of the gabion mattresses is partially disintegrating. However, the structure still appears to be stable.

Beginning break down of the wire mesh (01/2026).

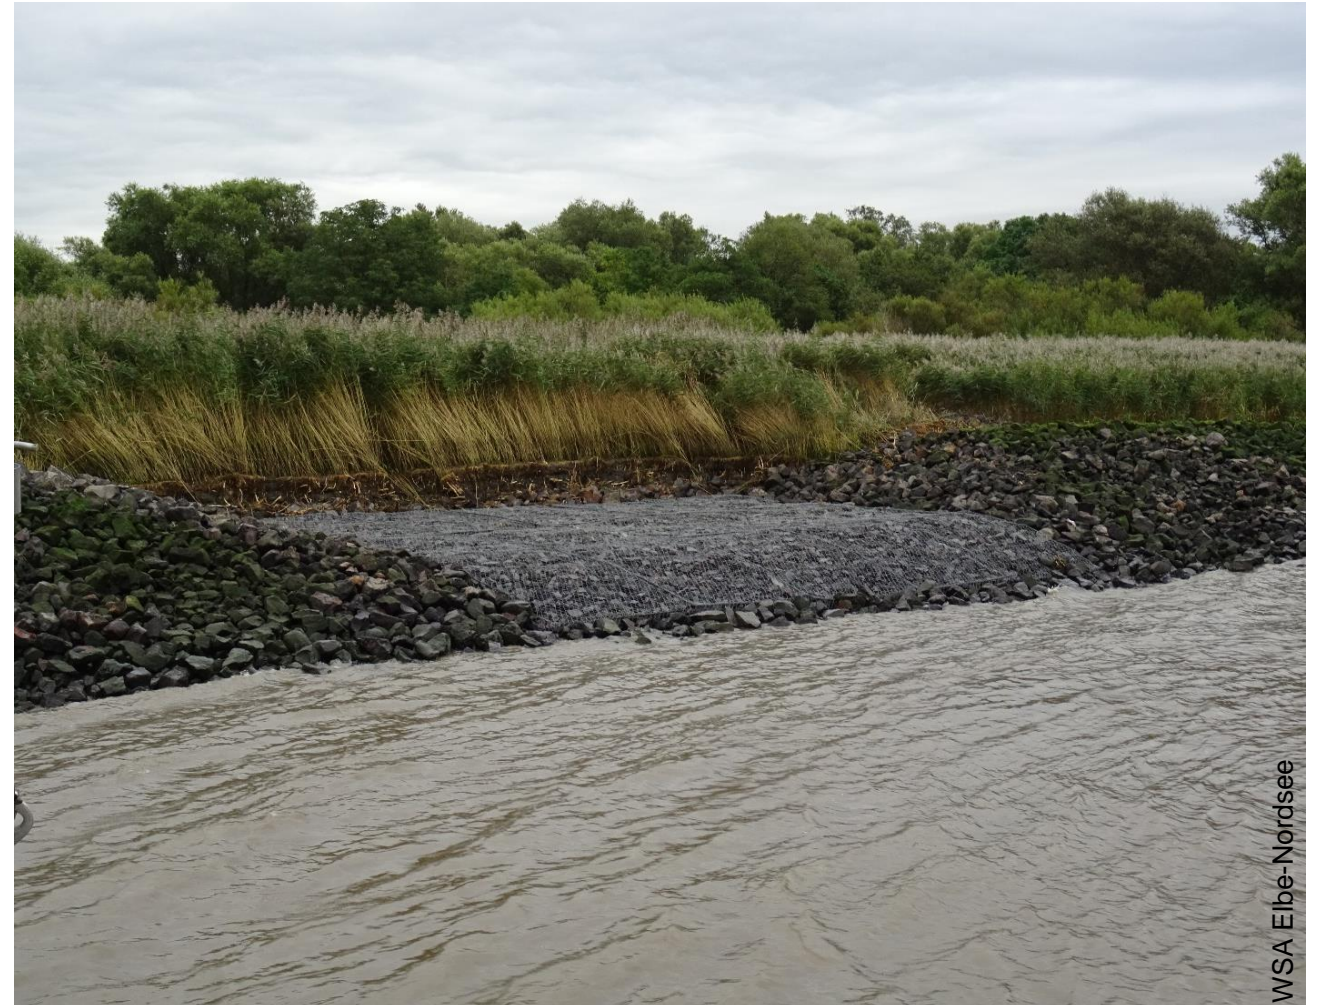
Lowering of the revetment at Rhinplate

- **Km 670,000 – 675,000** left bank Elbe
- **Implementation:** September 2015
- **Contact:** WSA Elbe-Nordsee: abz-wedel@wsv.bund.de, Stiftung Lebensraum Elbe
- **Bauweise:** Removal of the riprap and lowering of the revetment by approx. 60-80 cm at five 10 m wide sections. The lowered areas are secured using gabion mattresses. **Development:** The wire mesh of the gabion mattresses is slowly disintegrating, but the revetment remains stable overall, and various tidal creek structures are forming within the reeds behind it. An increase in structural diversity has also been observed.

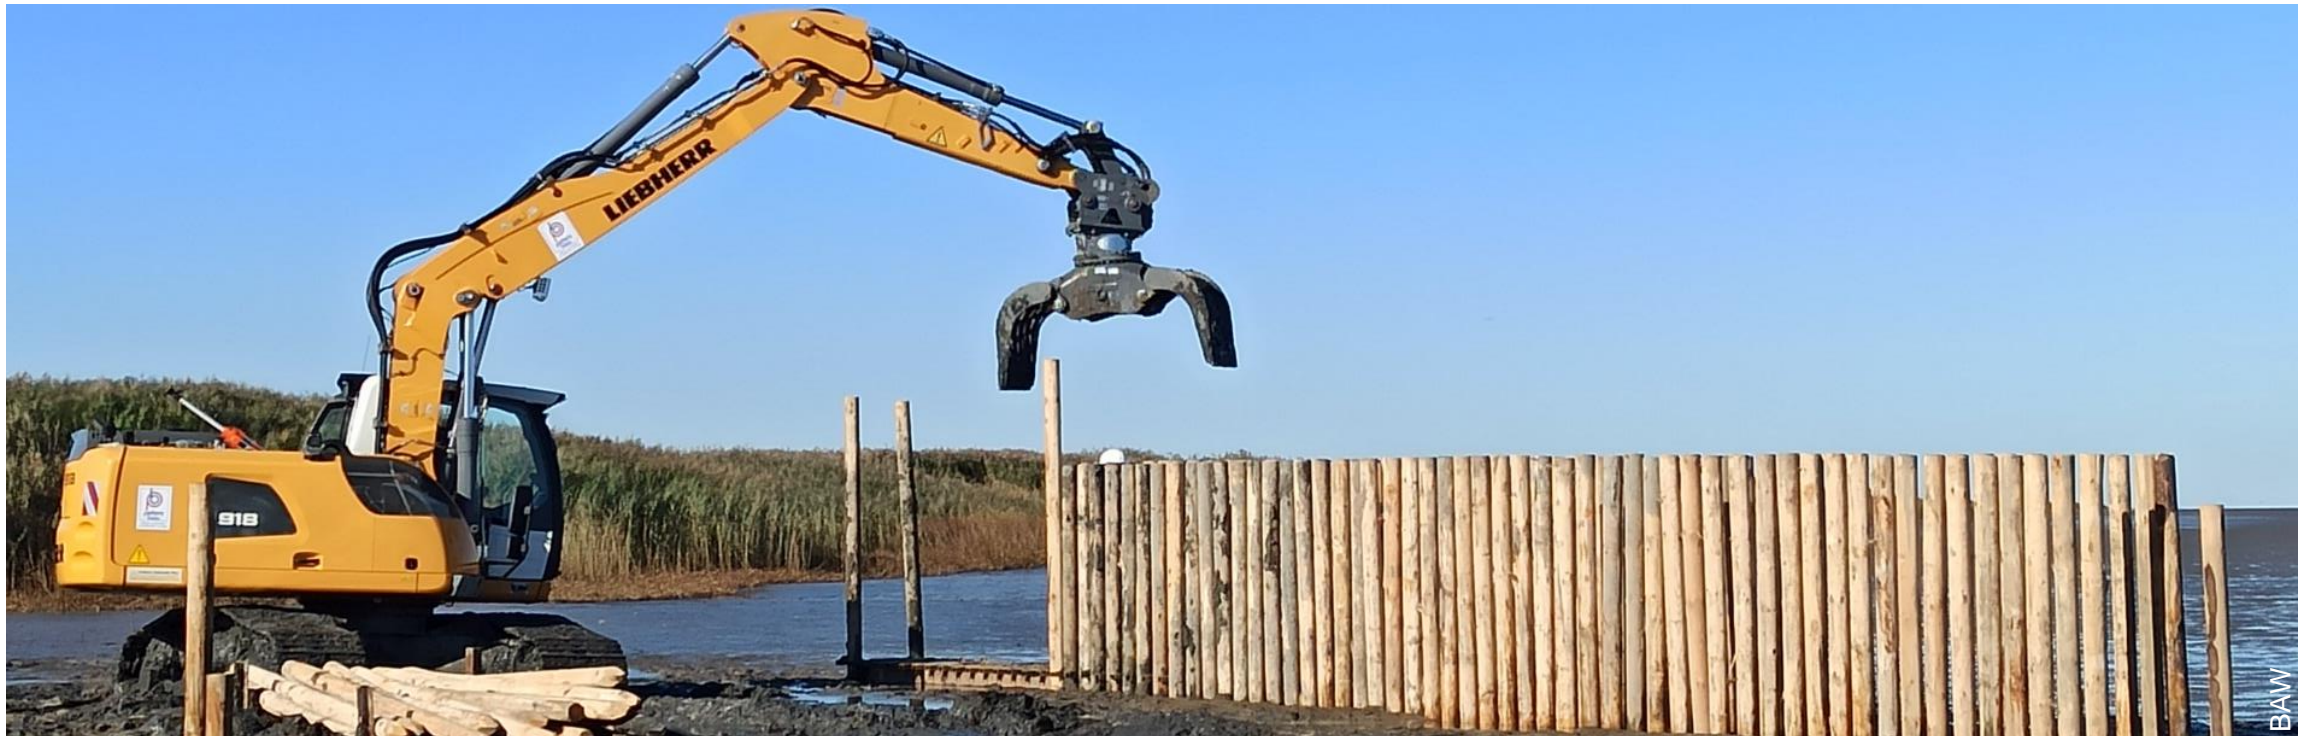
Indirect bank protection at Nordkehdingen

- **Km 686,300-687,500** left bank Elbe
- **Implementation:** September 2025; June-October 2026
- **Contact:** WSA Elbe-Nordsee: christoph.gerulat@wsv.bund.de
- **Construction design:** Double rows of piles filled with gabions serve as an indirect bank protection structure located off-bank to prevent further erosion and the associated threat to the dike. The structure features a 10-meter-wide opening every 30 meters, which is secured with lower brushwood boxes.
Development: The measure will be completed in the summer of 2026, so no statements regarding its development can be made to date.

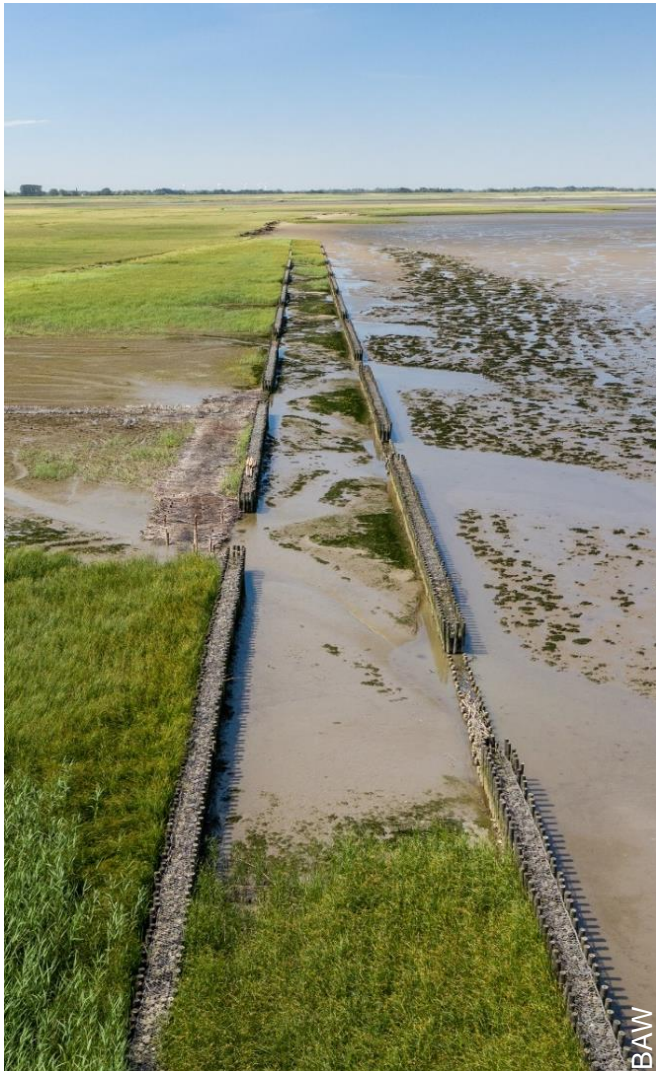
Indirect bank protection at the Hullen

- **Km 703,150-703,770** left bank Elbe
- **Implementation:** 2003, partially in 2014, last maintained in 2025
- **Contact:** WSA Elbe-Nordsee: abz-cuxhaven@wsv.bund.de

- **Construction design:** Double rows of piles filled with gabions serve as an indirect bank protection structure located off-bank to prevent further erosion and the associated threat to the dike. The structure features a 10-meter-wide opening every 30 meters, which is secured with lower brushwood boxes. The shoreline protection is being carried out in accordance with the maintenance contract, and the structure has been partially taken over by the State of Lower Saxony.

- **Development:** The structure serves its purpose. The area has silted up and vegetation has taken root. As needed, the outlet areas are raised with fascines, missing stakes are replaced, and stones are replenished. Due to high water and wave action, damage and land loss occurred at the former erosion edge during the winter of 2019/2020. To counteract this, the erosion edge was secured with a brushwood mattress. Work began in 2020 and was completed in 2021.

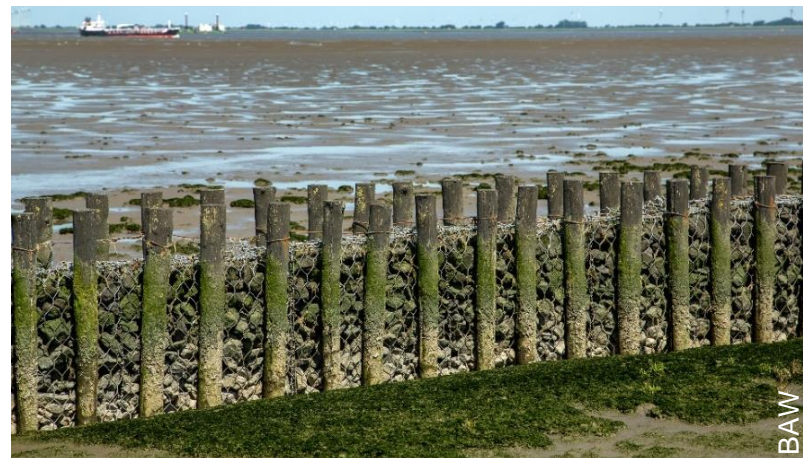
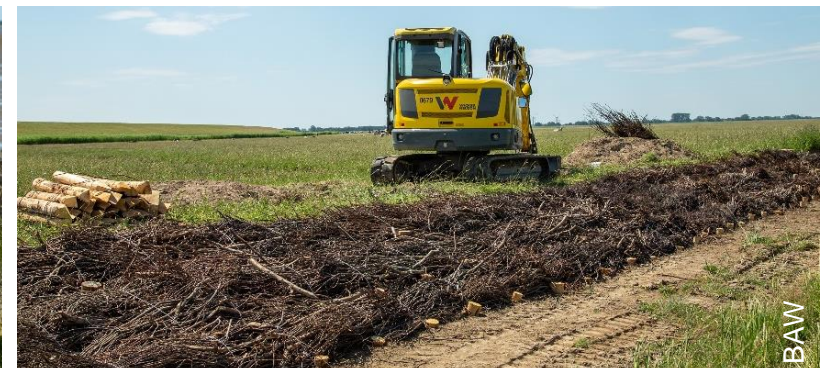
Protection of the erosion edge with a brushwood mattress in 2020.

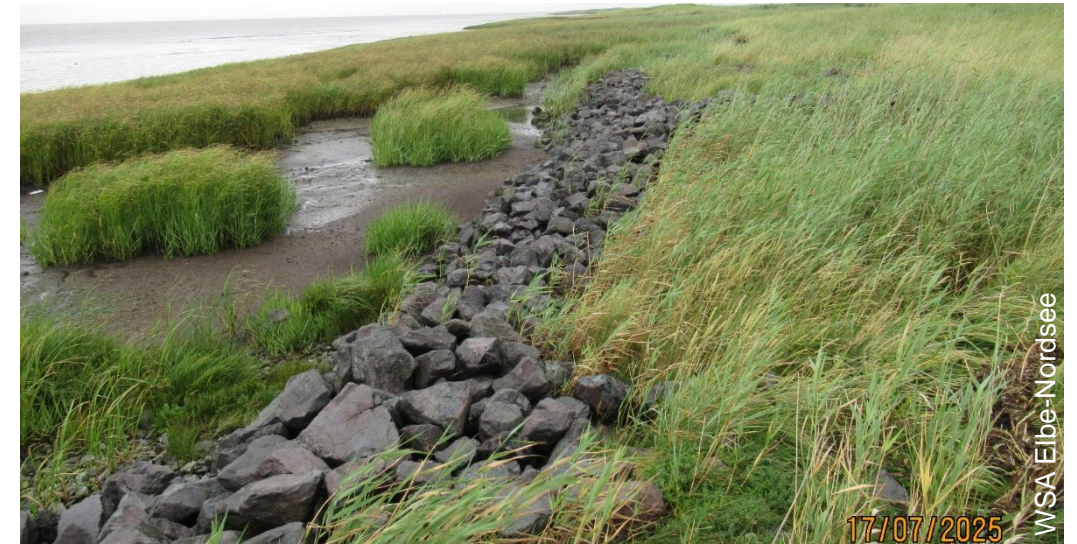
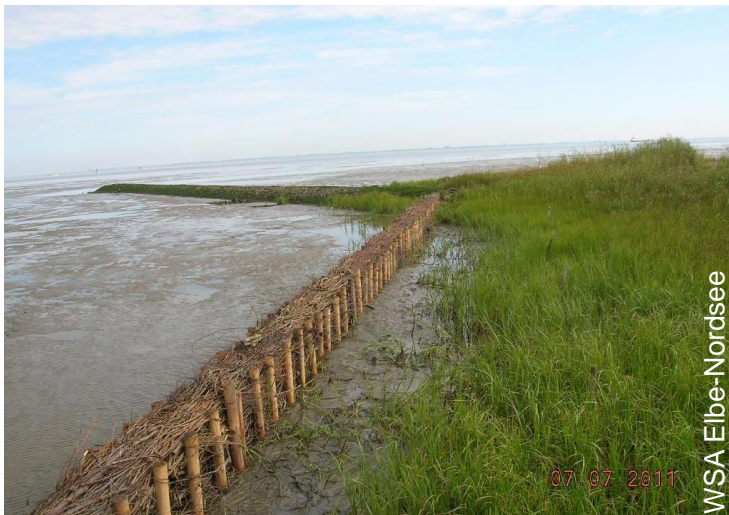
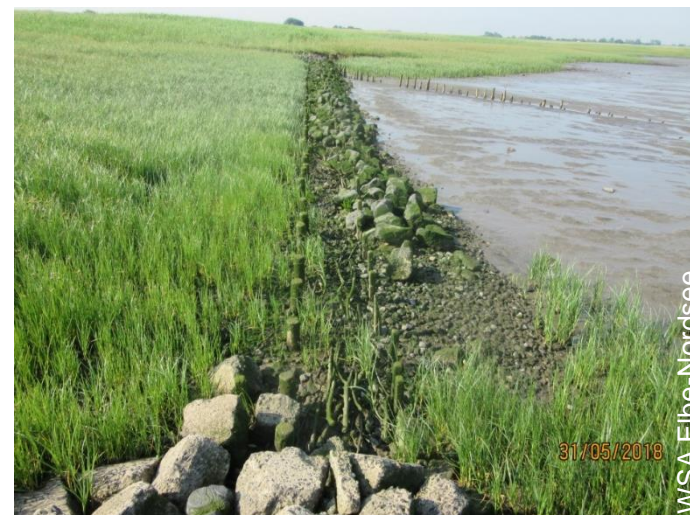
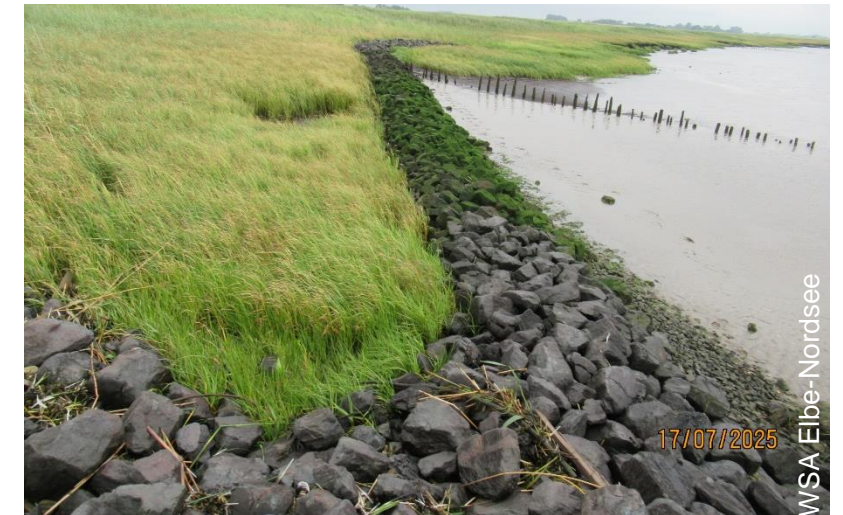
Rearward groyne protection Otterndorfer Stack

- Km 709,780-709,800 left bank Elbe
- **Implementation:** February 2011, August 2018, last maintained in 2023
- **Contact:** WSA Elbe-Nordsee: abz-cuxhaven@wsv.bund.de
- **Construction design:** Protection of the groyne foot using brushwood boxes covered by riprap
- **Development:** The brushwood boxes required a high degree of maintenance. During the repair of the groyne, they were therefore first reinforced with a layer of riprap and eventually completely covered with riprap. The measure serves its purpose, and maintenance work now consists of patching the riprap. The next repair is scheduled for 2026.

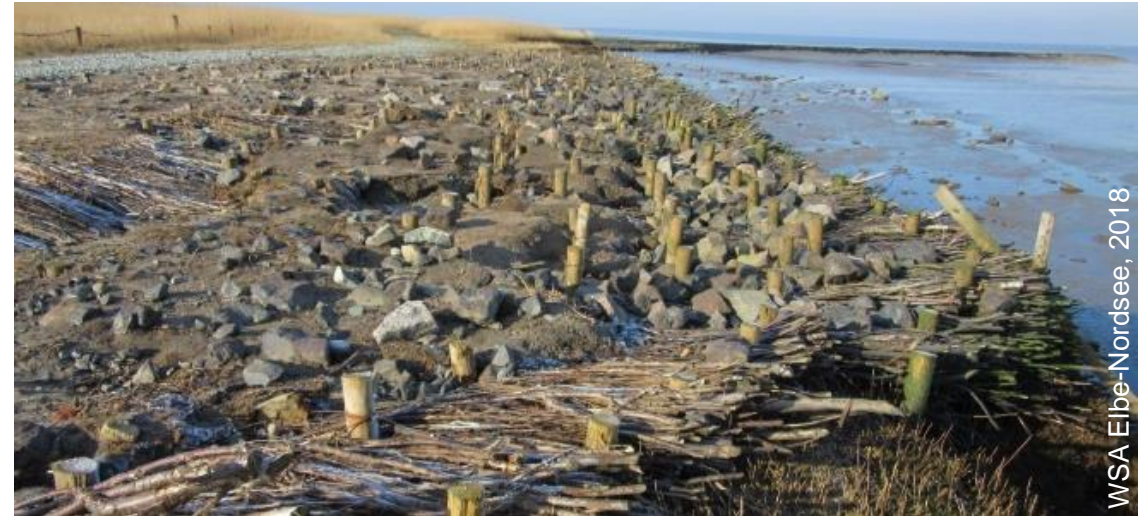
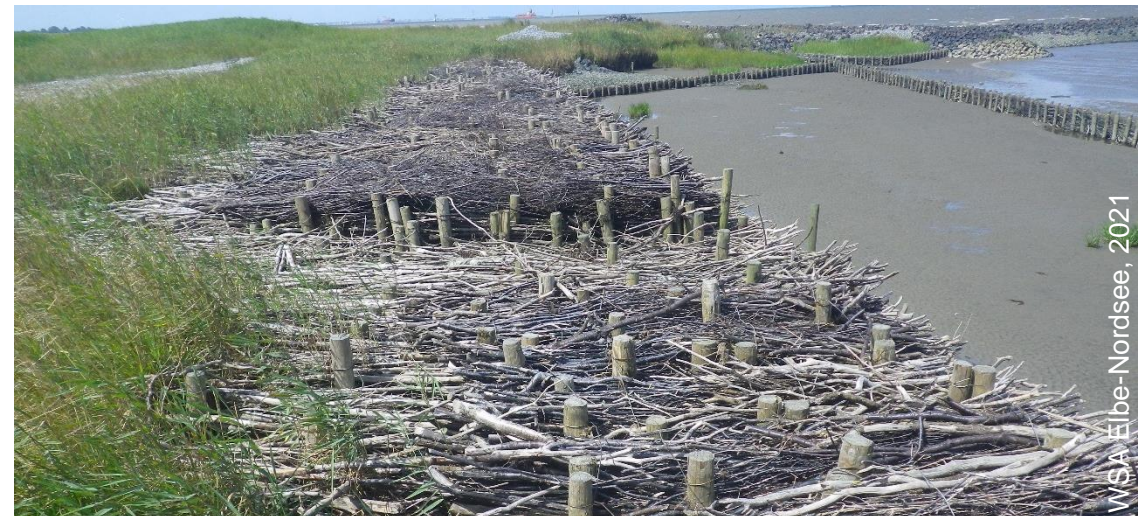
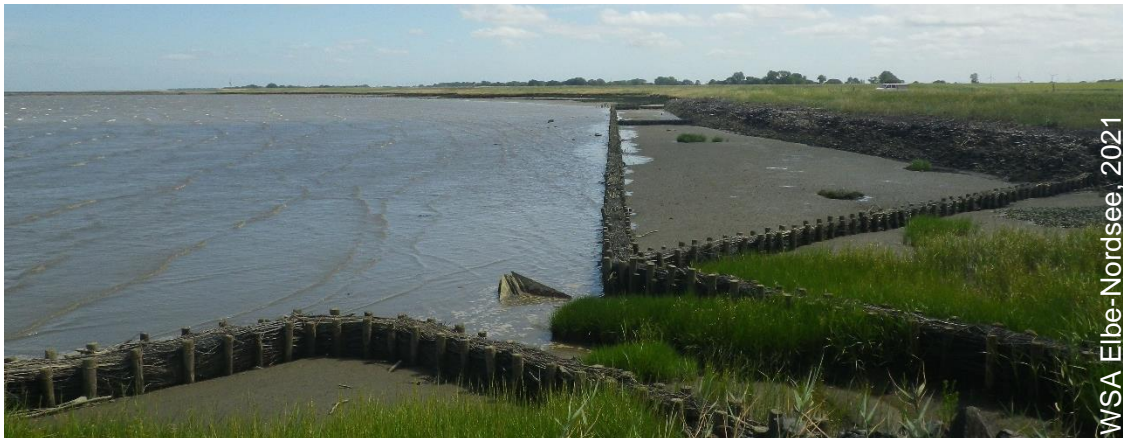
Groyne protection Medem Stack 3

- **Km 712,460-712,580** left bank Elbe
- **Implementation:** spring 2017, last maintained in 2025
- **Contact:** WSA Elbe-Nordsee: abz-cuxhaven@wsv.bund.de
- **Construction design:** Protection of the groyne foot with brushwood boxes and brushwood mattress
- **Development:** During the first construction phase, vegetated coir logs were used on a trial basis. The trial was unsuccessful, as no vegetation took root and 75% of the filling was lost. The brushwood mattress and the brushwood boxes have been continuously maintained and are functioning properly. In the area of the groyne foot, initial siltation and vegetation growth can be observed. The next maintenance is scheduled for 2026.

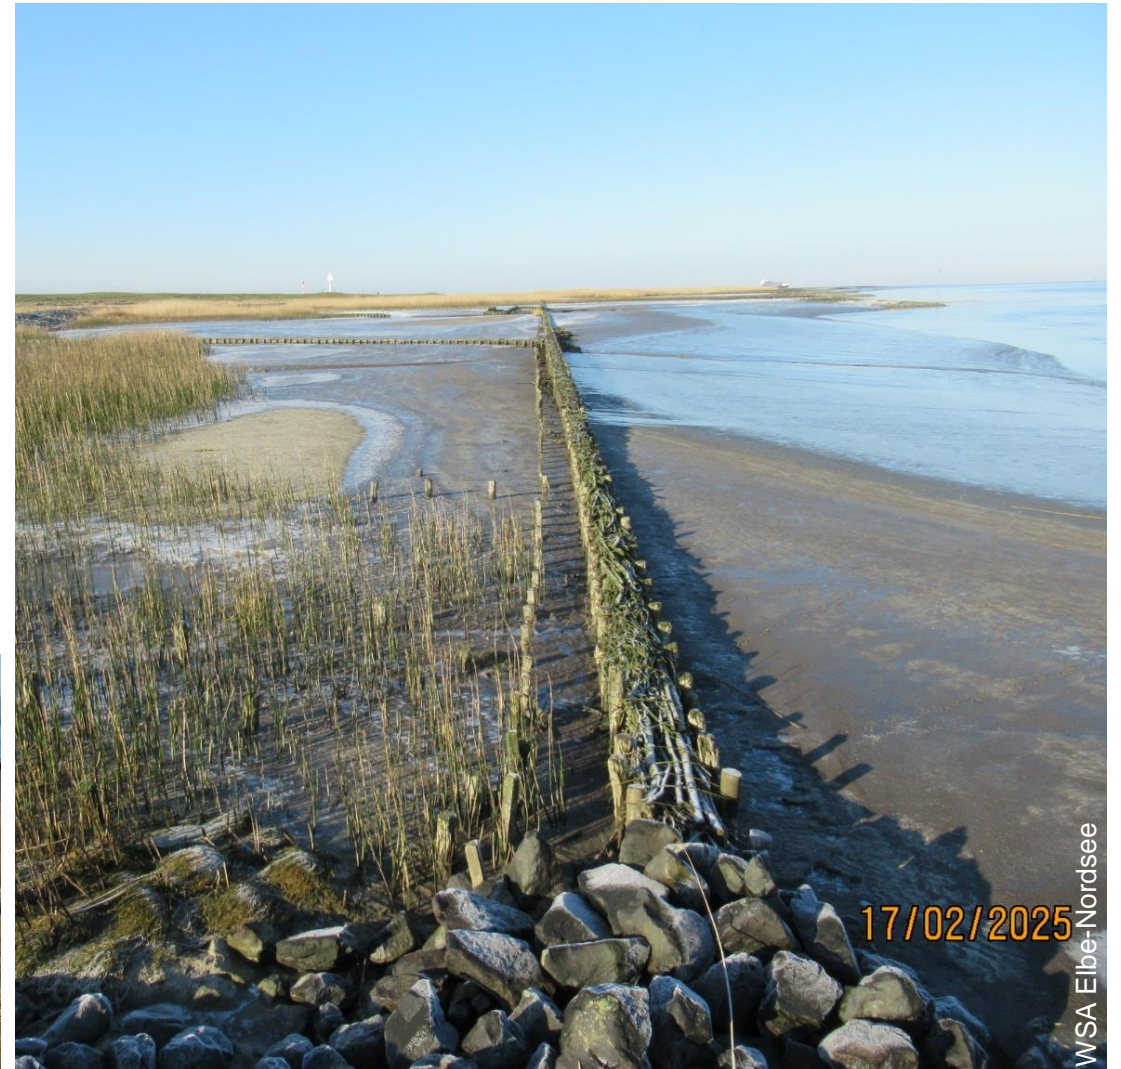
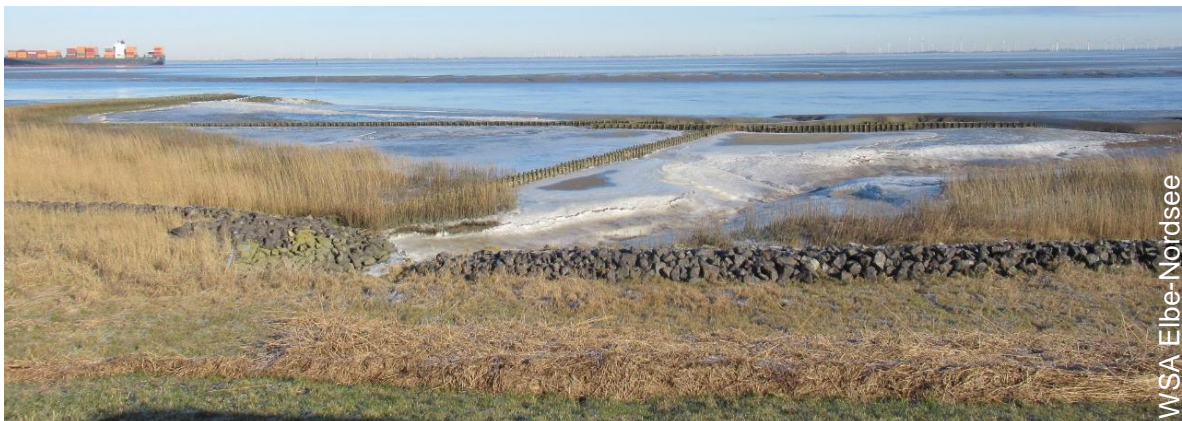
Brushwood boxes within groyne field of “Belumer“ groynes 9 and 11

- Km 73,140-73,375 left bank Oste
- **Implementation:** September 2011, annual maintenance (last maintenance in 2025)
- **Contact:** WSA Elbe-Nordsee: abz-cuxhaven@wsv.bund.de
- **Construction design:** Brushwood boxes for bank protection within groyne field of groyne 9 and 11
- **Development:** Initially, missing fascines in some sections were temporarily replaced with coir logs due to a shortage of fascine material. However, the coir logs had such a short lifespan that their use did not prove effective. The structure is developing positively and is inspected annually; repairs are carried out as needed (in some cases annually) by replenishing fascine material that has been lost due to storm surges and ice drift. Increasing siltation and vegetation growth are being observed.

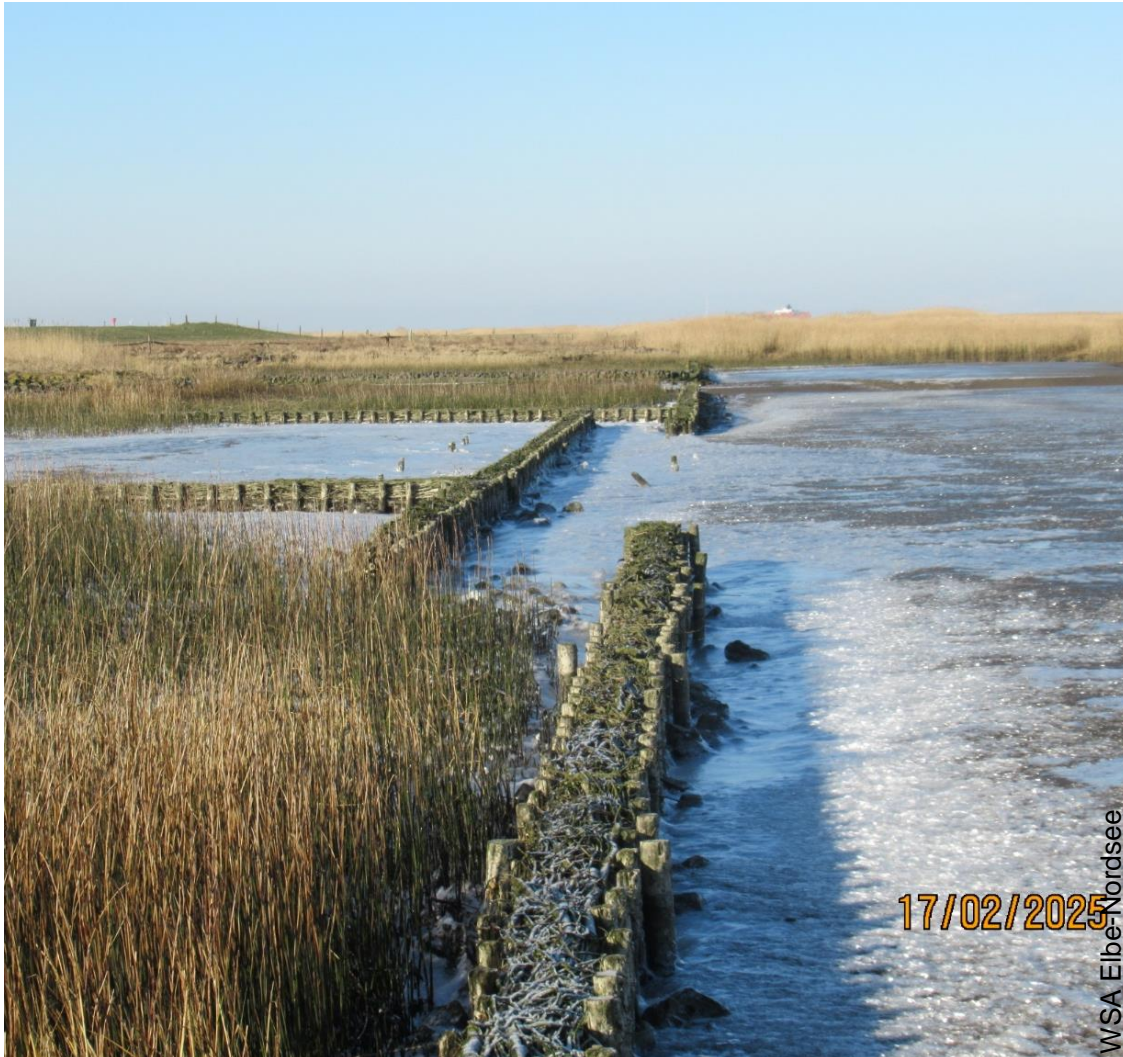
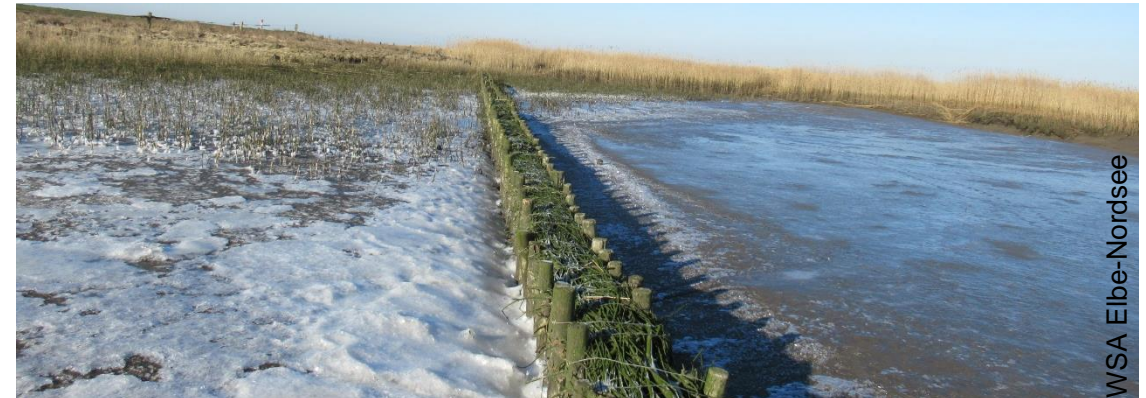
Brushwood boxes within groyne field of “Belumer“ groynes 7 and 9

- **Km 73,375-73,610** left bank Oste
- **Implementation:** Juni 2013 (continuously maintained), last maintenance in 2025
- **Contact:** WSA Elbe-Nordsee: abz-cuxhaven@wsv.bund.de
- **Construction design:** Brushwood boxes for bank protection within groyne field of groyne 7 und 9
- **Development:** Initially, missing fascines in some sections were temporarily replaced with coir logs due to a shortage of fascine material. However, the coir logs had such a short lifespan that their use did not prove effective. The structure is developing positively and is inspected annually; repairs are carried out as needed (in some cases annually) by replenishing fascine material that has been lost due to storm surges and ice drift. Increasing siltation and vegetation growth are being observed.
