Federal Waterways Engineering and Research Institute & Federal Institute of Hydrology

Nature-based solutions for bank protection in estuarine waterways

Collection of measures in tidal areas

30.04.2026
Version: 4

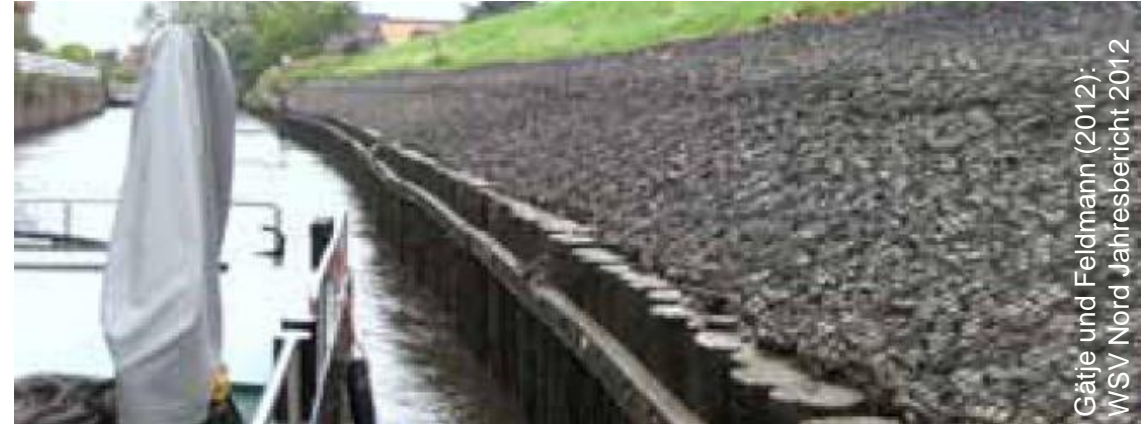
- **Construction design:** In the winter of 2010-2011, severe longitudinal cracks in the dyke and subsidences along the dyke toe were discovered. As a response, a combined technical-biological bank protection scheme was put in place: The steep embankment with a slope of 1:2 was protected with gabion mattresses. A strip of 1 m in width situated above the gabion mattress is also exposed to hydrodynamic loads in times of flooding. Therefore, it was covered with pre-grown, natural fibre based grass mattresses reinforced with an additional armouring (“composite”). In some sections pile walls (pine wood) were installed as a toe protection.

Implemented measure with pile wall toe protection in 2012

- **Development:** The measure is serving its purpose. No maintenance work has been necessary so far, and none is planned, as the measure is estimated to last for approximately 30 years. The use of grass mattresses requires a certain degree of predictability of the construction schedule since delays entail major maintenance efforts in terms of rolling out and irrigating the mats.

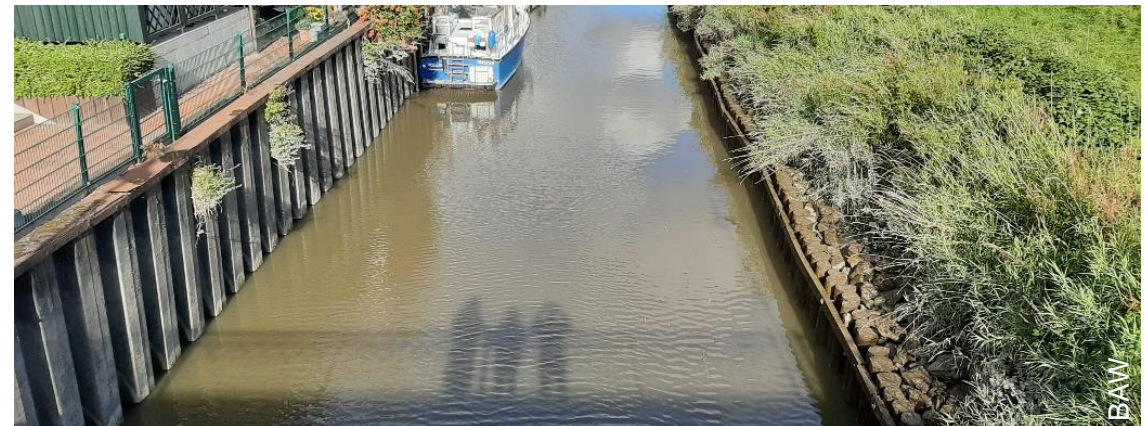
Measure in October 2020

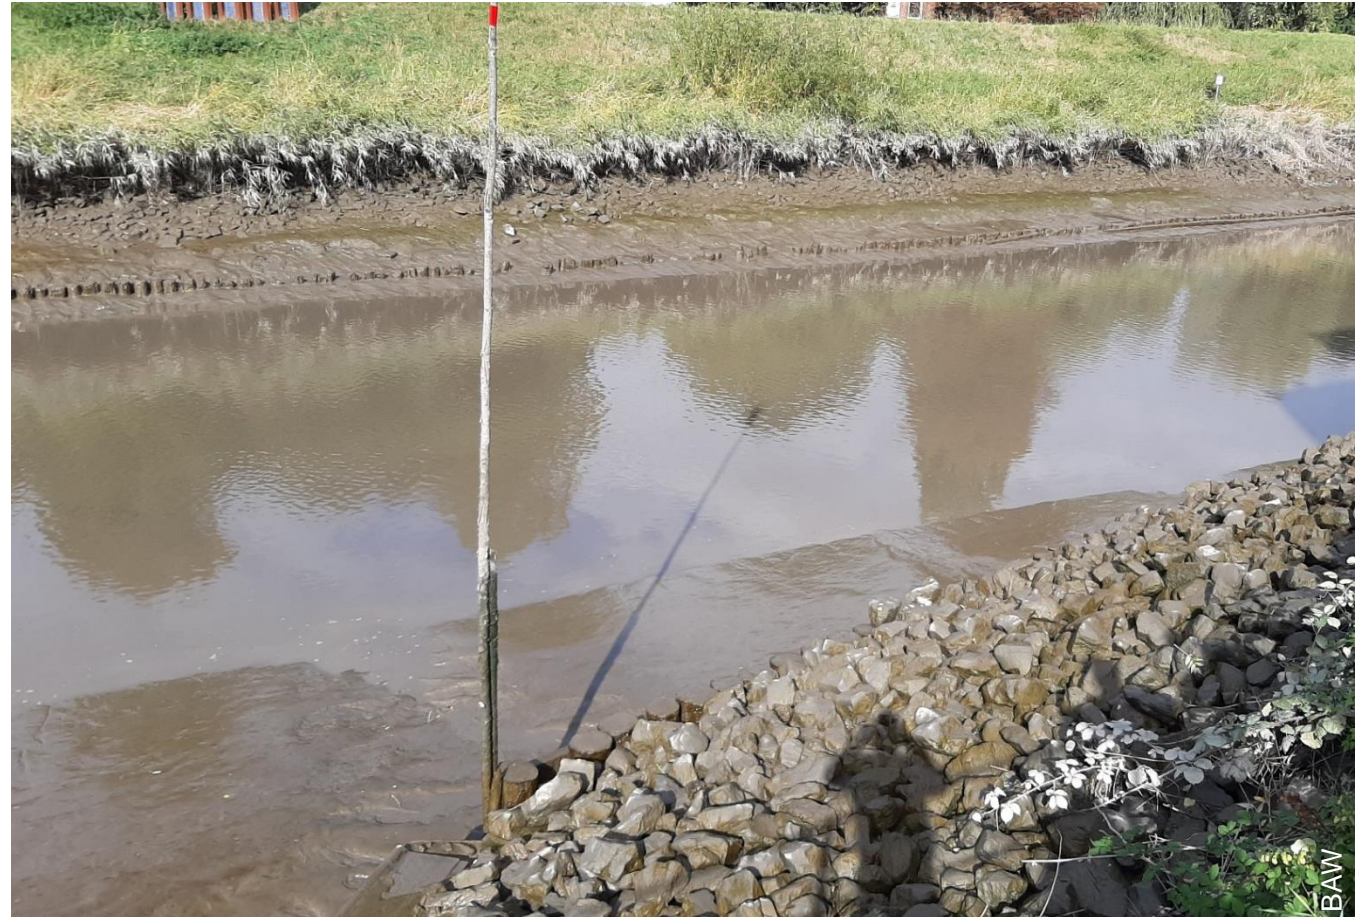
October 2020

- **Km 0,470-0,560** right bank Schwinge
- **Implementation:** 25 days in 2015, last maintenance approx. in 2018
- **Contact:** WSA Elbe-Nordsee: abz-stade@wsv.bund.de
- **Construction design:** Toe protection consisting of a pile wall made of driven spruce piles plus riprap revetment with natural vegetation to prevent bank erosion due to ship-induced loads
- **Development:** After approximately 3 years, repair work was needed on certain sections of the riprap. The measure is fulfilling its purpose, and no further maintenance work is planned, as its lifespan is estimated to be approximately 30 years.

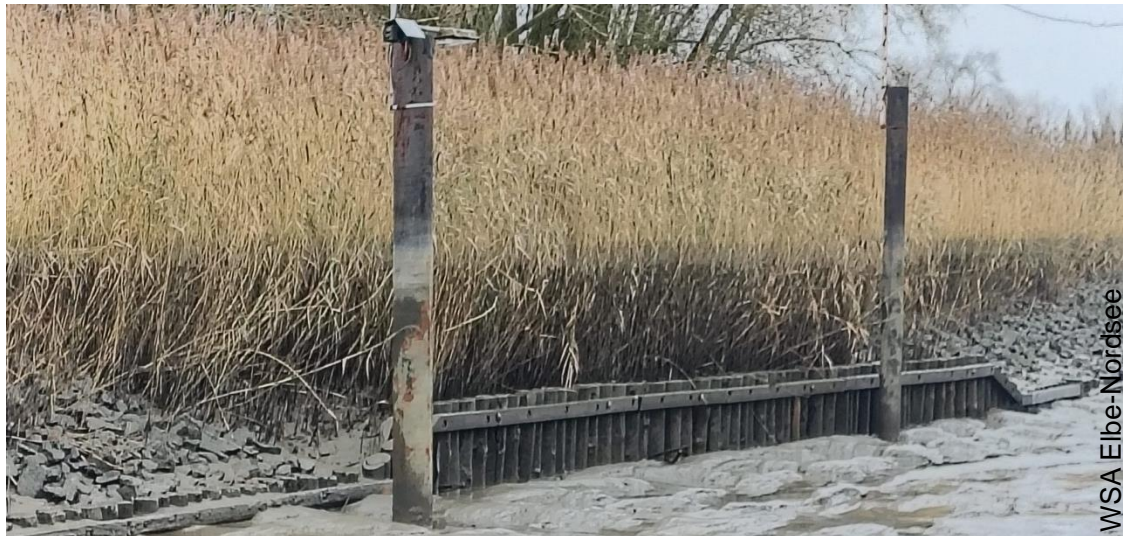
November 2025

- **Km 2,350-2,380** left bank Bützflether Süderelbe
- **Implementation:** 25 days in 2019
- **Contact:** WSA Elbe-Nordsee: abz-stade@wsv.bund.de
- **Construction design:** Toe protection consisting of a pile wall made of driven spruce piles with a soil backfill and reed cover to prevent bank erosion due to ship-induced loads
- **Development:** The bank is stable and overgrown with reeds. No repairs have been necessary so far, and none are planned for the future.

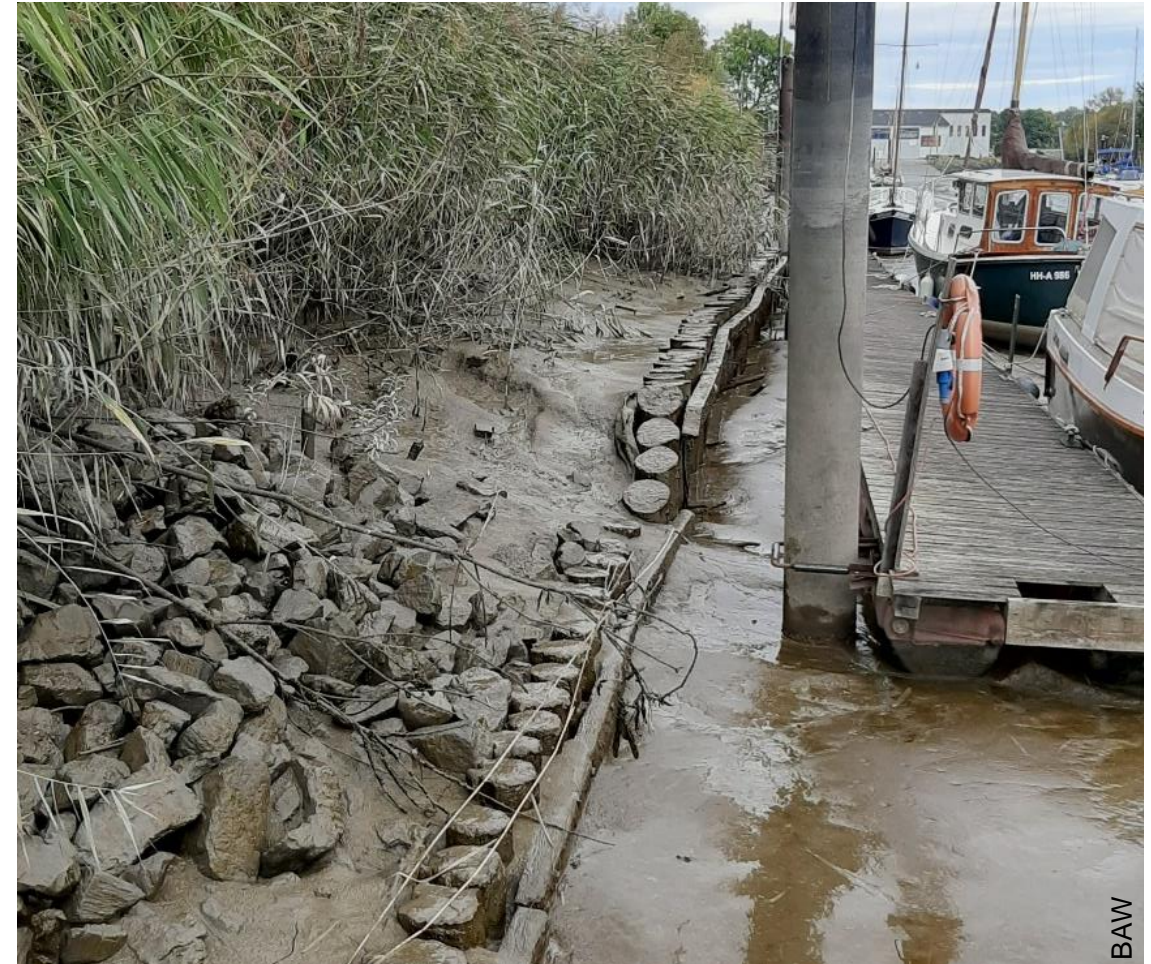
Measure in October 2020

- **Km 2,410-2,550** right bank Bützflether Süderelbe
- **Implementation:** 100 days in 2016
- **Contact:** WSA Elbe-Nordsee: abz-stade@wsv.bund.de
- **Construction design:** Toe protection consisting of a pile wall made of driven spruce piles with gabion mattresses to prevent bank erosion due to ship-induced loads
- **Development:** The measure is serving its purpose, and no maintenance has been required so far. The measure is expected to last approximately 30 years.

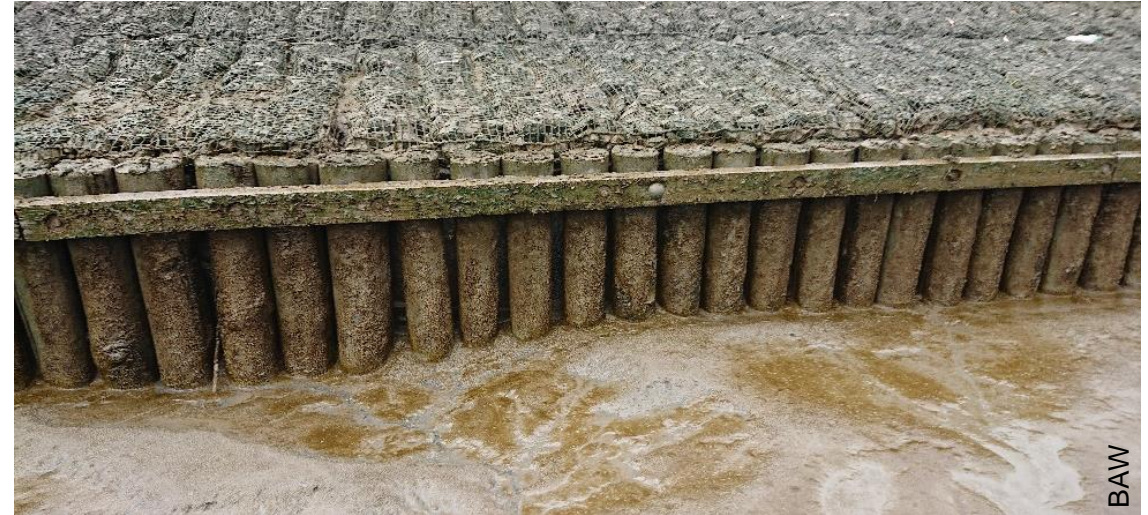
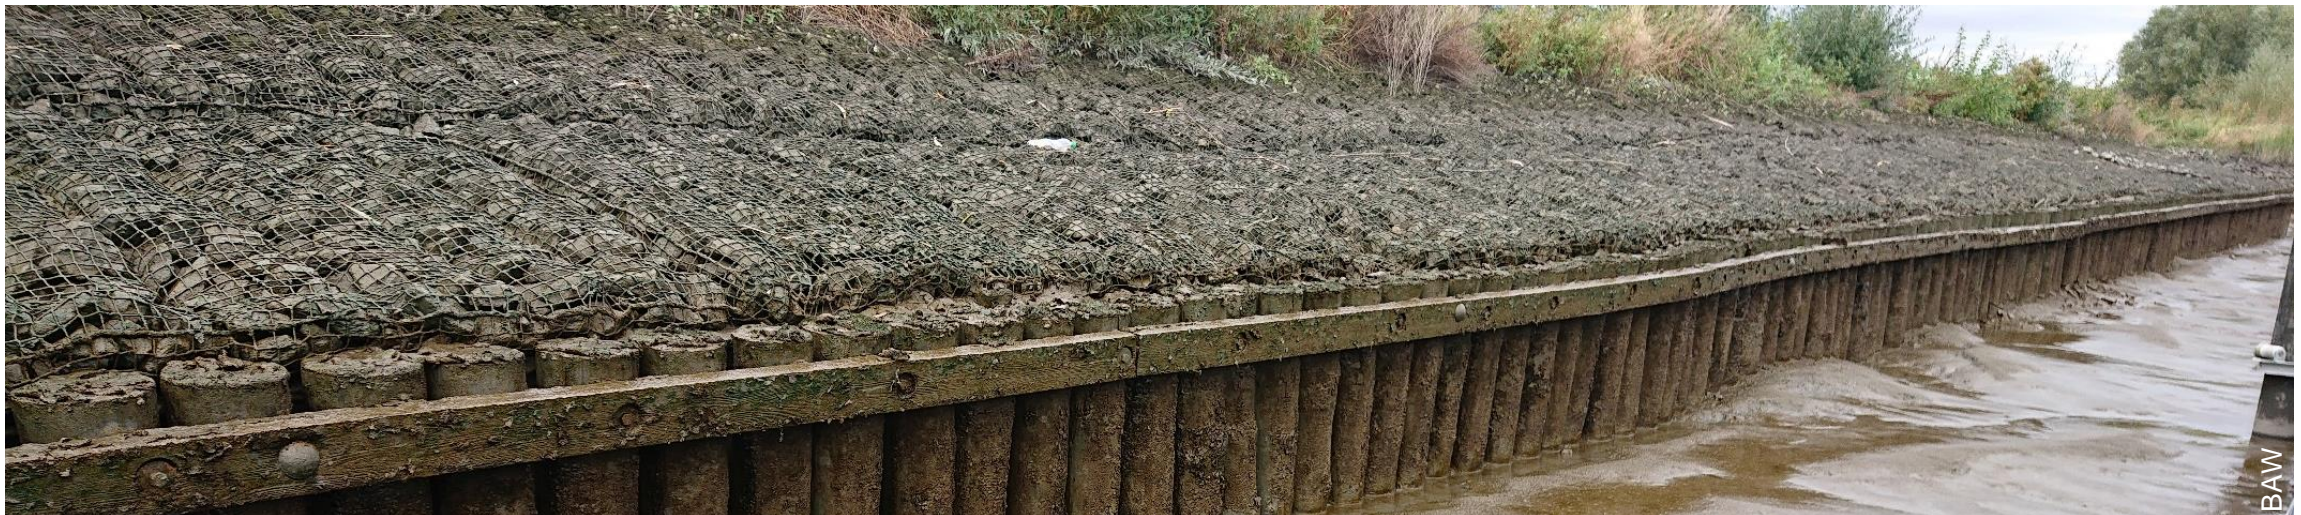
Pile wall at the Este

- **Km 7,030-7,090** right bank Este
- **Implementation:** 15 days in 2019
- **Contact:** WSA Elbe-Nordsee: abz-stade@wsv.bund.de
- **Construction design:** Pile wall made of horizontal round timber piles with a soil backfill and natural vegetation to prevent bank erosion due to ship-induced loads.
- **Development:** The section is stable, and the measure is serving its purpose. No repairs have been necessary so far, and none are planned for the future.

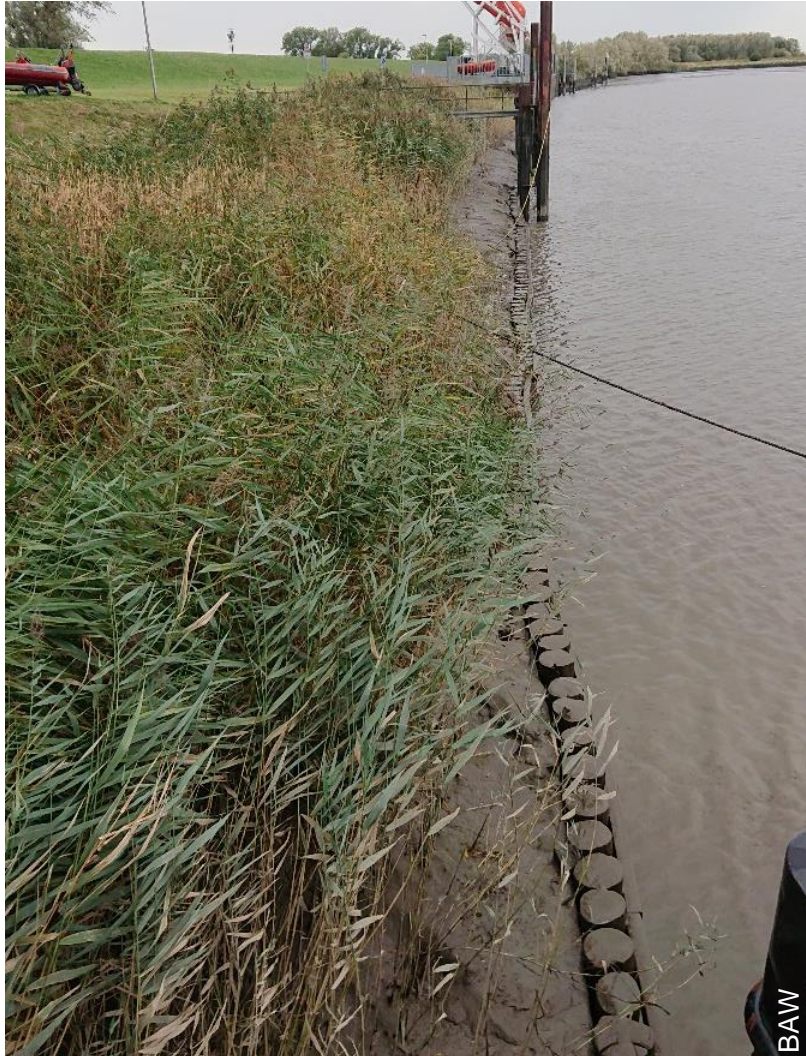
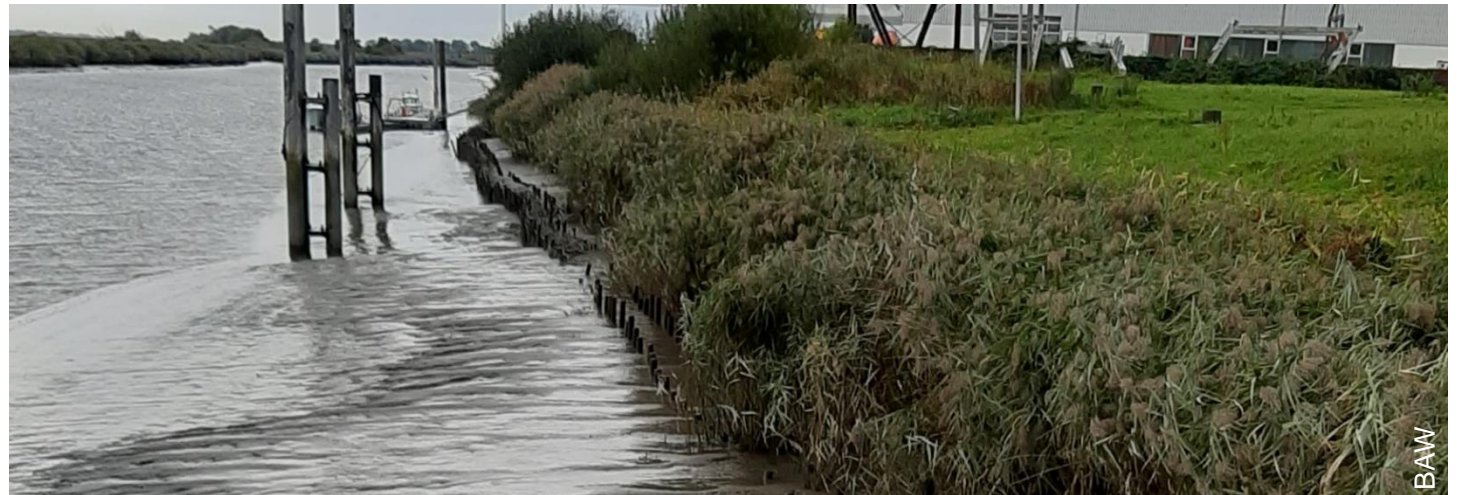
Bank protection at the Ruthenstrom

- **Km 5,220-5,350** left bank Ruthenstrom
- **Implementation:** 15 days in 2017, last maintained in 2024
- **Contact:** WSA Elbe-Nordsee: abz-stade@wsv.bund.de
- **Construction design:** Brushwood box with willow fascines to protect bank erosion due to ship-induced loads
- **Development:** The measure serves its purpose. Maintenance work involving the replacement of fascine material is necessary approximately every two years, or more frequently depending on the impact of wave action and ice drift.

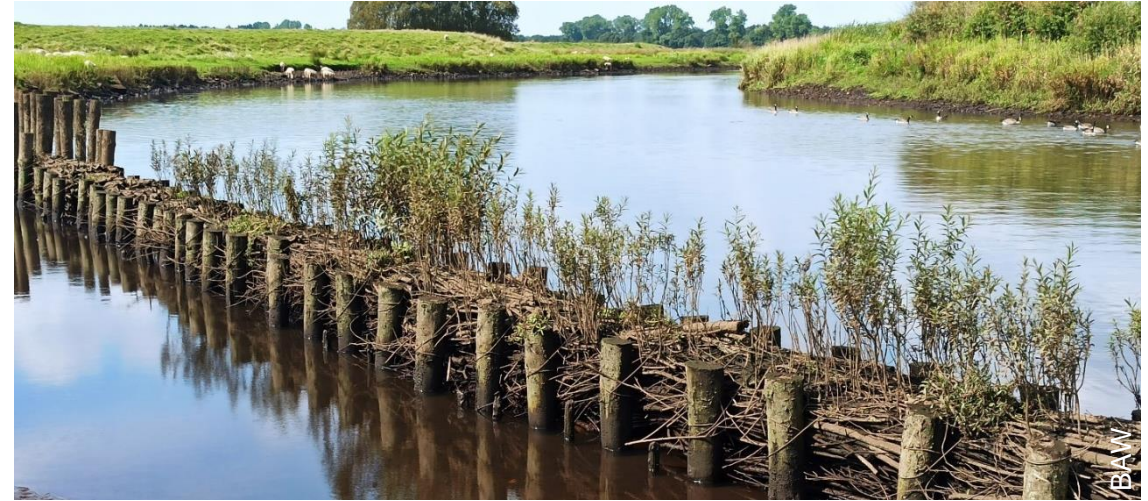
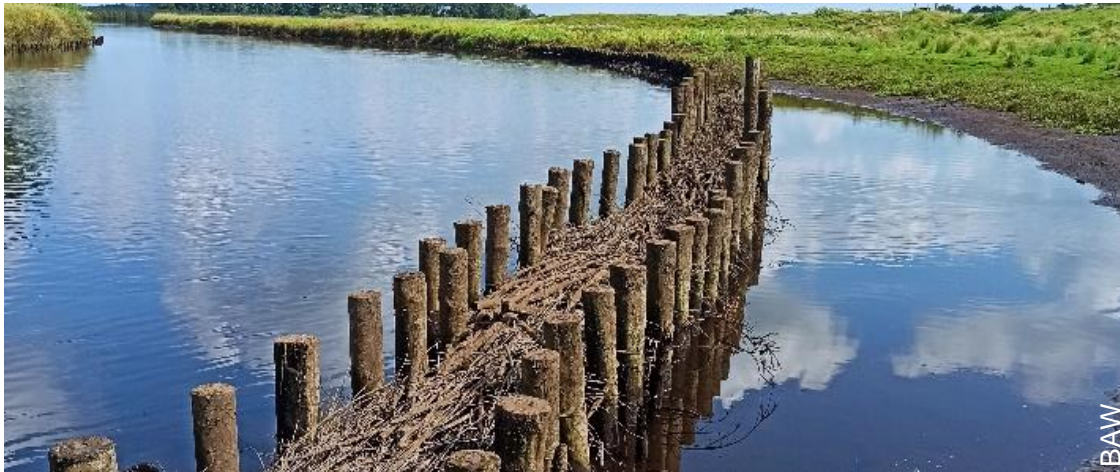
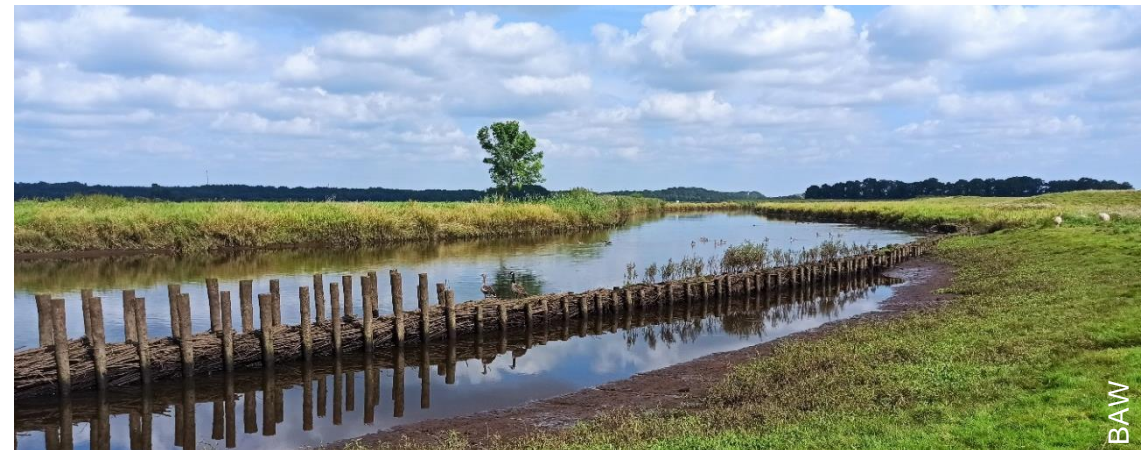
- **Km 6,500-6,600** left bank Stör
- **Implementation:** 2025
- **Contact:** WSA Elbe-Nordsee: abz-glueckstadt@wsv.bund.de
- **Construction design:** Brushwood box to protect the bank from further scouring and the associated threat to the dike. In one section, the brushwood box was filled with willow material, that was still able to sprout.
- **Development:** Since the measure was implemented, the scour has not spread further. So far, no significant vegetation growth or sedimentation has been observed behind the brushwood box. The section containing willow material capable of sprouting is still sprouting in 2026.

Unfinished brushwood box in summer of 2025. The piles were still to be cut to a uniform height.

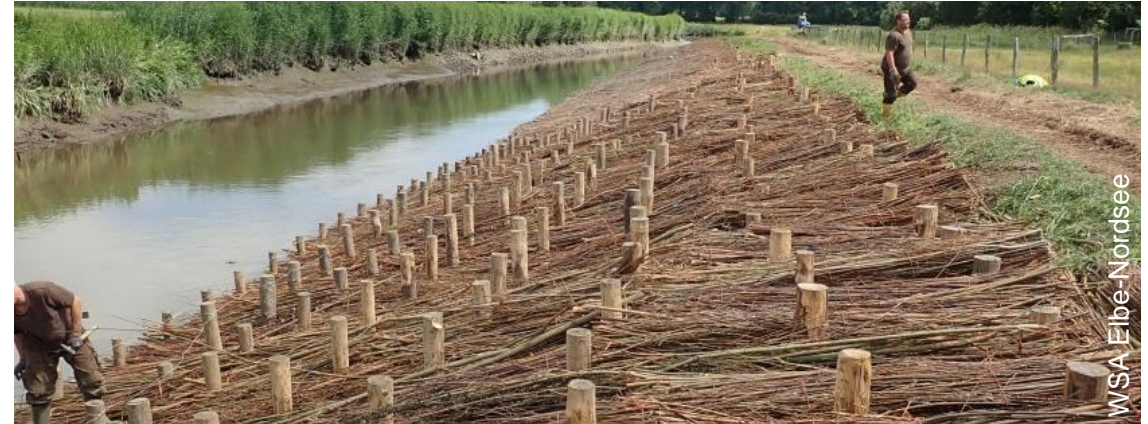
- **Km 6,750-7,000** left bank Pinnau
- **Implementation:** 29.05-04.07.2018
- **Contact:** WSA Elbe-Nordsee: abz-glueckstadt@wsv.bund.de
- **Construction design:** Protection of dikes without foreland with brushwood mattresses made of willow fascines from the preceding pruning season.
- **Development:** The brushwood mattress is overgrown in the upper half and covered with silt in the lower part. No maintenance has been necessary so far.

Measure during construction in 2018.

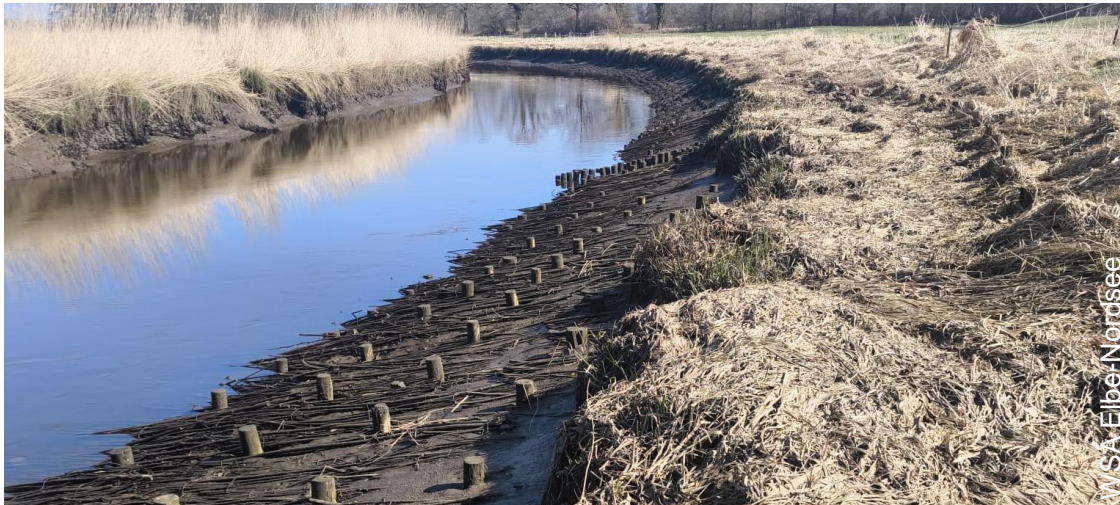
Measure in April 2026, upper part covered by vegetation.

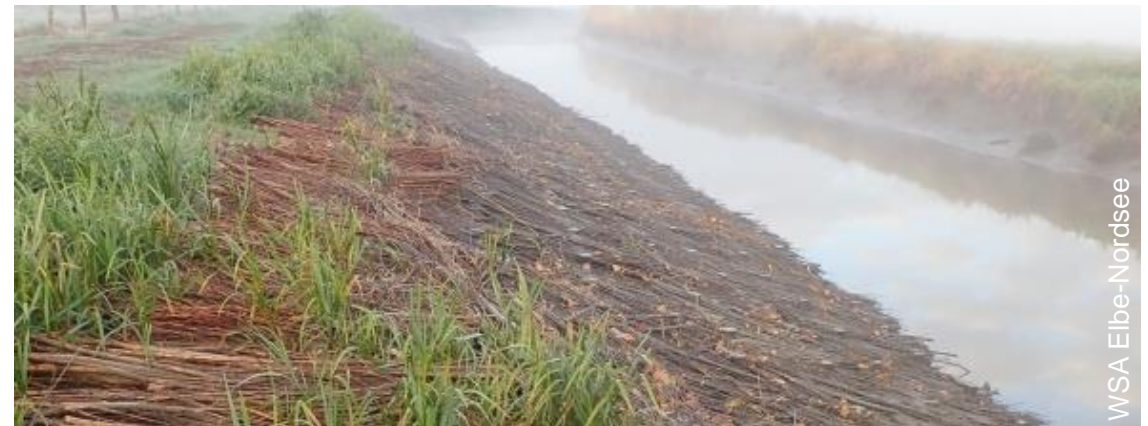
Measure 4 weeks after construction in 2018.

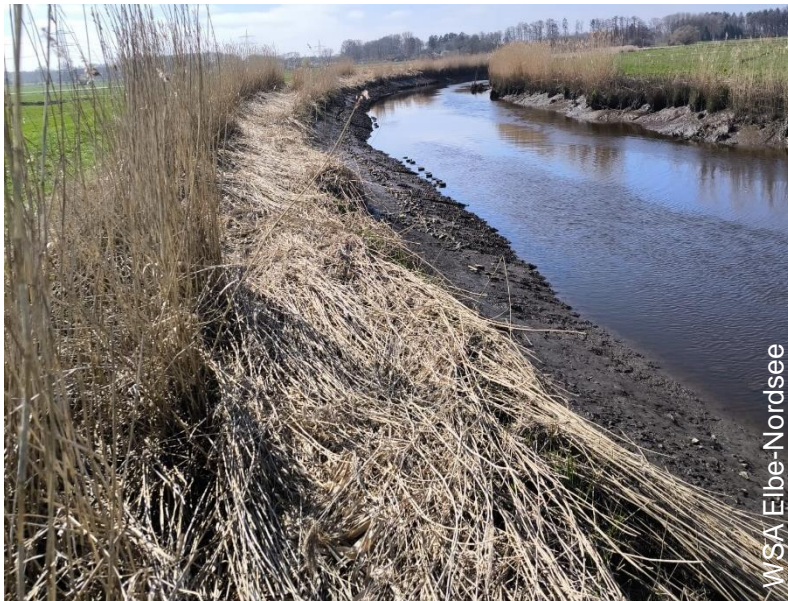
- **Km 7,340-7,500** left bank Pinnau
- **Implementation:** May-June 2020
- **Contact:** WSA Elbe-Nordsee: abz-glueckstadt@wsv.bund.de
- **Construction design:** Stable revetment using fascine reinforcement for dyke protection
- **Development:** The measure has quickly become overgrown, and a new stand of reeds has taken root. This growth was facilitated by the fact that the coconut fiber mesh allows roots to penetrate it. So far, no maintenance work has been necessary.

Measure in April 2026.

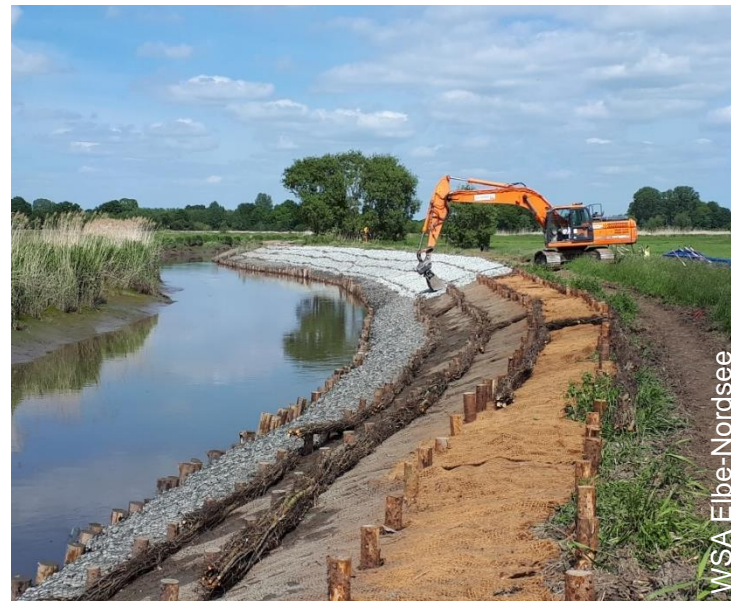
Construction of the measure in 2020.

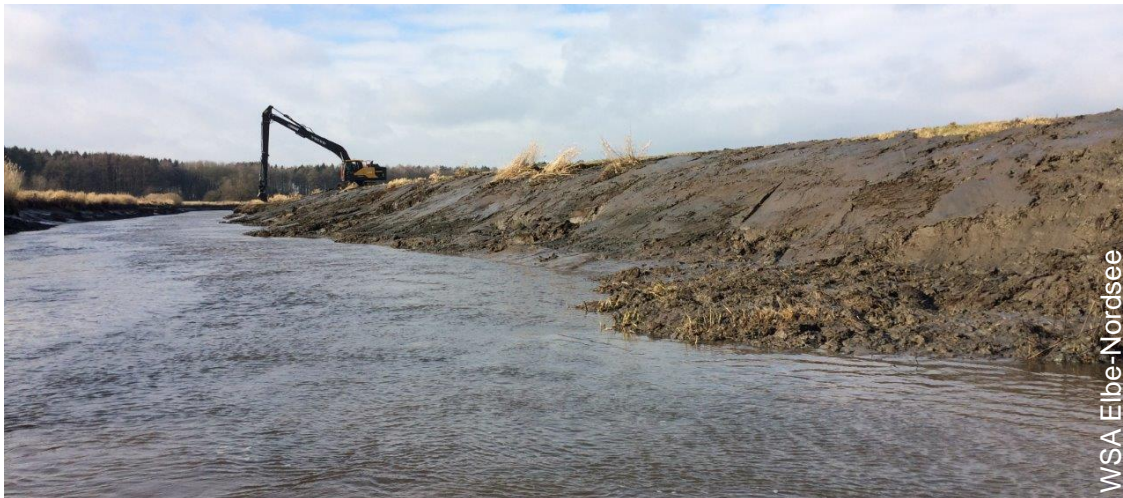
Bank reprofiling test site at the Pinnau

- **Km 7,500-8,080** right bank Pinnau
- **Implementation:** Calendar week 72019
- **Contact:** WSA Elbe-Nordsee: abz-glueckstadt@wsv.bund.de
- **Construction design:** In order to rectify scour damage and bank collapses at dykes without foreland the soil (cohesive, root-permeated) that had slid into the Pinnau River was reprofiled using an excavator to test on a pilot site whether the exposed material would remain stable within the newly formed slope profile.
- **Development:** The reed growth has re-established itself after a short time. However, due to persistent severe flooding during the winter of 2019/20, the cohesive soil material became saturated and slid down again before the roots of the new growth could take hold. The measure has not developed as intended and is under observation and will be replaced by a different measure if necessary.

Reprofiling work in 2019.

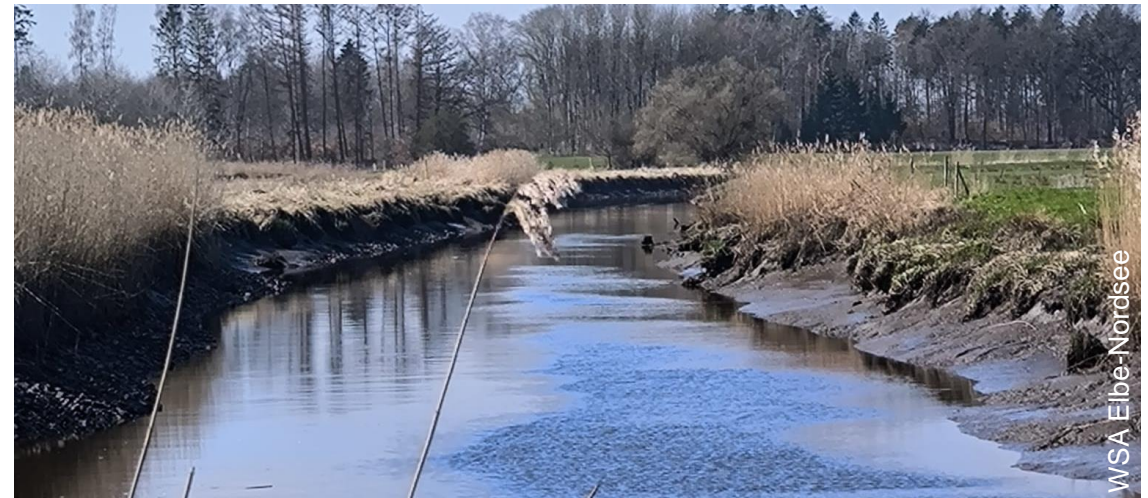
Bank area in April 2026.

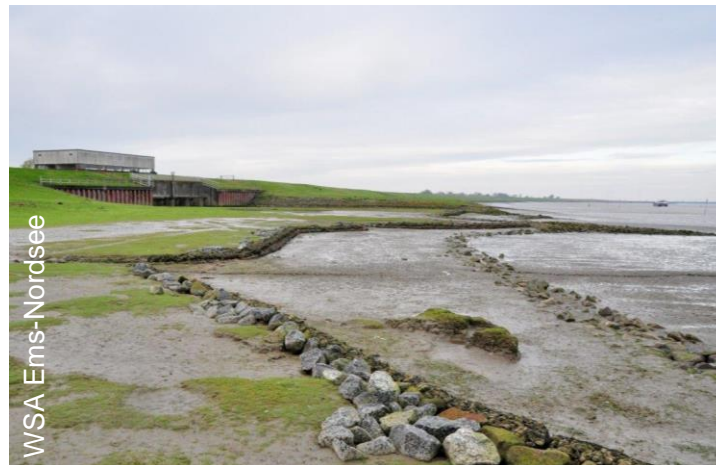
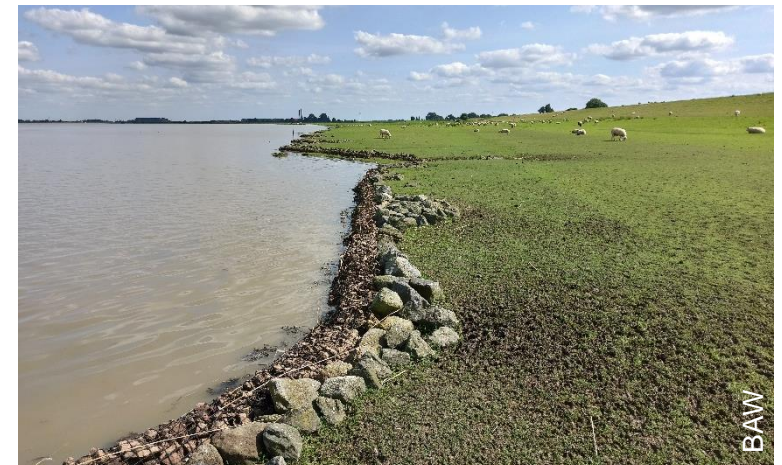
- Km 27,2-27,4 left bank Ems
- **Implementation:** 2015, 9 days (7.-15. August 2015)
- **Contact:** WSA Ems-Nordsee:
Friedhelm.Roeloffzen@wsv.bund.de
- **Construction design:** Rock rolls to protect an erosive dyke foreland above the revetment crest (see schematic sketch). The reason for the bank protection was the dyke inspection in 2014.
- **Development:** The area is stable and has not required any maintenance to date.

Erosive bank before (left) and after implementation (middle) and in 2021 (right).

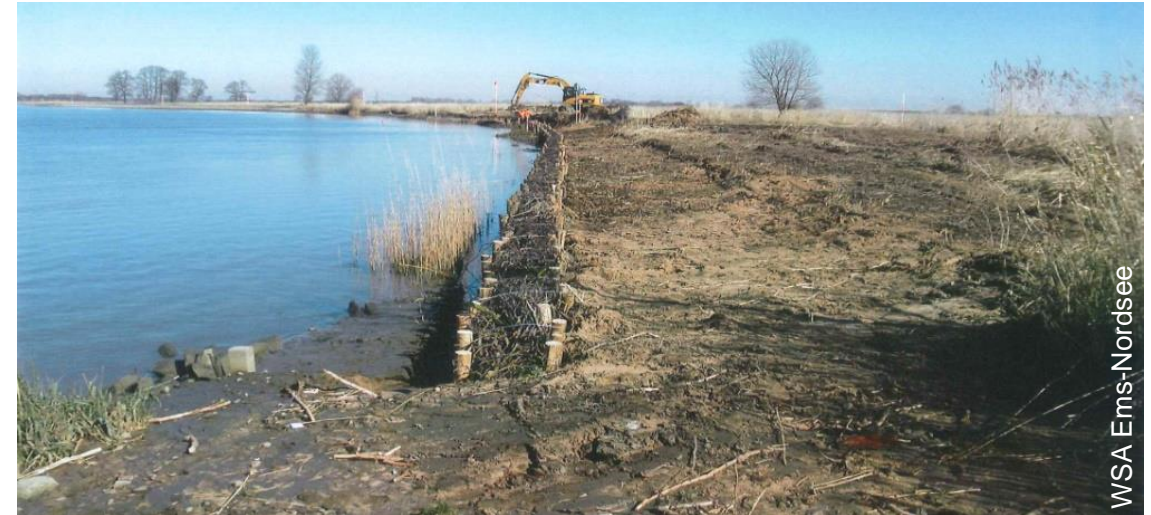
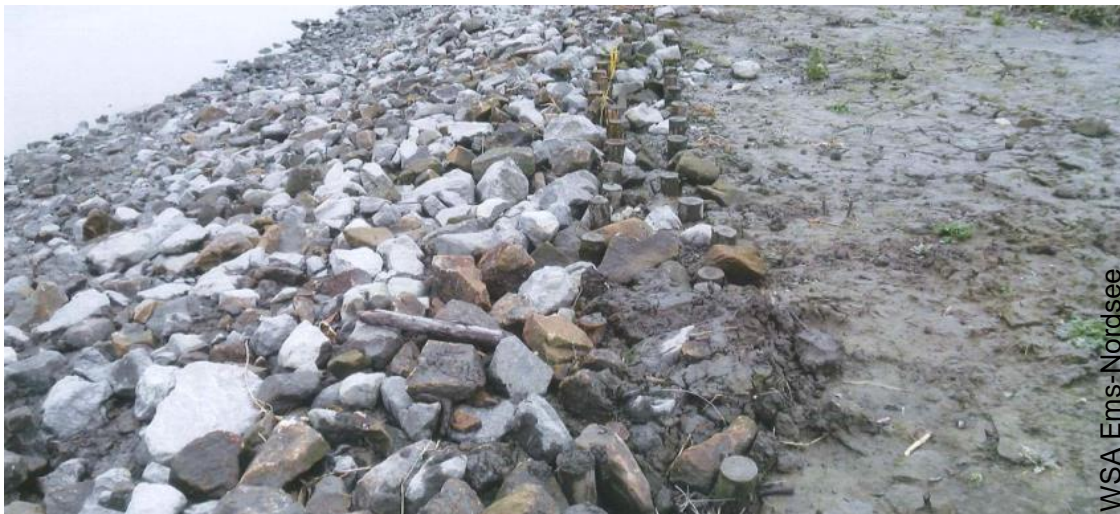
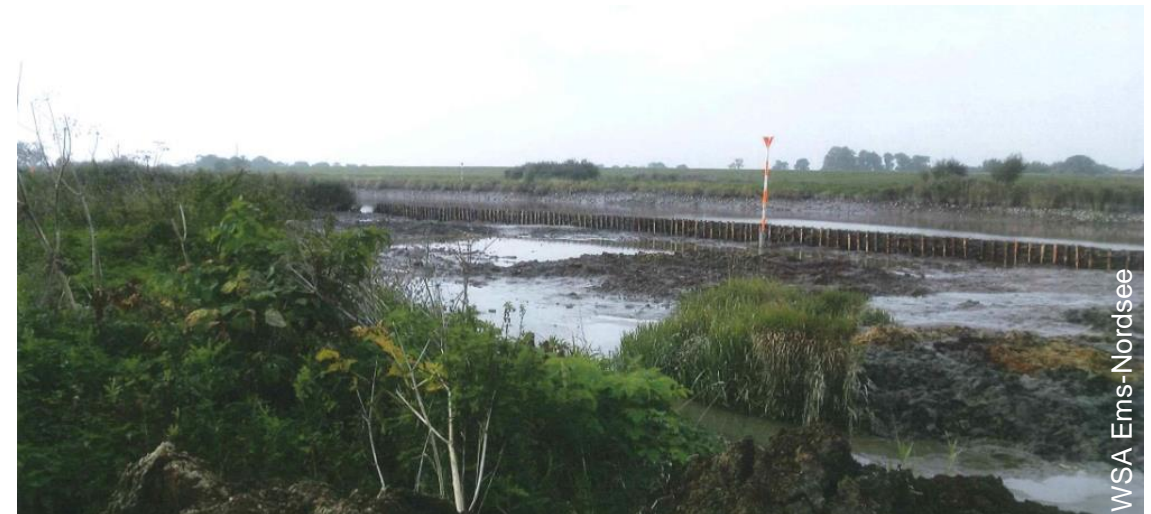
Brushwood boxes to secure the riprap crest

- Km 218,3-219,8 right bank Dortmund-Ems-Canal
- **Implementation:** 2010-2016
- **Contact:** WSA Ems-Nordsee: abz-lathen@wsv.bund.de
- **Construction design:** Repair of erosion damage to the revetment crest near the summer dike. The area was stabilized using brushwood boxes made from double pile rows and brushwood filling.
- **Development:** The measure is fulfilling its purpose.
