Paper 110 – Technical-biological river bank protection – a contribution to the ecological improvement of the banks of Federal waterways in Germany – First experiences from a field test along the River Rhine

Bundesanstalt für Gewässerkunde (BfG; Federal Institute of Hydrology), Koblenz, Germany

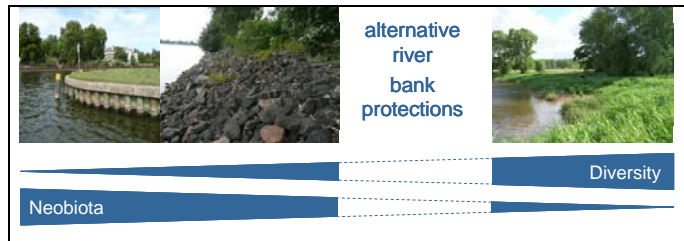
Figure 1: Technical bank revetments (on the left) are often inhabited by a higher portion of invasive alien species (neobiotics) than near-natural banks (on the right), where the species diversity is usually high, with options of compromises as combined technical-biological bank protection (centre).

These banks are often poor in their physical diversity, with the consequence that important habitats for plants and animals are lacking in the transition zone between land and water and that the natural zoning of the banks and the diversity of species living there are lost (Figure 1).

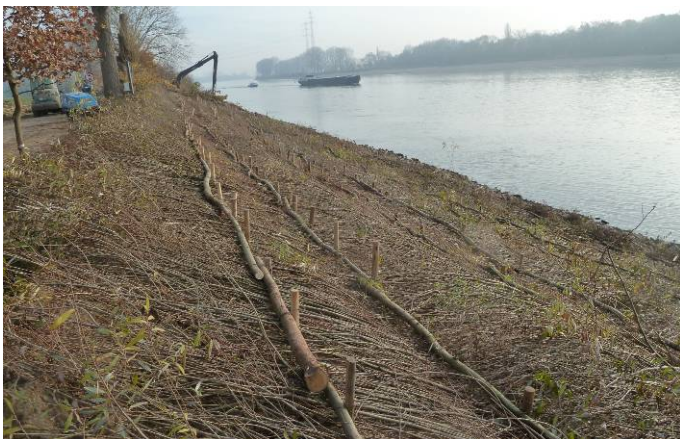
Figure 2: Construction of willow brush mattresses (perpendicular to the direction of flow)

In two test fields, willow brush mattresses were installed – once perpendicularly (Figure 2), and once diagonally to the direction of flow – densely packed and fixed with wire, wood beams, and pegs. The brush mattresses were made of native, site-typical willow species (predominantly *Salix purpurea* and *S. alba*) from the nearer surroundings.

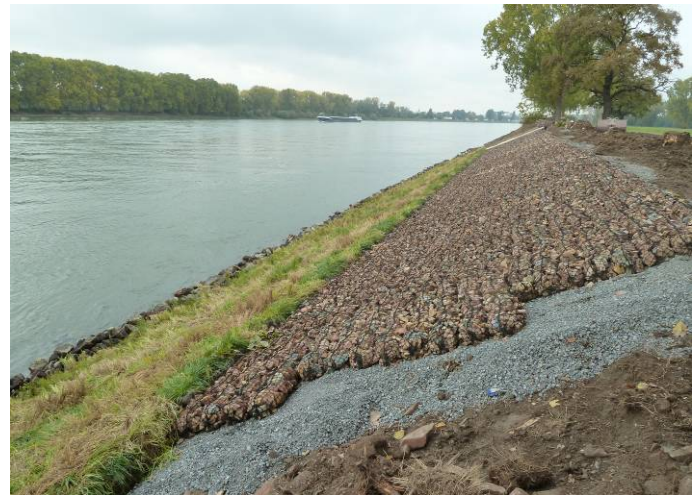
Figure 3: Test field with reed gabions (at the water-line) and stone mattresses on a granular filter layer on the upper slope

In a next test field, reed gabions with pre-cultivated species for two different plant zones were installed from the toe to the middle bank slope (in one half of this test field). Towards the upper margin of the slope and on the remaining half of the test field stone mattresses without plants were spread. They consist of crushed, little stones filled into a polypropylene net. Their thickness is up to 30 cm (Figure 3).

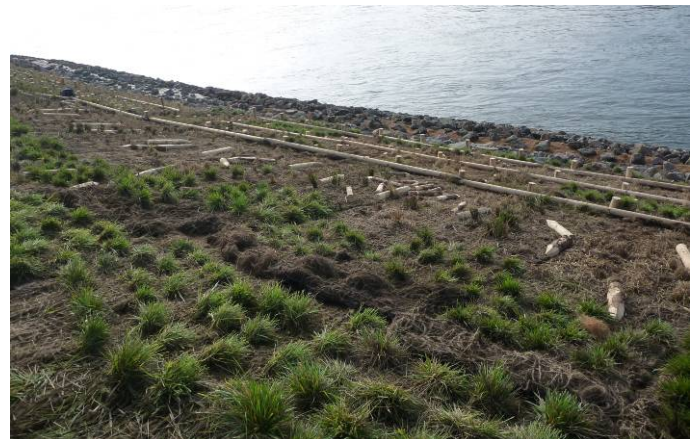
Figure 4: Test field with plant mats arranged on different filter mats

In another test field, different filter mats (of sheep wool, synthetic fleece material, or coir) were combined with overlaying, peg-fixed plant mats (Figure 4). A suitable site-typical natural floodplain species composition (predominantly *Carex acuta*, *C. acutiformis*, *C. riparia*, *Festuca arundinacea*, *Phalaris arundinacea*, *Iris pseudacorus*, *Agrostis stolonifera*) was pre-cultivated over one year on plant mats. For several reasons, the vitality of individual plants in the mats was not satisfactory when the test stretch was prepared.

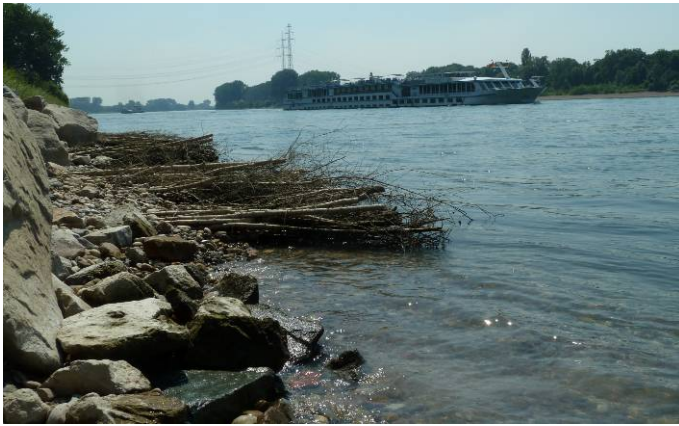
Figure 5: (Dead) wood fascines at low-flow water level

The rip-rap was ecologically upgraded, on the one hand, by willow-branch cuttings, brush and hedge layers as well as living fascines and, on the other hand, by hydroseeding on soil alginate and structural improvement with (dead) wood fascines and groups of individual stones (Figure 5). Here too, native site-typical species were used for seeding

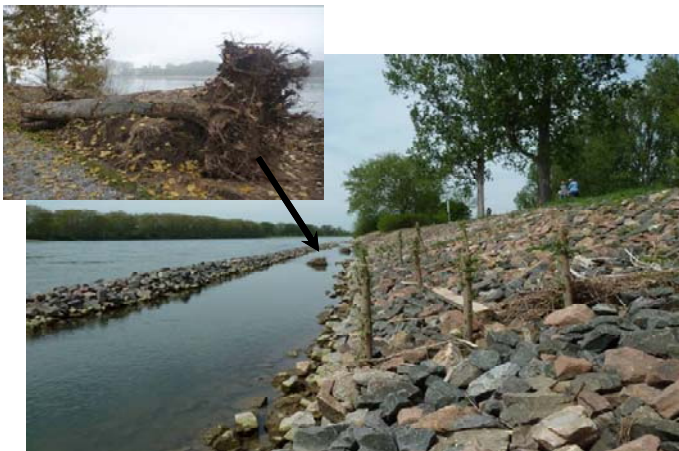
Figure 6: Stone wall with shallow-water zone and structural elements in the water and slope zones (dead wood trunks with roots, willow branch cuttings)

In two test fields, a breakwater-like stone wall was built in the river in front of the bank, so that a shallow-water zone protected against hydraulic impacts was created (Figure 6).

In these test fields, the rip-rap continues to protect the stability of the bank. The additional components were inserted purely for ecological reasons. The testing of these designs is of special relevance for waterway reaches, where the protection with rip-rap is indispensable due to heavy hydraulic impacts. Here, the main purpose of the tests is to prove the ecological effectiveness.

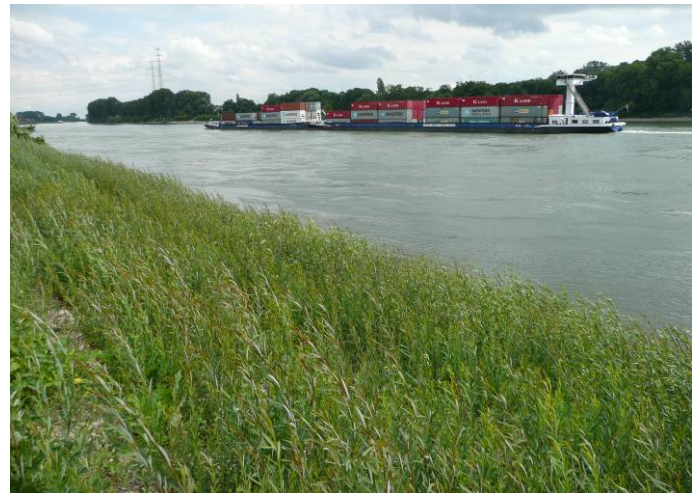
Figure 7: Growth of willow-brush mattresses (six months after construction)

The good growth of the willow-brush mattresses (Figure 7) initiates the establishment of typical soft-wood floodplain vegetation.

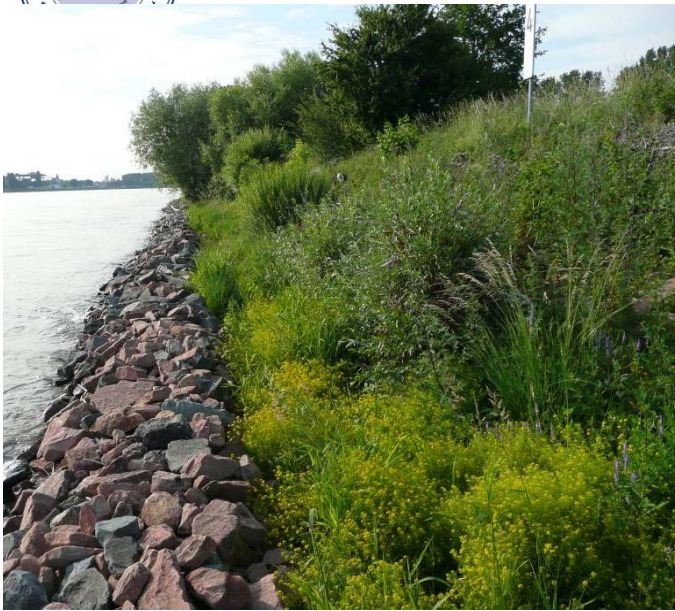
Figure 8: Growth of reed and tall forbs protected by a stone wall (June 2012).

The plants that were inserted into the rip-rap fields are also growing well. Single losses of structural elements, like some reed ball plantings, occurred in one test field mainly in the wave-impact zone around the AZW water level. Generally, the inserted elements developed into habitat components (woody plants – single or in groups, grass and herb growth) and thus improved the structural diversity of the vegetation on this technical bank stabilization system considerably. Moreover, in the bank zones that are protected by a stone wall, the first Potamogeton species could settle and first reed stands began to evolve (Figure 8).

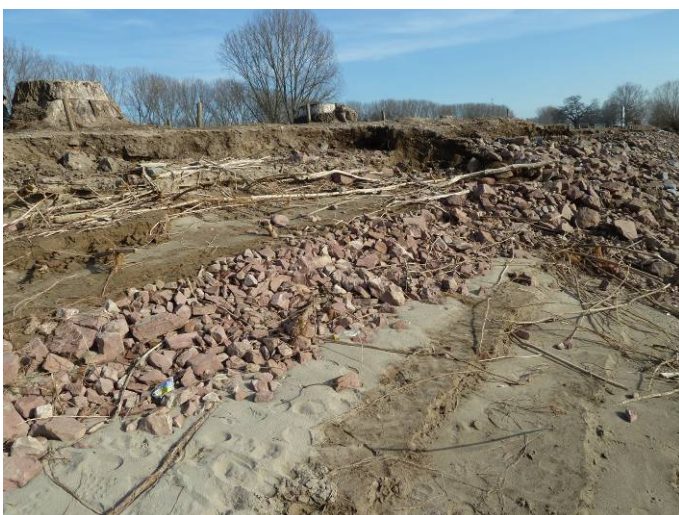
Figure 9: Structural diversity (floating wood debris, different substrates (sand, gravel fill, stones), and break-off edges after flooding in the test field left without bank protection.

In the test field that was left without any bank protection the prevailing hydraulic stresses caused – as expected – erosion and slope slips. Whether the hinterland can be sufficiently protected by establishing vegetation-based systems at the transition to the slope top will have to be tested in future studies. In the first year after the removal of the rip-rap, the bank formed here a variety of structures like break-off edges, accumulations of flotsam, and a rich diversity of substrate materials (Figure 9).
