# Evaluation of optimised groyne designs in response to long-period ship wave loads at Juelssand in the Lower Elbe Estuary

Gregor Melling<sup>1</sup>, Hanne Jansch<sup>2</sup>, Bernhard Kondziella<sup>2</sup>, Klemens Uliczka<sup>2</sup> and Bettina Gätje<sup>3</sup>

<sup>1</sup> Federal Waterways Engineering and Research Institute (BAW), [gregor.melling@baw.de](mailto:gregor.melling@baw.de)

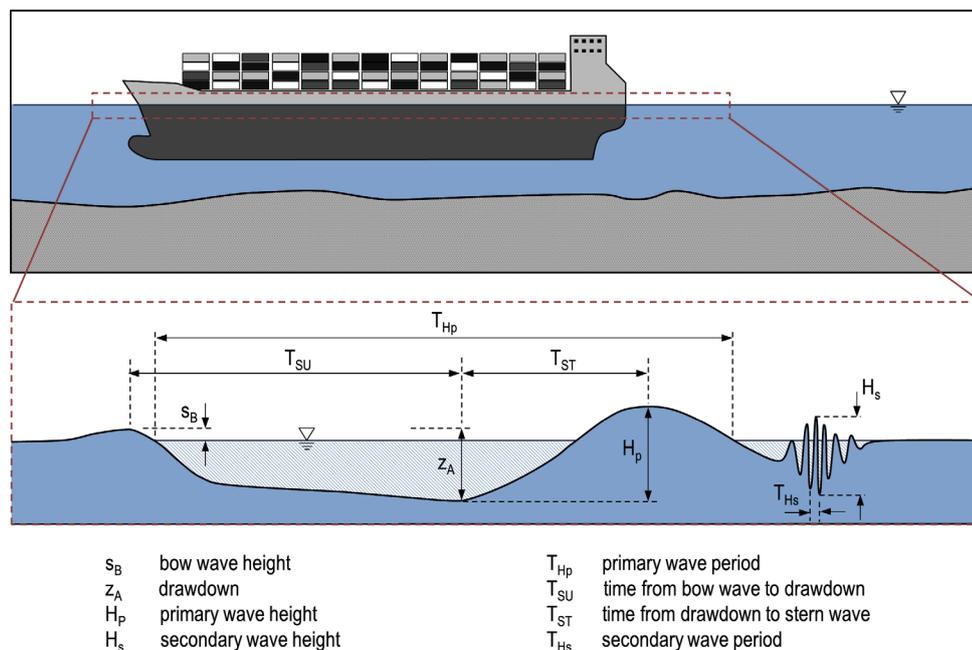
Figure 1: Schematic illustration of the ship-generated wave system in confined shallow water with idealised ship wave record and definition of characteristic parameters.

For large vessels in relatively narrow waterways, the long-period ship wave can present the most relevant load with respect to shoreline infrastructure stability. Figure 1 illustrates the primary and secondary wave systems associated with a ship travelling in confined and shallow water. The primary wave system consists of a bow wave followed by a water level depression caused by a pressure drop around the vessel hull, and a transverse stern wave. This long-period wave system is hydraulically bound to the ship hull and thus travels along the shoreline at a rate equal to the vessel speed. Following the passing of the stern wave, the water level drawdown is compensated with the slope supply flow which works to restore the ambient water level. The period  $T_{Hp}$  of the primary wave is determined by vessel length and its speed over ground (SOG); for the current vessel fleet structure in the Elbe Estuary values of approx.  $60 \text{ s} < T_{Hp} < 120 \text{ s}$  are typical.

- filtering the data with a high-pass filter with cut-off frequency of 1/1800 Hz (30 min) in order to separate ship-induced and tidal contributions to the pressure signal
- filtering the ship-induced components with a low-pass filter at a cut-off frequency of 1/10 Hz (10 s) to derive a clear signal of the long-period ship waves
- extracting wave events and determining the relevant parameters of the long-period ship wave (cf. Figure 1)
- correlating the wave events with AIS data

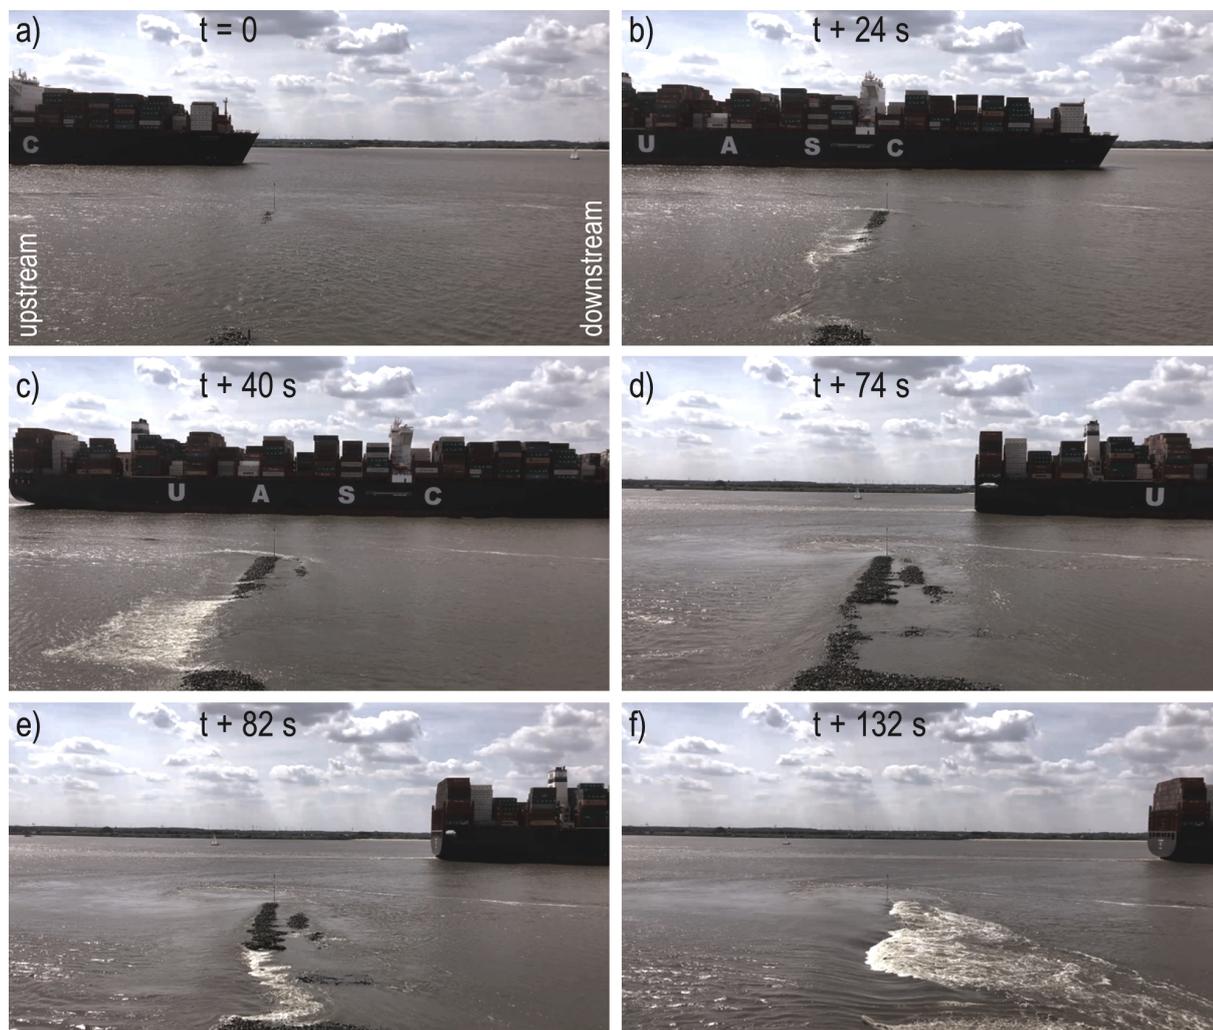
Figure 2: Interaction of long-period ship wave with groyne at Juellssand (Lower Elbe Estuary) during passage of seaward-travelling ULCV (length 368 m, breadth 51 m) at approx. mean water level. Passage with draught of 12.5 m, 13 kn  $STW$  and passing distance  $d$  of 228 m.

The interaction of a primary wave ( $T_{Hp} = 95$  s) with a groyne at approximately mean water level (freeboard  $R_c \approx 0$ ) is illustrated by a series of time-lapse photographs in Figure 2. The interaction begins with the bow wave (Figure 2a), typically small with negligible impact (here  $s_B = 0.1$  m), followed by the drawdown ( $\zeta_A = 0.7$  m) which causes a water level drop in the upstream groyne field. The resulting water level gradient results in compensatory flow over the groyne opposite to the direction of travel (Figure 2b, c). This flow situation weakens as the vessel, and the drawdown, gradually moves into the downstream groyne field and the original water level in the upstream groyne field begins to be restored (Figure 2d). This is associated with the arrival of the transverse stern wave and the water-level-restoring slope supply flow. The drawdown in the downstream groyne field now acts to reverse the water level gradient and results in a flow over the groyne in the direction of travel (Figure 2e).

that is characterised by high velocities and strong turbulence; flow aeration on the lee side is also common, the extent varies with the hydraulic configuration of the overflow and boundary effects (Figure 2f). The described processes are representative of the load case for freeboards in the approximate range  $R_c \lesssim 0$ . For positive freeboard heights overflow phenomena may be weaker, restricted to lower parts of the groyne or replaced by stronger flows around the head of the groyne; in this case wave run-up, wave breaking and overtopping processes are dominant.

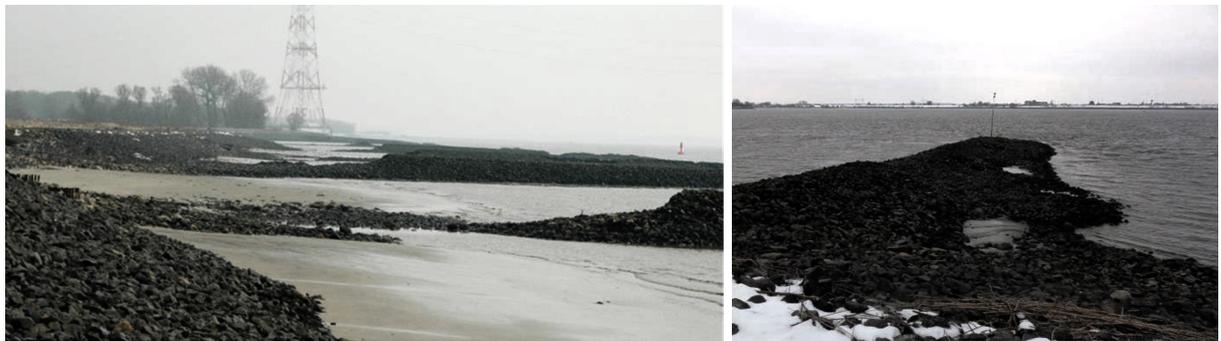
Figure 3: Characteristic damage to groynes at Juelssand (Lower Elbe Estuary) caused by long-period ship wave action. Destruction of the groyne root (left) and erosion of the crest and lee side slope (right).

The structural response of groynes under long-period ship wave action is described in detail in BAW (2010) and BAW (2012). At the study site, the groynes exhibit a characteristic pattern of damage that features the deterioration of the groyne root to the point of complete destruction and deformation of the crest, particularly on the lee side, w.r.t. the incident wave (cf. Figure 3).

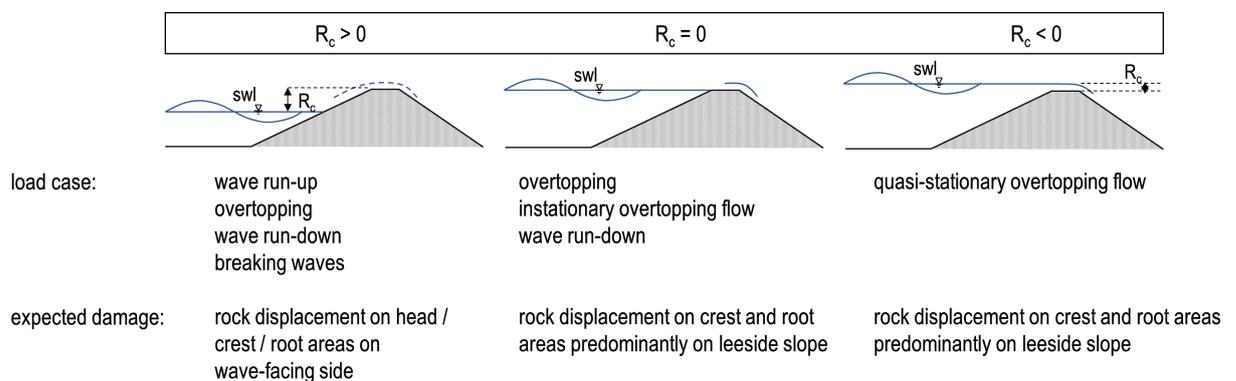
Figure 4: Conceptual model of load cases and associated damage due to long-period primary ship waves in relation to freeboard  $R_c$ . Modified from Gier and Schüttrumpf (2012).

Different load cases are relevant depending on water level and freeboard height. A differentiation of the load cases  $R_c > 0$  and  $R_c \lesssim 0$  is useful, as the processes and damage mechanisms are distinct and typically also affect different areas of the groyne, as illustrated conceptually in Figure 4.

For positive  $R_r$ , wave impact processes are prevalent, affecting mostly the wave-facing slope (in this publication “wave-facing” is used with respect to stern waves from outgoing ships), although some overtopping and wave run-down on the lee side is possible, depending on structure parameters such as crest height and permeability. For  $R_r \lesssim 0$  the forces on the armour layer are related primarily to overflowing of the groyne. In this case, the structural response to supercritical loading is expected in the lee portion of the root and crest areas. Gier and Schüttrumpf (2012) conclude that the long-period wave is particularly damaging due to the fast-flowing and highly-turbulent overflow of the groyne.

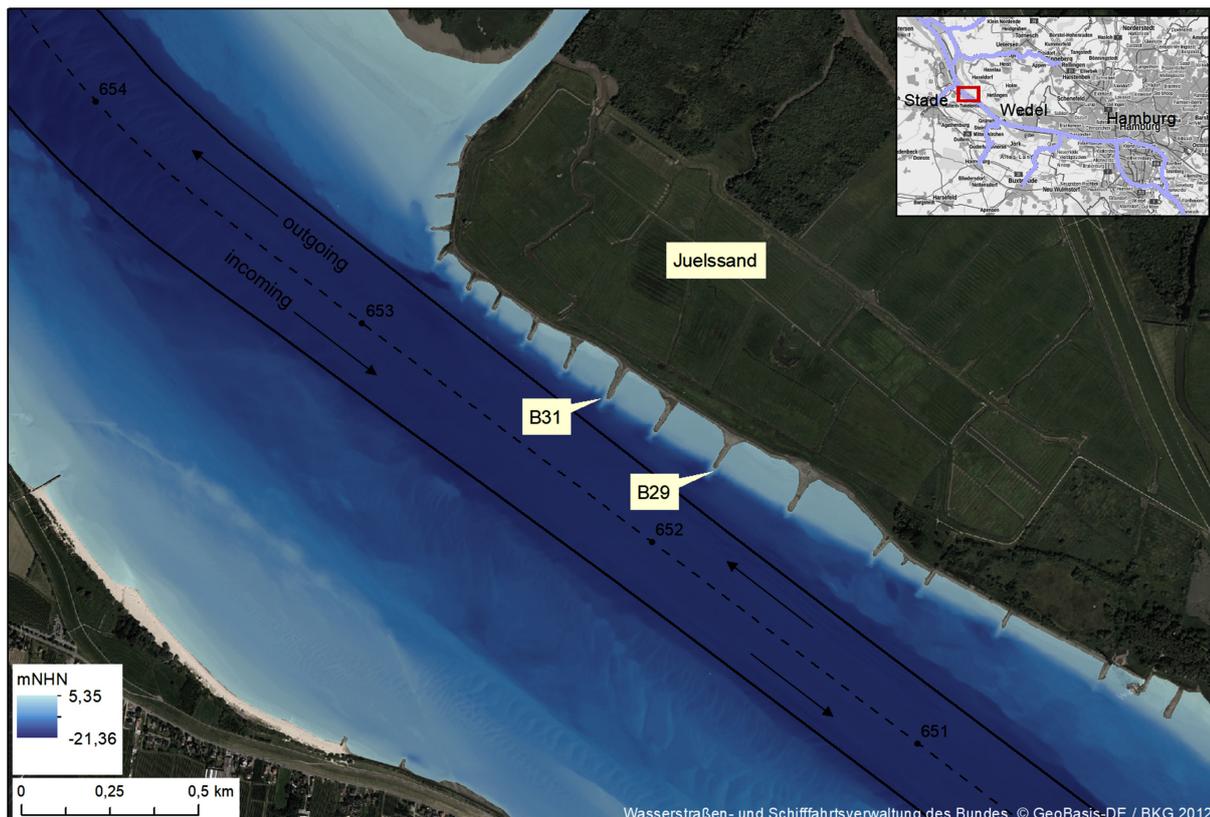
Figure 5: Location of study site at Juelssand with pilot study groynes, indicative bathymetry, location of navigational channel and chainage.

Juelssand is located on the northern bank of the Lower Elbe Estuary, along the main access channel to the Port of Hamburg, between chainage km 651–653 (Figure 5). The groynes here are already experiencing significant structural deterioration from ship waves (cf. Figure 3); the site is thus an ideal site for the pilot study. For this purpose, groynes B29 and B31 were rebuilt using optimised designs. Mutual interferences stemming from changes to the loading regime as a result of the rebuilding of the groynes are eliminated by keeping the intermediary groyne B30 in its current state.

Owing to the proximity of the shipping channel to the shoreline, this area is characterized by close passing distances and significant ship wave energy, especially in the case of seaward travelling vessels. The distance from groyne tip to the edge of the fairway can be as short as 65 m. The channel side is very steep with slopes of approx. 1:5 (cf. Figure 5).

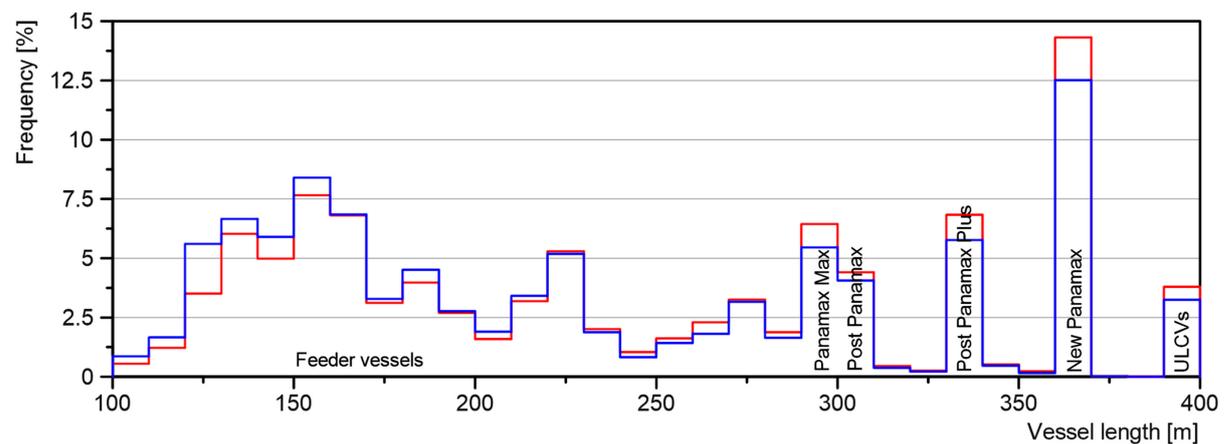
Figure 6: Distribution of vessel length for wave events registered at position 1 at B29 (red) and B31 (blue).

Based on an examination of Automatic Identification System (AIS) data, the distribution of vessel sizes for which wave events were registered during the monitoring period is shown in Figure 6. The vessel sizes are relatively evenly distributed, although vessels of the New Panamax type (on average 366 m length, 49 m breadth) constitute the dominant ship in terms of loading frequency with over 12.5 % of recorded wave events attributable to this class. Approximately 4 % of recorded wave heights originated from the currently largest ULCVs (length > 395 m, breadth > 53 m) sailing on the Elbe Estuary.

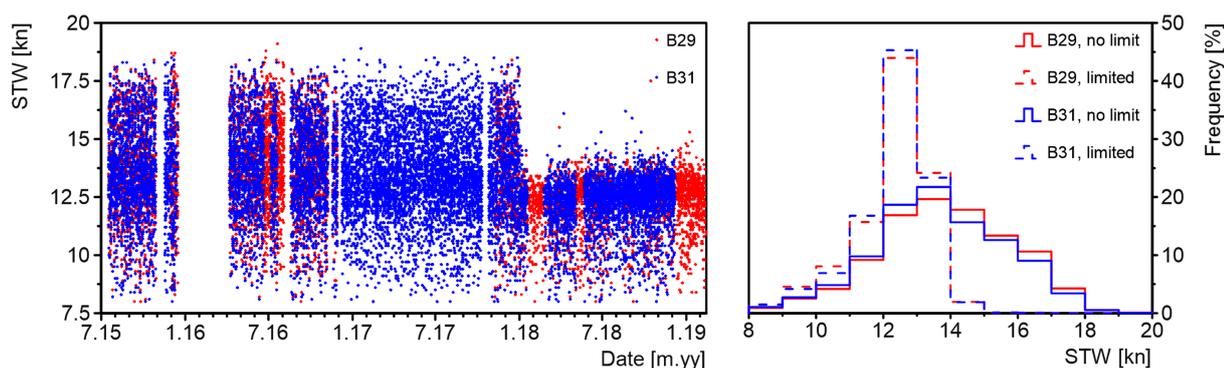
Figure 7: Change of  $STW$  with time (left) and distribution of speeds before and after introduction of speed limit (right).

In January 2018, a speed restriction of 12 kn *STW* for vessels with lengths greater 90 m was instated in this part of the Elbe Estuary. In response, the statistical distribution of ship speeds has changed significantly as shown in Figure 7. The median speed shows a reduction from 13.8 and 13.5 for B29 and B31, respectively to 12.5 kn. Crucially, the occurrence of large velocities above 15 kn is significantly reduced.

The speed restriction falls within the monitoring period and must be taken into account when interpreting rock armour stability. Since AIS data only provides the speed over ground (*SOG*), current velocity data from an operational model (see Section 3.3.3) was used to derive the corresponding *STW* for each vessel.

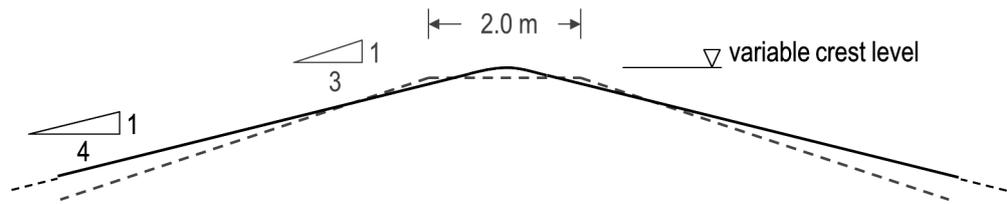
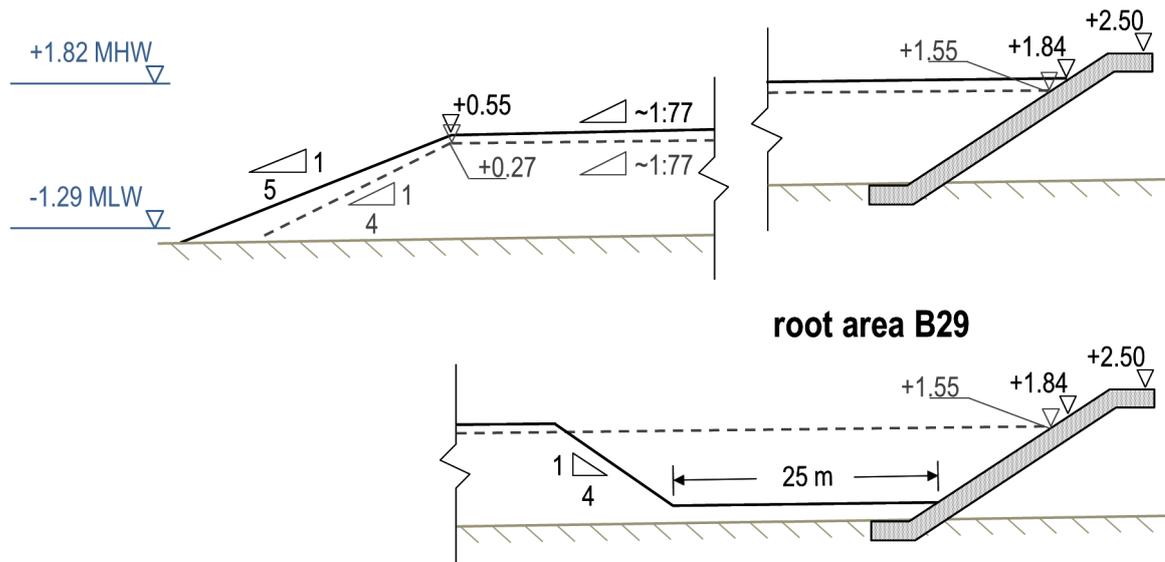
Figure 8: Comparison of conventional groyne profile (grey dashed) and optimised design profile in pilot study (black). All levels in mNHN. Not to scale.

For the new groyne types, shallower slope angles were used, as well as a higher crest level (Figure 8). The crest width was reduced and rounded to produce a “chevron”-shaped crest. The difference between B29 and B31 is related to the configuration of the groyne root and revetment transition. The characteristic pattern of damage (cf. Figure 3) and the understanding of wave-structure-interaction point to the fact that the most vulnerable part of the groyne is the root area due to the focussing of wave energy. Hence, two design solutions were implemented in this area with the aim of increasing rock armour stability by reducing loading in vulnerable areas of the groynes. At B29 the transition area from groyne body to revetment was fashioned as a 25 m wide recess (at its narrowest point) with scour protection (Figure 8, Figure 9). The intention is to allow wave energy to bypass the structure thus minimising focussing effects in the root area which lead to overtopping flows on the groyne body. At B31, the transition to the revetment was profiled to a larger diameter radius of 25 m with the intention of reducing wave focusing and strengthening the groyne in the root area.

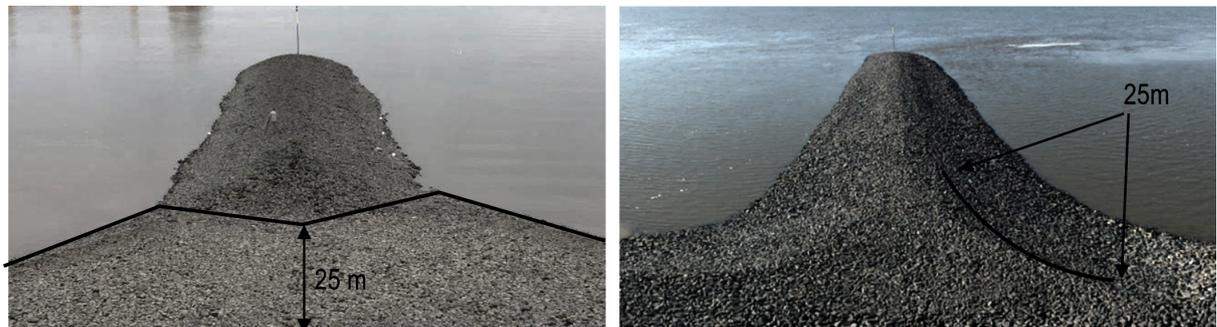
Figure 9: Photographs of the optimised groyne root designs taken from the crest of the revetment: recessed root (B29, left) and large radius root (B31, right).

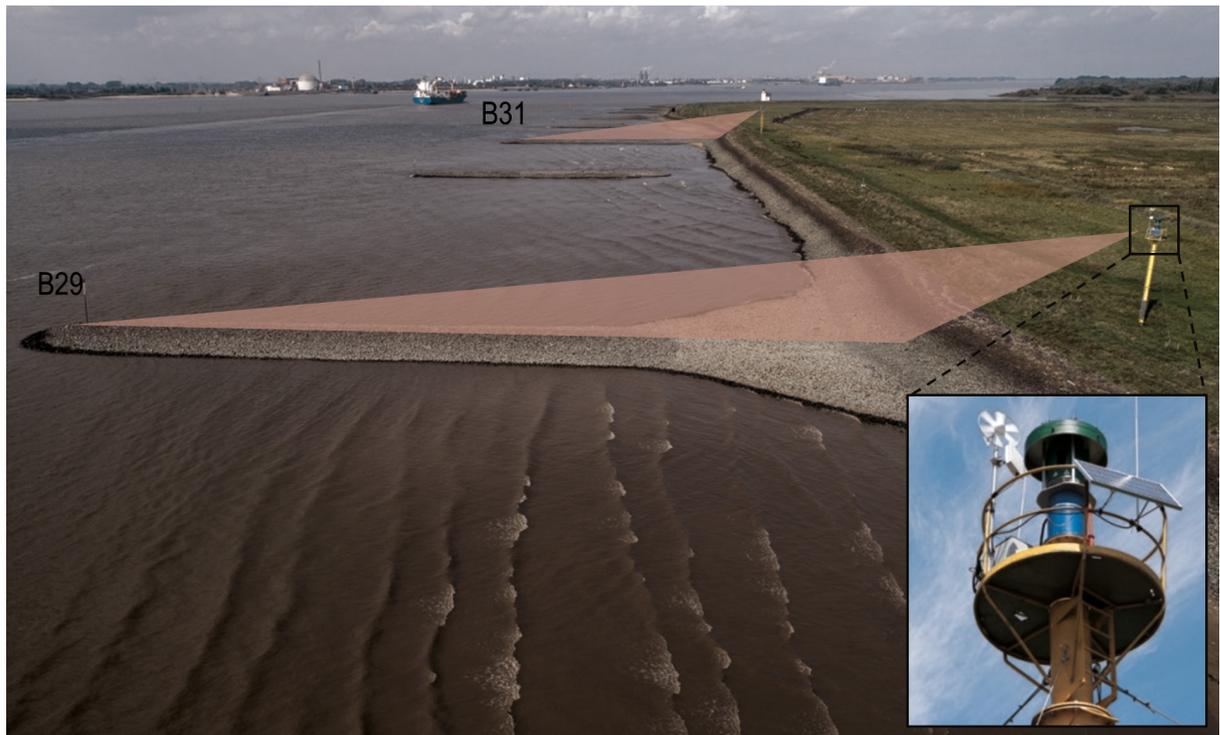
Figure 10: Set-up for monitoring of groyne topography at low tide levels with pile-mounted laser scanners. Close-up of the monitoring platform with laser scanner housing.

The geodetic monitoring system for each groyne consists of a terrestrial laser scanner (Zoller+Fröhlich IMAGER 5010) as shown in Figure 10 encased in a custom-built secure weather-proof housing and mounted on a monitoring platform at a height of 12 m above ground. The masts which elevate the monitoring platforms were installed by the WSA Hamburg and secured in position by four steel cables to reduce lateral movement and leaning due to wind and movements in the marshy subsoil. Power to the equipment is supplied by a solar panel, a small wind turbine and a fuel cell.

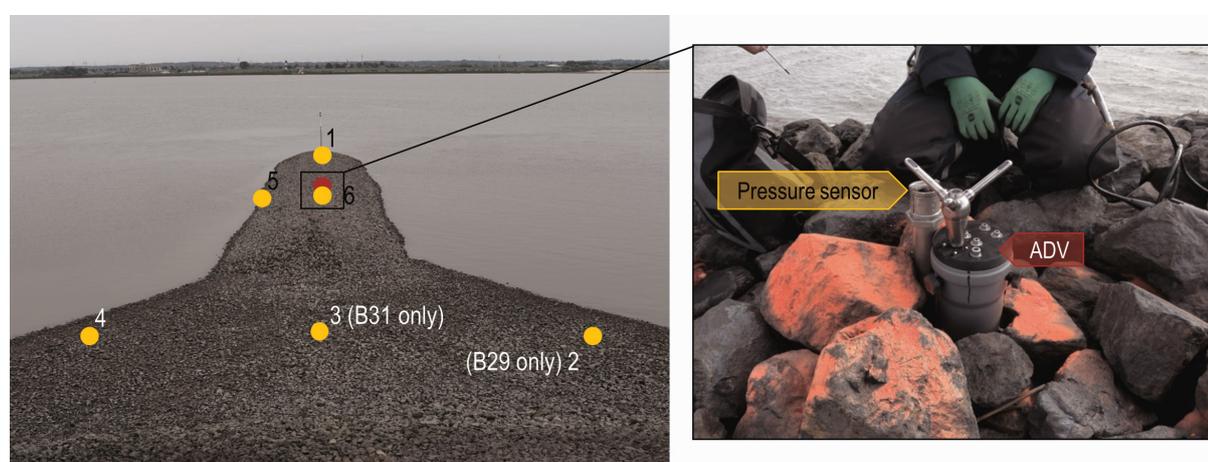
Figure 11: Distribution of pressure sensors (yellow) and current meter (red) (left). Current meter only deployed at B29. Set-up and housing of current meter and pressure sensors (right).

The changes to the water surface level at the structure were measured with pressure sensors positioned at various locations in the head, foot, root and crest areas of the groynes (cf. Figure 11). Pressure sensors by Driesen & Kern and RBR were used with a sampling rate of 1 Hz. The data loggers were installed in the rock armour layer in order to measure pressure fluctuations at the structure level. For this purpose, metal tubing, in which the instruments were housed, were driven into the armour layer as illustrated in Figure 11. The data loggers were exchanged on an approximately three-weekly rotation in order to recharge the batteries and download the data before the internal data memory was exceeded. Post-processing of the raw measurements includes:

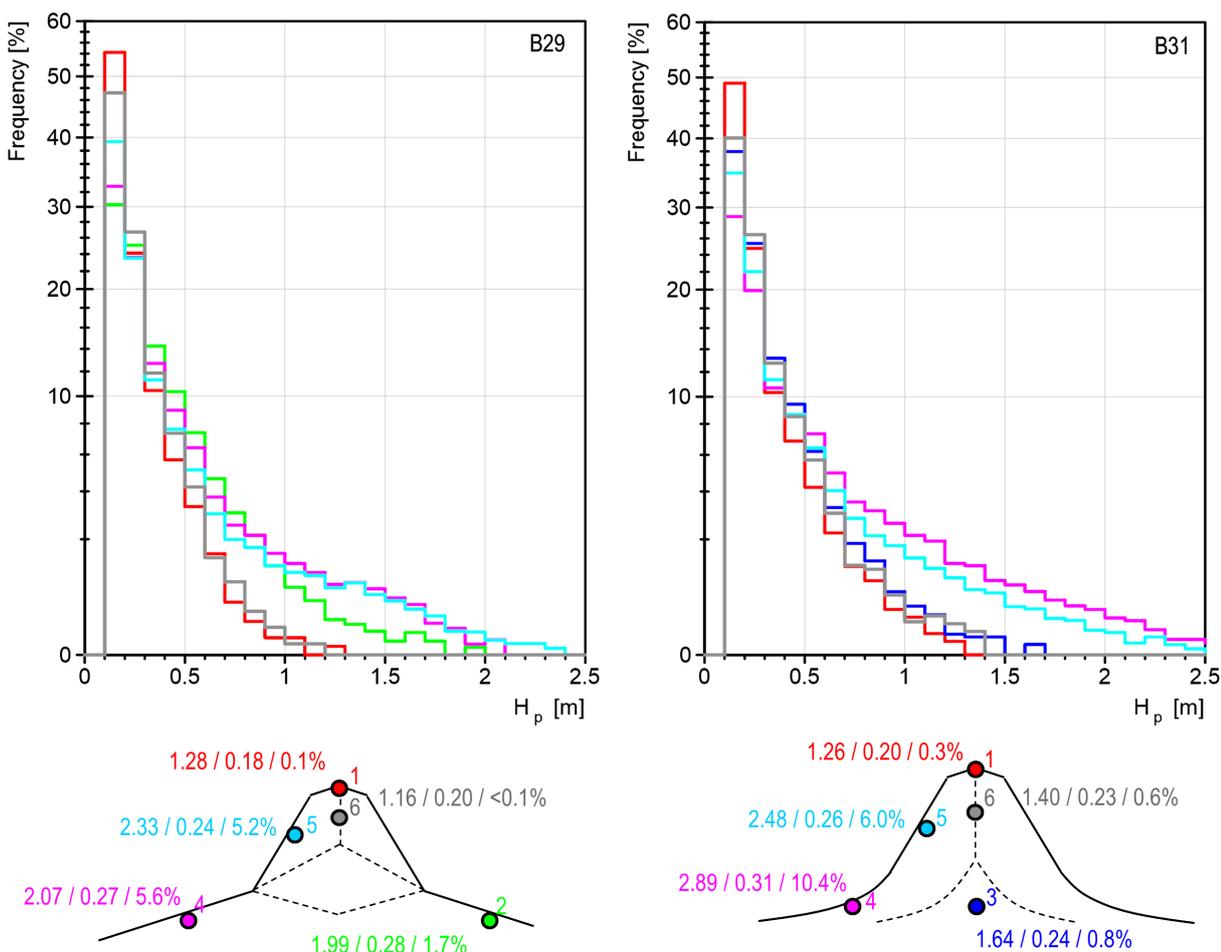
Figure 12: Histograms of wave heights at measurement locations (top).  $H_{p,max}$  /  $H_{p,med}$  / %  $H_p > 1.0$  m given for each measurement location (bottom).

The statistical distribution of wave heights at the measurement locations is shown in Figure 12. Comparing the wave heights at the groyne heads which are mostly undisturbed from the effects of wave-structure interaction a similar distribution of  $H_p$  magnitudes is observed. Over 90 % of incident primary wave heights are below 0.5 m. Differences in the wave regime at this location appear marginal, with a slightly higher median wave height at B31. The measurements at the other locations are more strongly influenced by the specific structure geometry. At B29 the maximum  $H_p$  was recorded at position 5, however, on average, larger waves are encountered further toward the root area at positions 2, 3 and 4.

In terms of large wave heights, arbitrarily defined here as  $H_p > 1.0$  m, only 5.6 % of observations satisfy this condition at position 4. At B31, the largest waves are also experienced in the root area, however the heights are greater. At position 4 over 10 % of the wave heights exceed 1.0 m and just over 3 % exceed 1.5 m. The comparison of wave heights at the groyne crests (pos. 6) suggests that somewhat higher loads are experienced at B31 and a larger number of events exceeding 1.0 m.

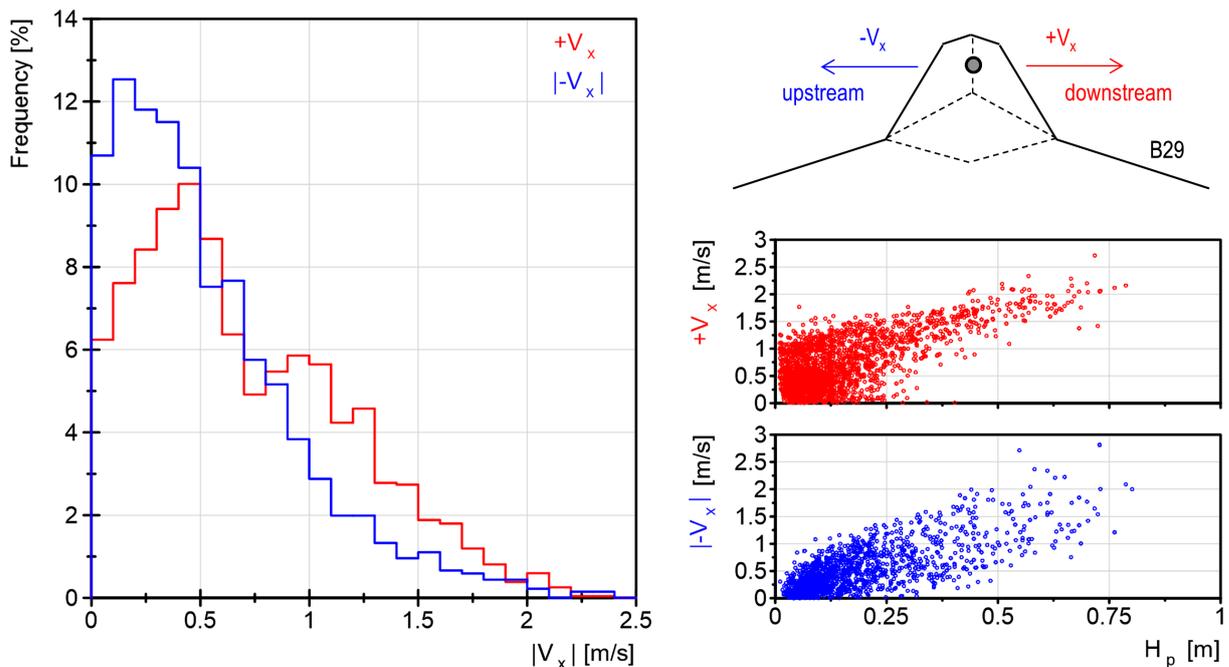
Figure 13: Frequency of occurrence of overtopping flow velocities at groyne B29 (left). Relationship between  $H_p$  and  $V_x$  (right).

The statistical distribution of the flow velocities  $|V_x|$  over the groyne crest is shown in Figure 13. Tidal flow effects have not been removed here. Although the most common values are below 0.5 m/s, velocities in the downstream direction show a significantly larger proportion of higher values, indicating the higher loading caused by seaward travelling ships. Approx. 27 % of flows in downstream direction are over 1.0 m/s, whereas less than 13 % exceed this threshold in the opposite direction. The maximum flow velocities commonly exceed 2.0 m/s, in rare cases overflow velocities exceeding 3.0 m/s have been recorded.

The overflow process, as described by the event-associated parameter  $V_x$  is dependent on ship wave celerity, ambient (tidal) flow and modified by its interaction with and transformation over the structure. The relationship between the overflow velocity and the primary wave height at the groyne crest shows that flow velocities, in general, tend to scale with  $H_p$ .

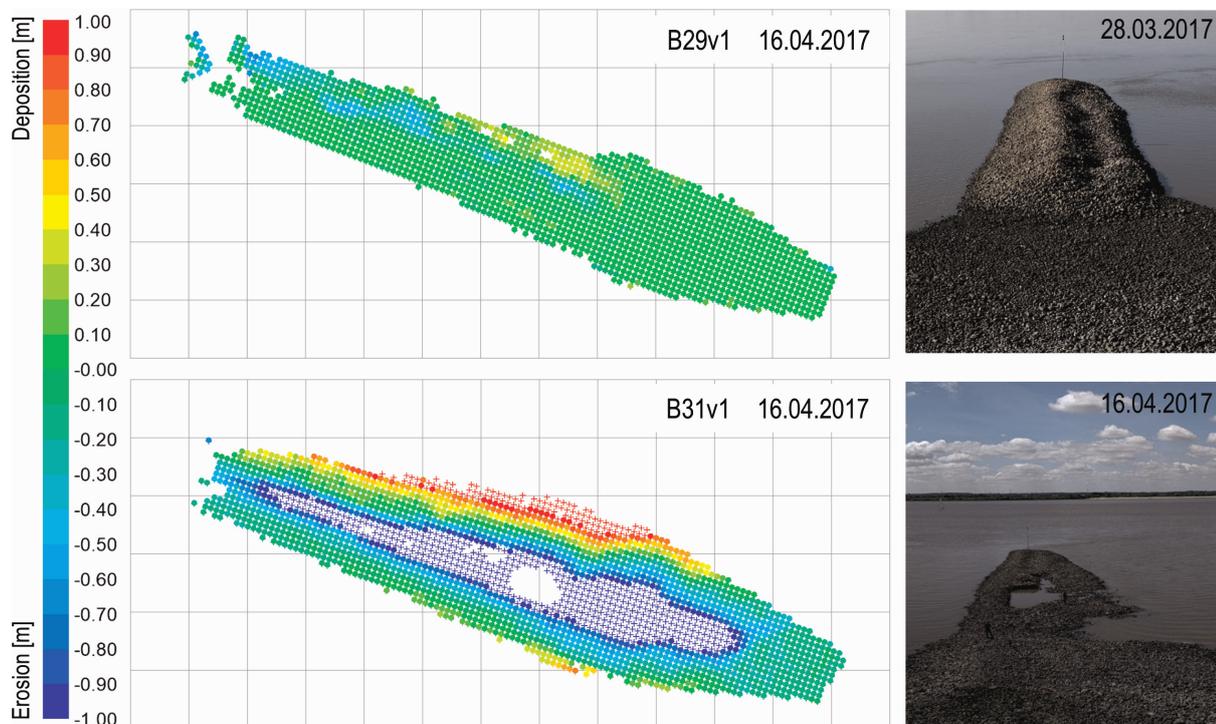
Figure 14: Damage development at B29v1 and B31v1 visualised as difference plots between 07/2015 and 04/2017. Crosses indicate exceedance of scale. Photographs of the groyne condition at or near time of survey.

The damage to the armour layer is assessed by means of changes to the surface elevation between two surveys, as given by difference plots of the survey data. Figure 14 shows the deformation of the rock armour layer in the first groyne variants (B29v1, B31v1) and supporting photographic evidence taken on or close to the date of the survey. The difference plots represent the damage observed between the reference survey in July 2015 and another survey in April 2017, corresponding to a period of 645 days ( $\sim 1.75$  years). Over 6000 ship-induced long-period wave events were registered in this time period. For B29v1 some deformation of the crest and lee side slope area are observed; up to approx. 0.7 m of erosion are recorded here, with greater displacement of rock armour toward the groyne head. The wave-facing slope and the scour protection have remained stable. In contrast, groyne B31v1 displays much more severe deformation of the rock armour layer. The crest is

destroyed over nearly the entire length of the structure and erosion of 1.0–2.0 m, locally exceeding 2.0 m are observed. This has resulted in the exposure of historic groyne construction efforts, which form the core of the structure. The displaced rocks have been re-deposited, predominantly at the groyne foot on the lee side, as a result of the asymmetric loading from overflow events, leading to a flattened and widened appearance. The root area has remained remarkably stable.

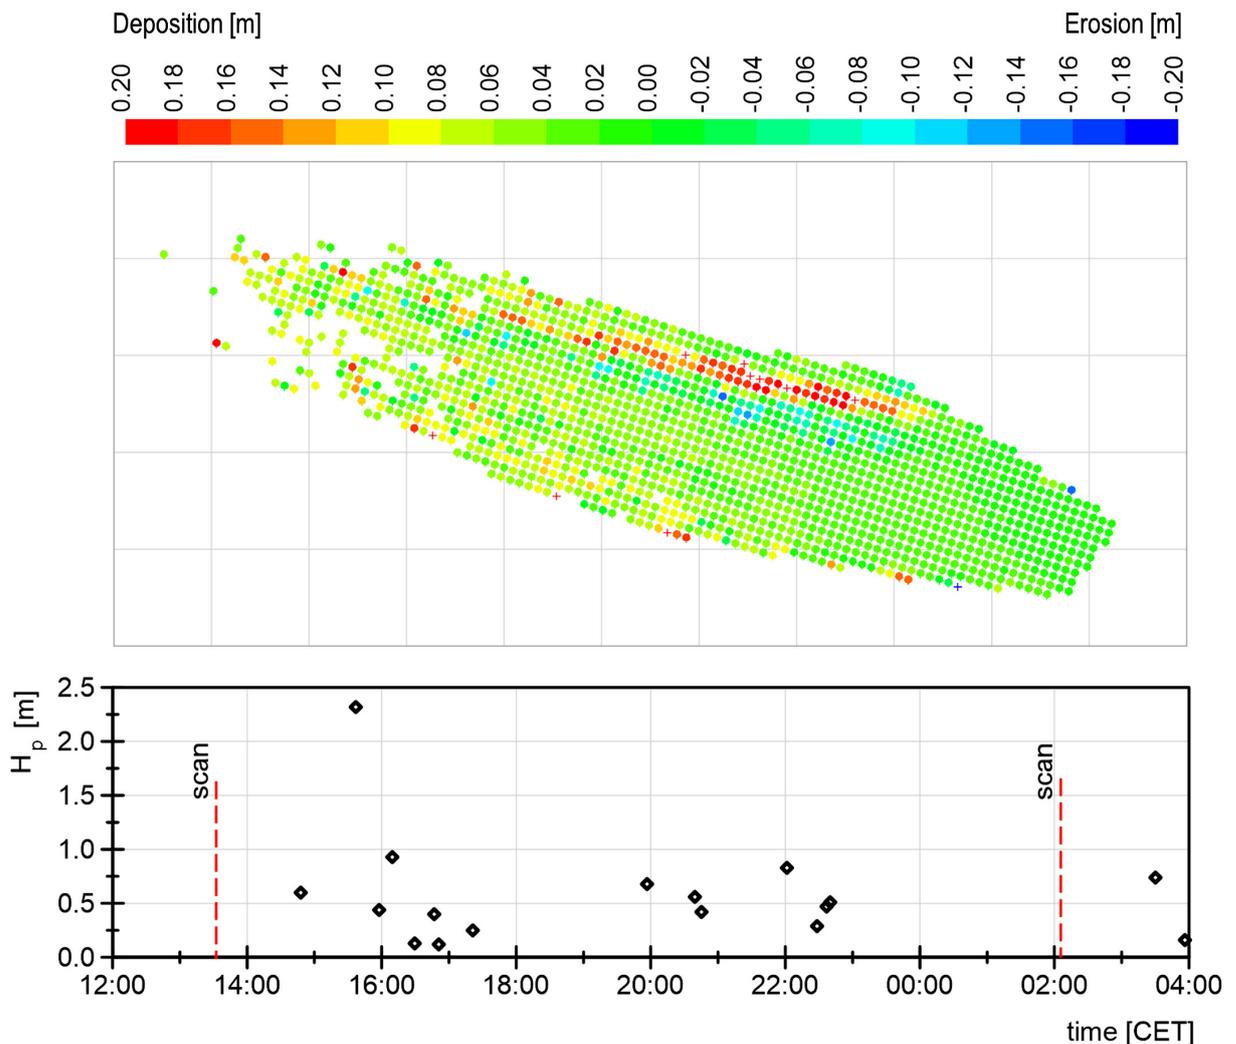
Figure 15: Damage development at B31v1 between two consecutive scans and measured wave heights at the groyne (pos. 5). Crosses indicate exceedance of scale.

The analysis of difference plots suggests that individual events, or the grouping of one or more relatively high-energy events can effect significant damages in the short period of time between consecutive low waters. One such example is illustrated in Figure 15 which shows the damage incurred at B31v1 between low water on the 4<sup>th</sup> and 5<sup>th</sup> of August 2015. A crest-parallel deformation of the lee side slope in the order of  $\pm 0.2$  m (average value for a 1 x 1 m raster cell) is observed, suggesting erosion on the order of approx. one layer of rock. Also shown are the wave events registered in this time. One extreme event with  $H_p = 2.3$  m, among other events of up to 1.0 m, was recorded. The largest event was associated with a vessel of 363 m length and 46 m breadth travelling seaward with 13.7 kn *STW* and 11.5 m draught at approximately mean water level. The vessel passed the groynes at a distance of 187 m.

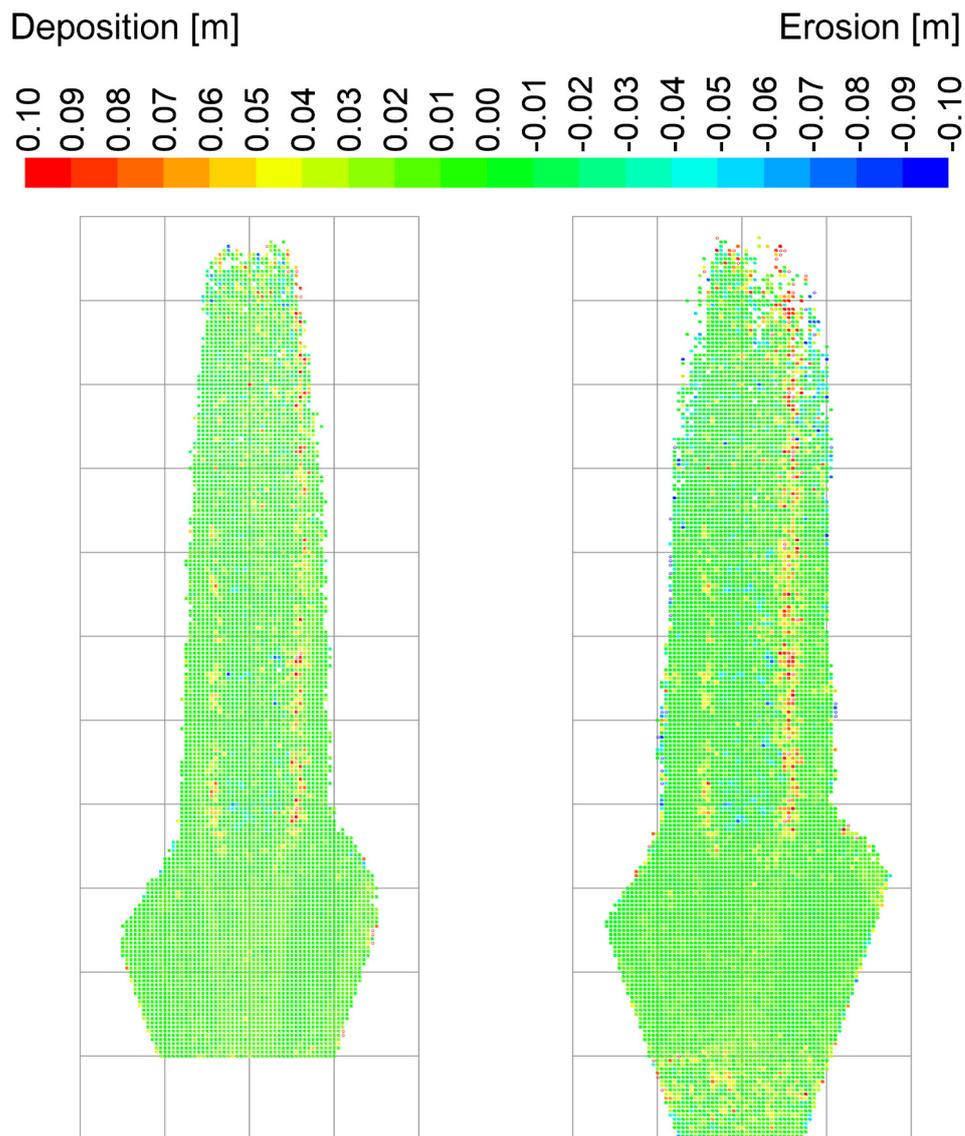
Figure 16: Damage development at B29v2 with larger rock size  $LMB_{5/40}$  visualised as difference plot between 11/2017 and 02/2019 (left) and 12/2019 (right).

Although B29v1 shows significantly enhanced rock armour stability compared to B31v1 despite the same rock grading, the observed damage after only 1.75 years did not satisfy the objectives of sufficiently increased armour layer stability. Subsequently, the groyne was rebuilt with a coarser grading of LMB<sub>5/40</sub> and a reference condition for variant B29v2 was scanned in November 2018. The changes to the rock armour over the time period of 442 days (~1.5 years) to the last scan in February 2019 shows only minor local deformation of typically less than 0.05 m on the wave-facing side and 0.1 m on the lee side (Figure 16). This can be attributed to an initial rearrangement and self-armouring of stones into a more stable position. The deformation pattern follows the previously described crest-parallel pattern, indicating the areas most affected by overflow events. The improved stability and condition of the rock armour layer was confirmed in recent manually conducted scan in December 2019 (Figure 16). It shows that after approximately two years, still very limited damage to the crest and lee side slope in the order of  $\pm 0.1$  m is recorded.

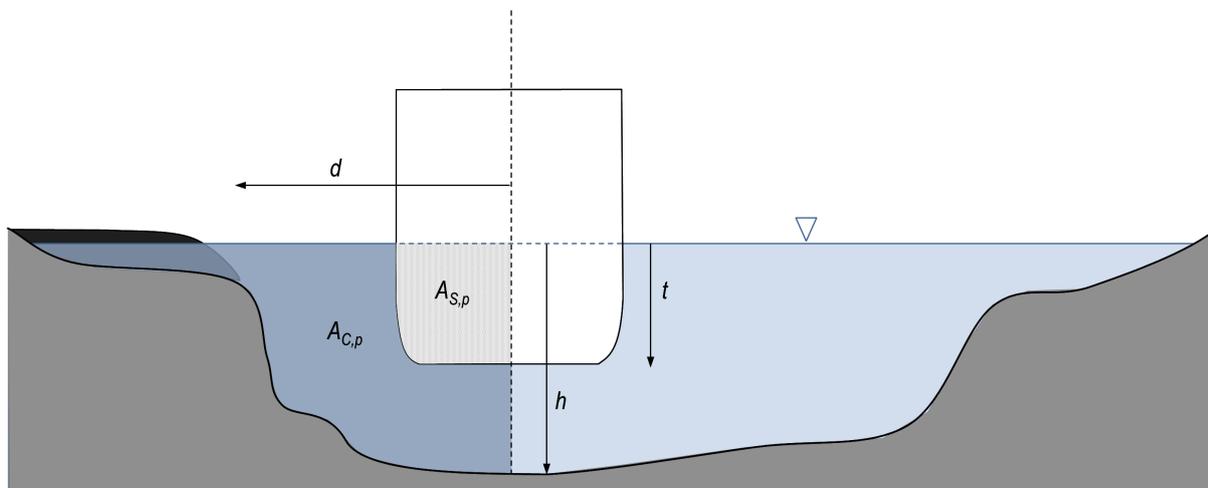
Figure 17: Definition of partial channel blockage factor  $S_p$  with immersed partial midship-section  $A_{S,p}$ , partial waterway cross-section  $A_{C,p}$ , passing distance  $d$ , water depth  $h$  and draught  $t$ .

Mitigating the wave loads at the source is also possible, but requires an understanding of how the nautical factors, in particular those that can be managed by vessel traffic regulations, influence the height of the near-shore wave at a specific site. Although the physics indicate the expected correlations between nautical parameters and incident primary wave heights, examination of the relationships in the field data set shows significant scatter, as would reasonably be expected. Nevertheless, certain parameter constellations can be identified which appear to favour the occurrence of large waves. At the study site for example the largest waves appear to be facilitated by conditions of highest vessel speed and channel blockage. Channel blockage is given by the blockage factor  $S = A_C / A_S$ , the ratio of the cross-sectional area of the waterway  $A_C$  and the ship's immersed midship-section  $A_S$ . It follows, that the blockage factor in a certain waterway cross-section is a function of ship breadth, draught and water level. To also account for the passing distance, the partial channel blockage factor  $S_P = A_{C,p} / A_{S,p}$  is introduced. Hereby only the part of the waterway cross-section and immersed midship-section comprising the area between vessel centreline

and the relevant shoreline is used as illustrated in Figure 17. The largest waves occur at high blockage, i.e.  $S_p$  ratios of approx. 5–10 (see Figure 18).

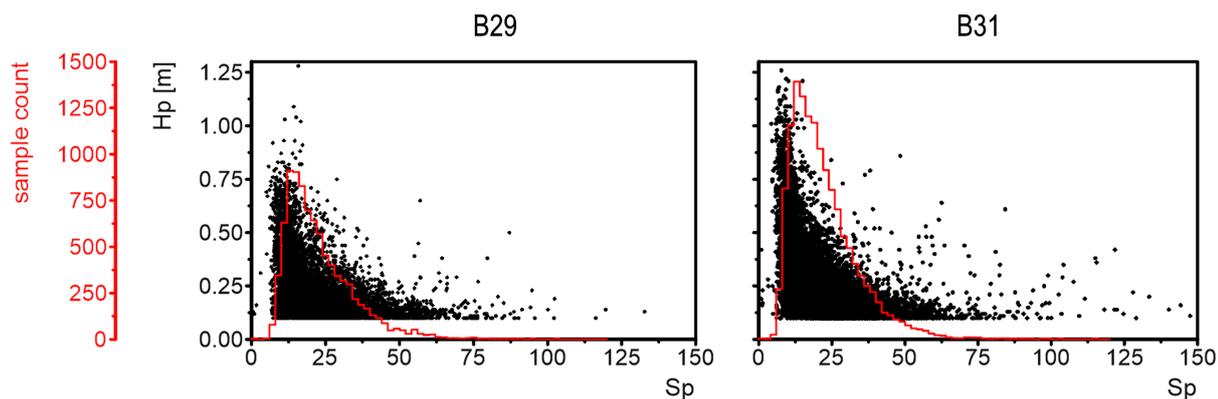
Figure 18: Influence of partial channel blockage factor  $S_p$  on primary ship wave height  $H_p$  at the heads of groynes B29 and B31. Sample count in red.

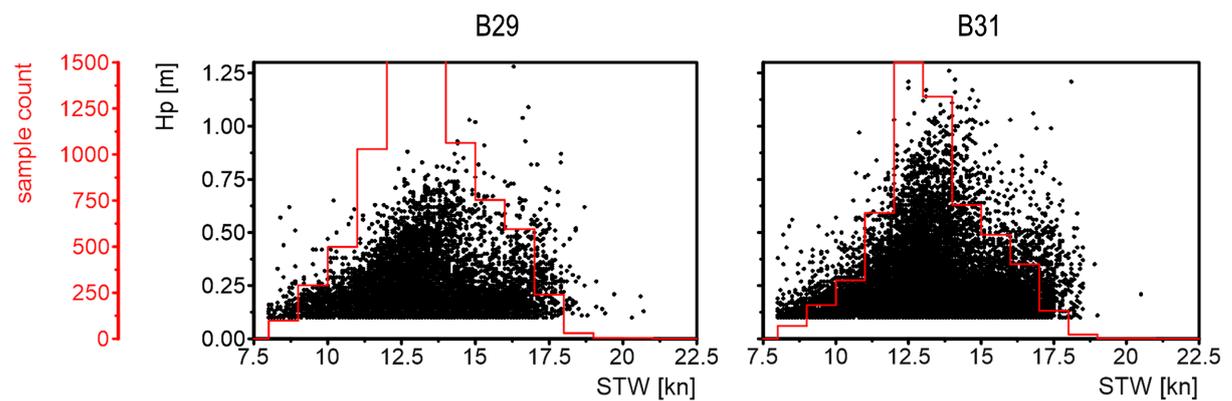
Figure 19: Influence of vessel STW on primary ship wave height  $H_p$  at the heads of groynes B29 and B31. Sample count in red.

Figure 19 also shows the vessel speed through water in relation to the long-period wave heights. It can be observed that the maximum wave heights increase with speed until approx. 15 kn. Beyond that greater scatter and reduced sample size is observed. One factor contributing to the scatter is the fact that high-speed passages are often associated with smaller feeder ships, which despite the higher  $STW$  tend to produce smaller waves than ULCVs due to the lower partial channel blockage (high  $S_p$  value).
