# Full scale stability tests

Dr. C. Zwanenburg

30 september 2016

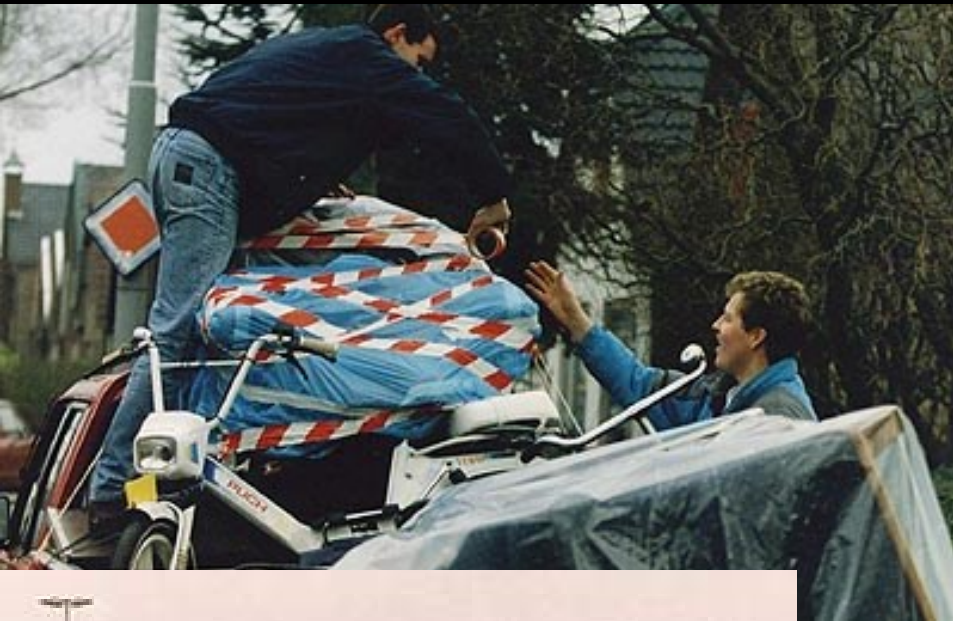
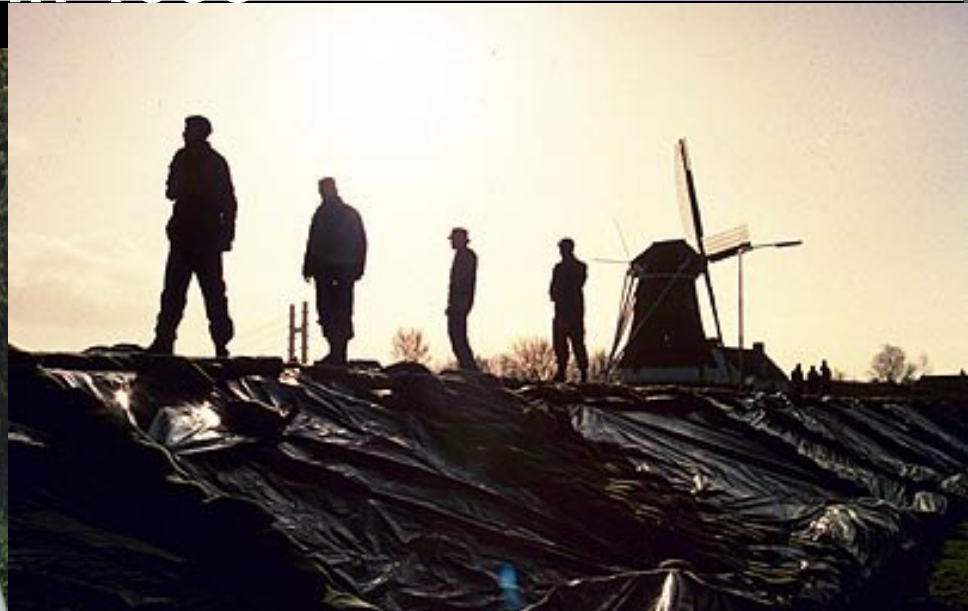
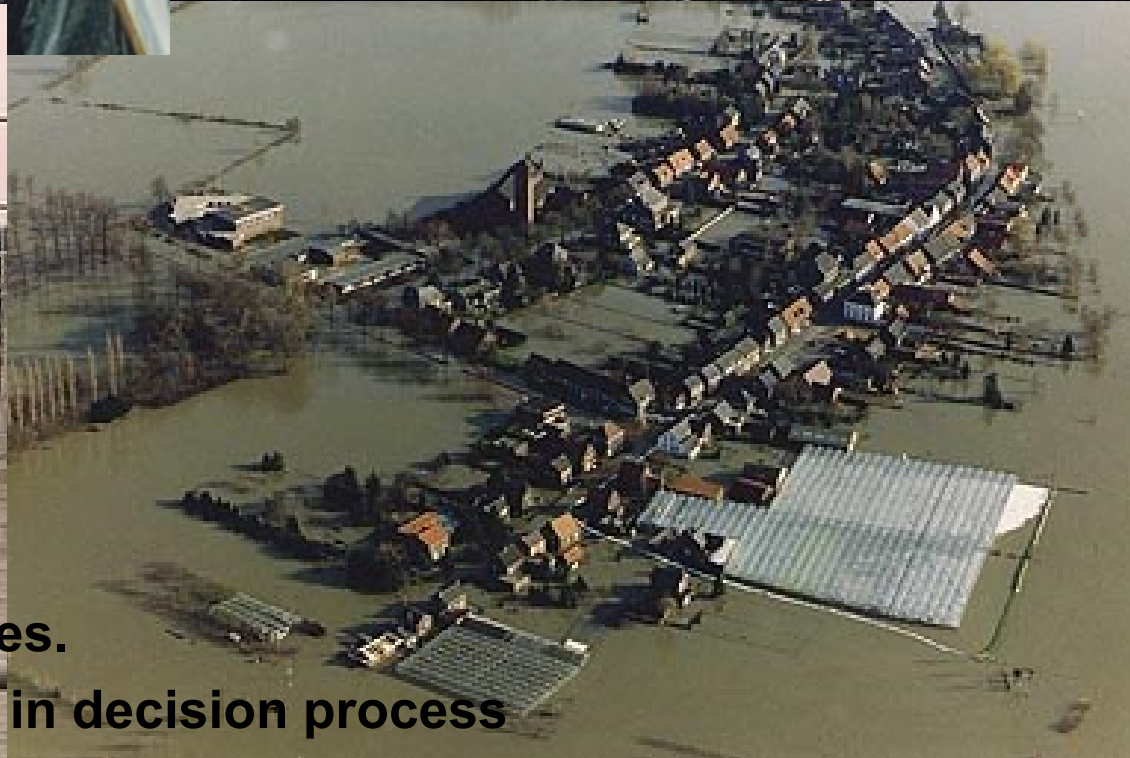
# Evacuation 210000 people in 1995

**Decision of evacuation was based on expert opinions  
Height was not a problem but strength (stability) of levees.  
Need for forecasting strength in decision process**

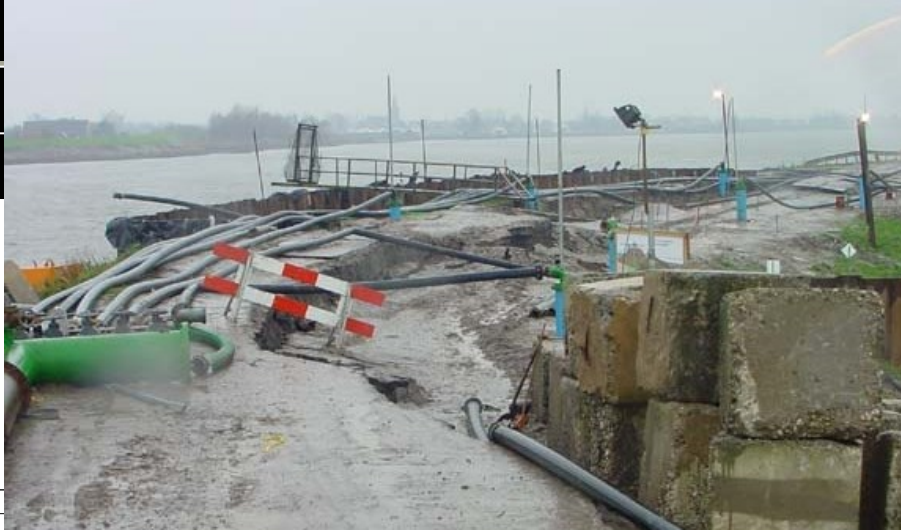
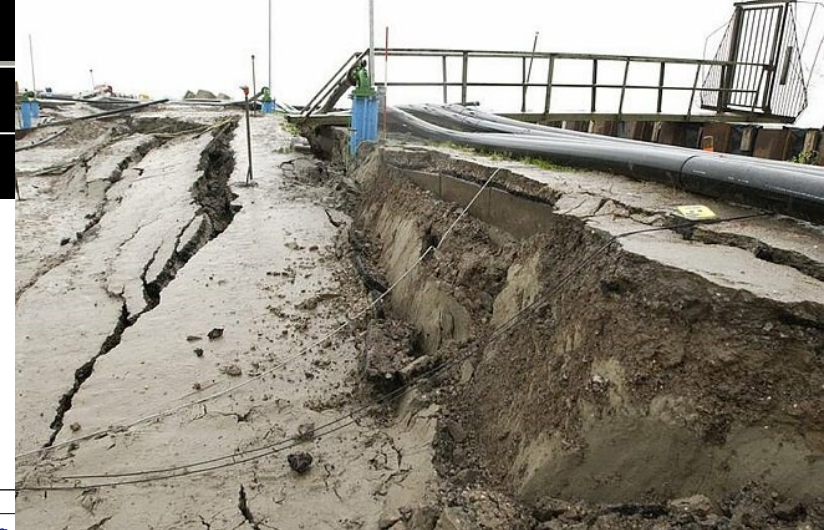
Metingen Proefterrein Bergambacht  
 Drukken in dwarsraai en rivierwaterstand  
 Infiltratiedebiet

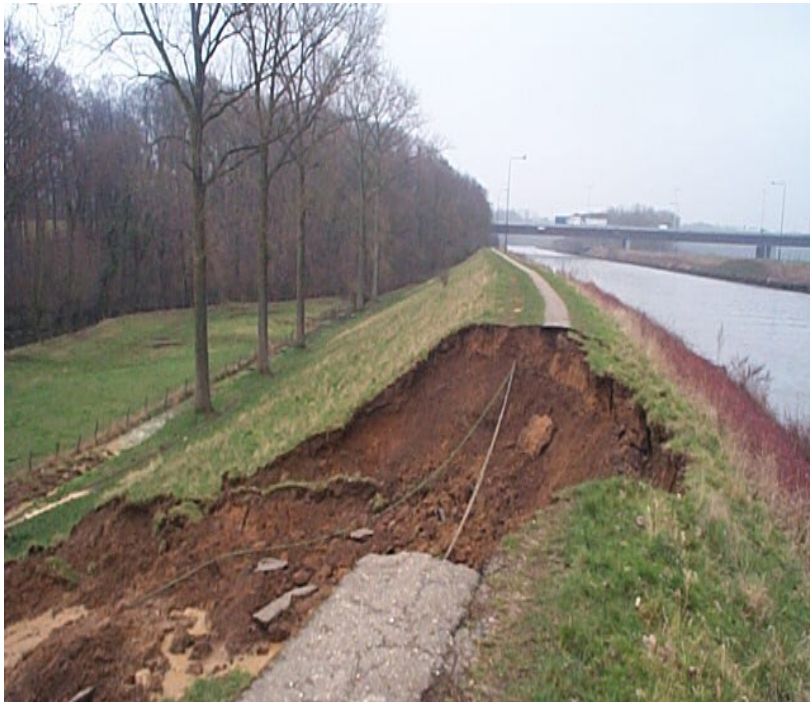
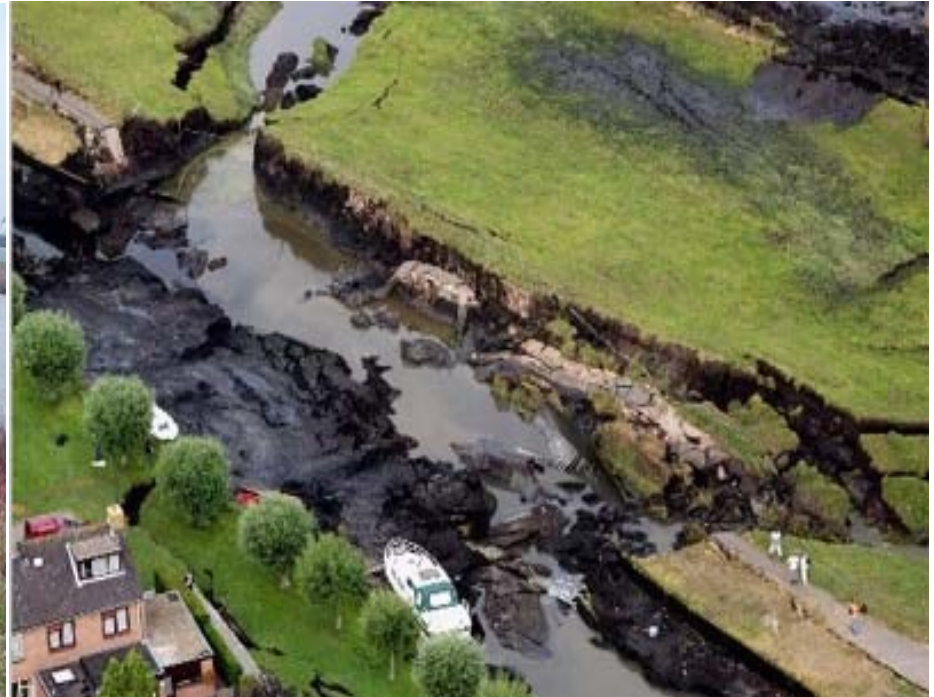
After events in Stein and Wilnis push from sensor technology.

- . Which sensors are useful?
- . At what location?
- . Length of period between warning and dike failure?

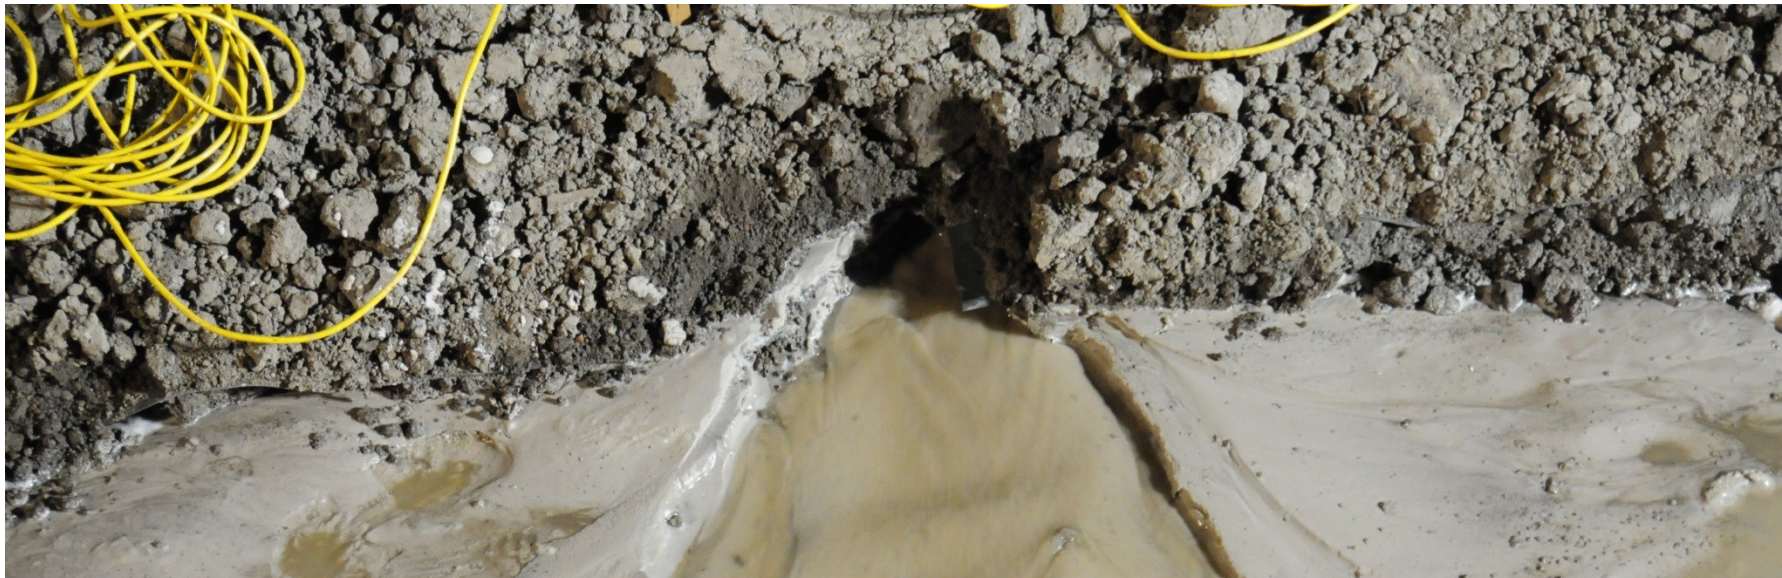
# Observations: Failure

Next, either breakthrough or only settlement of the levee, causing a re-start of the widening proces

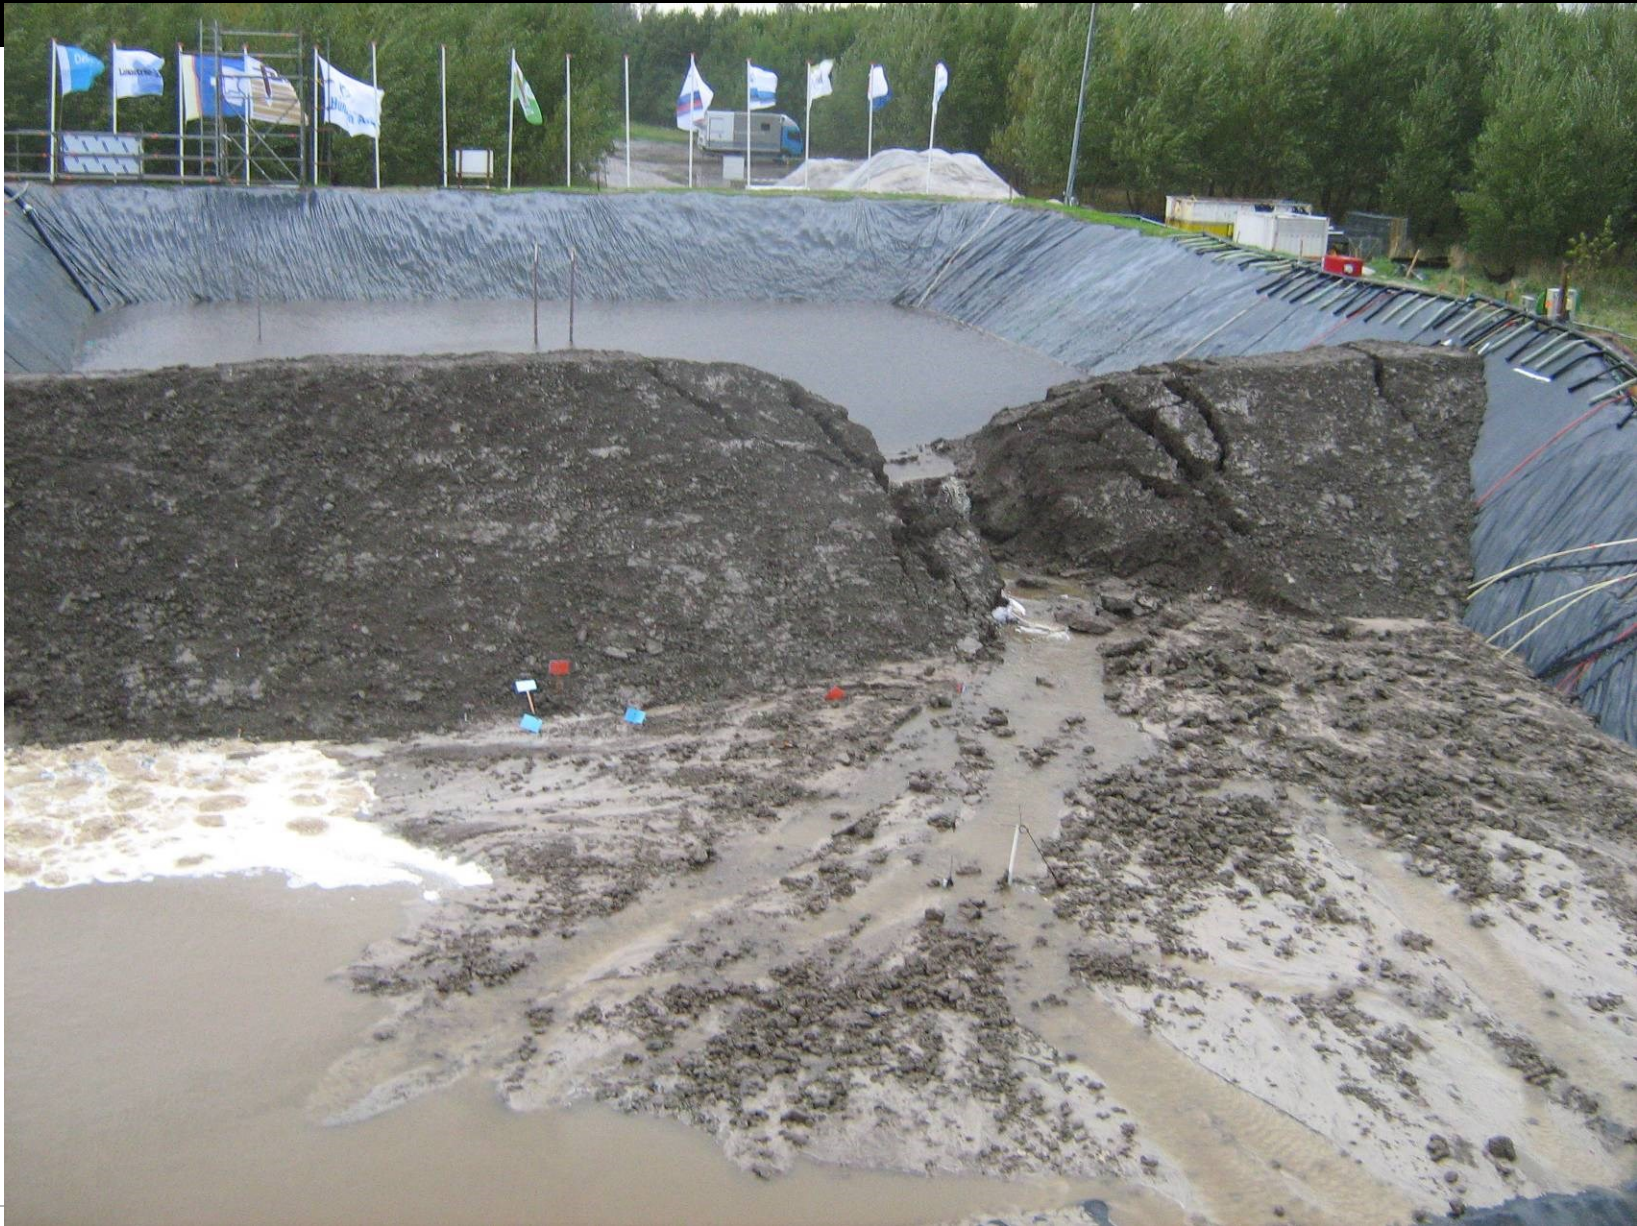
Test 1

# Observations: failure of levee

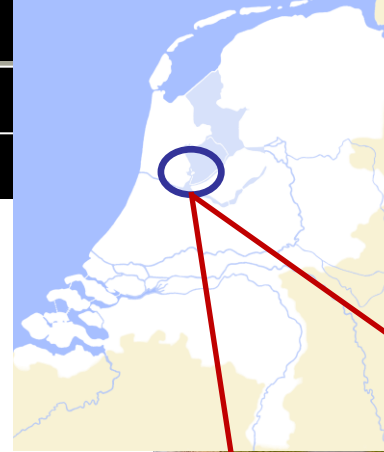
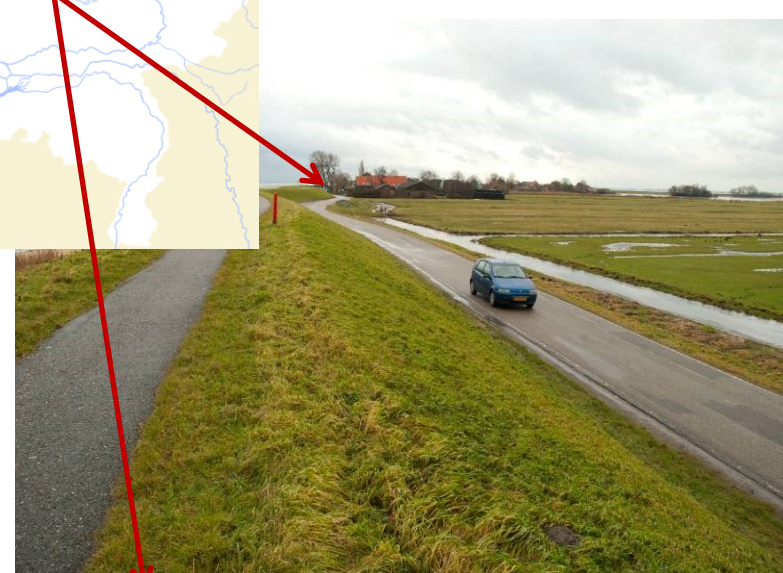
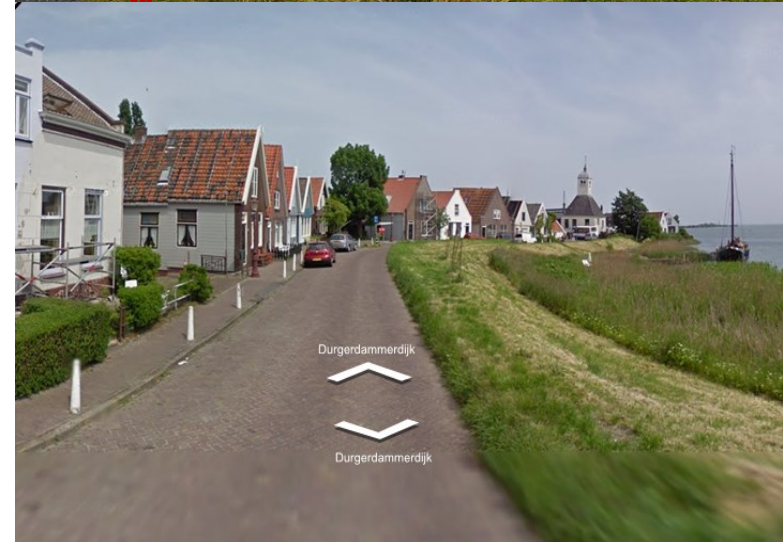
A 30 km long dike near Amsterdam does not fulfill the required safety level. However, the origin of the dike is more than 800 years old and closing the direct connection to the sea (1932) reduced max water levels considerably

The calculated stability does not match engineering judgment.

Uncertainty in the peaty subsoil contributes strongly to the low, calculated, stability factors

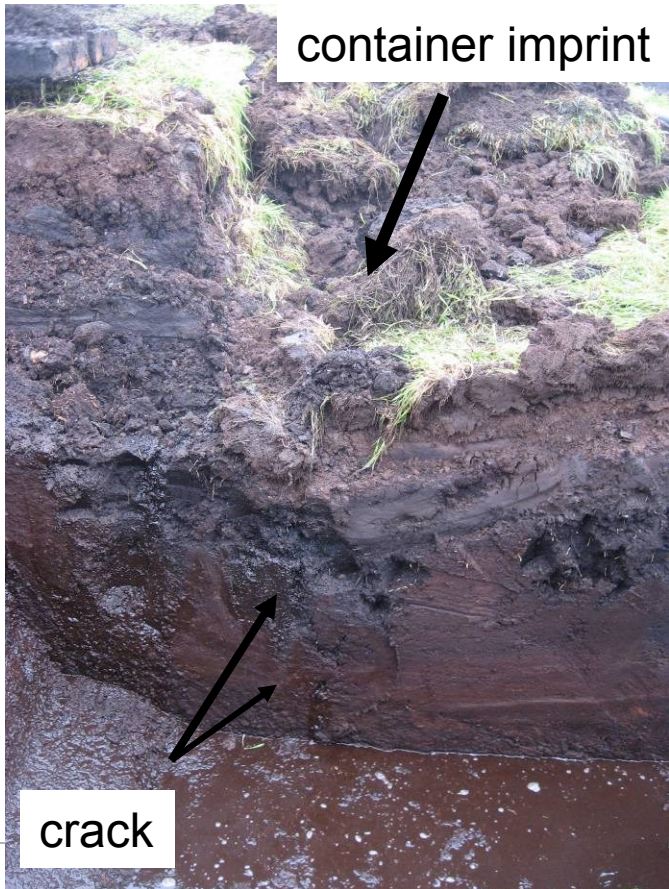
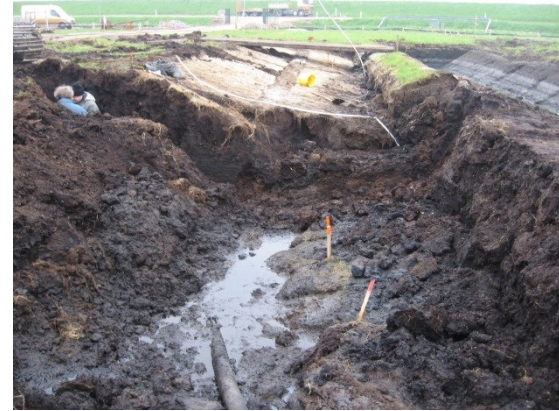
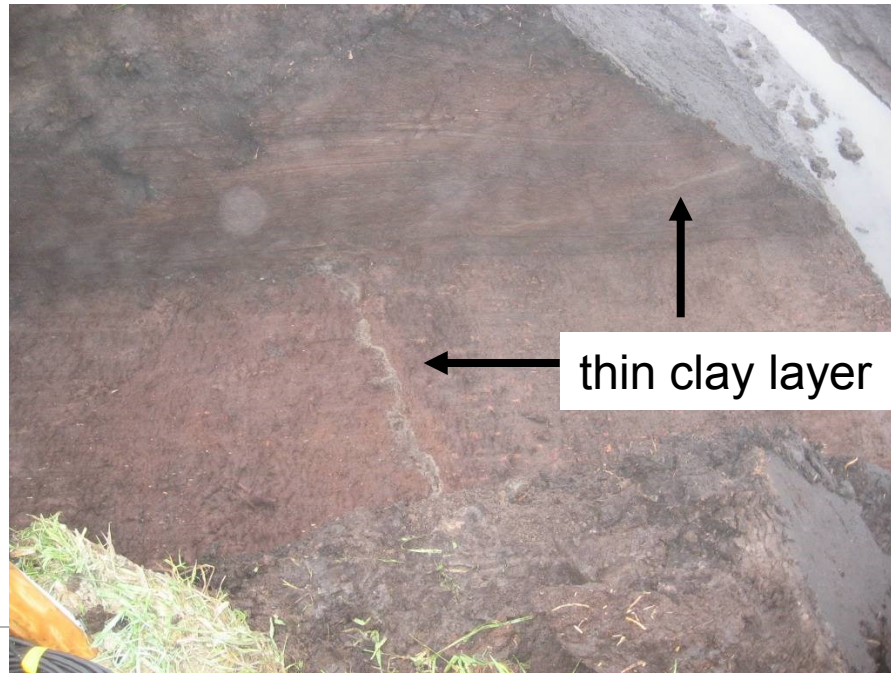
# Finding Failure mechanism

- Failure is reached in each test
- The failure mechanism is established by excavating trial pits and displacement measurements
- Brittle behaviour is observed in test 6, ductile in tests 1 and 2
