6th International Conference on Scour and Erosion

## Scour at Unknown Foundations

or What I Did on My Summer Vacation

# Scour Plans of Action (POAs)

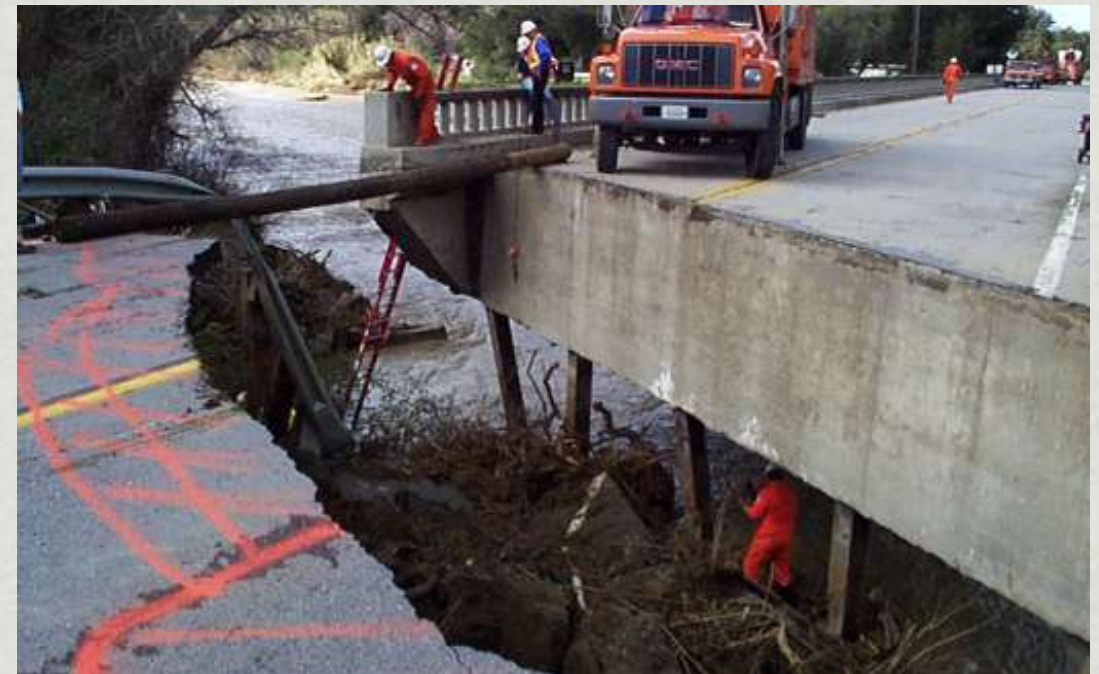
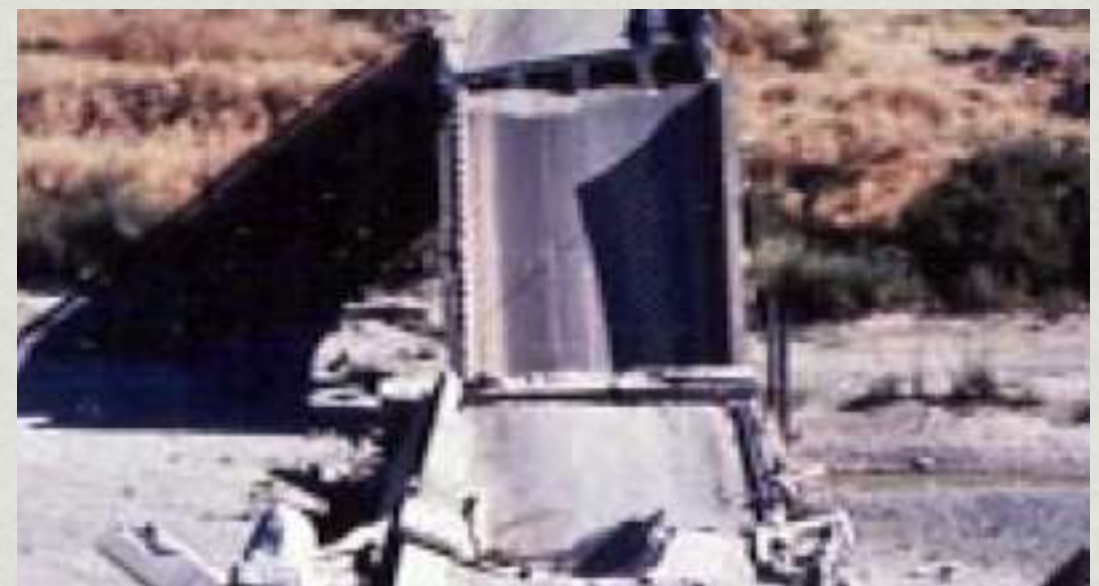
# Structural: Failure Mechanism

- ✱ What is the Structure Type?

- ✱ Monolithic
- ✱ Robust System
- ✱ Redundant Systems

- ✱ Mechanism for Failure?

- ✱ Catastrophic Failure
- ✱ Deformational
- ✱ Slow Rotational

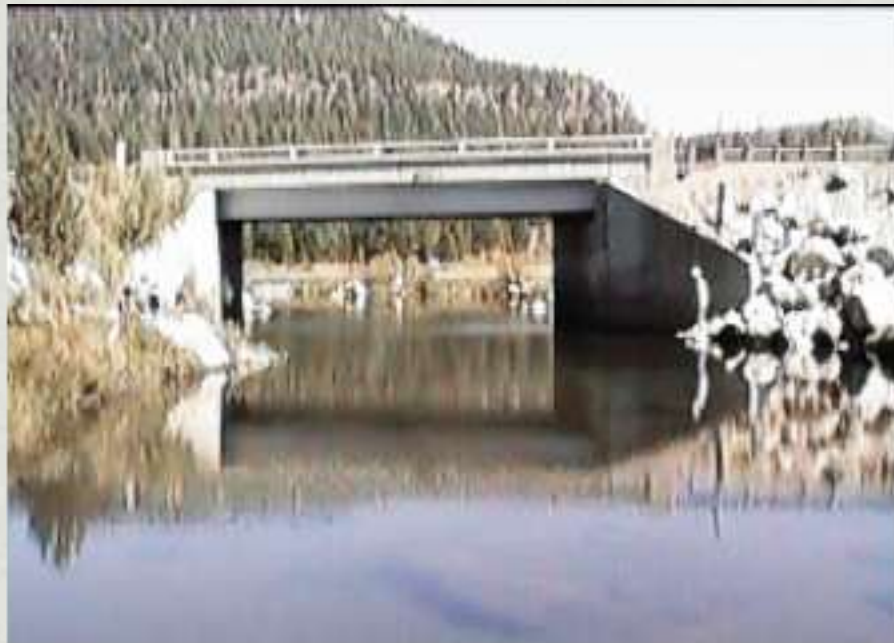
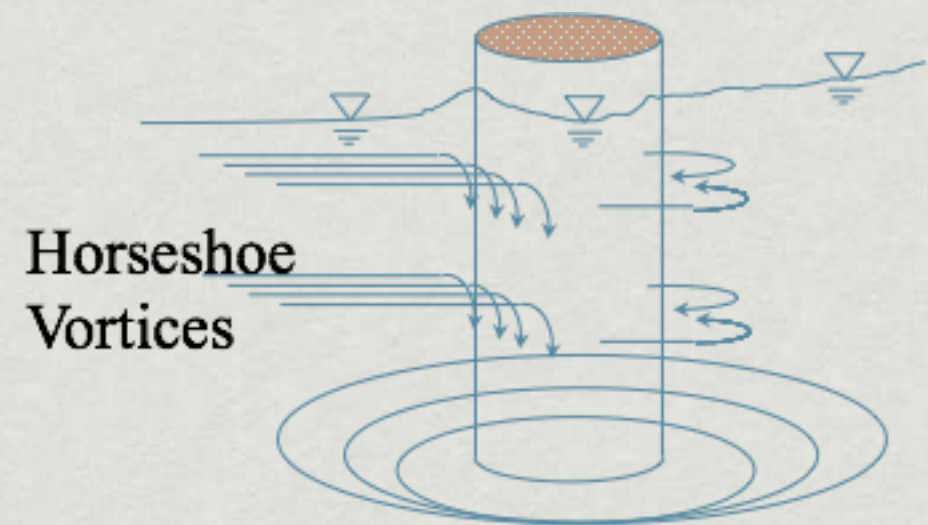
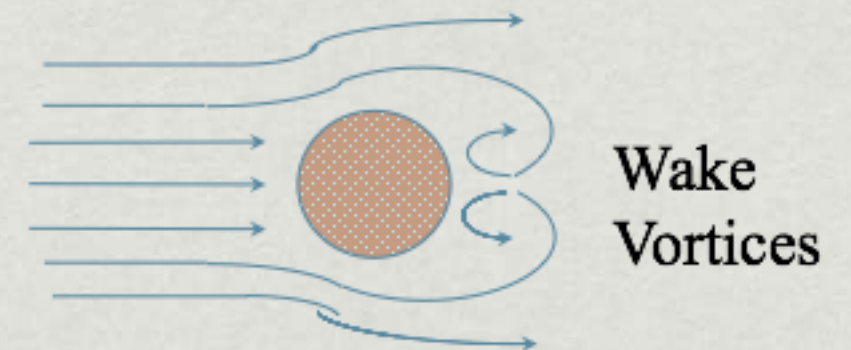
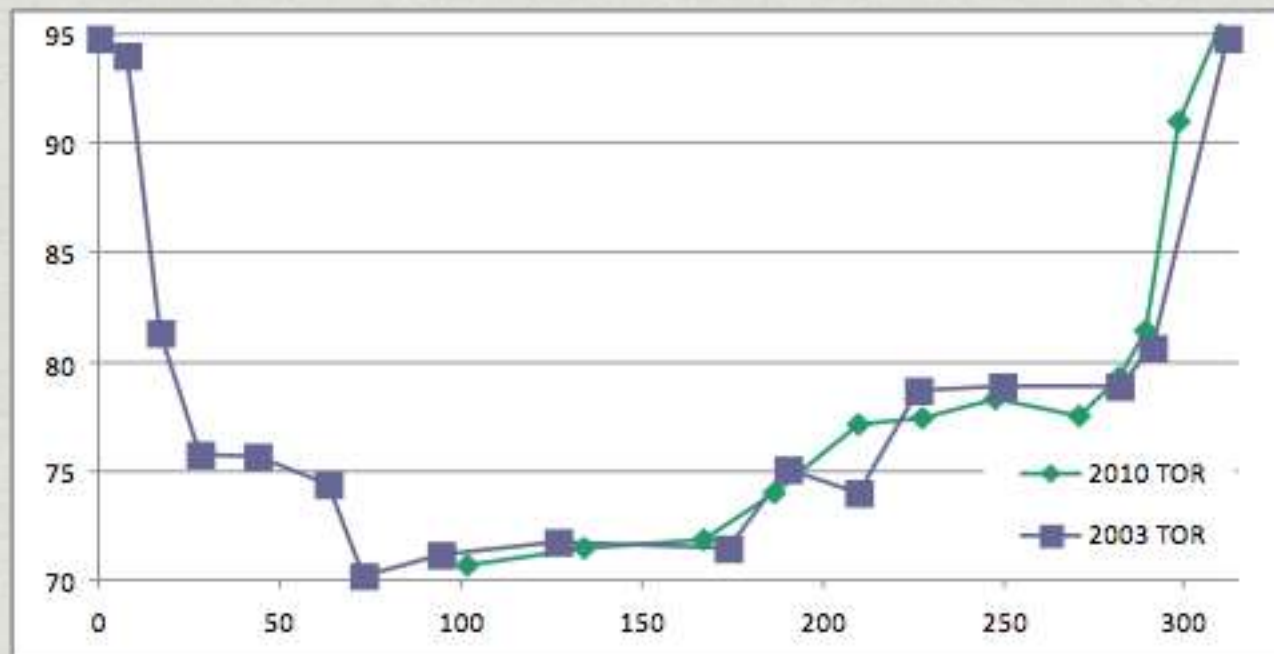
# Hydraulics: Classic Scour Analysis

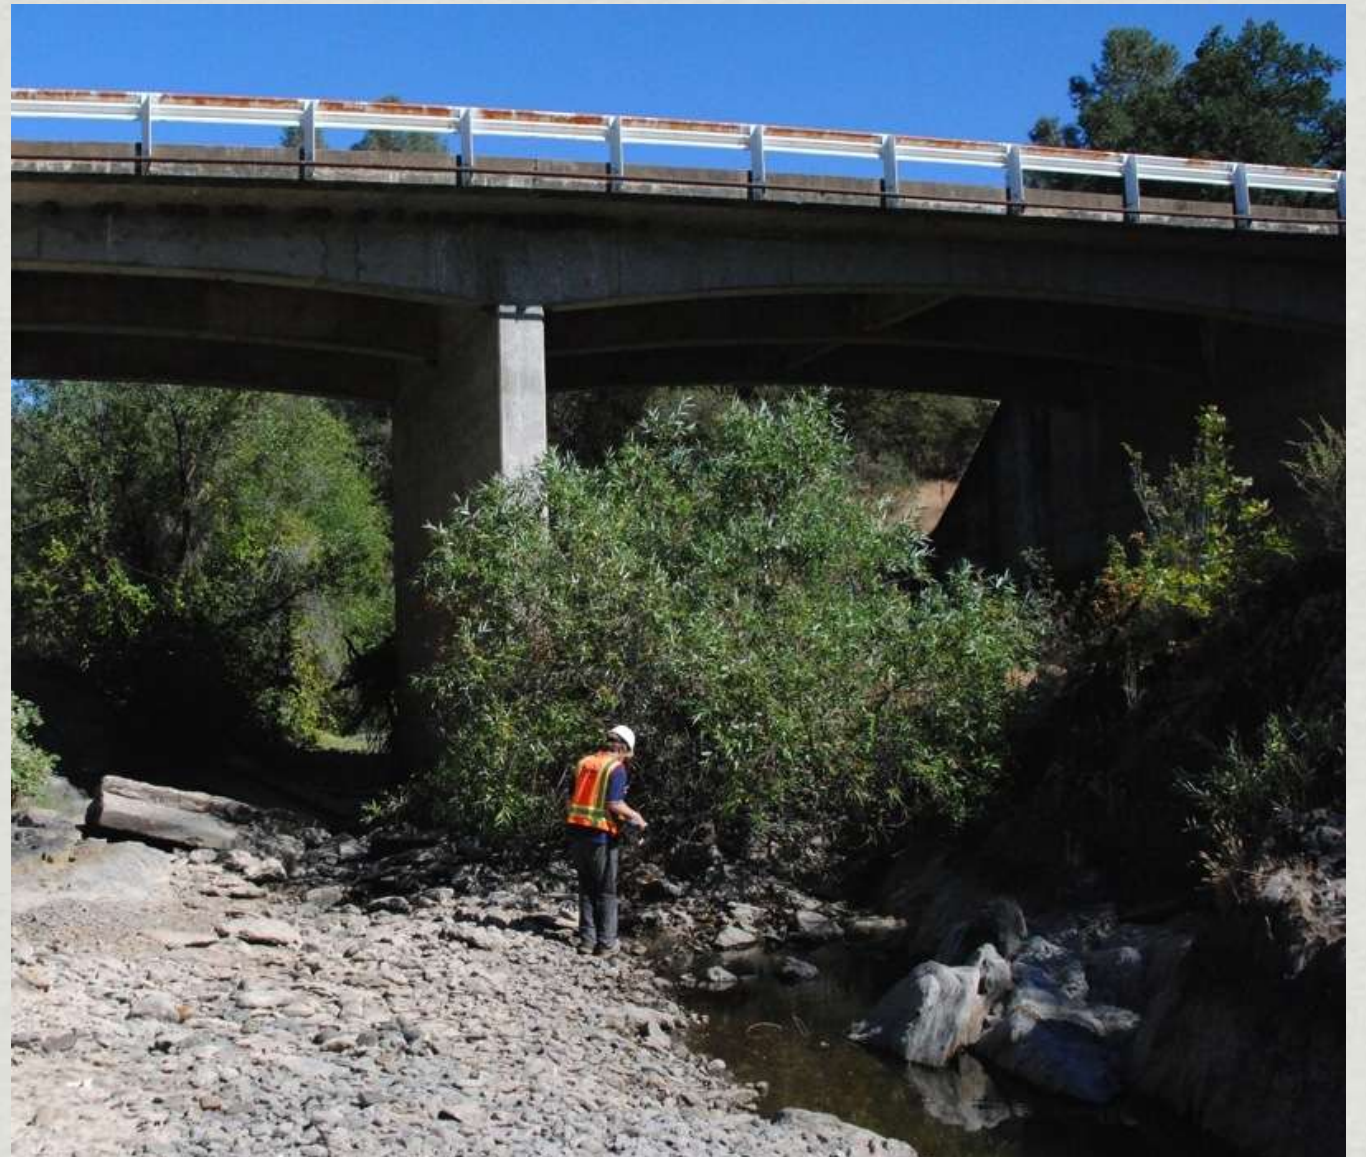
# Geotechnical: Are you in rock?

- \* Alluvium
- \* In Rock vs. On Rock
  - \* Level of Security
- \* Joints
  - \* Adverse?
- \* Rock Quality
  - \* Erodible?

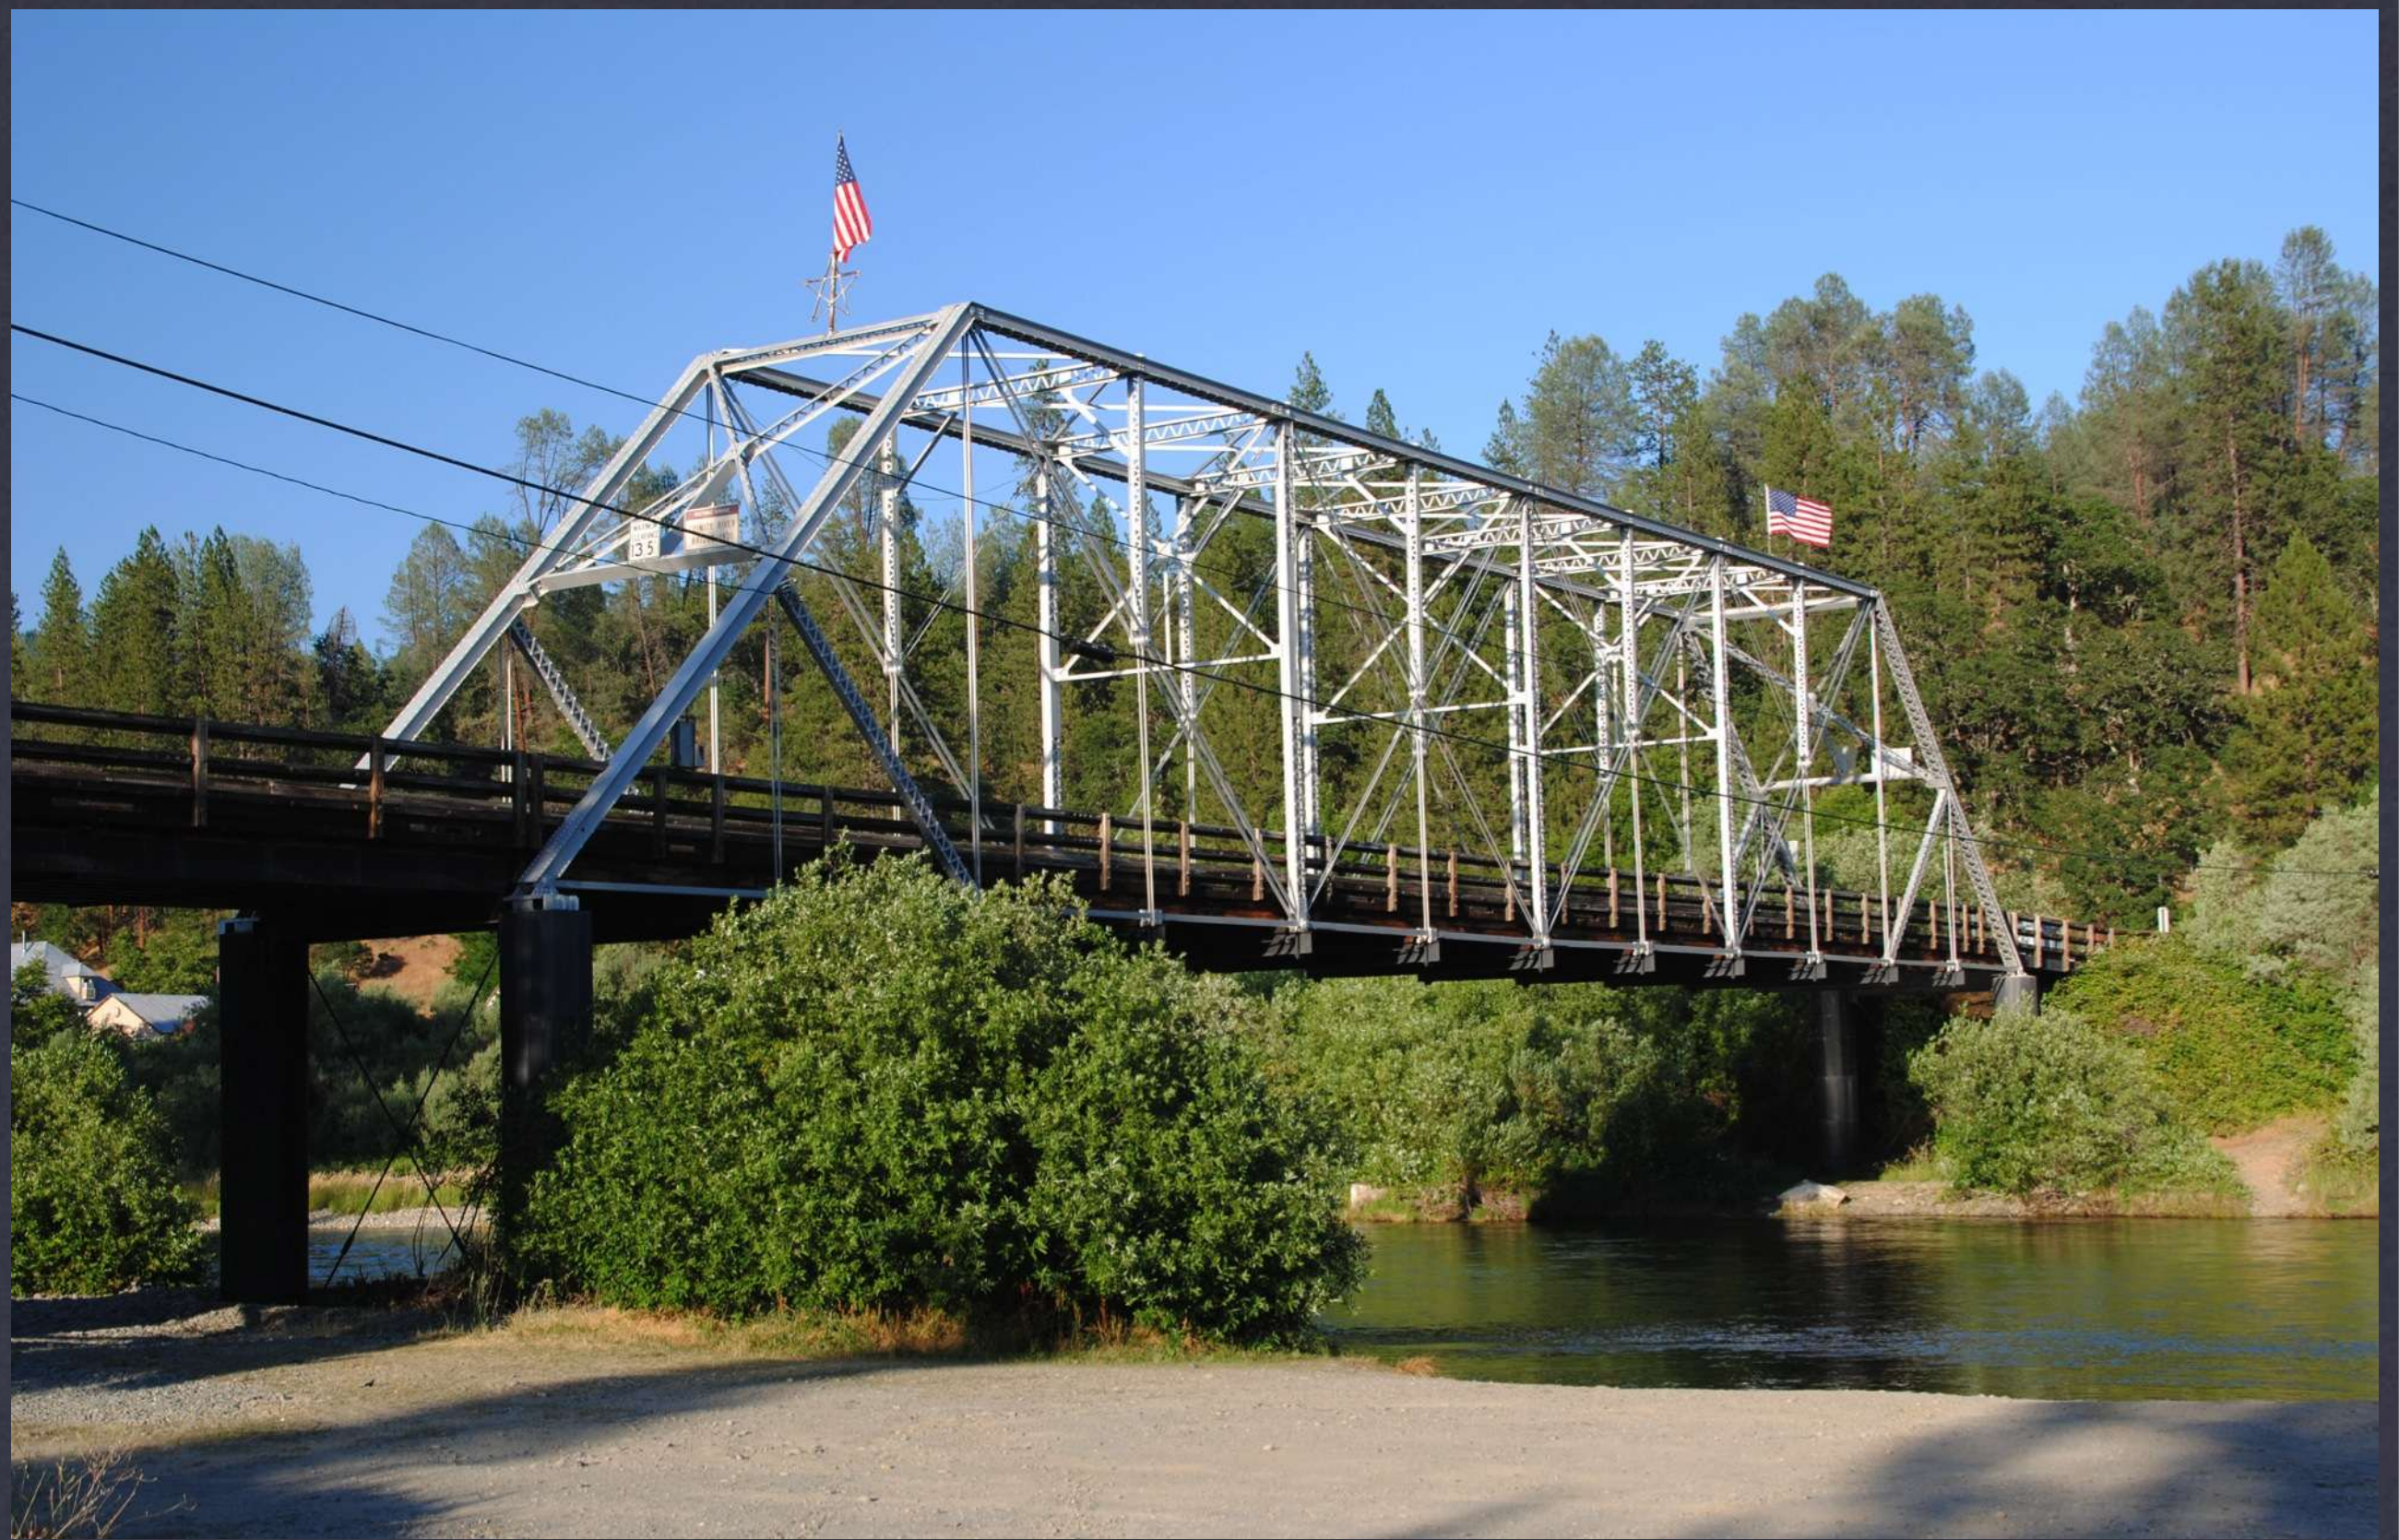
# Lewiston Bridge - Trinity River, Trinity County, CA

Hydraulics Control

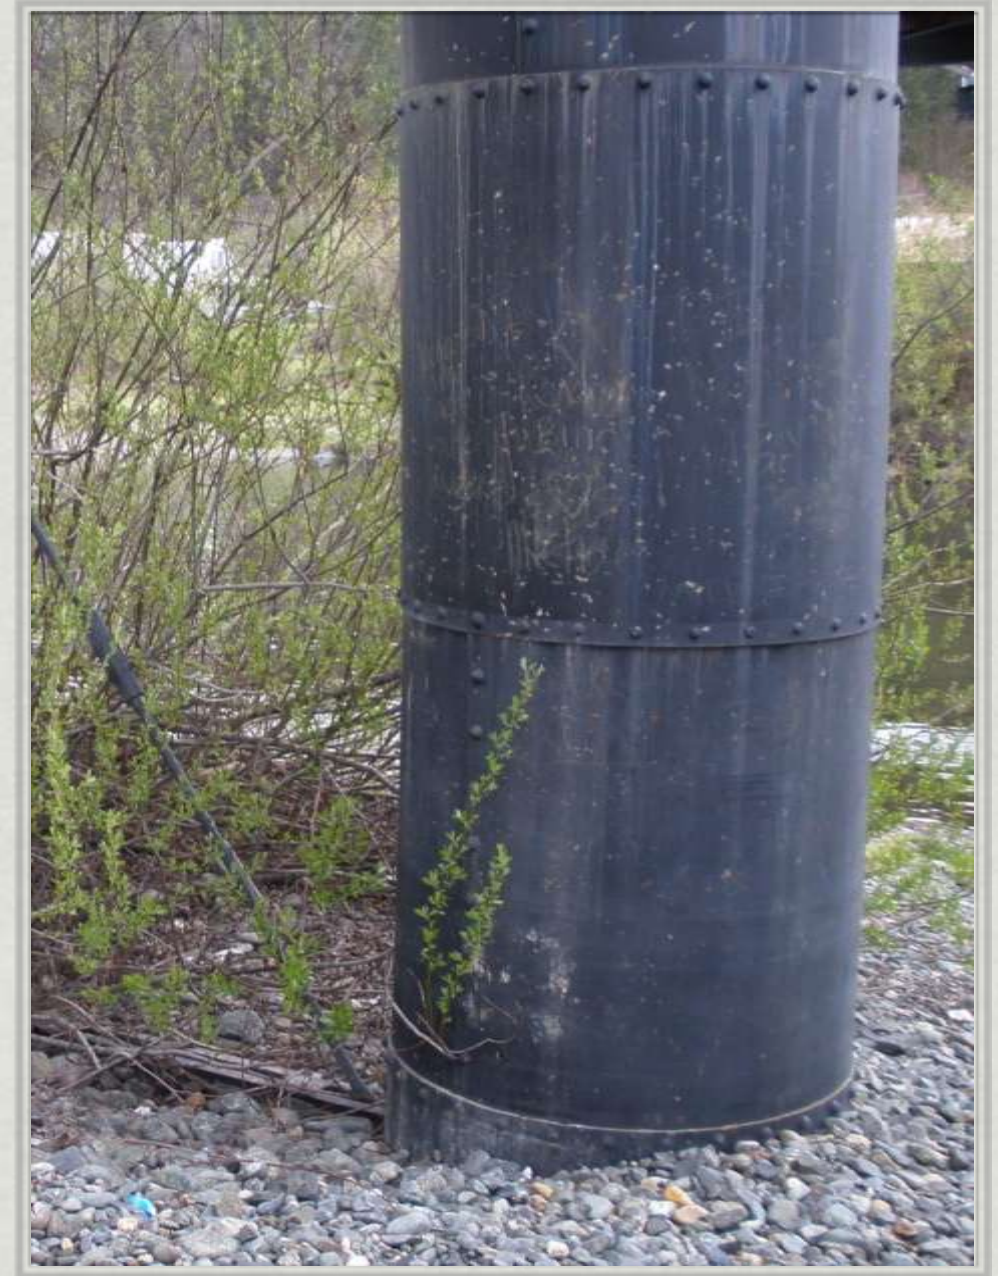
# Lewiston Bridge

- \* Built in 1901
- \* Columns Made from Mining Materials and Riveted
- \* Main Truss Survived 1952 Flood (200-yr?)
- \* Upstream Dam Started in 1954 Finished in Early 60s

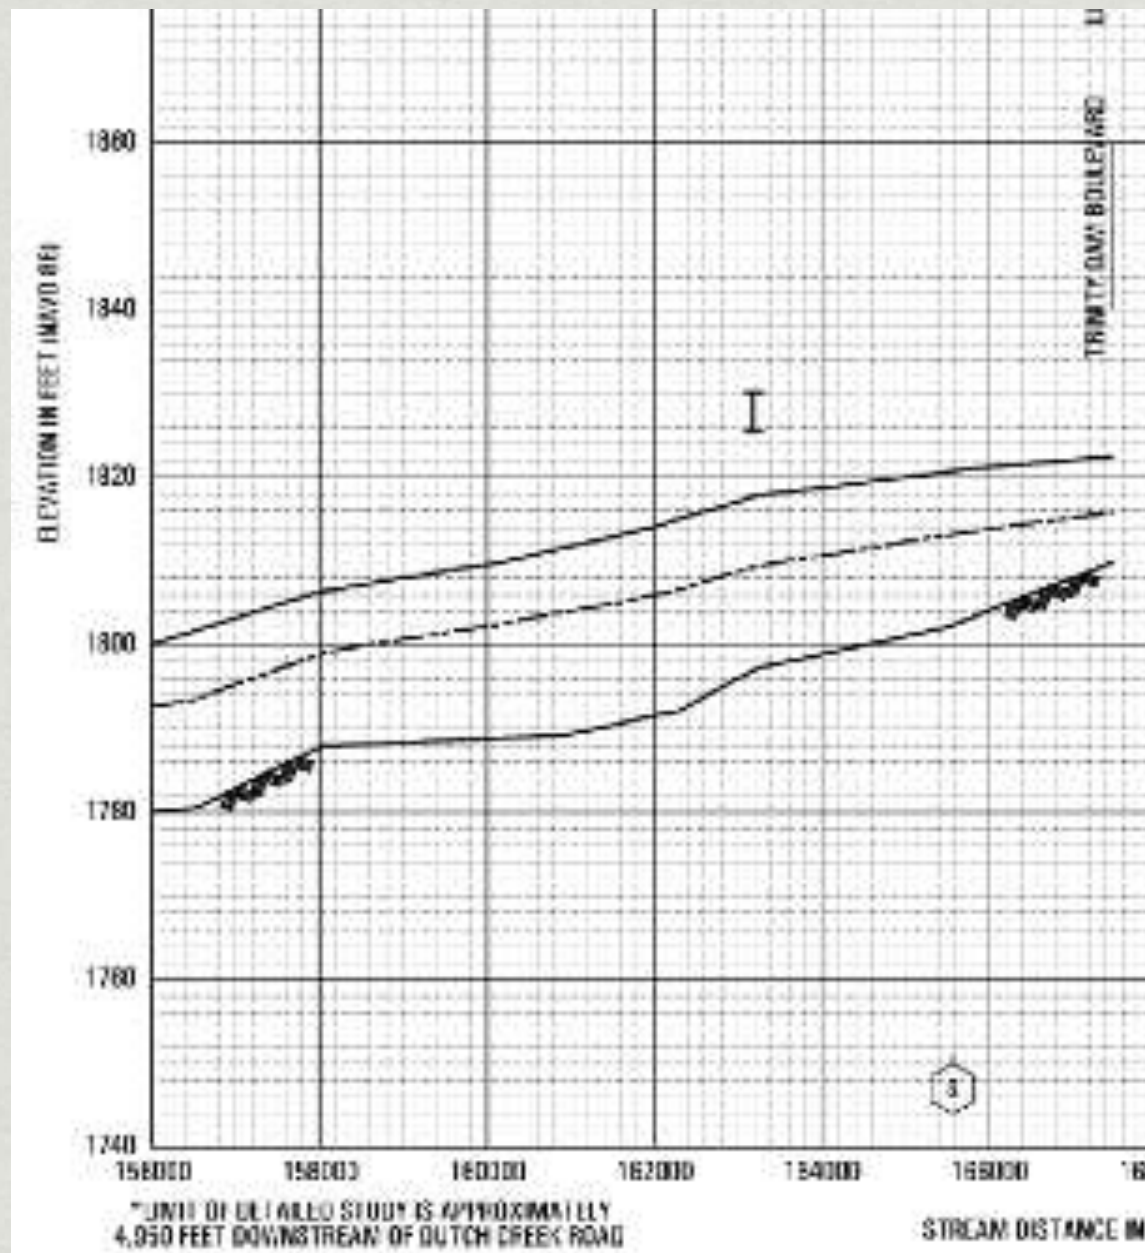
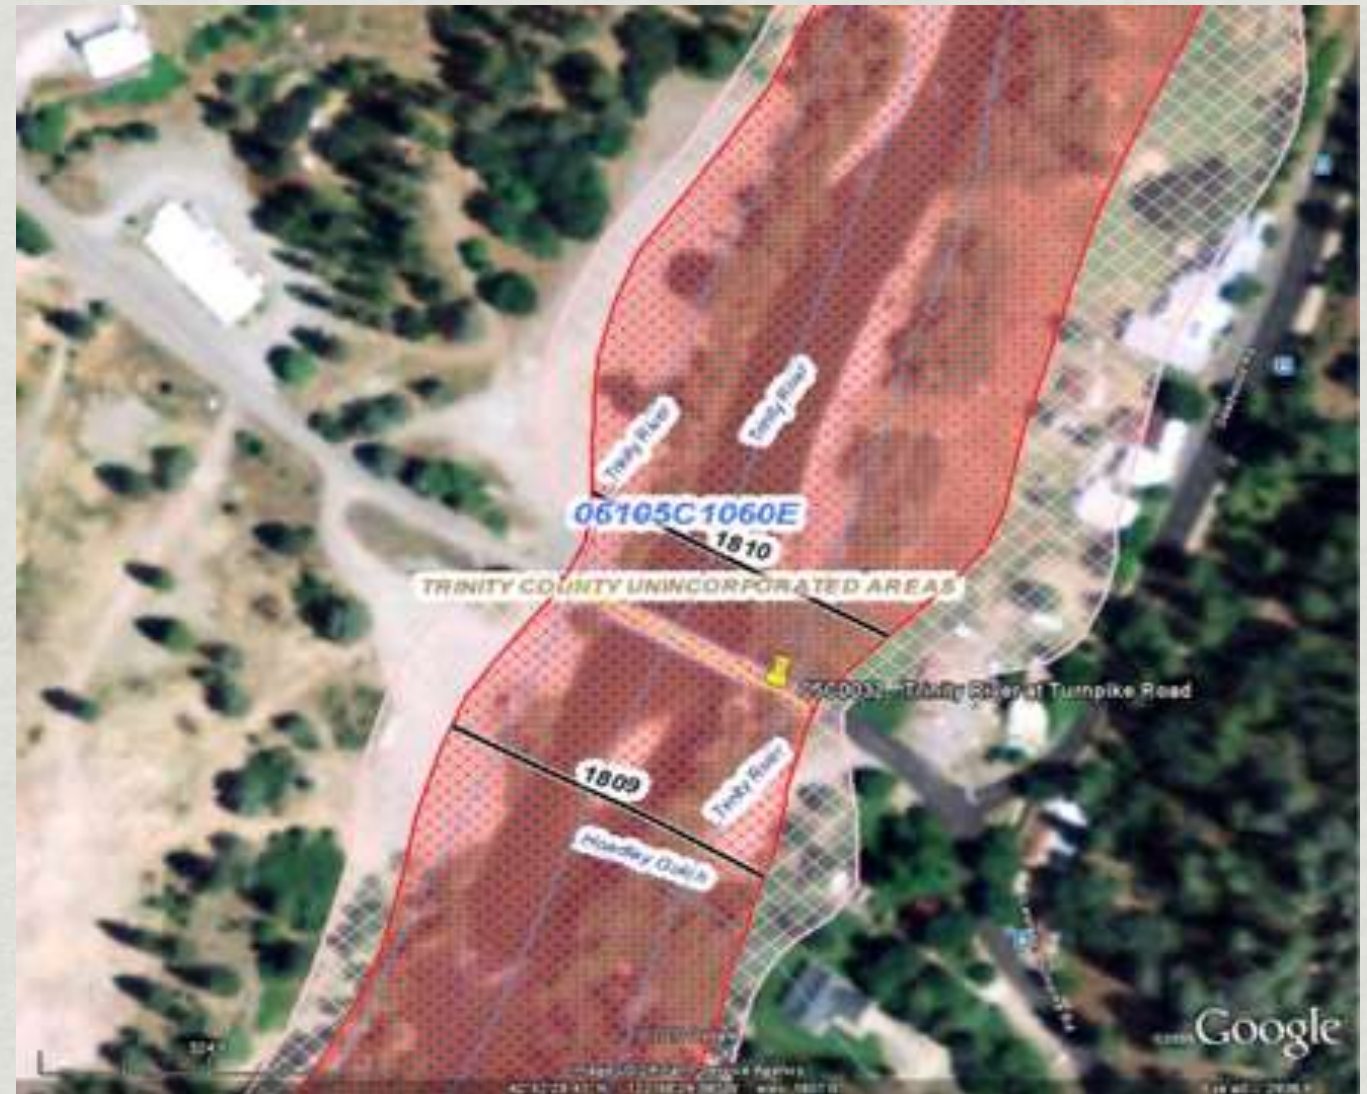
# Lewiston Hydraulic Analysis

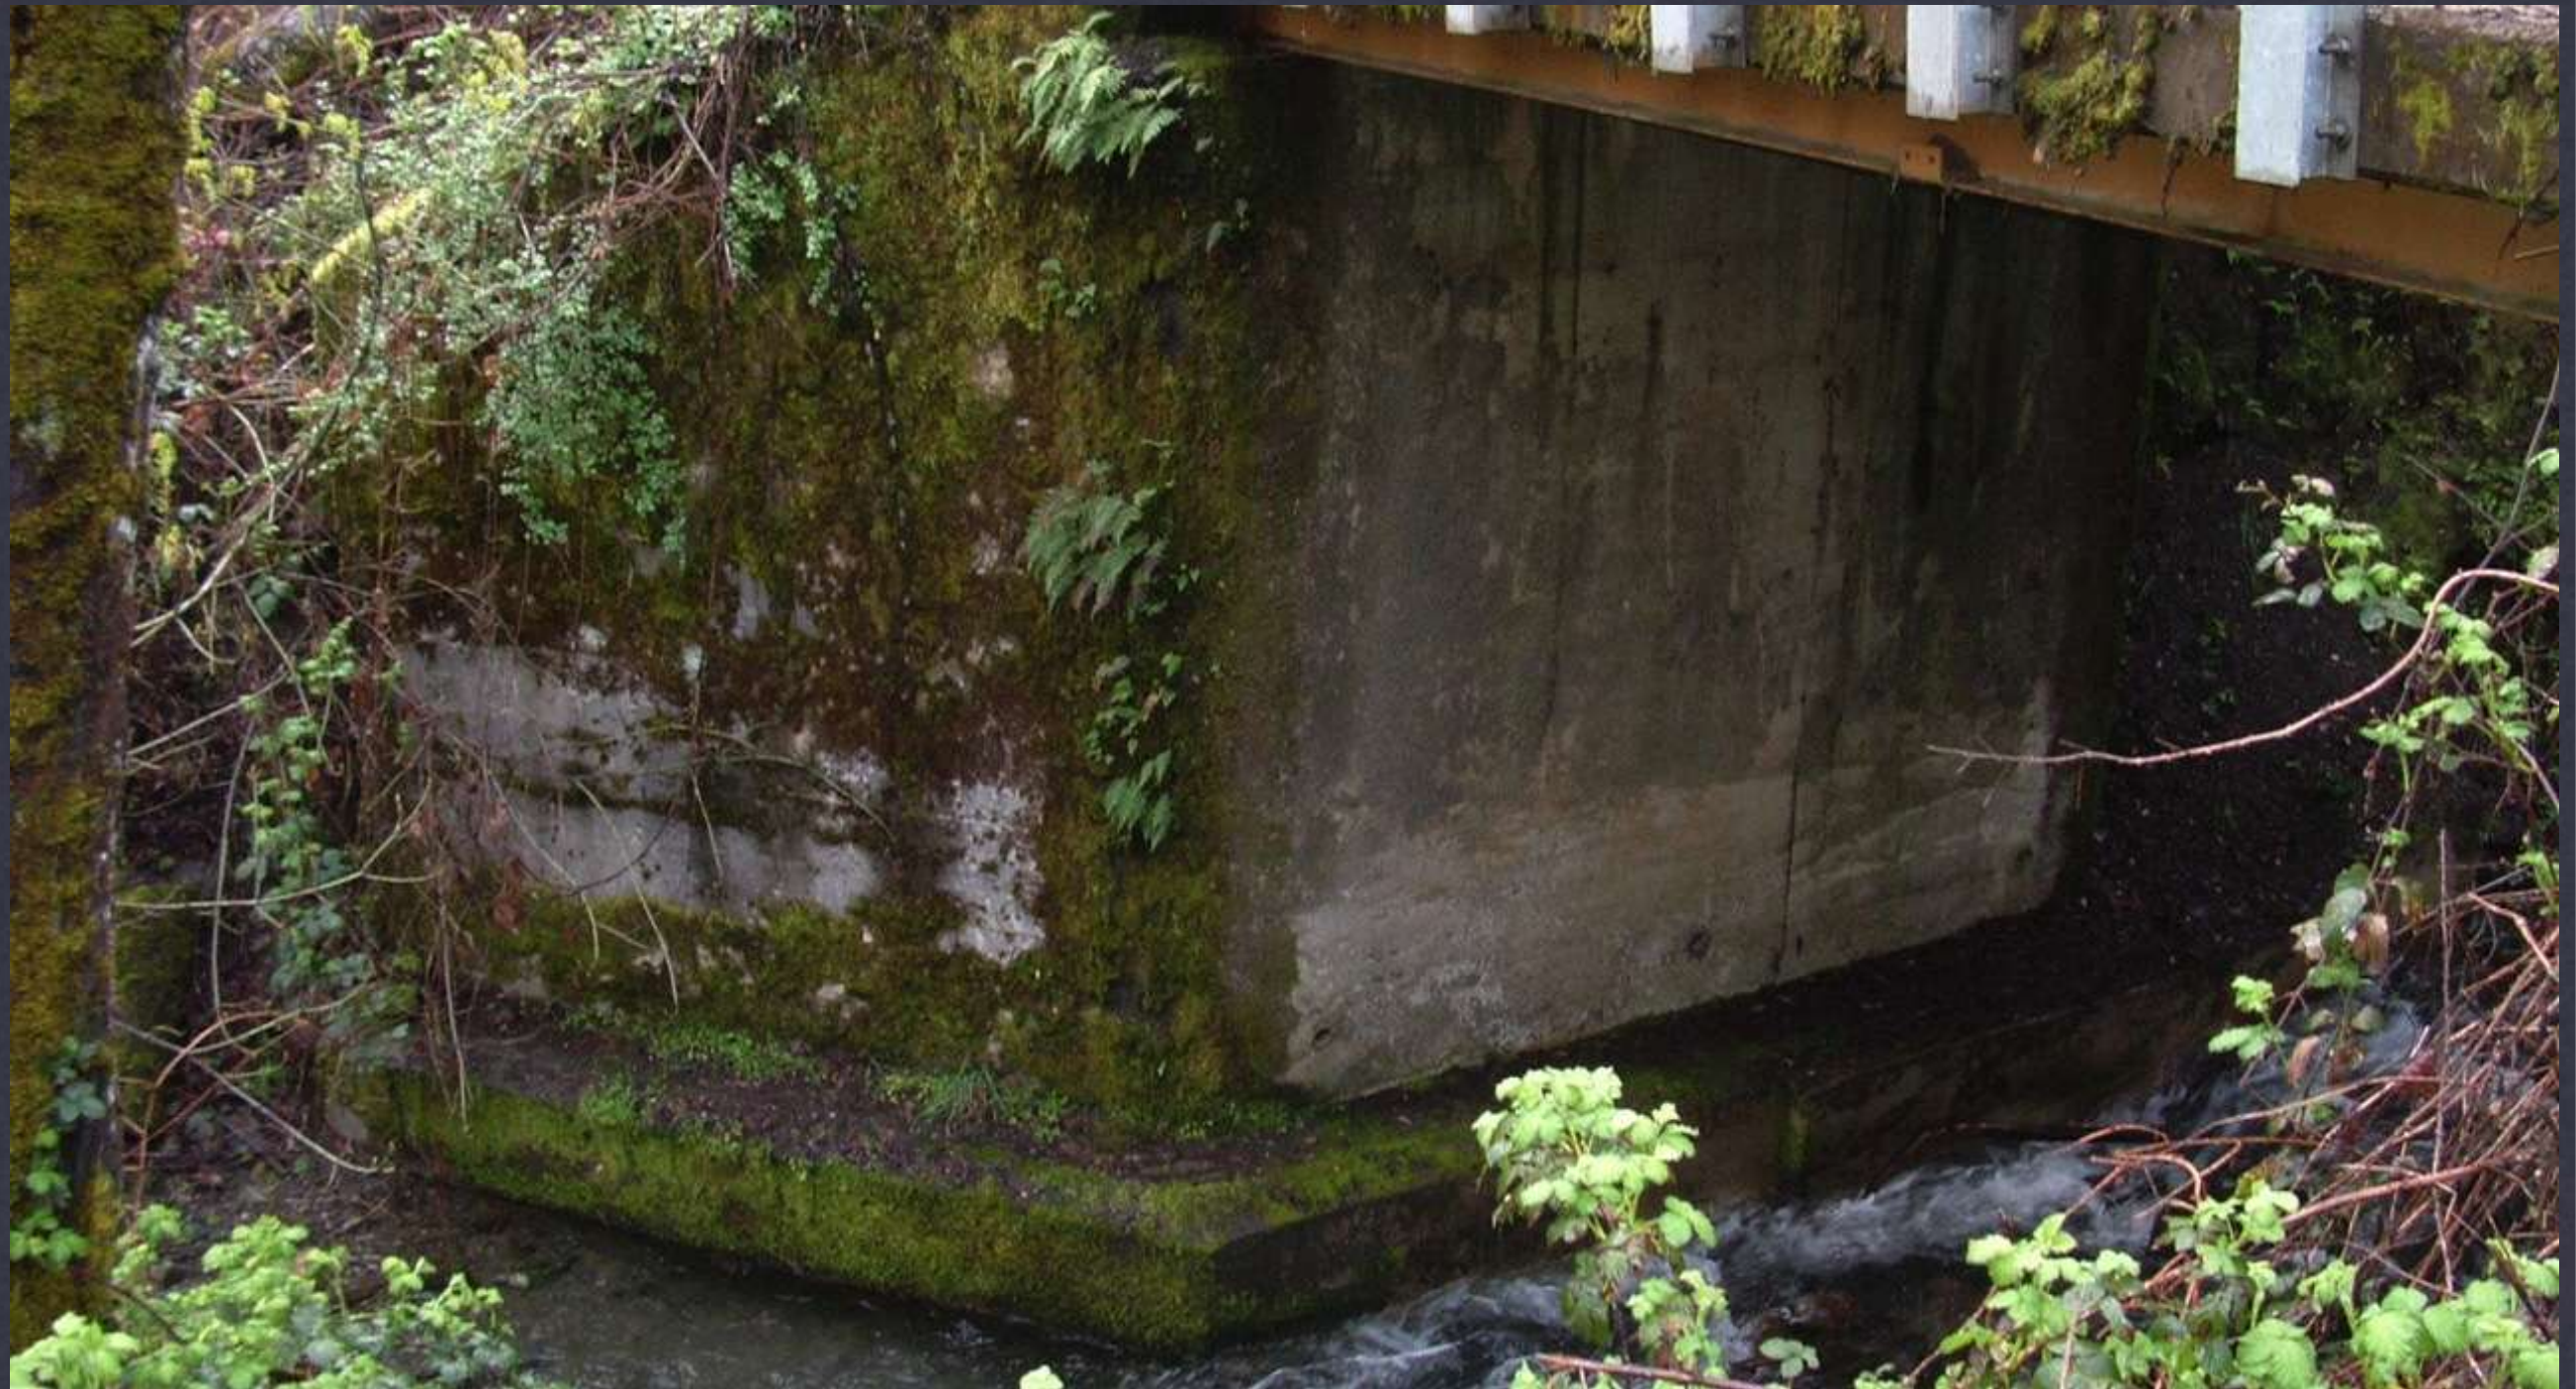
## Price Creek Bridge, Trinity County, California

Structural Controls

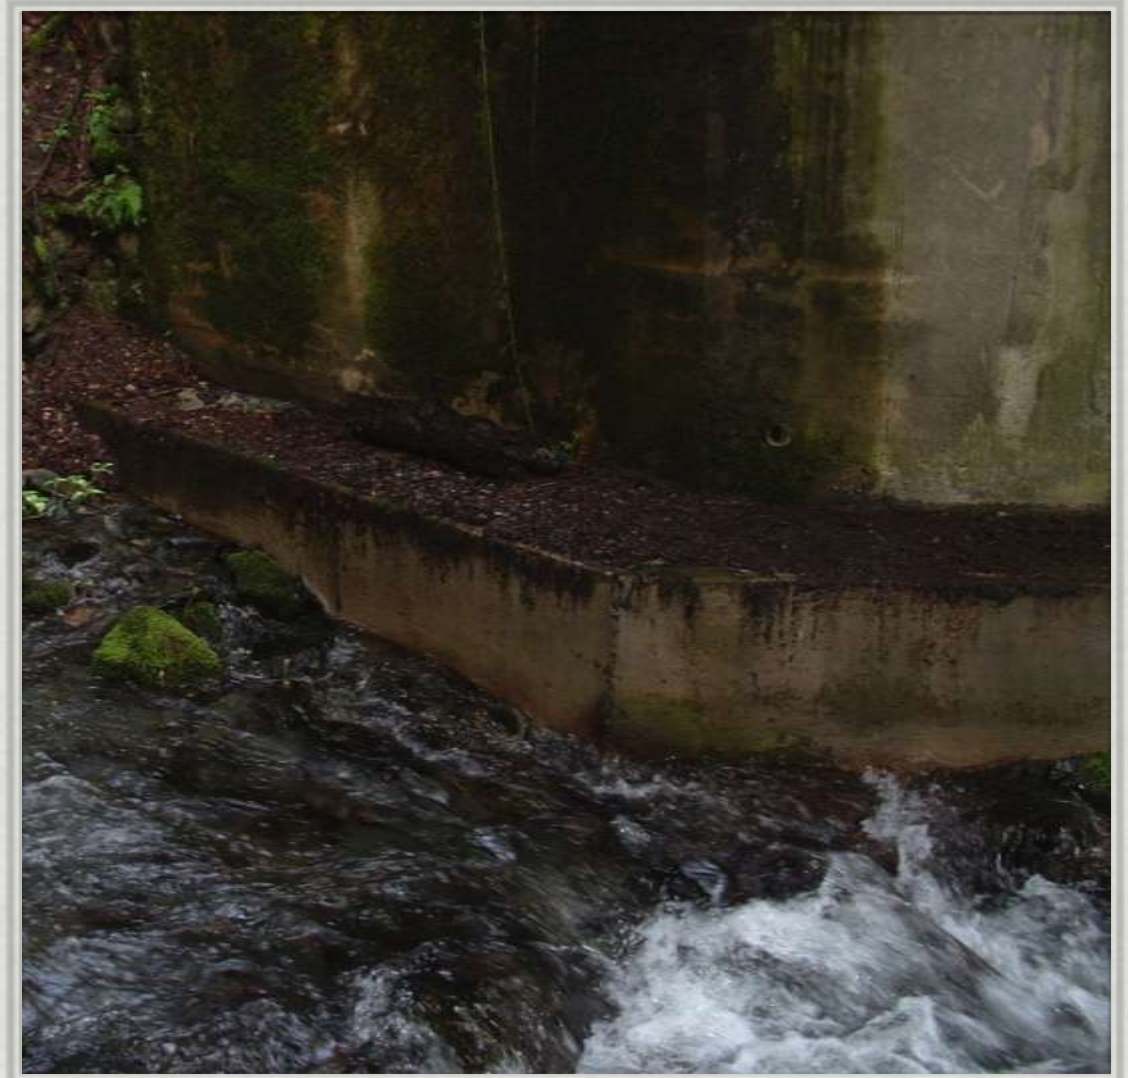
# Price Creek Bridge

- ✱ Monolithic Abutments
- ✱ Large Spread Footings
- ✱ Tall Abutments
- ✱ Short Bridge Span
- ✱ Multiple I-girders

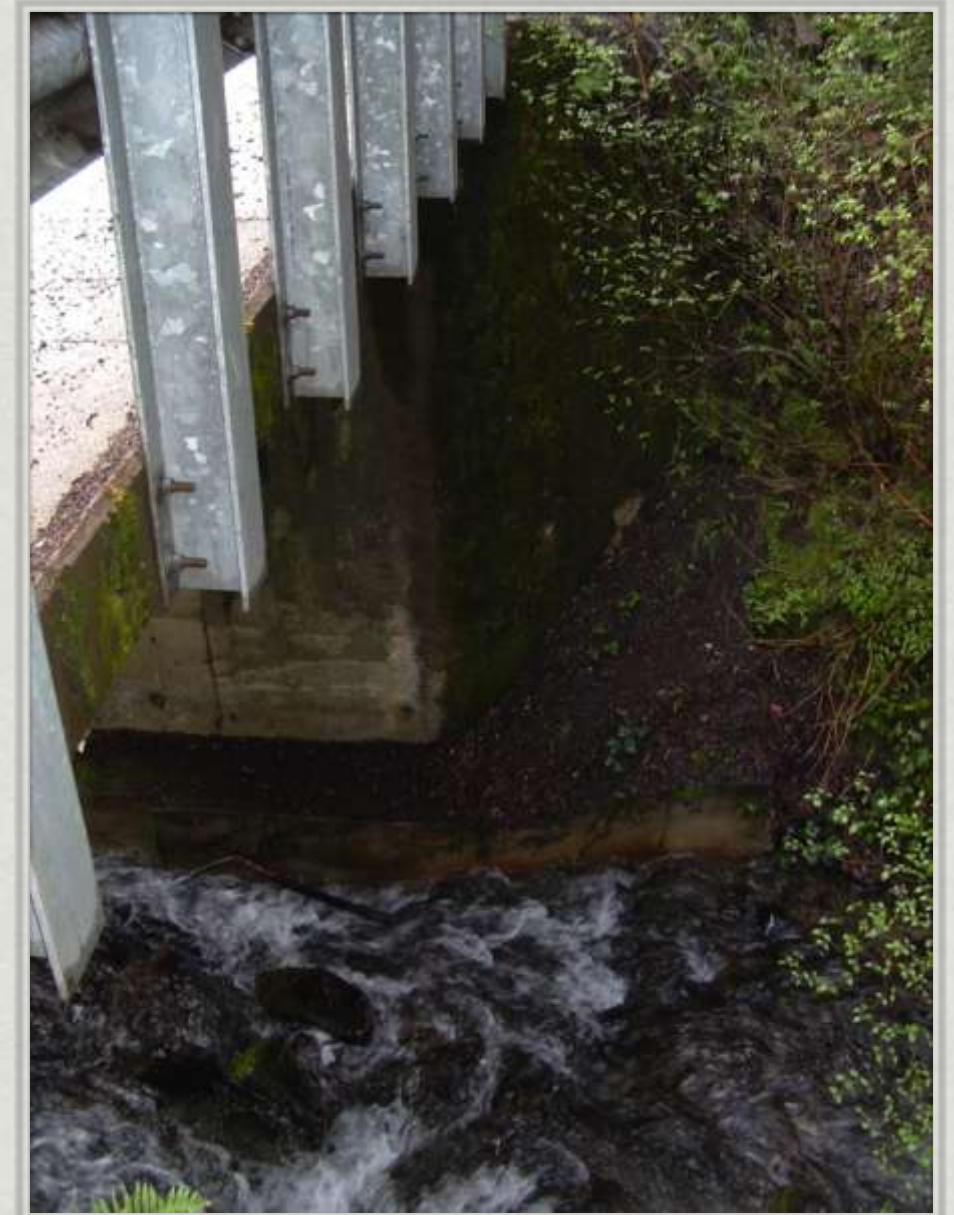
# Price Creek Bridge

- ✱ Seat Abutments
- ✱ Structure Inertia
- ✱ Slow Rotation
- ✱ Pavement Distress
- ✱ Settlement

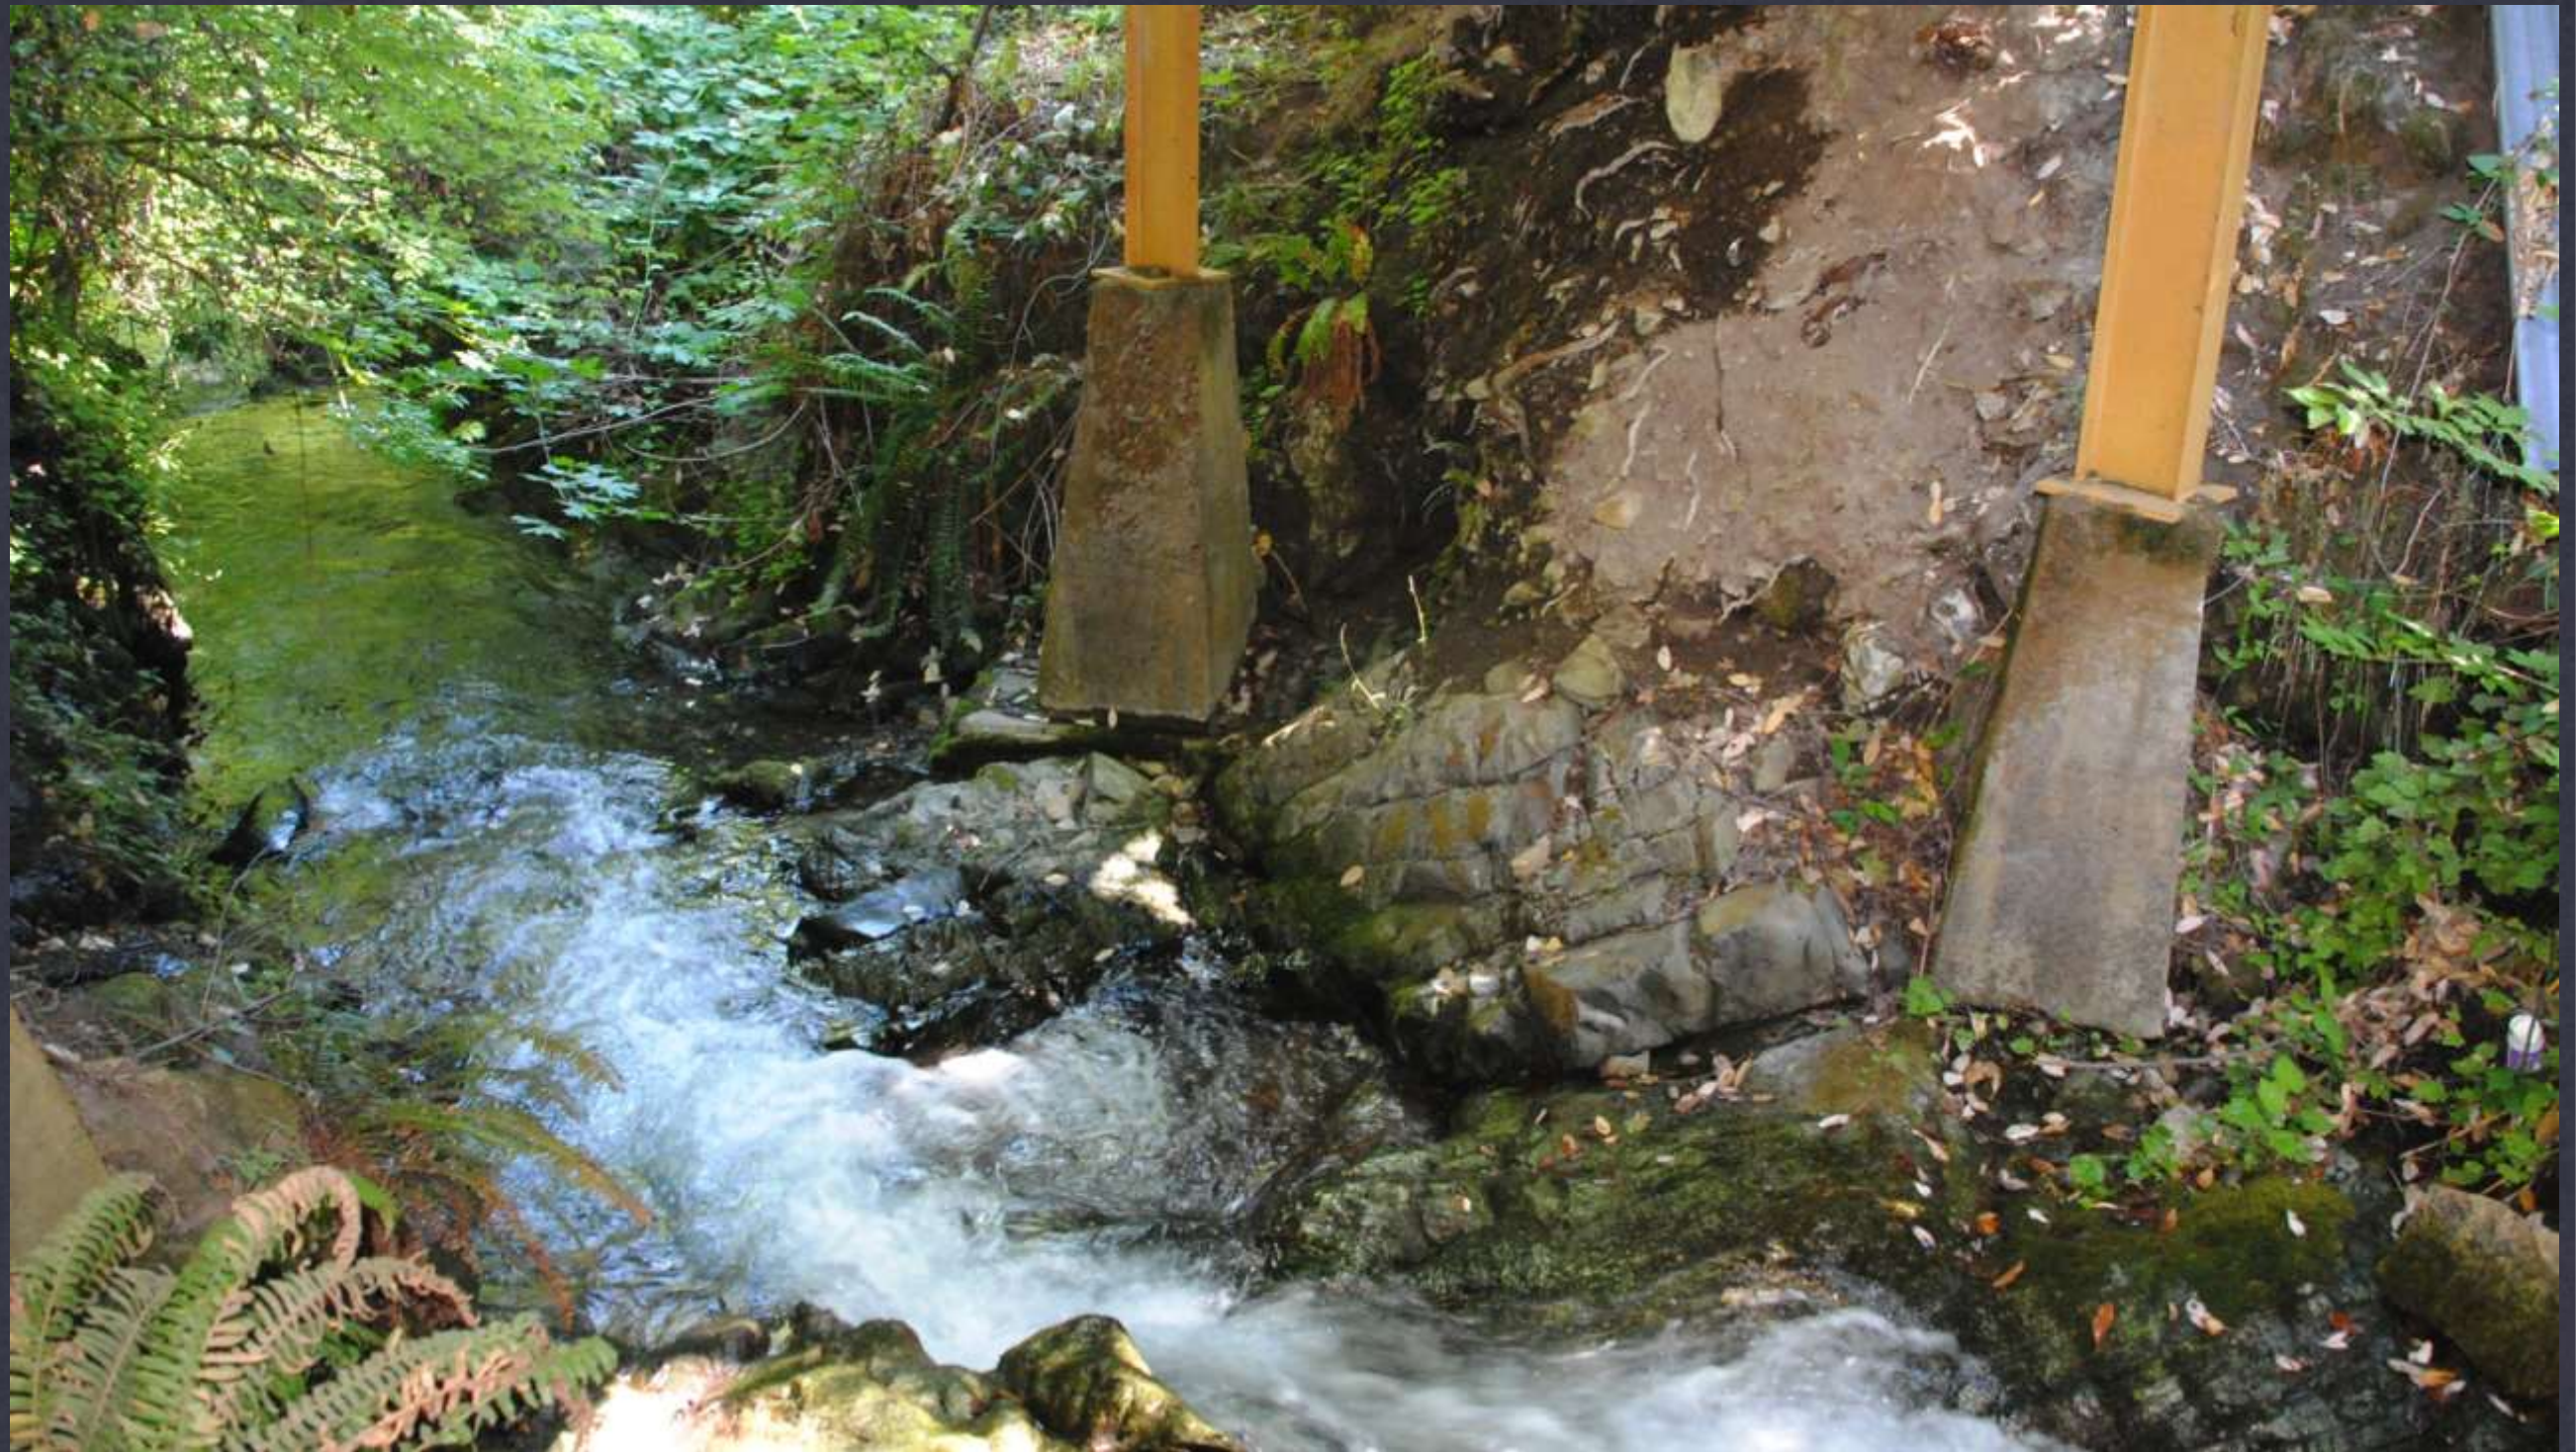
Price Creek Bridge, Trinity County, California

Geotechnical Controls
