6th International Conference on Scour and Erosion

## Scour at Unknown Foundations

or What I Did on My Summer Vacation

# Scour Plans of Action (POAs)

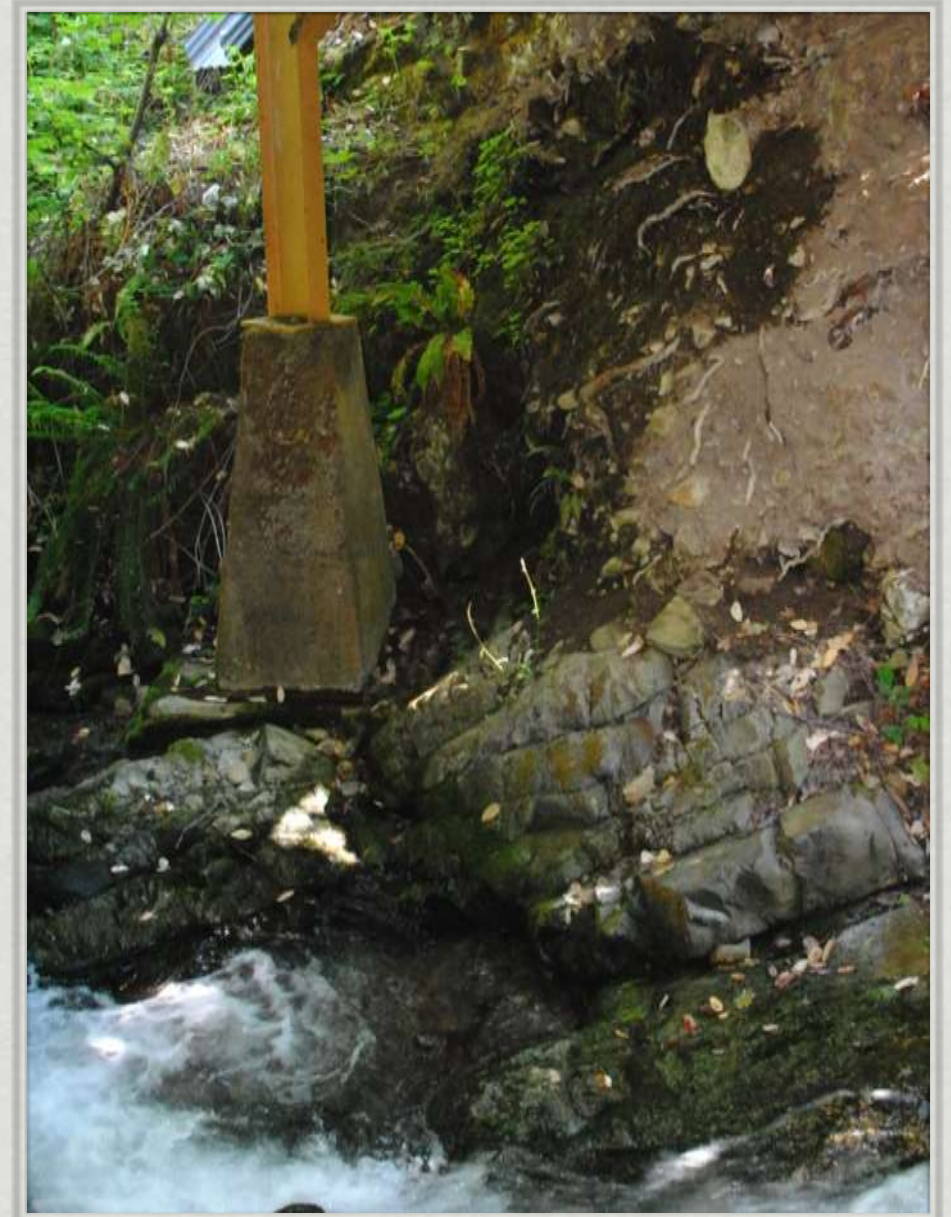
# Price Creek Bridge

- \* Pedestal Footings on Rock; Not in Rock
- \* Adverse Dipping Joints
- \* Plucking Apparent
- \* Secure the Footings

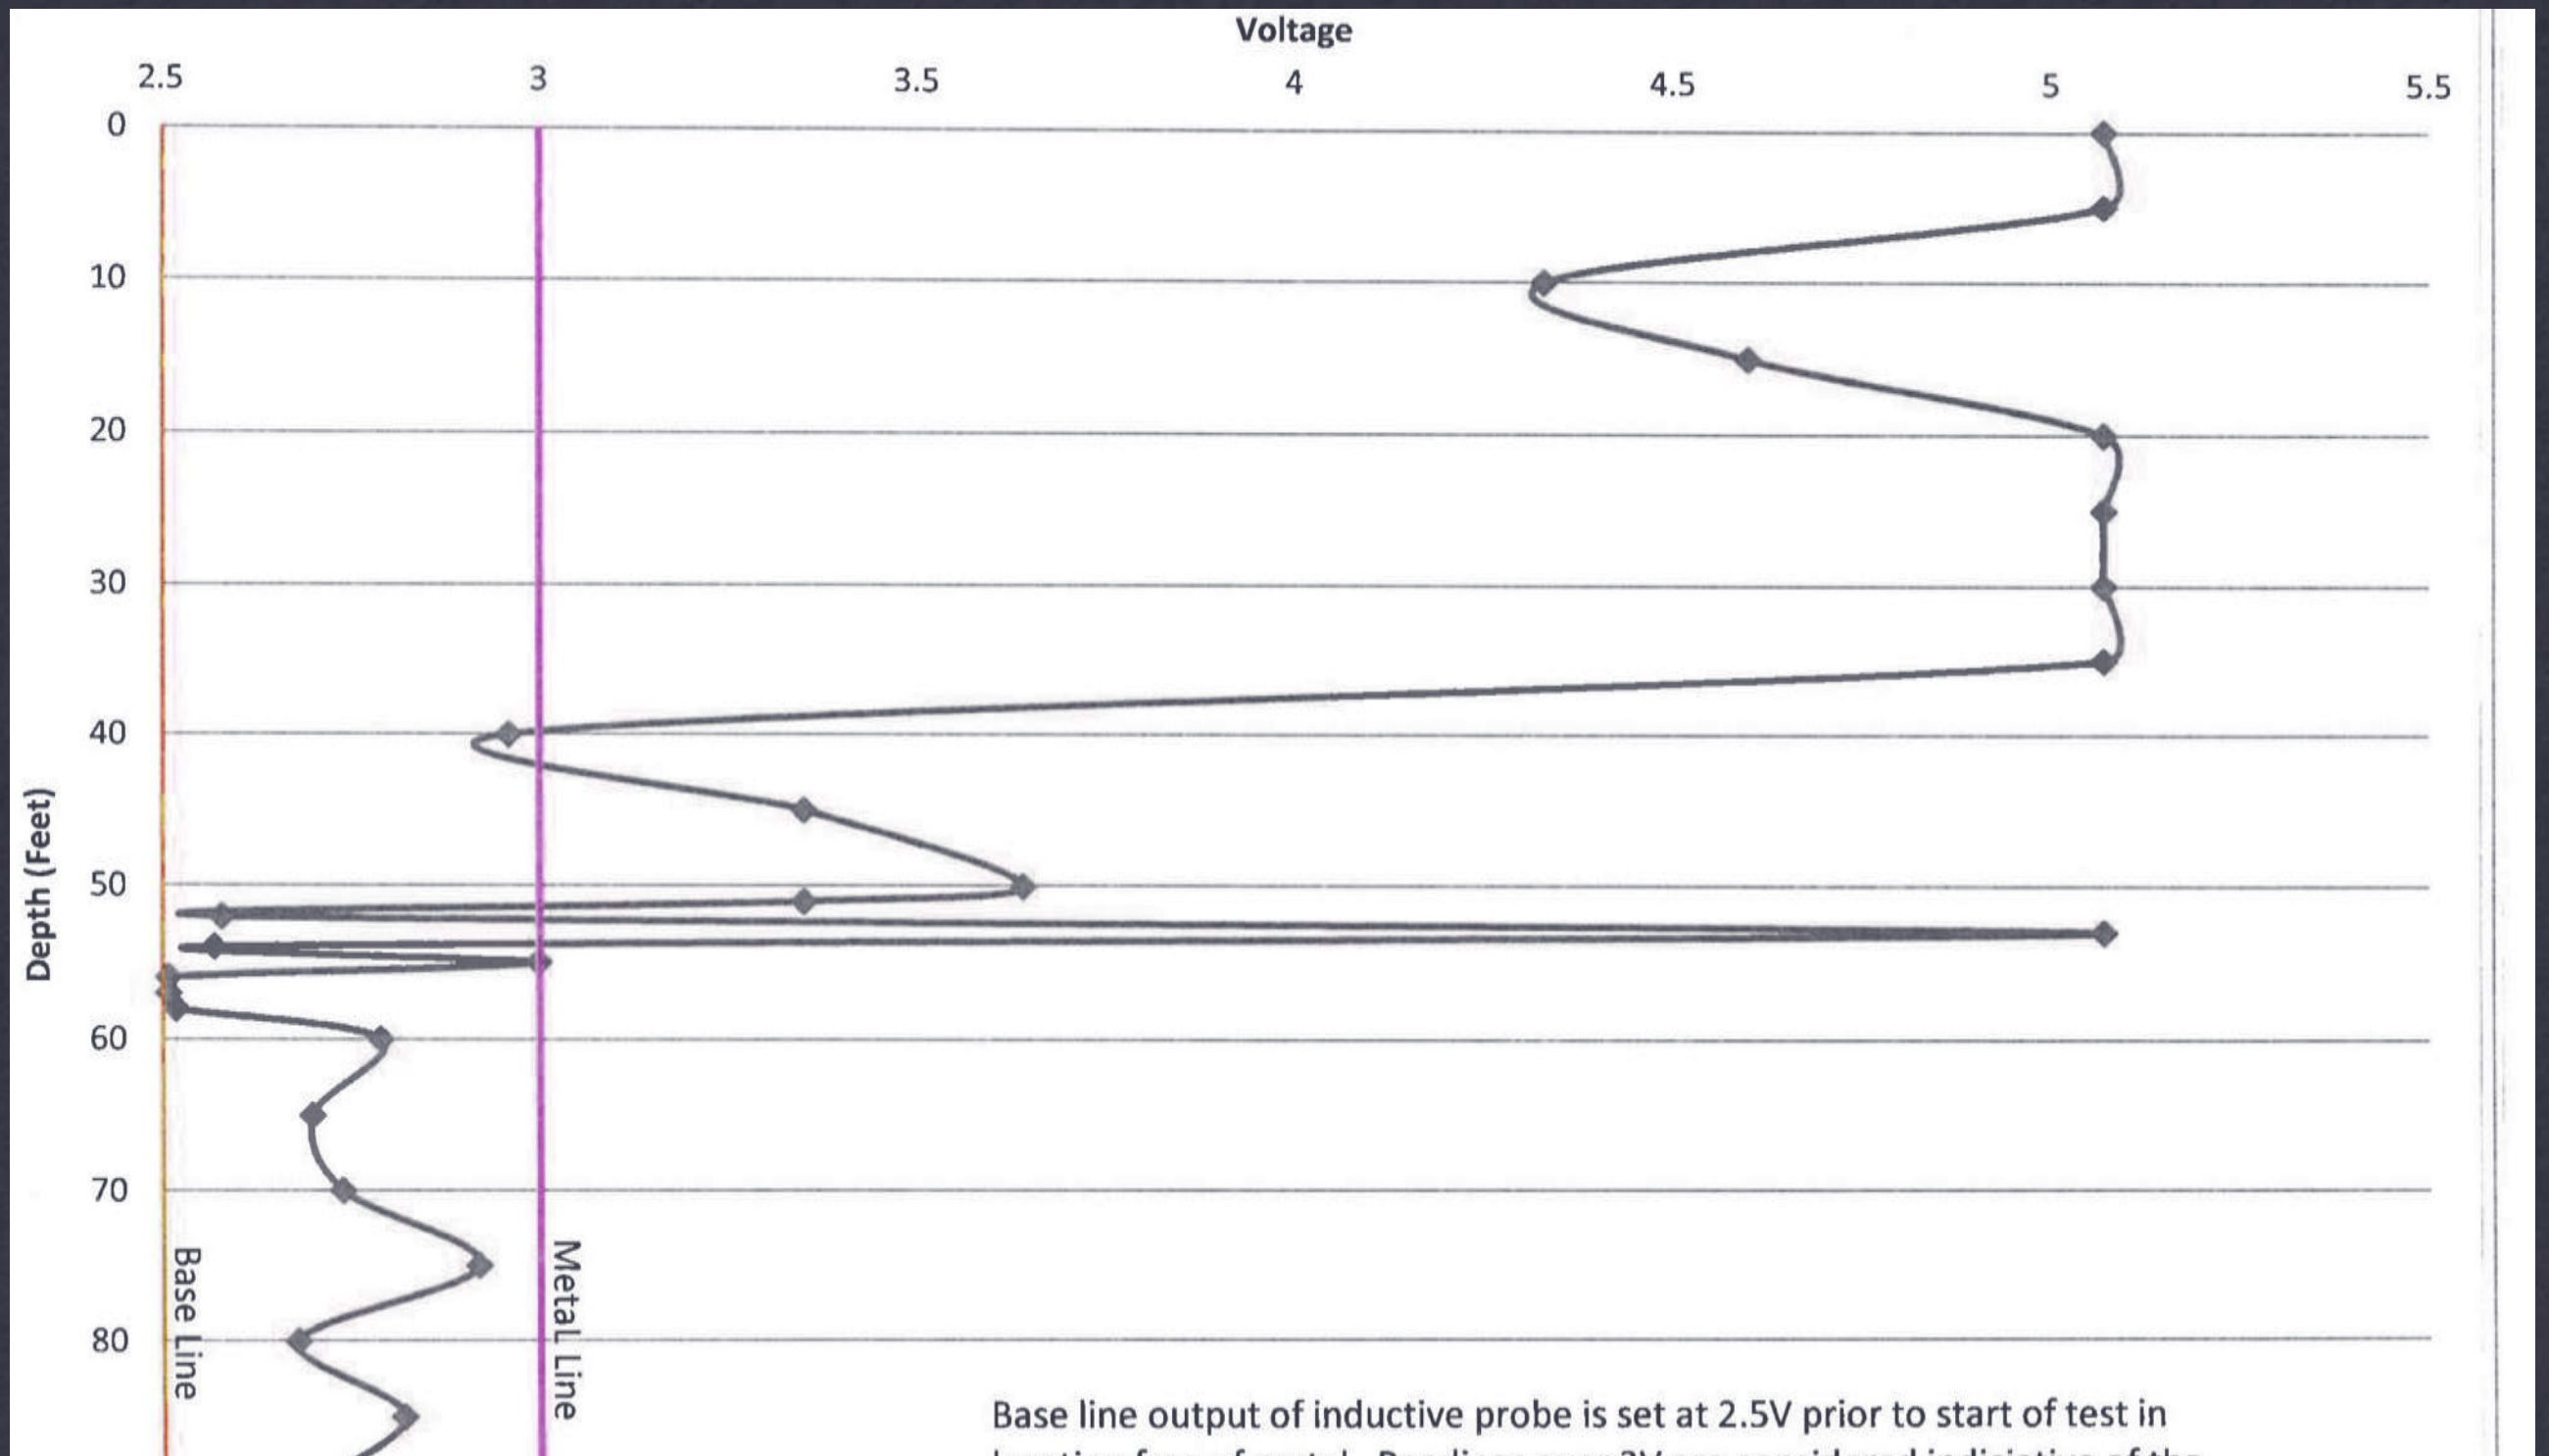
## Making Unknown Foundations Known

Induction Probe - Alamo Pintado Bridge

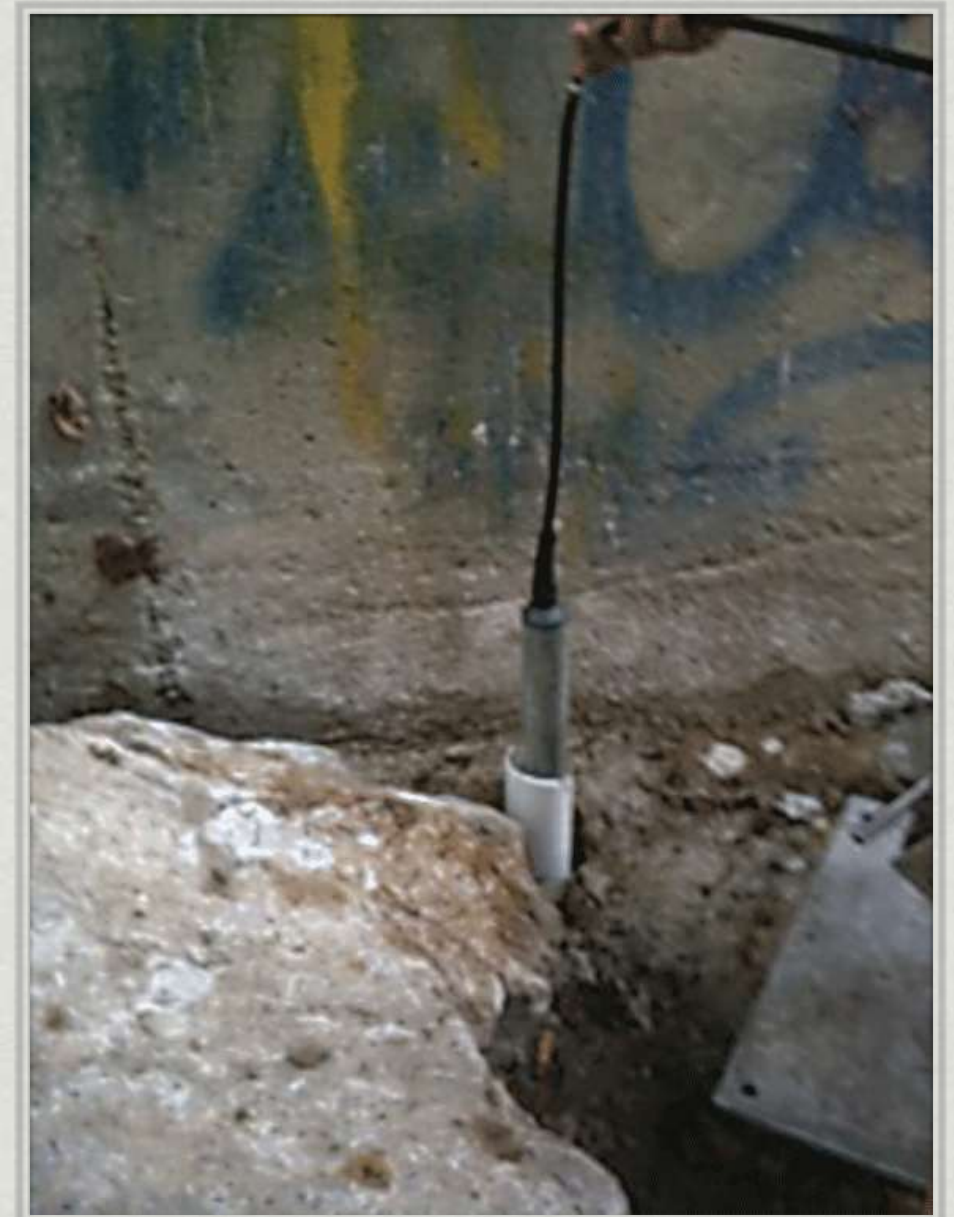
# Induction Probe

- \* Alamo Pintado Bridge
- \* Steel H-pile Sections
- \* Scour Issues
- \* Needed Pile Depth Information
- \* Large Metal Detector

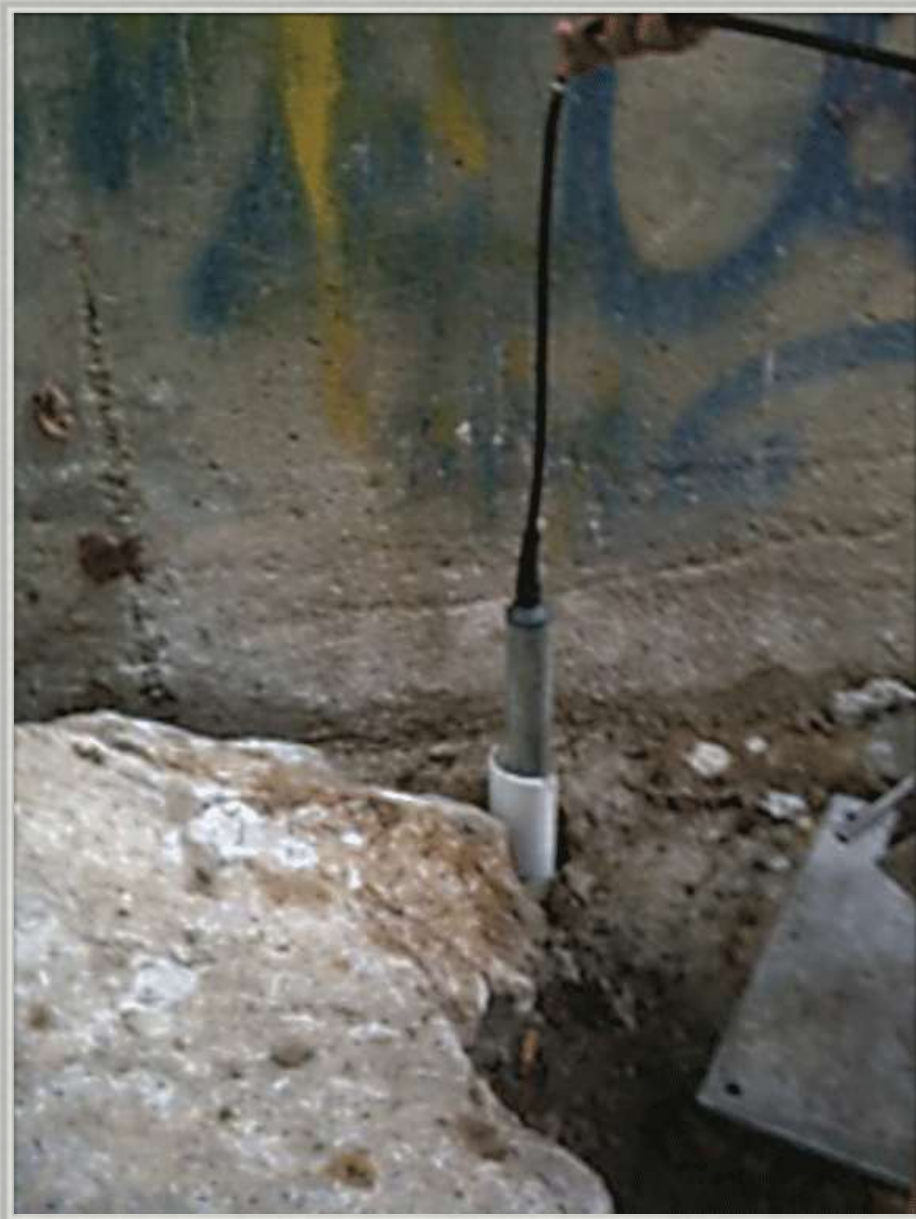
# Induction Probe

- \* Borehole with Plastic Pipe
- \* Horizontal induced field
- \* Maximum 18-in (45 cm)
- \* Field 24-in (60 cm)
- \* Seismic Refraction

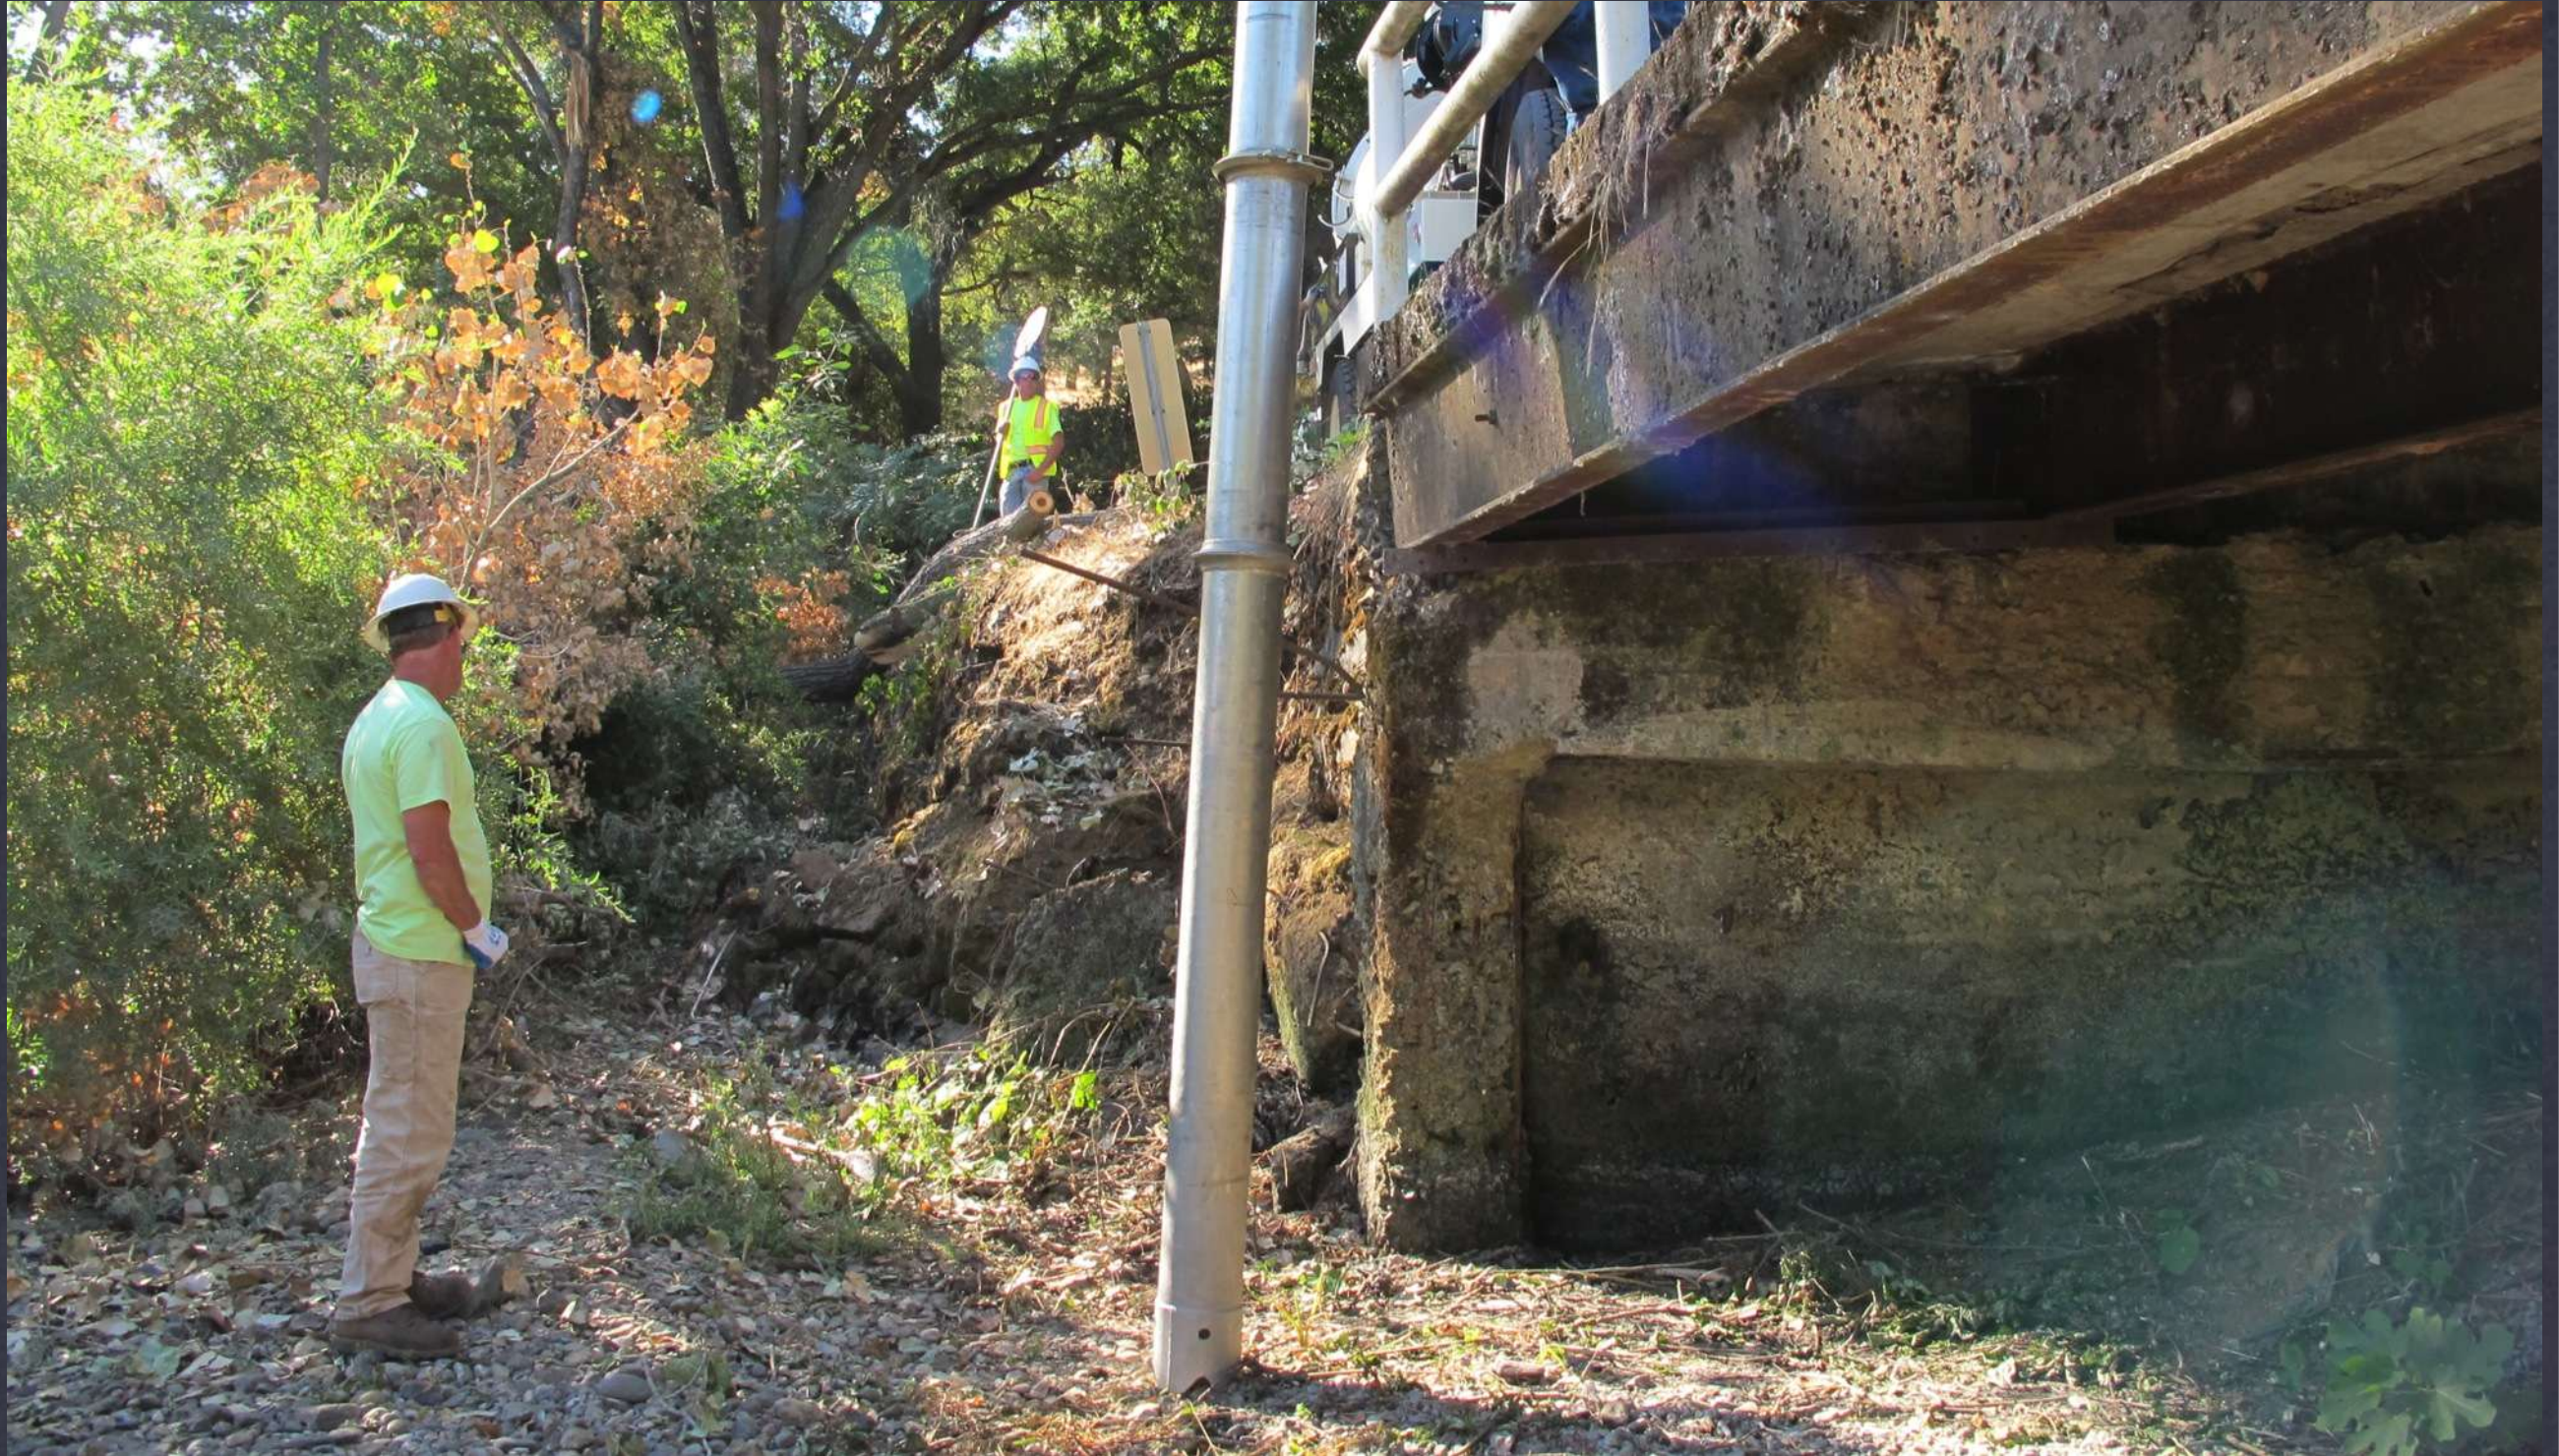
## Making Unknown Foundations Known

Vacuum Truck - Rancheria Creek on Old Amador Road

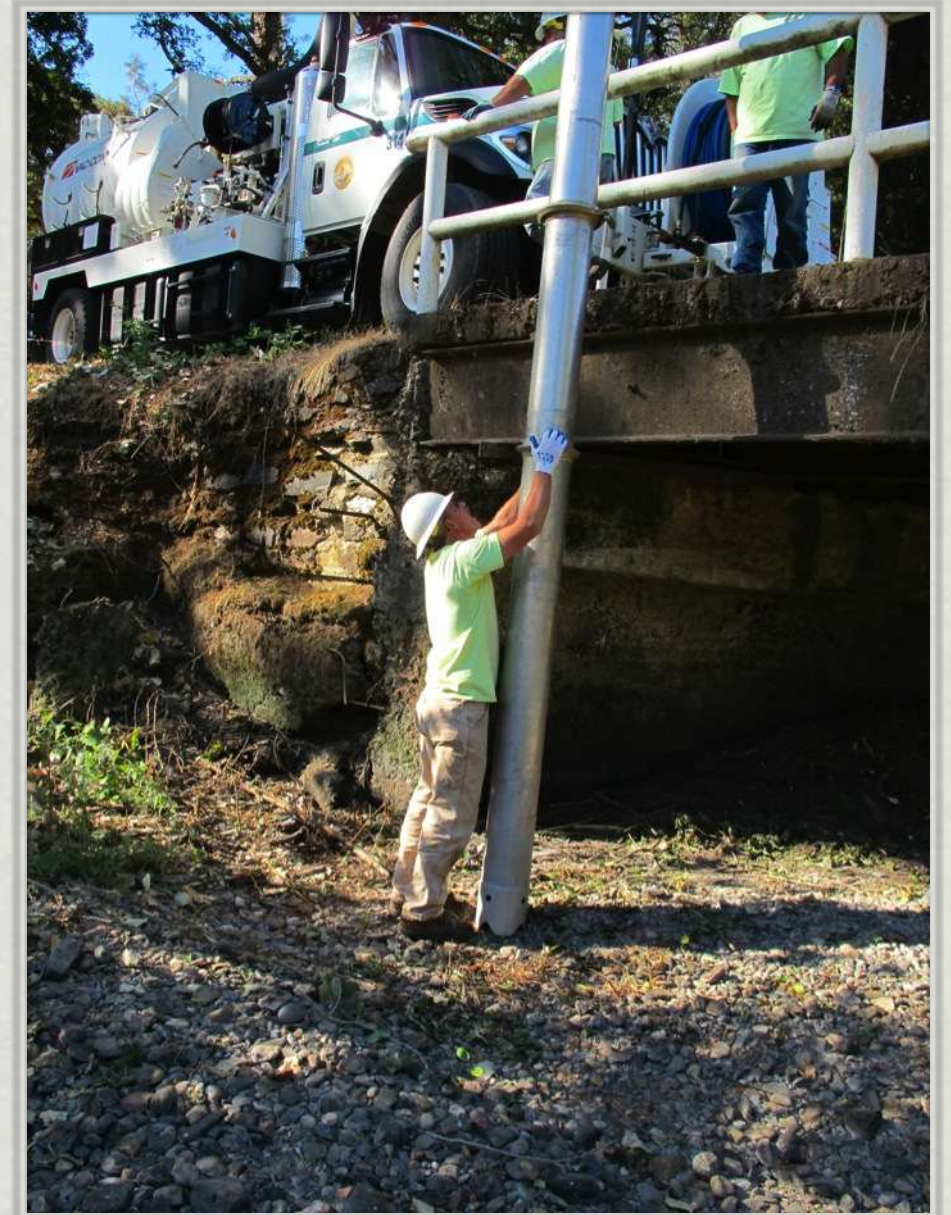
# Vacuum Truck

- ✱ Verify Depth of Footings
- ✱ Is There Shallow Rock?
- ✱ Within Scour Depths?
- ✱ Quick, Easy Excavation
- ✱ Completed Next Day
- ✱ Enhanced Assessment
