# WATERCOURSE HARNESSING BANK EROSION AND CONSOLIDATION

*PhD. student: ALUPOAE Daniel*

International Conference on Scour and Erosion - ICSE 6

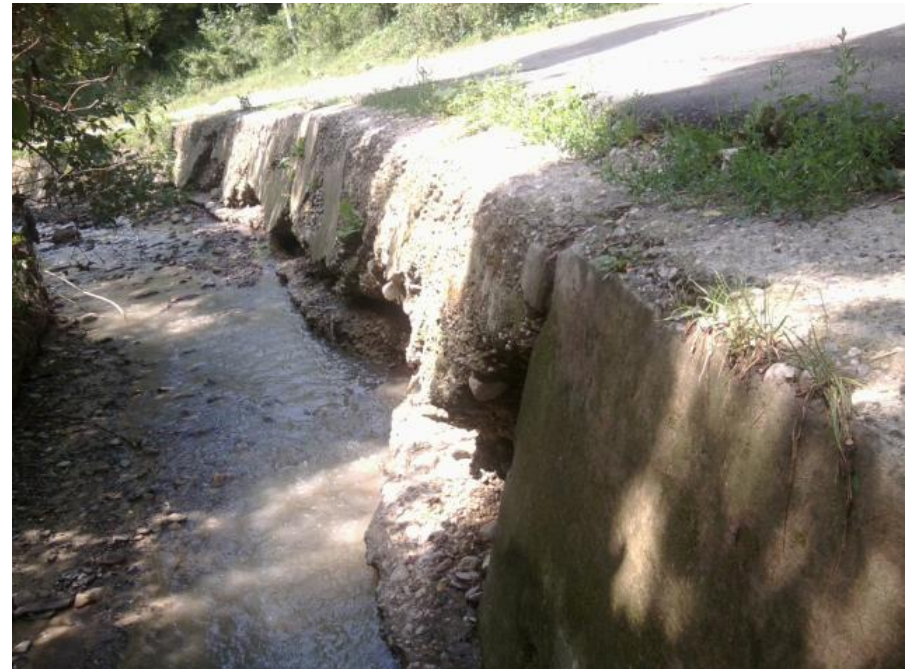
- ❑ forces reached their maximum intensity during floods, due to rising water level and caused sediment displacement;
- ❑ degradations to a retaining wall made in 1975, over a length of 300 meters, in the joint area between foundation and elevation.
- ❑ erosion of river banks where the watercourse changed its flowing direction;
- ❑ access route to 15 households in the village;
- ❑ 70 meters of road infrastructure.

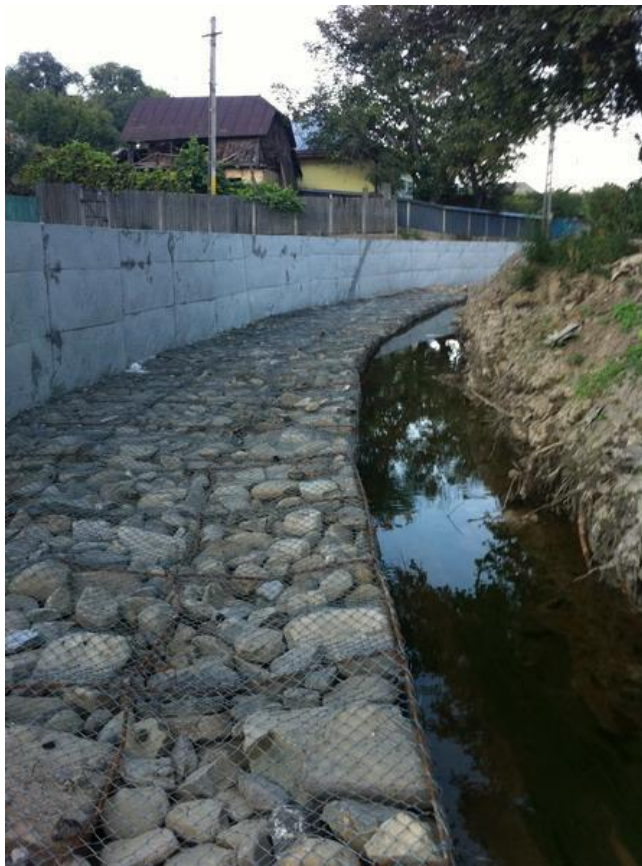
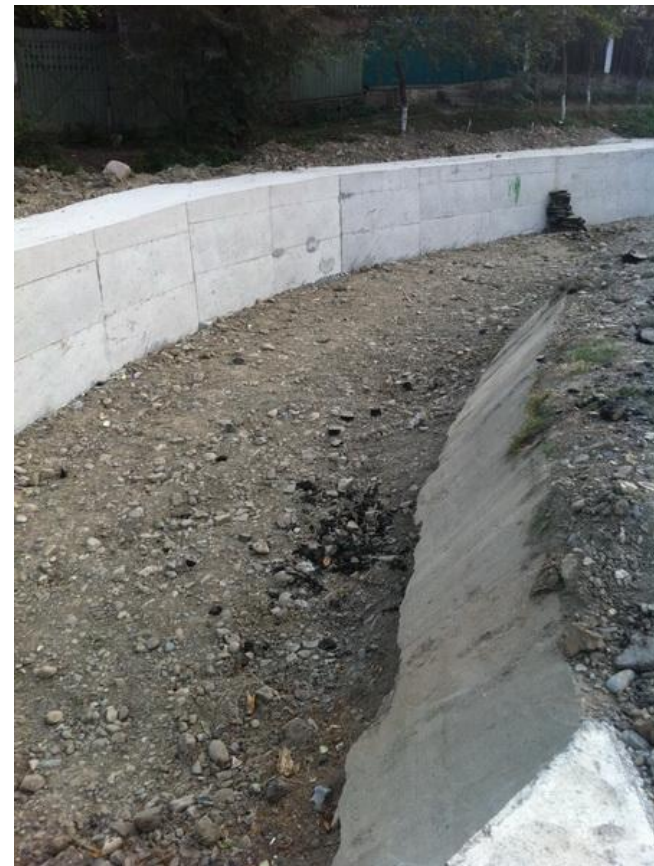
**The area affected by the flow of water from torrential rains, after the execution of watercourse improvement works**
