Sixth International Conference on Scour and Erosion

Full-Scale Testing of Levee Resiliency During Wave Overtopping

Engineering Research Center

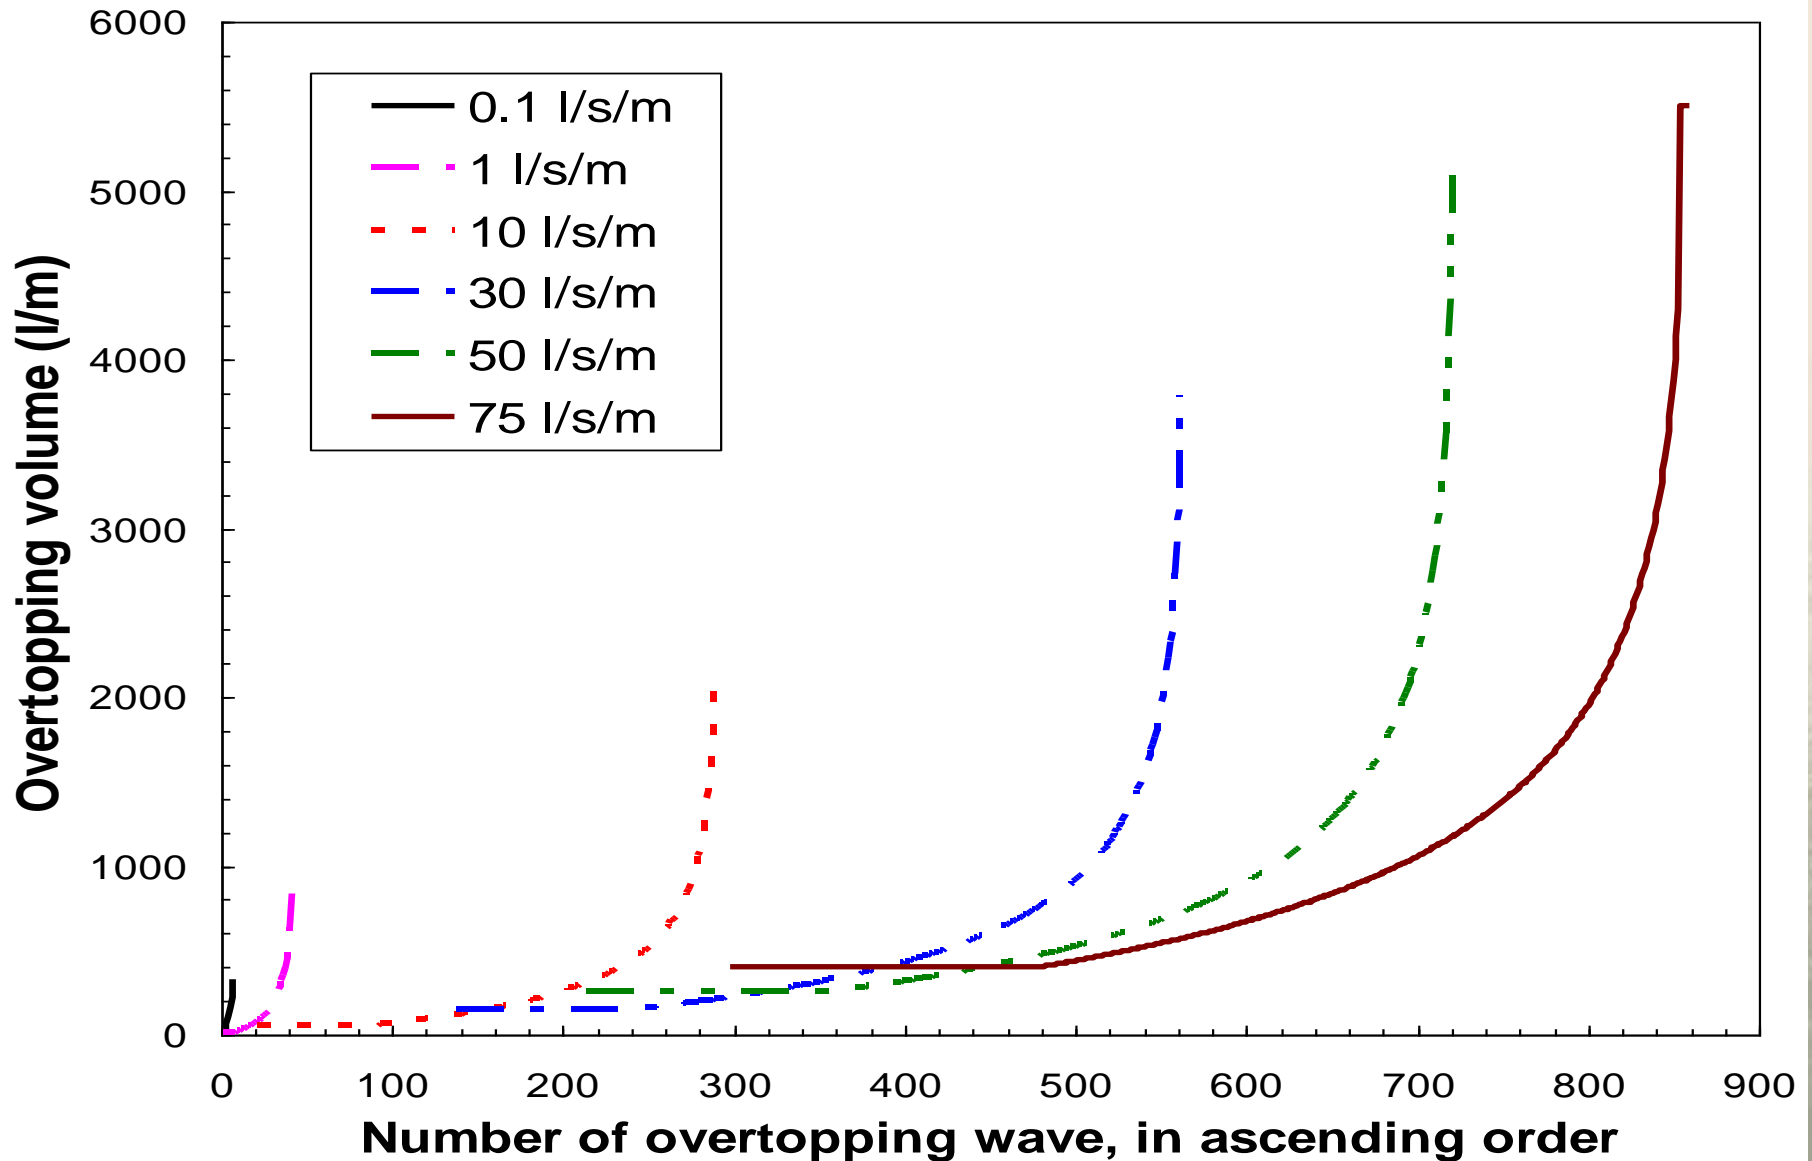
Overtopping Distribution

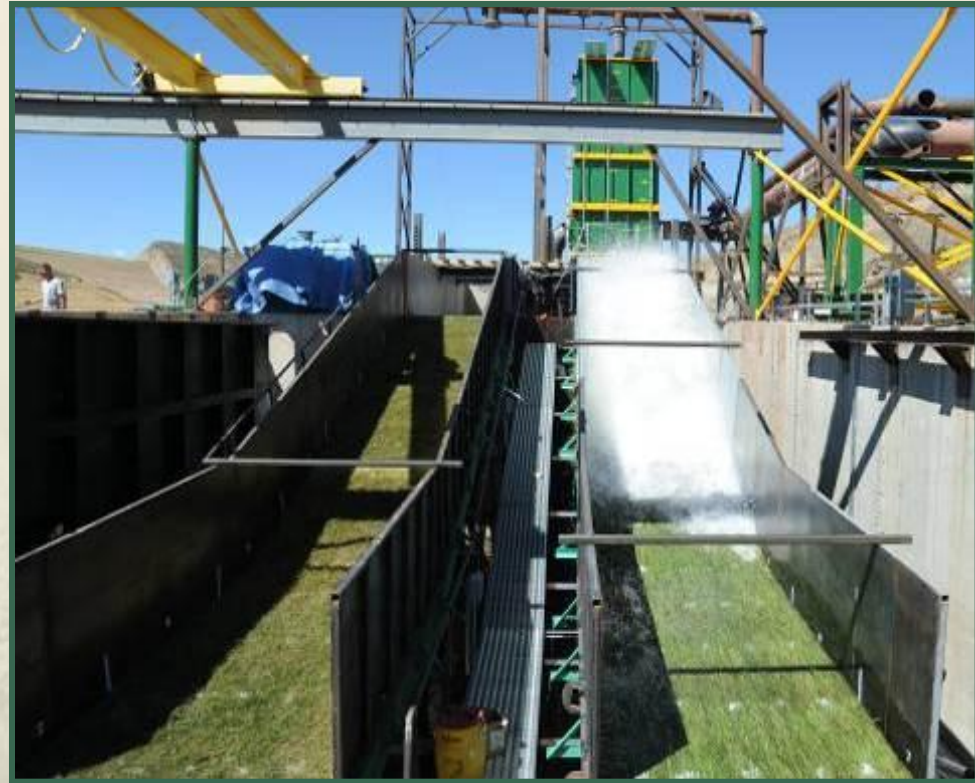
Physical Features

- Full-scale testing
- Dual test channels
- Steady state capabilities
- Flow measurements
- Accommodate different tray geometries

Hydraulic Features

- Total simulator capacity – 27 m^3 or $15 \text{ m}^3/\text{m}$
- Average wave overtopping discharge 200 – 380 l/s per m (depends on wave period)
- Corresponds to $H_{m0} = 2.4 \text{ m}$, $T_p = 9 \text{ s}$
- Steady overflow – $2.5 \text{ m}^3/\text{s}$ per m (or more)

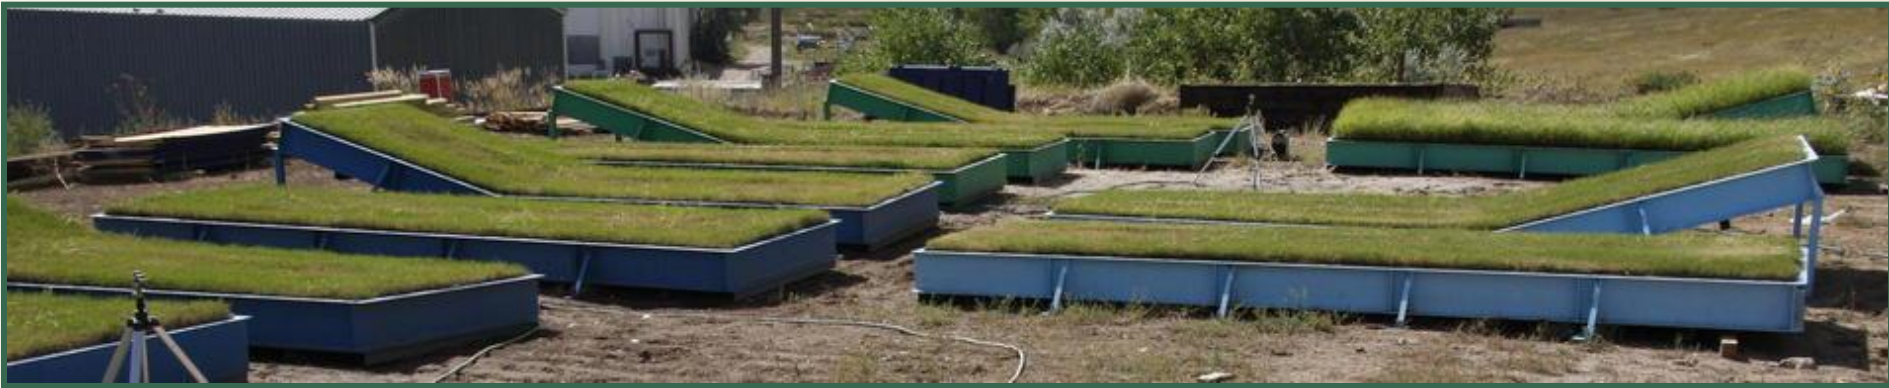
Planter Tray Dimensions

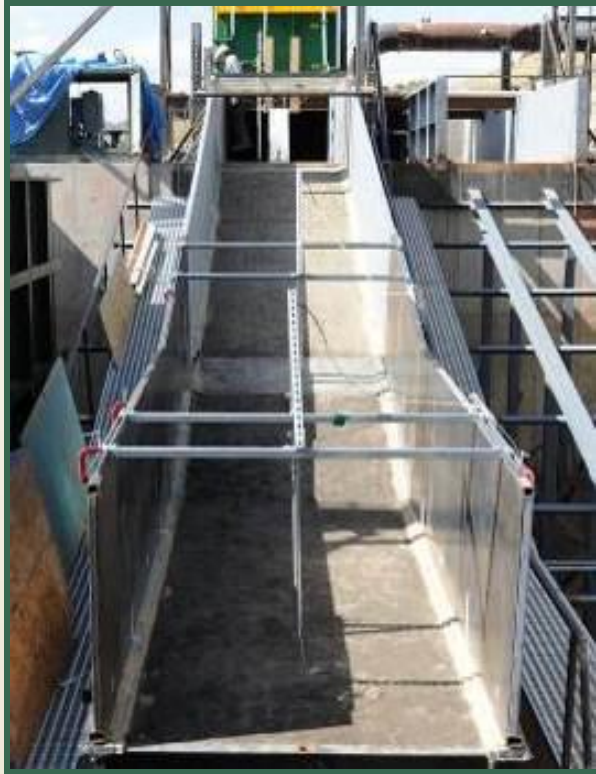
Bare Clay Slope Test

Before

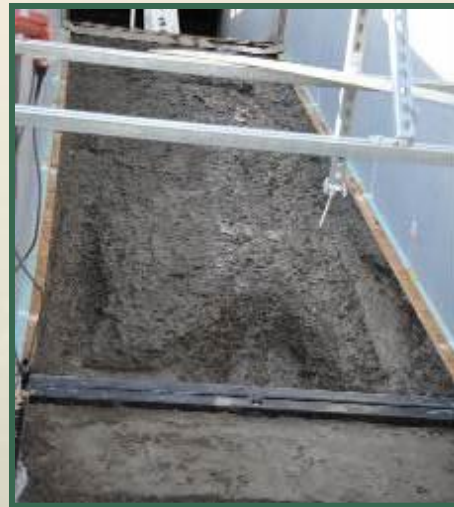
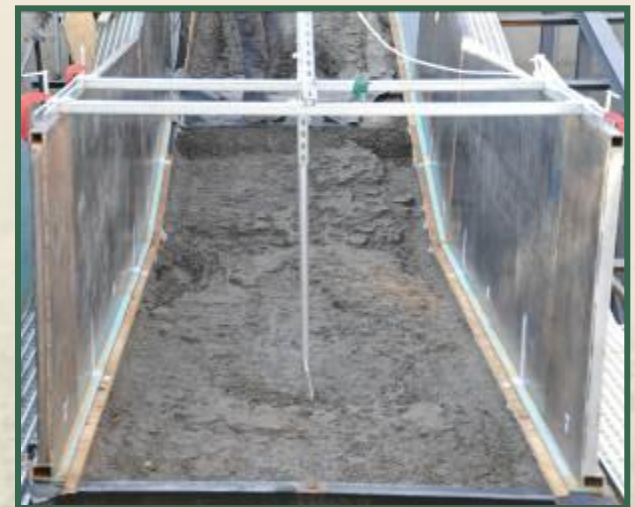
After 1 hour at 9.3 l/s per m

Total failure after 20 min at 18.3 l/s per m

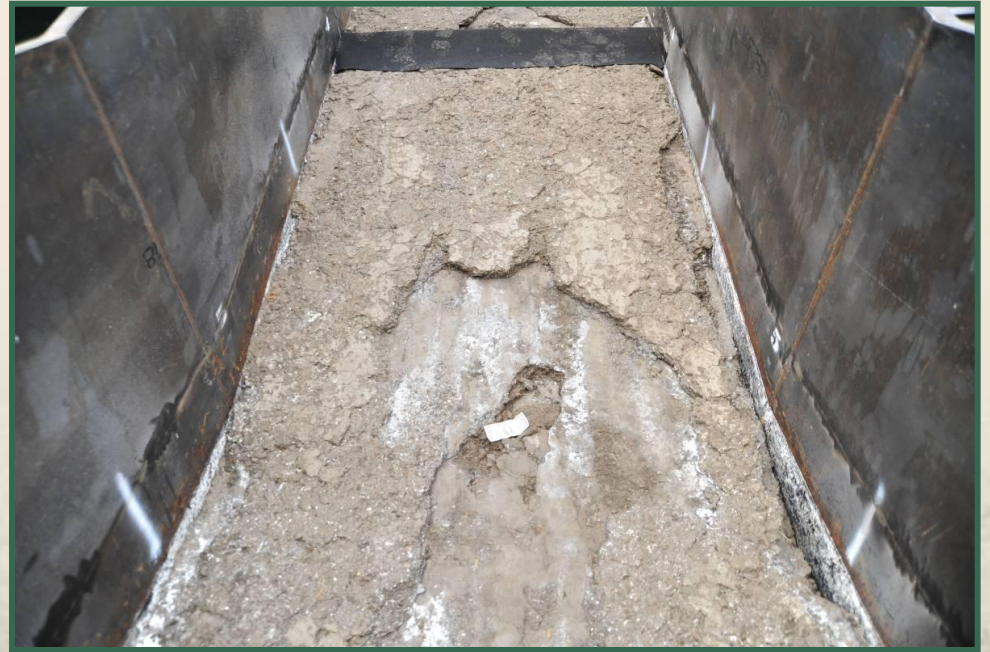
Lime-Stabilized Bare Clay Test

After 20 min at 370 l/s per m

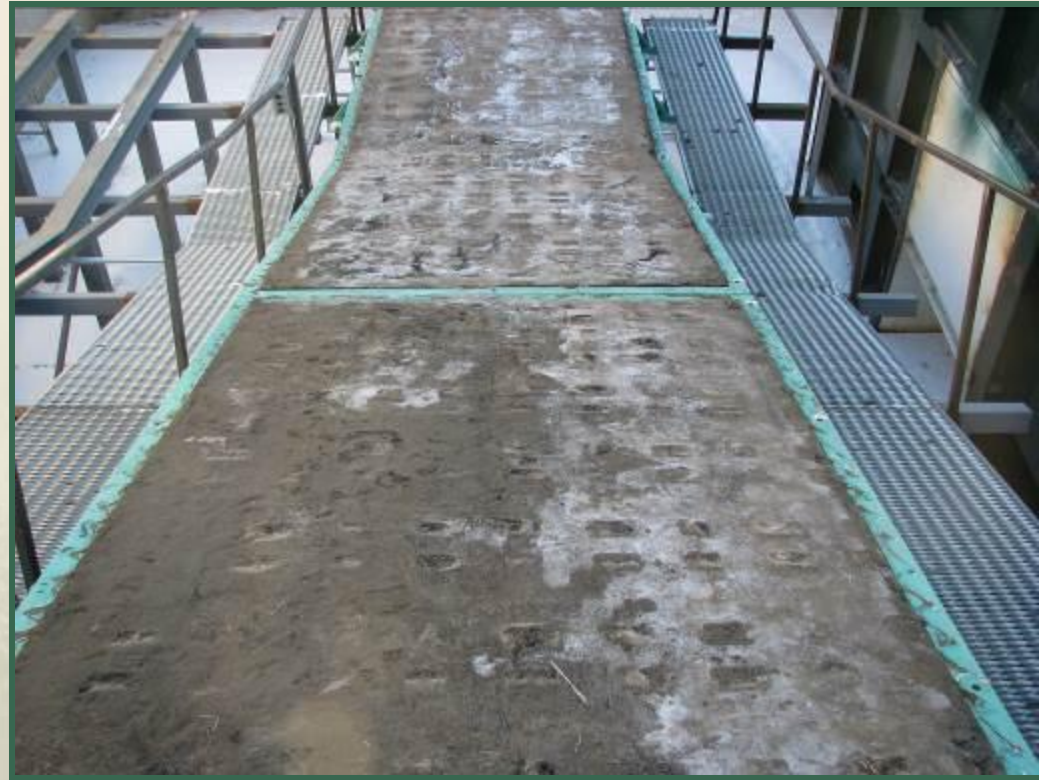
ACB Slope Protection Tests

New Orleans Clay

After test at 370 l/s per m

- Healthy sodded grass surfaces did not fail
- Damaged healthy grass surfaces survived at high loads
- Dormant grass failed at reduced loads
- HPTRM provided significant protection for dormant grass
- Open-weave TRM provided little protection for dormant grass
- Bare clay and lime-reinforced clay fail rapidly
- ACBs effectively protected the underlying clay, but performance dependent on soil type

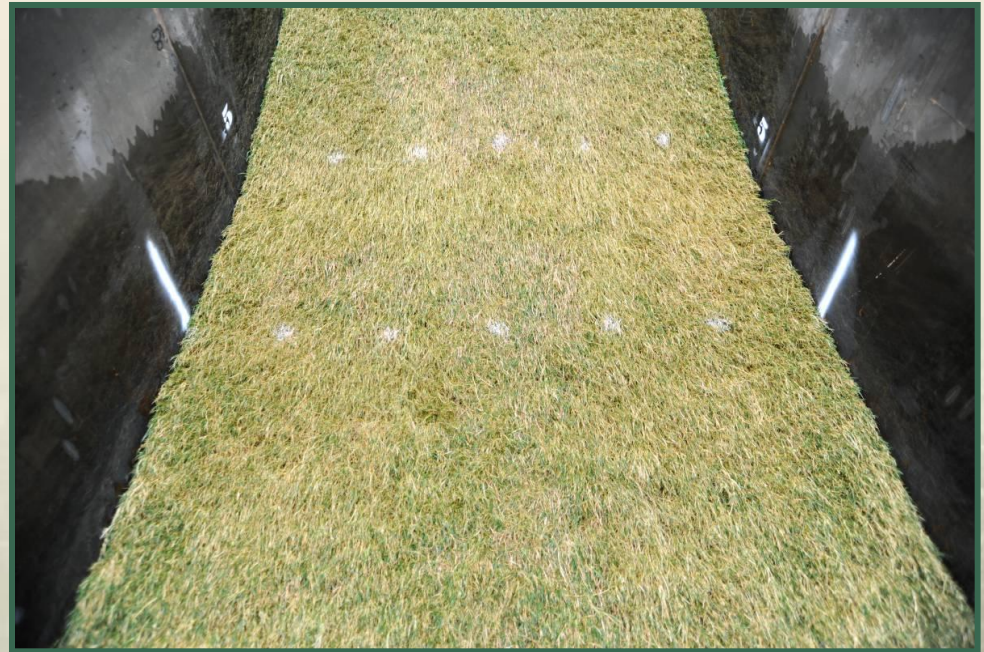
Bermuda Grass Slope

No damage after 370 l/s per m

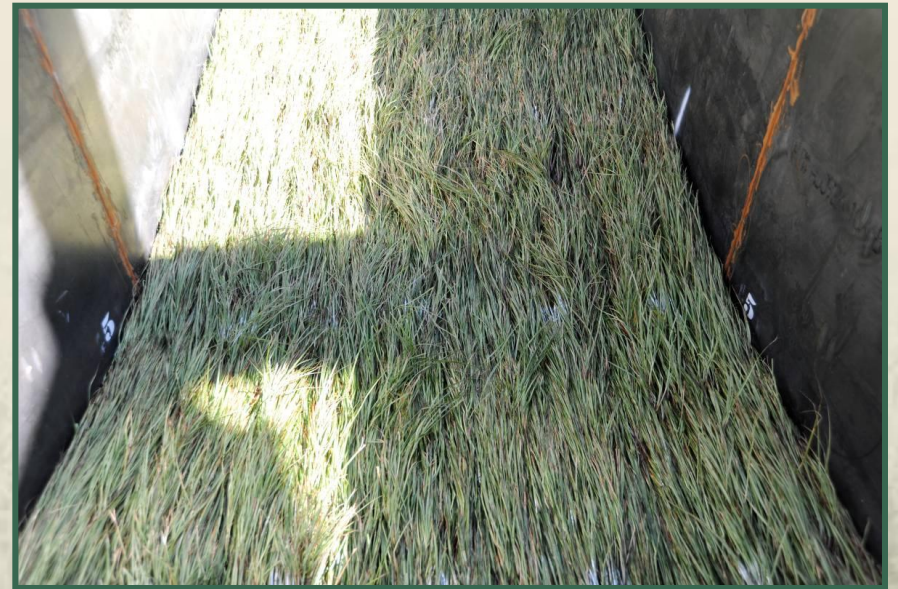
Bahia Grass Slope

No damage after 280 l/s per m

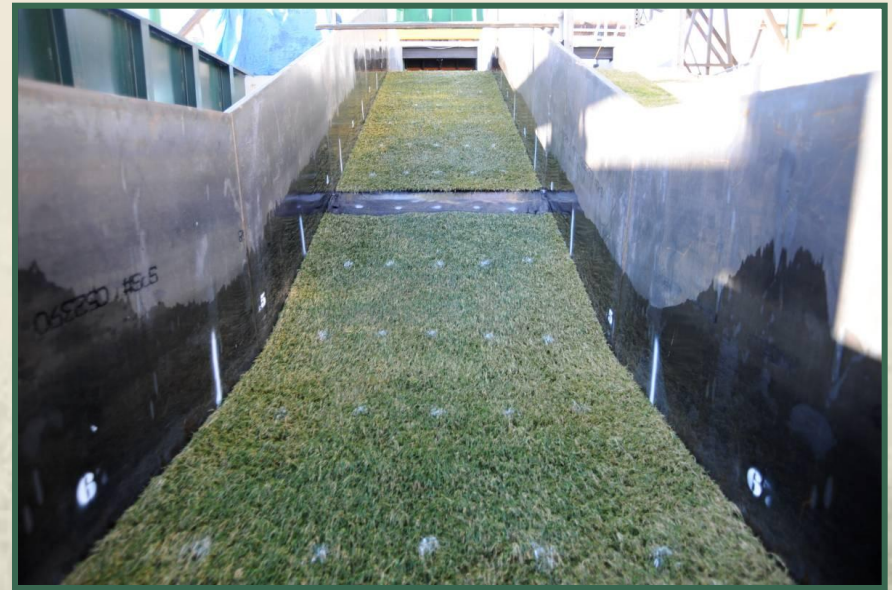
Bermuda Grass with TRM

No damage after 370 l/s per m

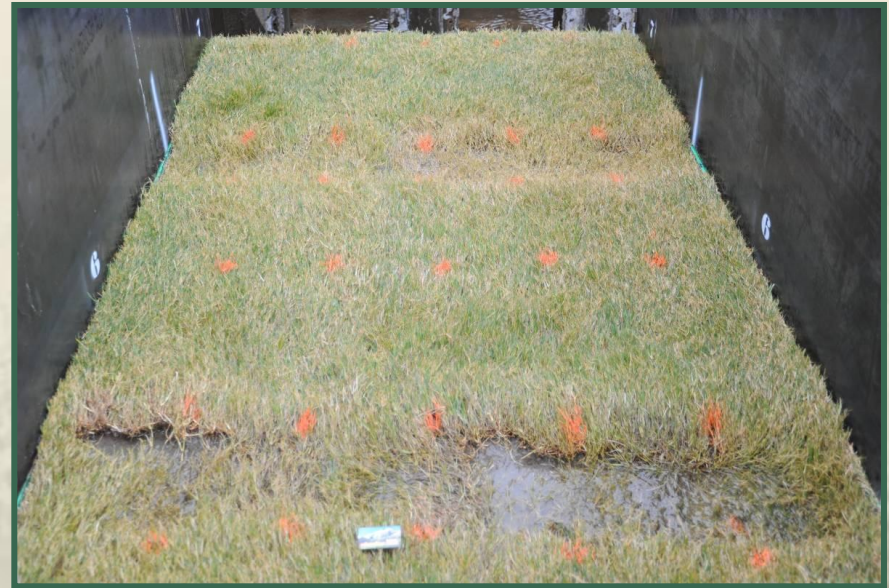
Grass with Wheel Ruts

After test at 370 l/s per m

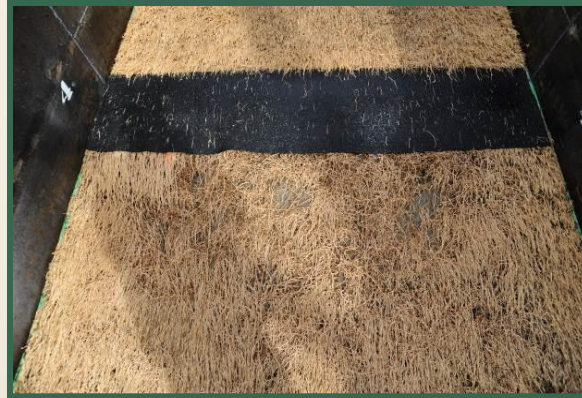
After 1st hour at 230 l/s per m

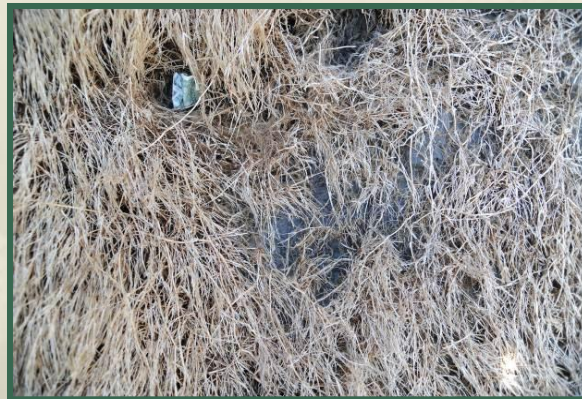
After 2nd hour at 185 l/s per m

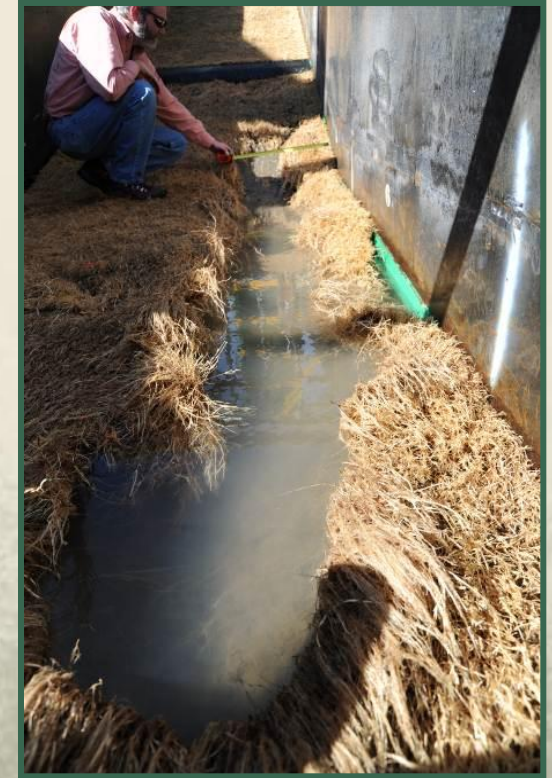
At end of 3rd hour

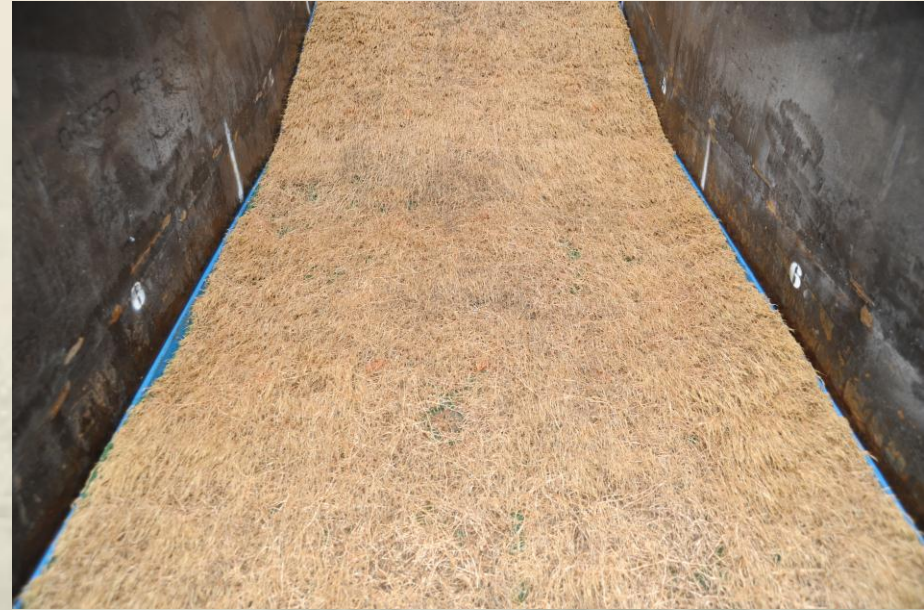
Dormant Grass + Tight Weave TRM

After 3rd test at 370 l/s per m

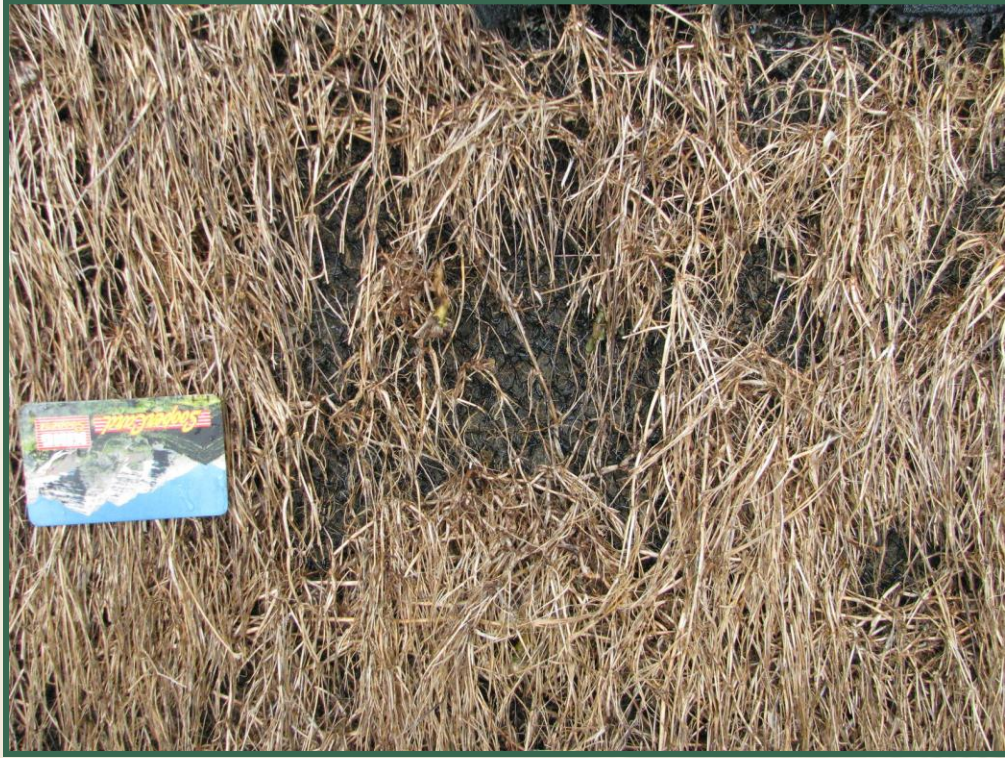
Dormant Grass + Open-Weave TRM

After 3rd hour at max. of 140 l/s per m

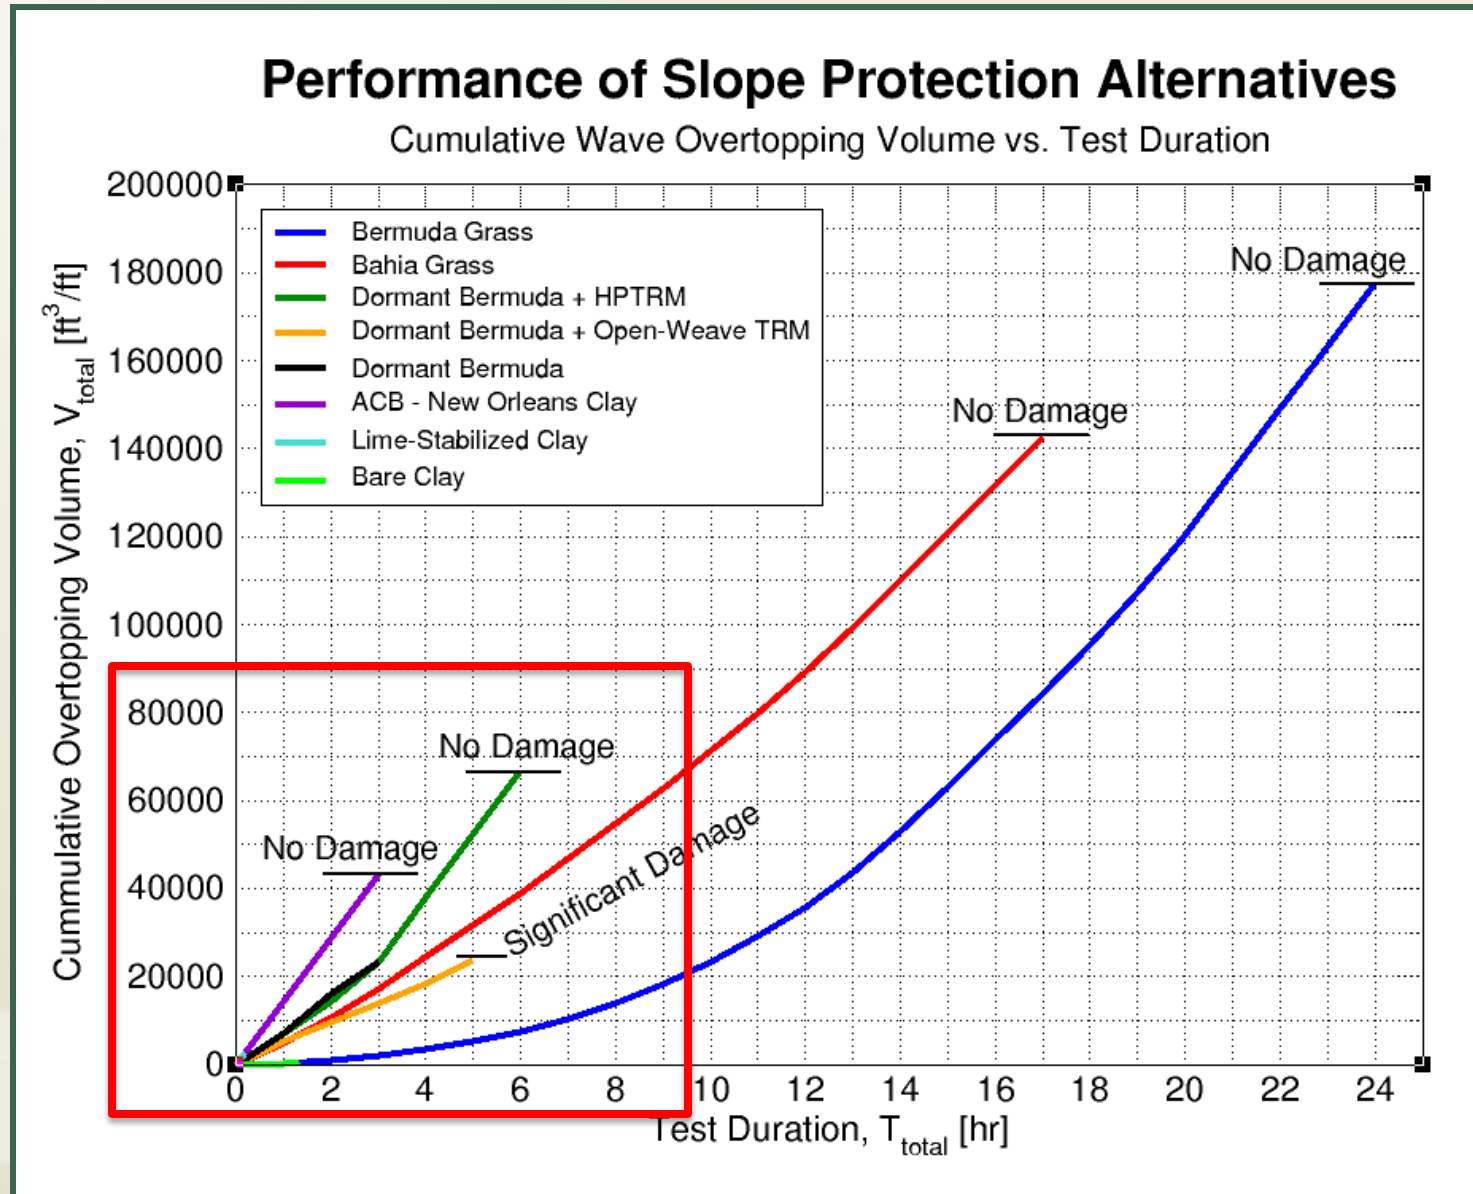
Cumulative Loading vs. Duration

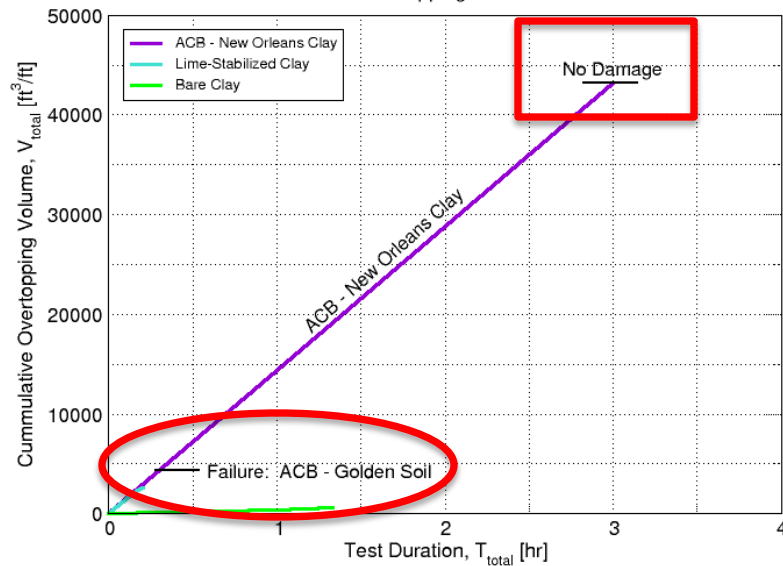
Cumulative Wave Overtopping Volume vs. Test Duration

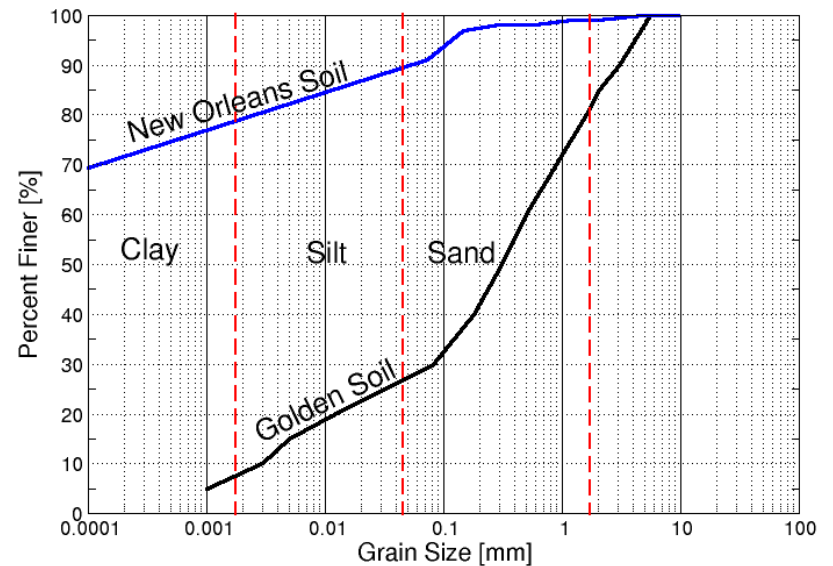
ACB Soil Grain Size Distributions
