**ICSE6 2012**

**BED EROSION ON THE RIVER  
GALET AND ITS IMPACT ON  
RAILWAY INFRASTRUCTURE**

**Mark CHEETHAM**  
**SNCF - Direction de l'Ingénierie**

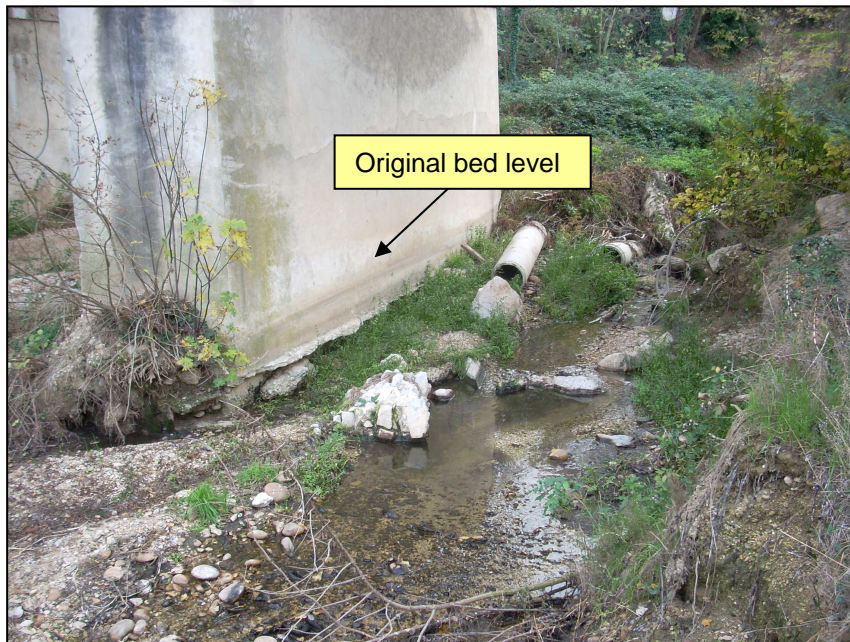
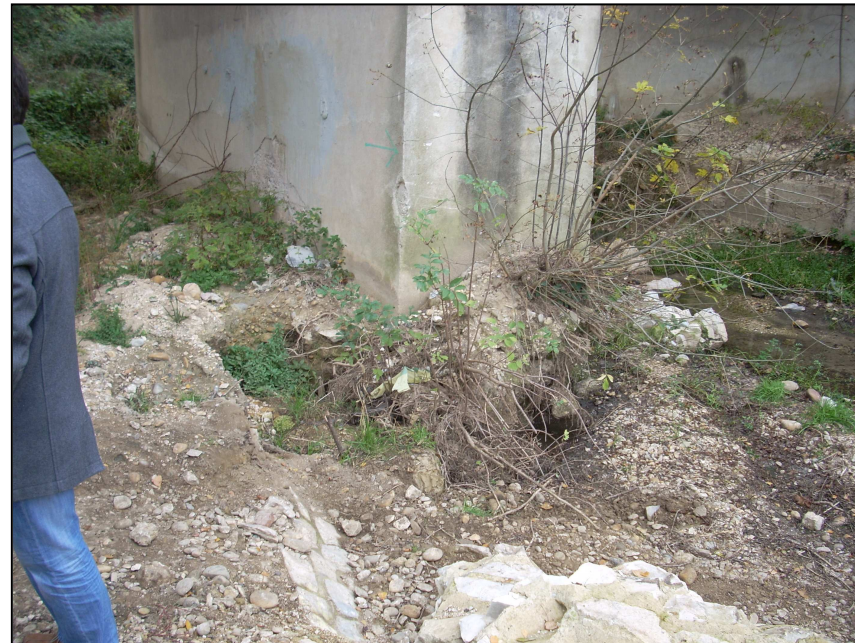
- An inspection of the viaduct railway in 2008 following flooding in the Galet catchment identified generalised bed lowering of the Galet exposing the foundations of the structure.

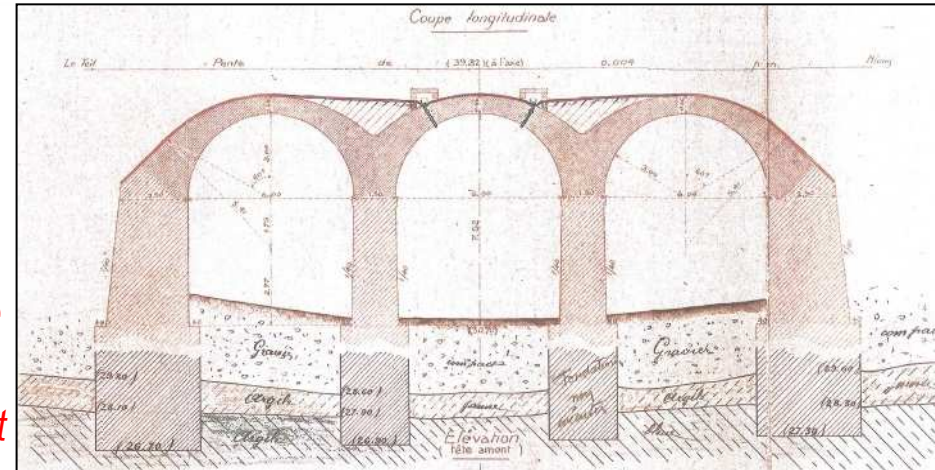
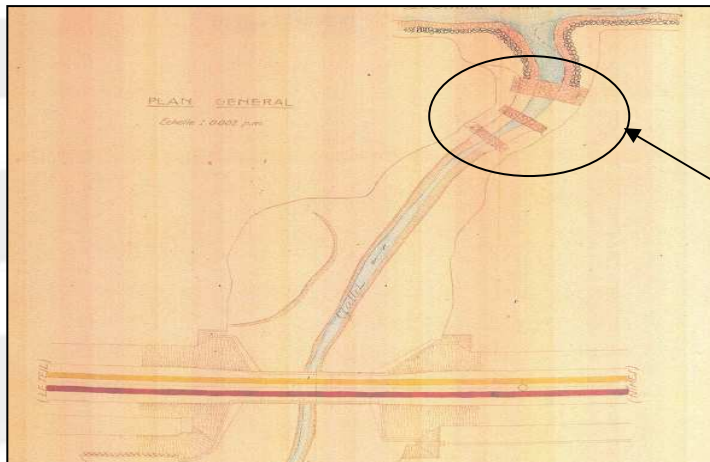
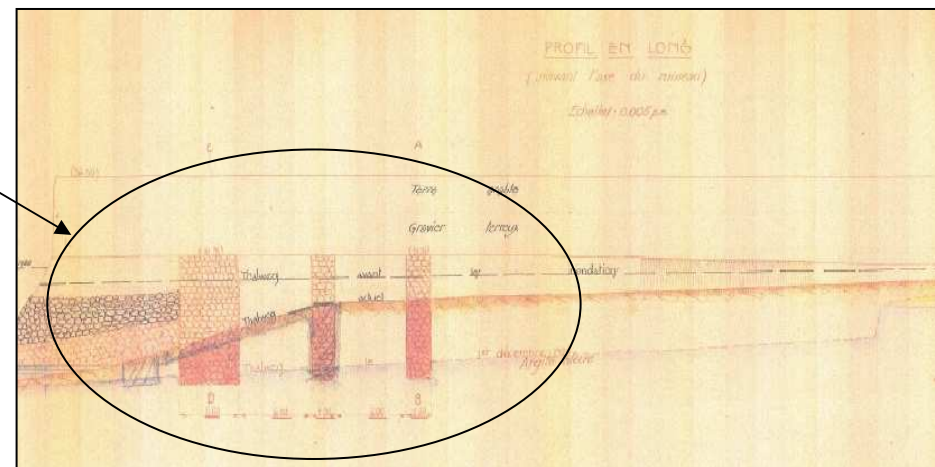
- Rebuilding of the railway viaduct in 1926
  - ◆ 3 arches each of 6m span
  - ◆ Construction of 3 weirs at the confluence of the Galet and the Rhône
  - ◆ Artificial raising of the river bed between the weirs and the new viaduct (imported fill material)

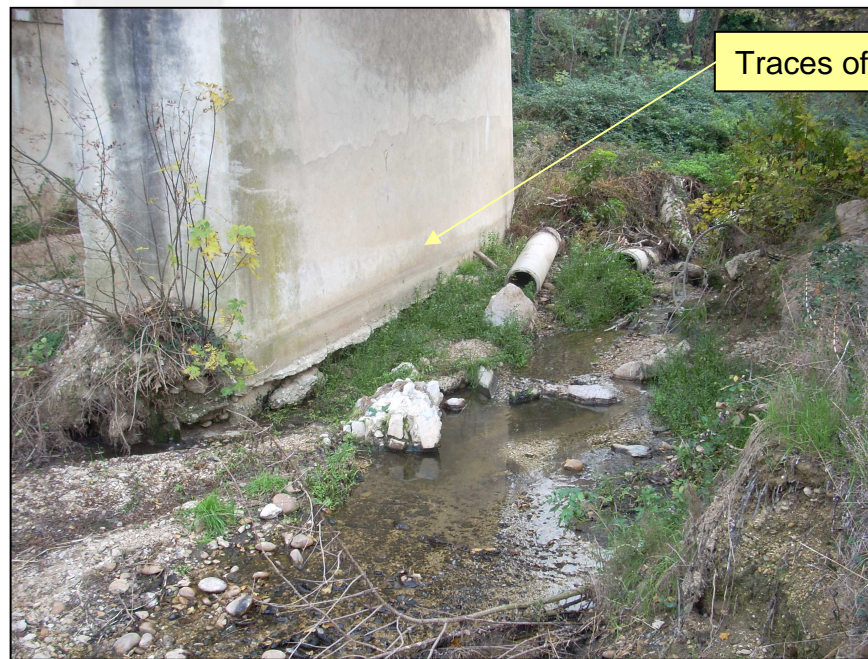
Viaduct pier base 2008

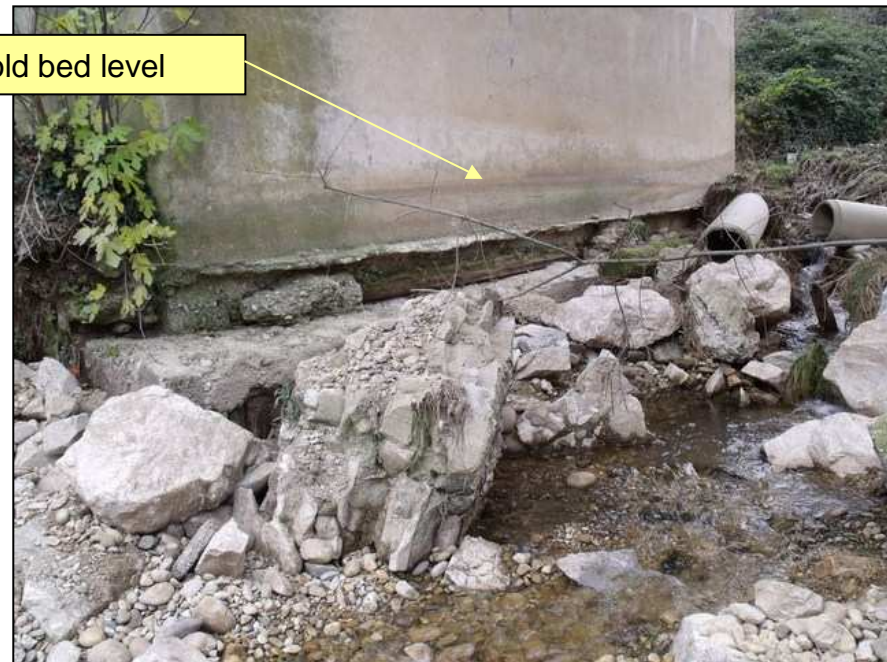
Viaduct pier base 2011

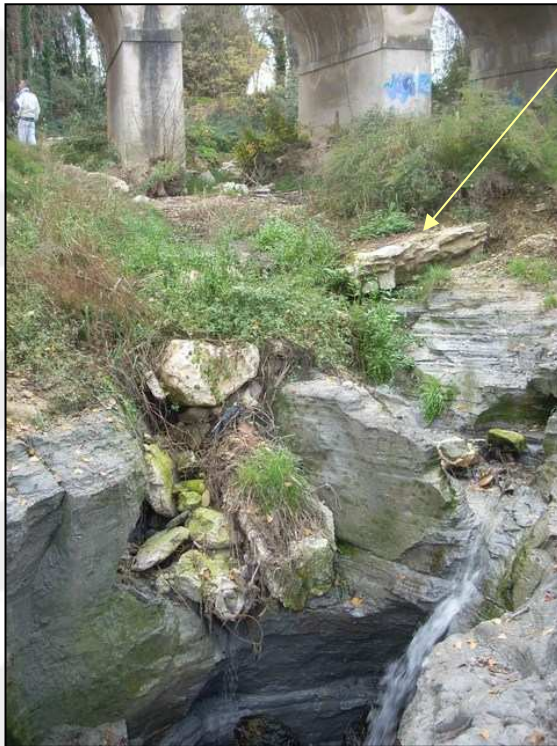
Waterfall downstream of viaduct 2008

Concrete block

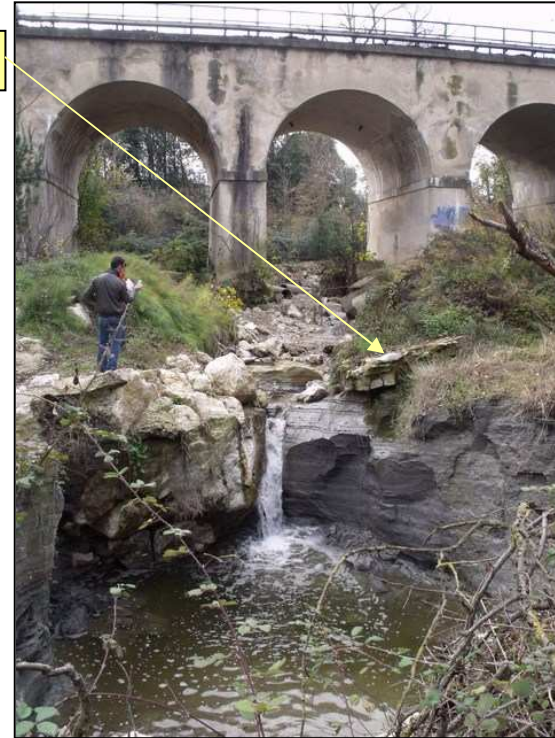
Waterfall downstream of viaduct 2011

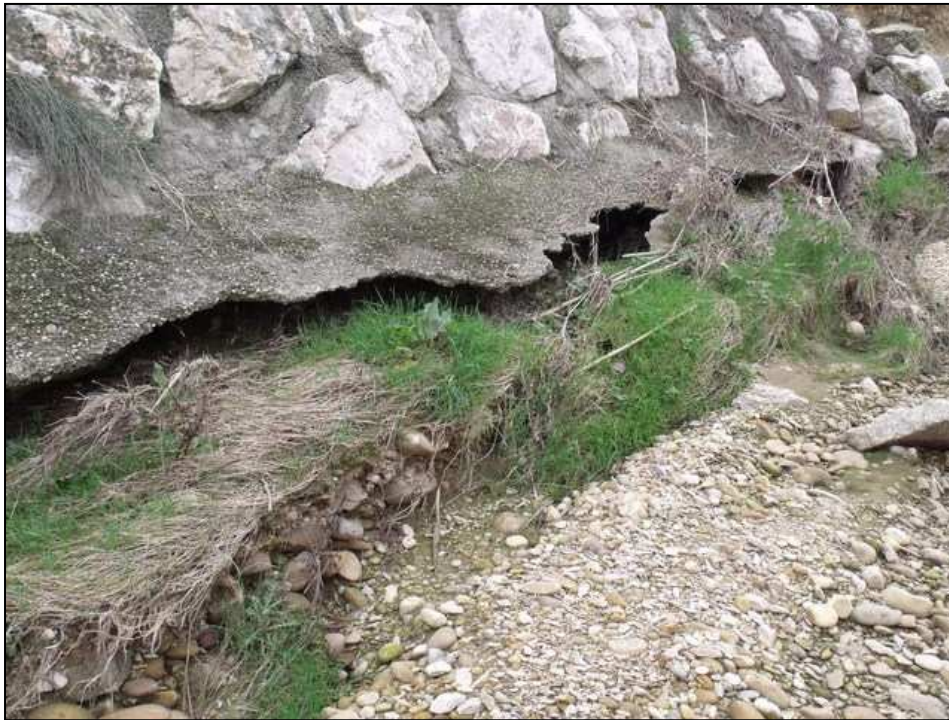
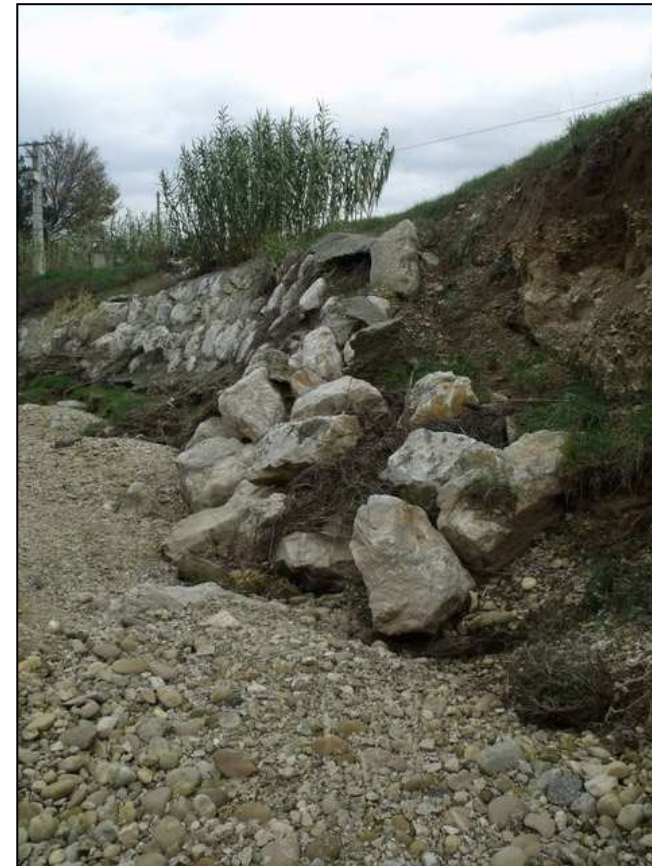
Reach between Garrigues Bridge and the Galet Viaduct (bank protection placed in 2002/3)

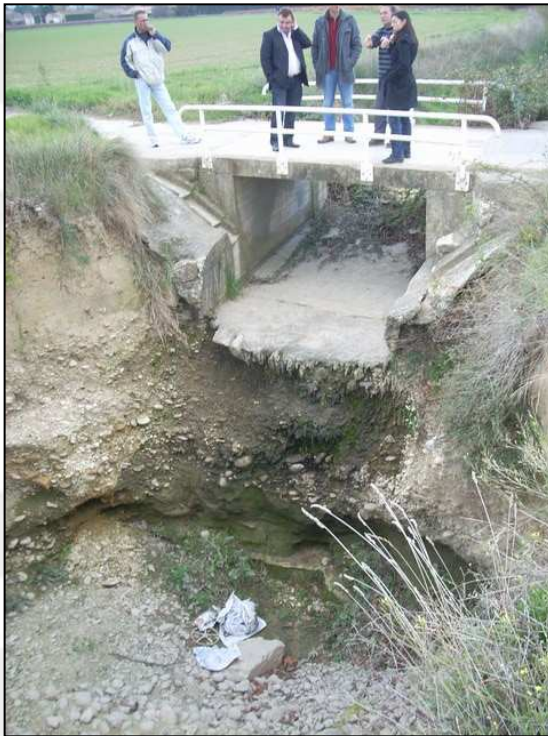
Immediately downstream of Garrigues Bridge 2008

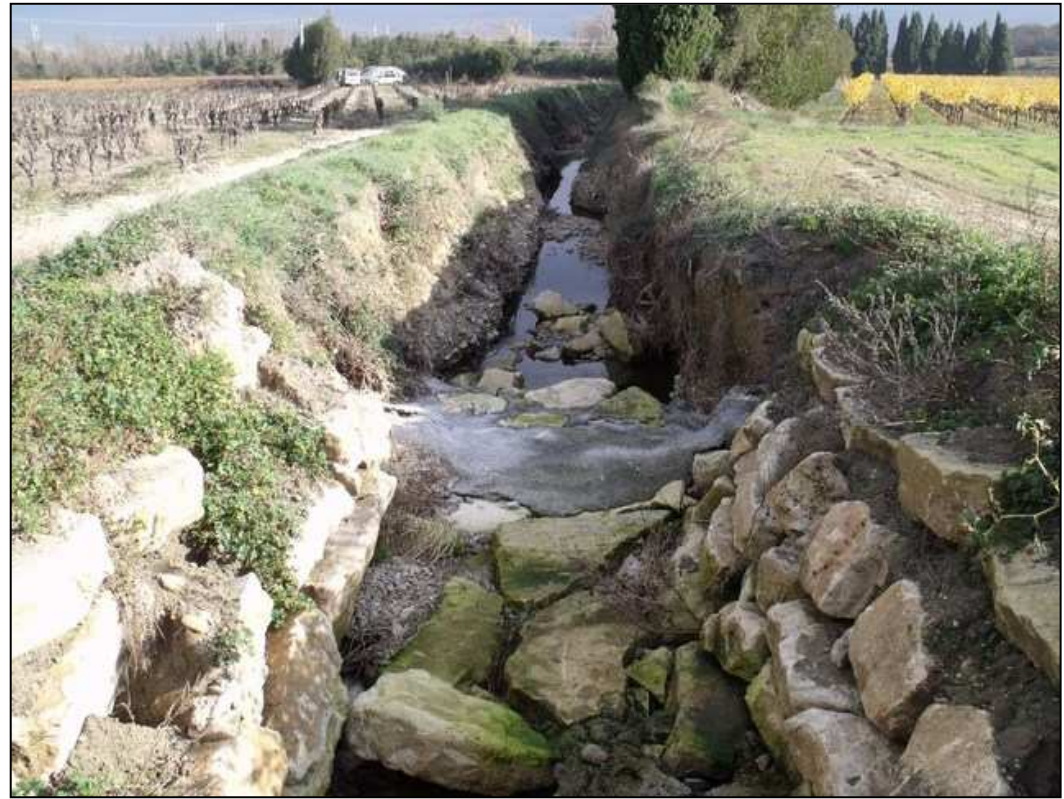
Following works in 2011

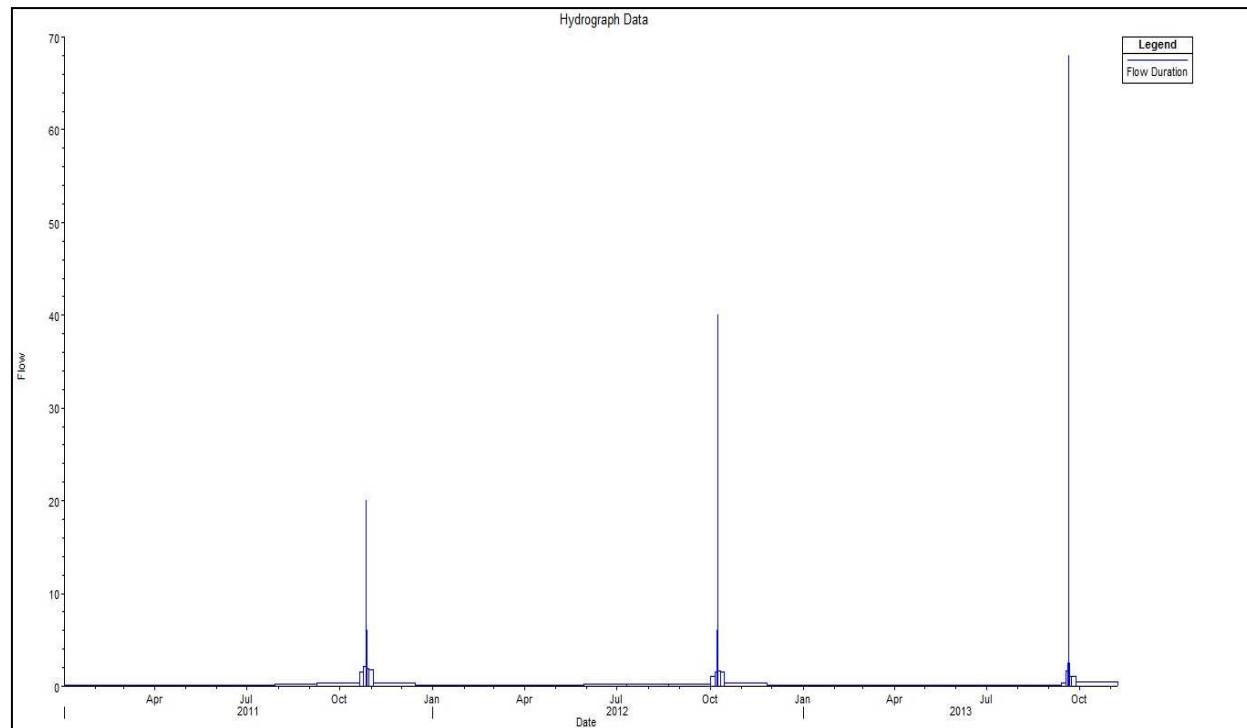
- HEC RAS 1D
- River length  $\approx 1\text{km}$
- Run in steady state and sediment transport mode
- 3 year simulation:
  - ♦ Yr 1 – 1 flood  $20\text{m}^3/\text{s}$
  - ♦ Yr 2 – 1 flood  $40\text{m}^3/\text{s}$
  - ♦ Yr 3 – 1 flood  $68\text{m}^3/\text{s}$

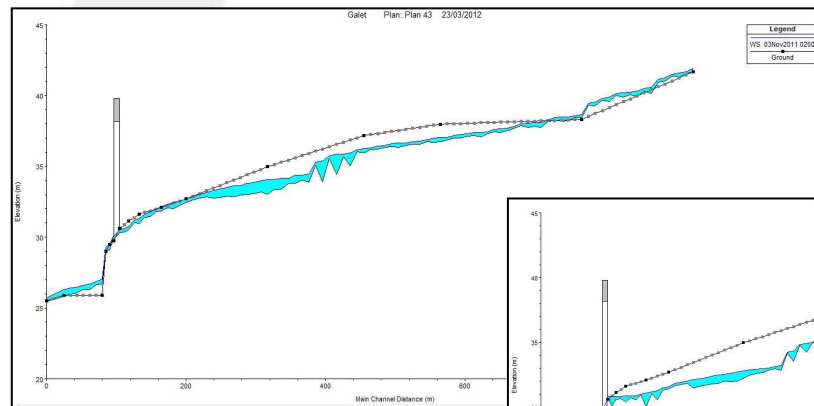
- Results of sediment transport modelling (series of 3 floods of  $20\text{m}^3/\text{s}$ ,  $40\text{m}^3/\text{s}$  and  $68\text{m}^3/\text{s}$ ) reflect well observations made on the ground

After  $20\text{m}^3/\text{s}$

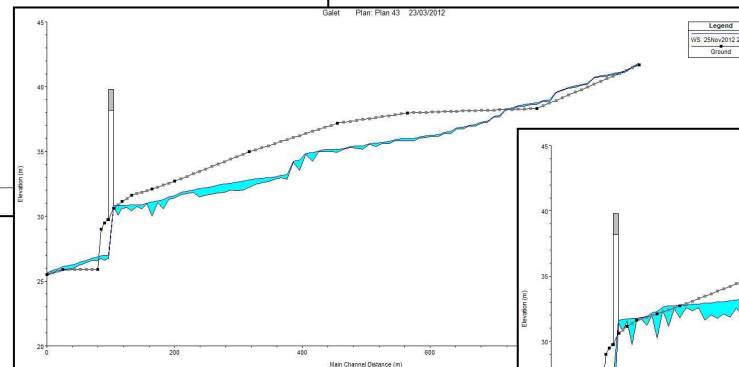
After  $40\text{m}^3/\text{s}$

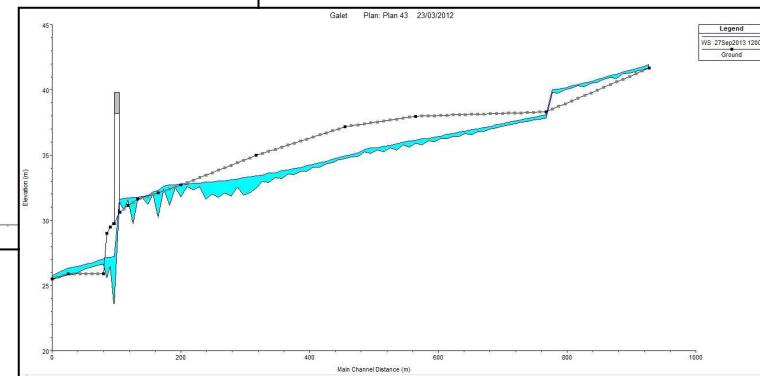
After  $68\text{m}^3/\text{s}$
