Knickpoint evolution across anticline structure: A case of uplifted reach in the Taan River, Taiwan

Ming-Wan HUANG, Yii-Wen PAN,
Jyh-Jong LIAO, Meng-Hsiung CHENG

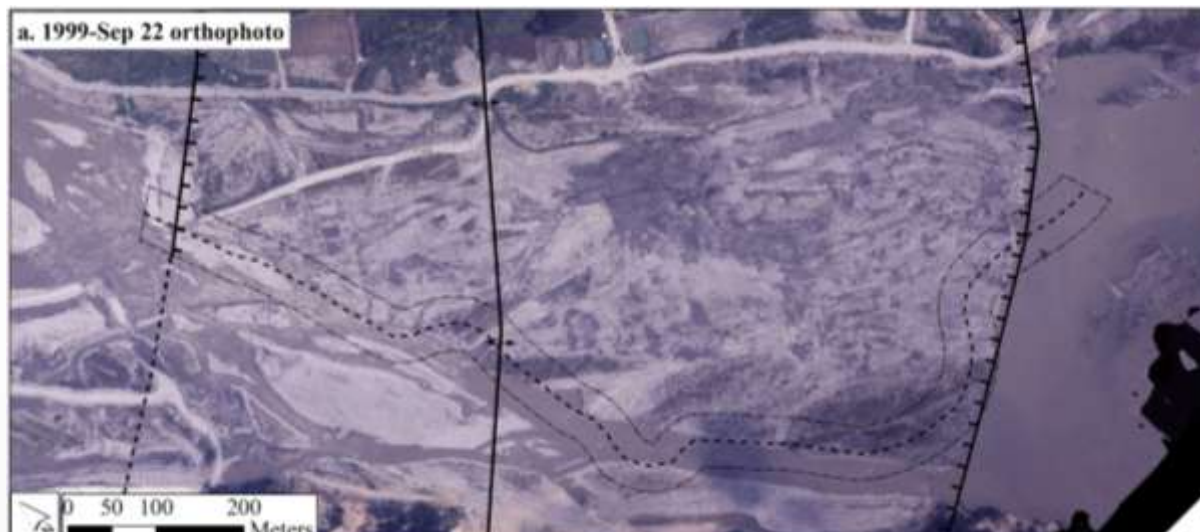
Study site

- The Taan River
 - Drains 758 km²
 - Trunk length 96 km
 - Headwater in EL. 3500m
- The uplift reach
 - Two ruptures parallel to the Tungshih anticline
 - Max. 10m uplifted
 - 1 km longitudinal length
 - Pliocene weak sed. rock
