**ICSE6 Paris – August 27-31, 2012**

Evolution of Beach Morphodynamics in light of Sediment Budget Assessment with the Coast of Joetsu, Niigata, Japan

Ryoukei AZUMA<sup>1</sup>, Tetsuya HIRAISHI<sup>1</sup>, Hideo SEKIGUCHI<sup>2</sup> 1. DPRI, Kyoto University 2. Osaka City University

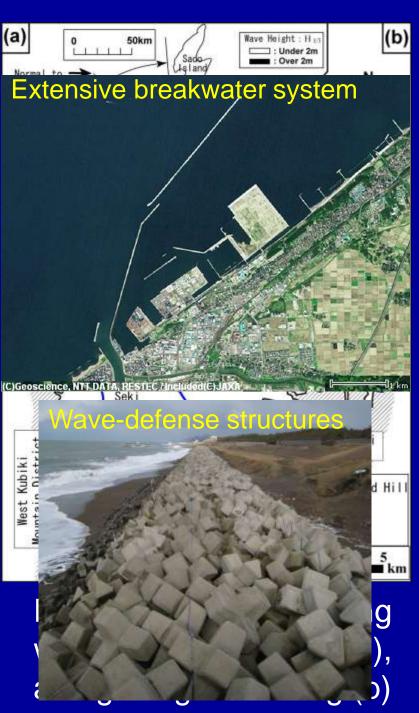
The Joetsu Coast is featured by 28km-long
Sheltered by Noto peninsula and Sado Island
Oprevalent wave directions are normal to shoreline
Osignificant wave height H<sub>1/3</sub>=9.24m was recoded on (20/12/2003)

The fluvial supply is principally due to the Seki River

The factors responsible may include...

Odevelopment of extensive breakwater system Odeployment of wave-dissipative or wave-defense structures

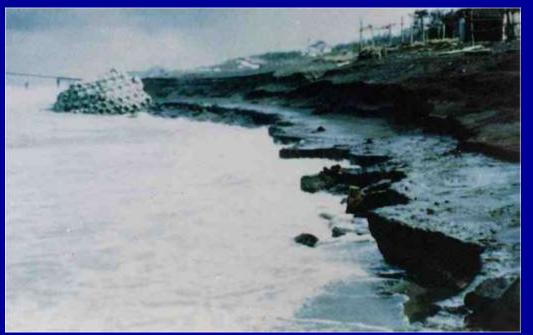
Photo 1: Serious beach erosion associated with severe winter storm from Jan. 27 to 30, 1989 (adapted from Hirano (2008)).

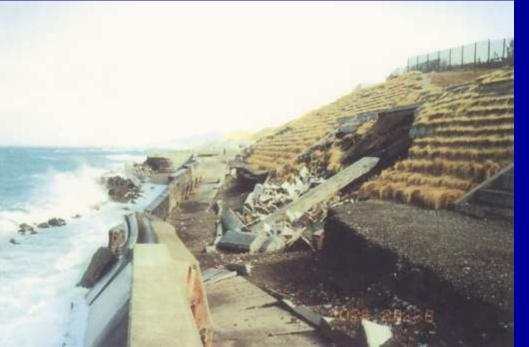
Photo 2: Affected seawall and slope due to severe winter storm (Photograph taken on Apr. 1, 2002: adapted from Hirano (2008)).
