Applying New Soil-Tire-Vegetation Method (STV) to Mitigate the Surface Erosion at the High-Gradient Mudstone Slopes

Po-Ying Chen, Der-Her Lee, Jian-Houng Wu,
Hui-Ling Chen, Yi-En Yang

2012/08/29 Paris

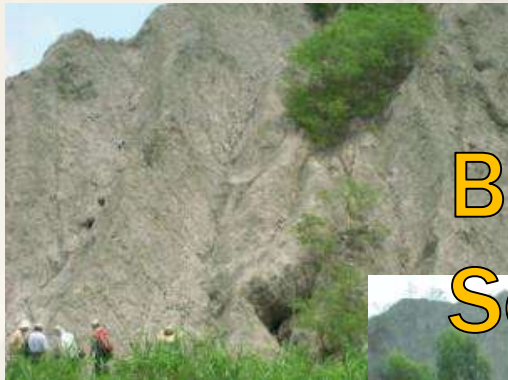
Badlands terrain at Southwestern Taiwan

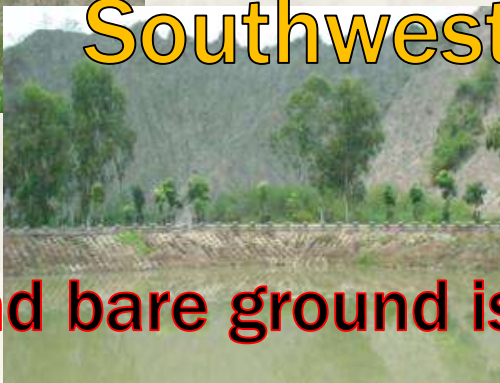
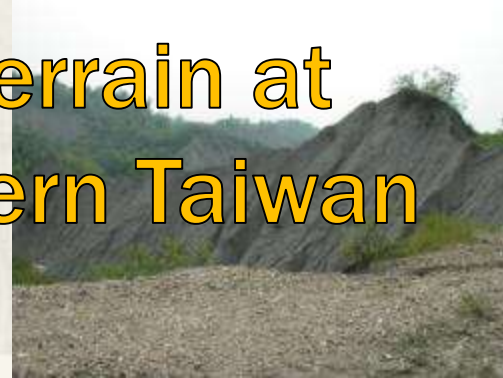
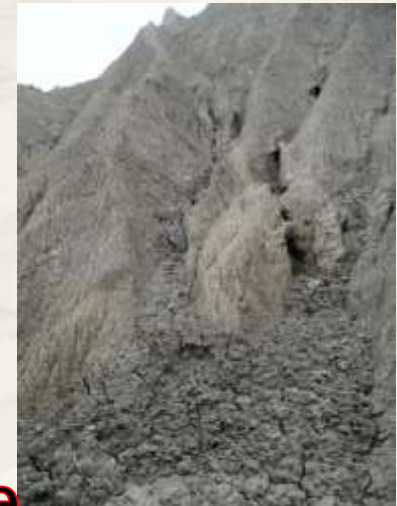
Gullies and bare ground is typical landscape

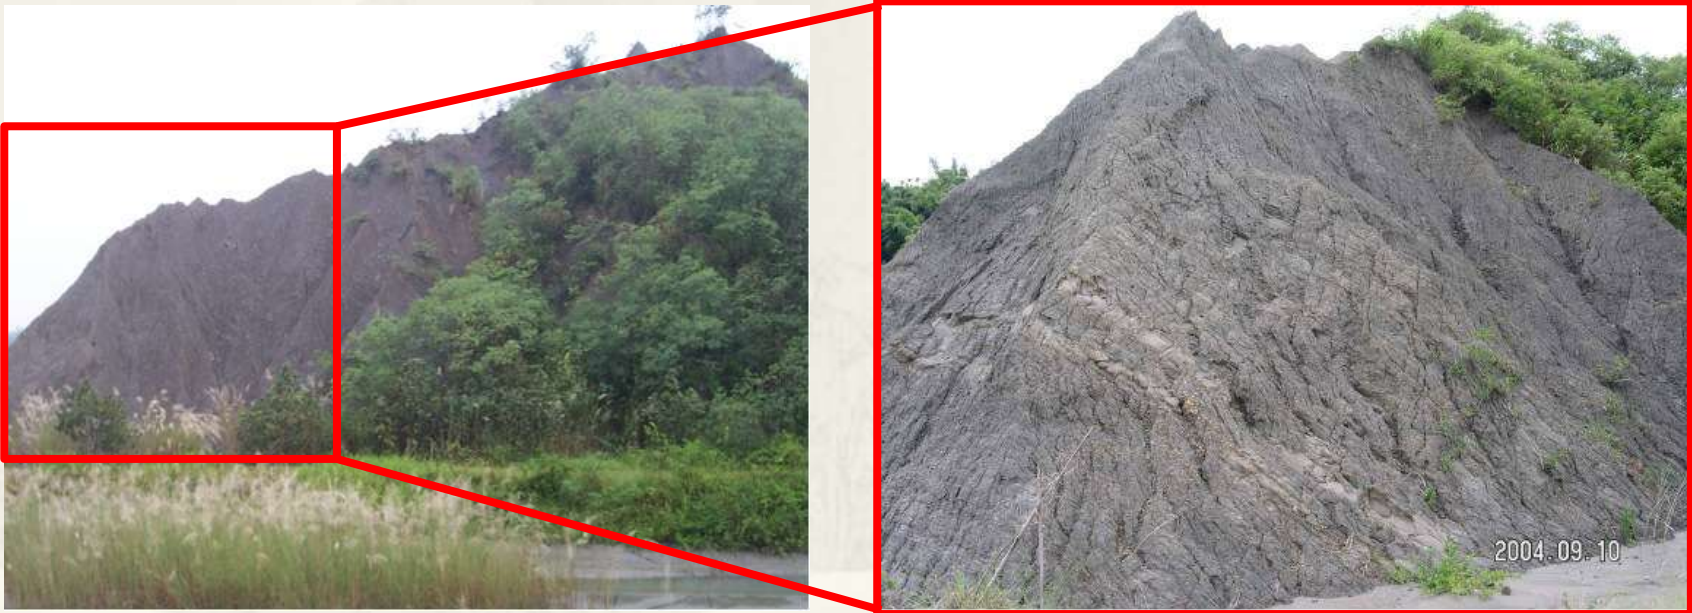
- * The nature slope was cut into a slope with three 45° stages, and the slope protection work covered an area of 390 m².

1. Bare the weight of the grid element
2. Avoid the water runoff infiltrating to the mudstone

Intercept the surface runoff

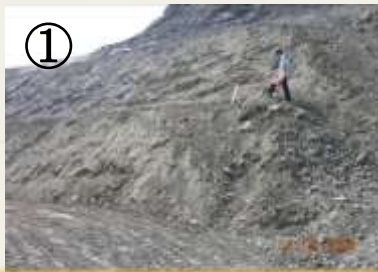
① Shape the 3-stage slope and the platform

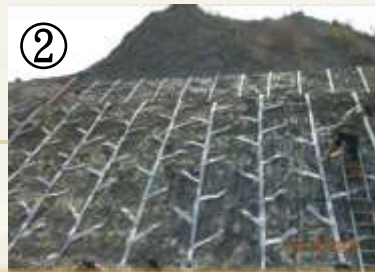
② Install the fabric drain

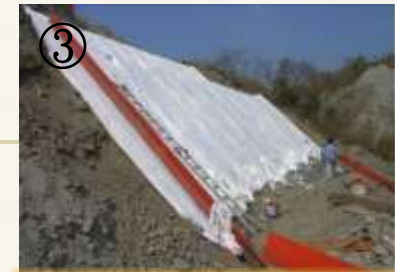
③ Put the geotextile sheet

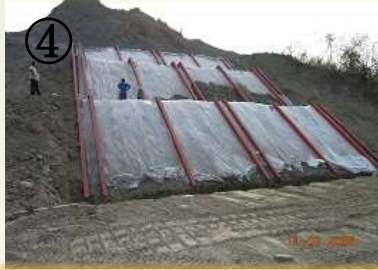
④ Install the grid elements

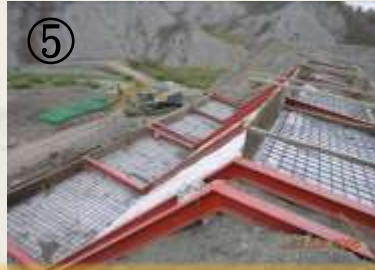
⑤ Construct transverse ditches and RC-platform

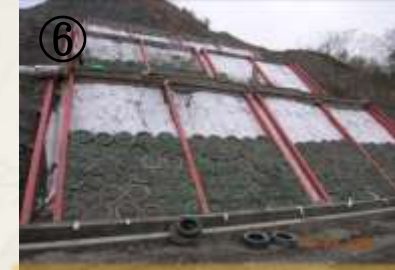
⑥ Place waste tires in the grid and fill with vegetative bags

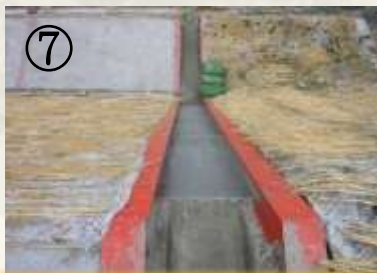
⑦ construct longitudinal ditches

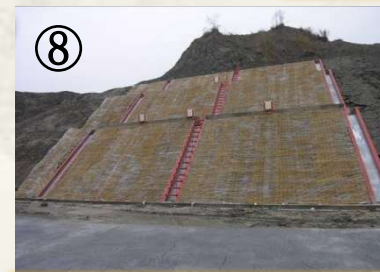
⑧ Put the vegetative mat on the grid and complete the work

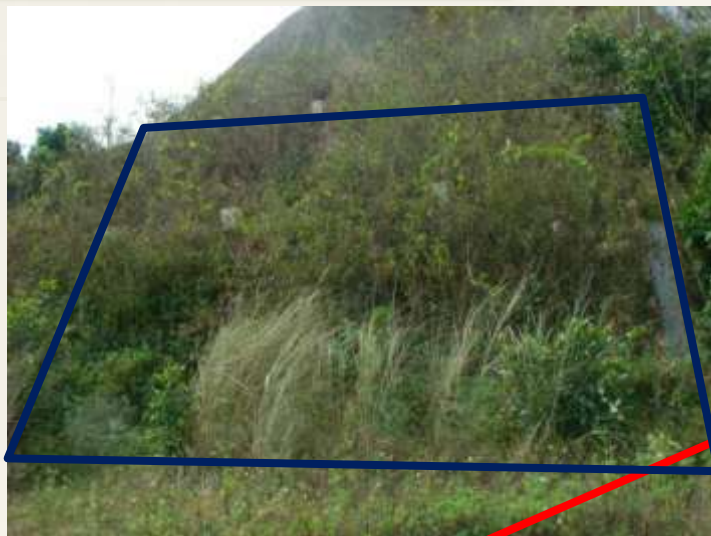
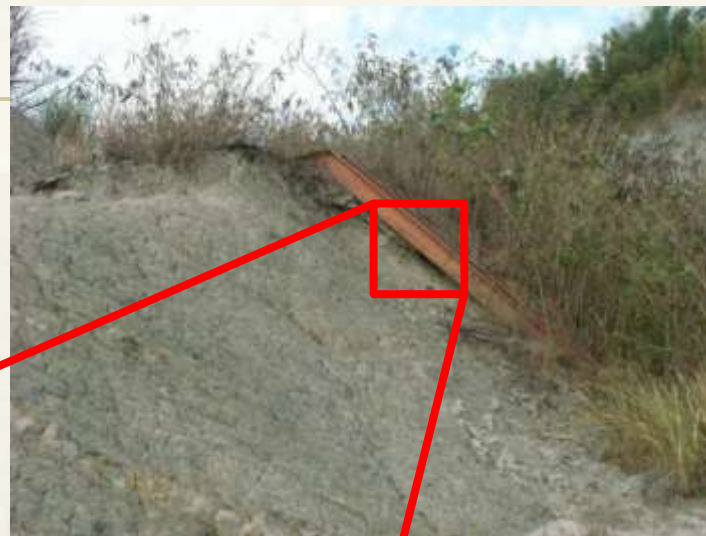
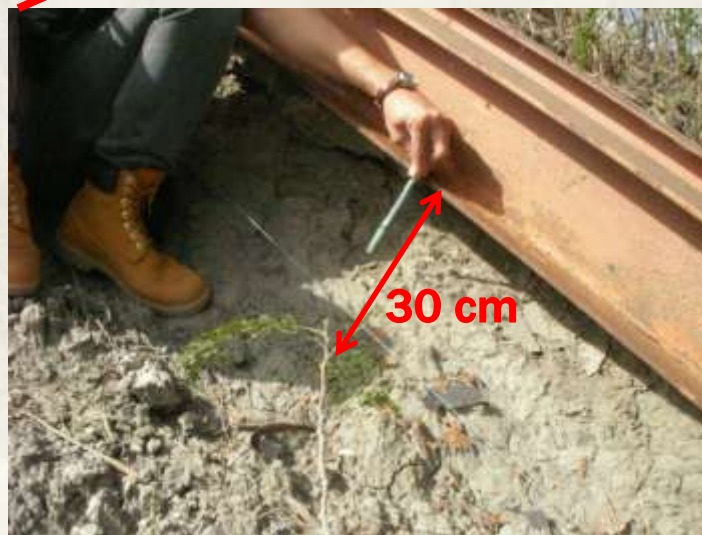
After almost 5 years

Bare slope surface erodes about 30 cm. But STV slope still keep original look, but a lot of vegetation.
