Falling aprons at circular piers under currents

International Conference on Scour and Erosion

Paris, 30th of August 2012

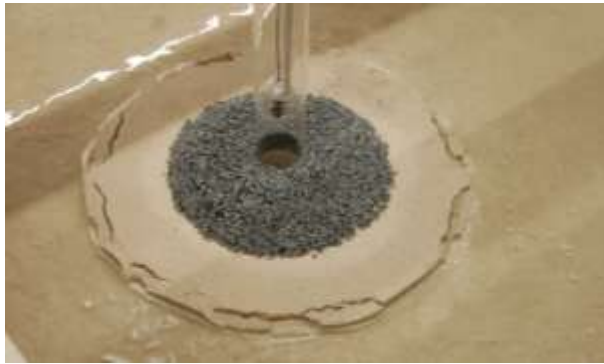
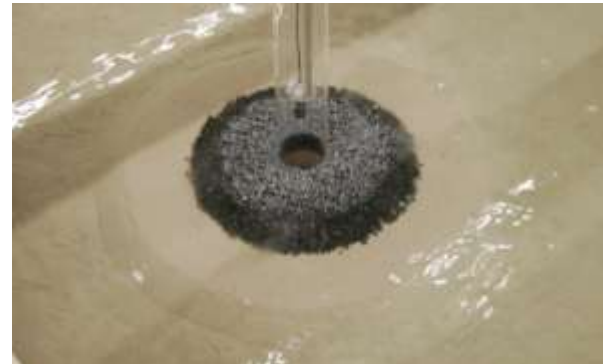
- Filling the basin

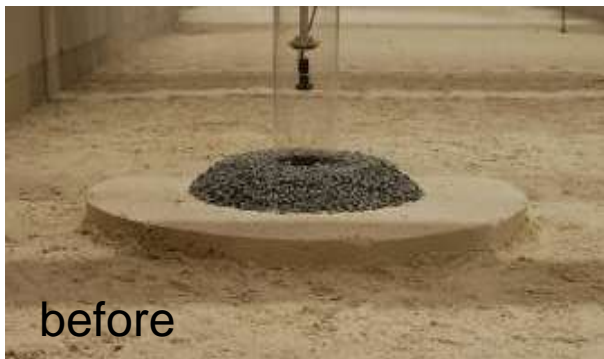
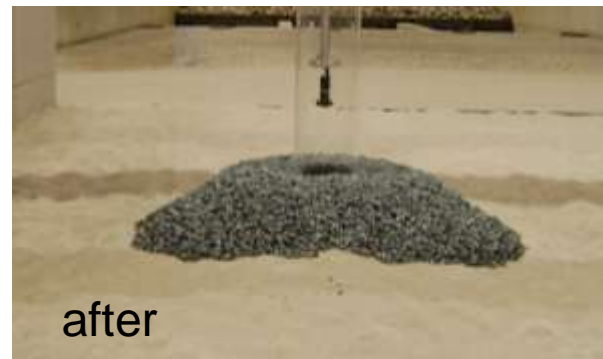
- Reference case: extent of $4D$ with sill height of $0.5D$

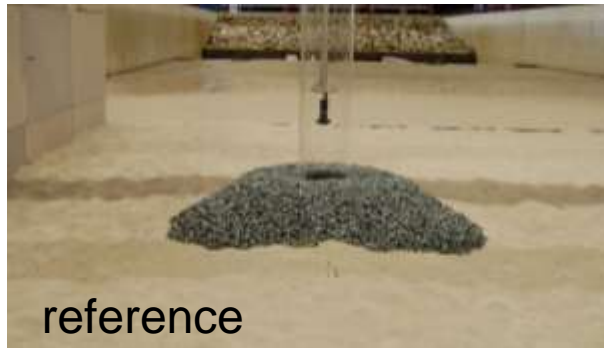
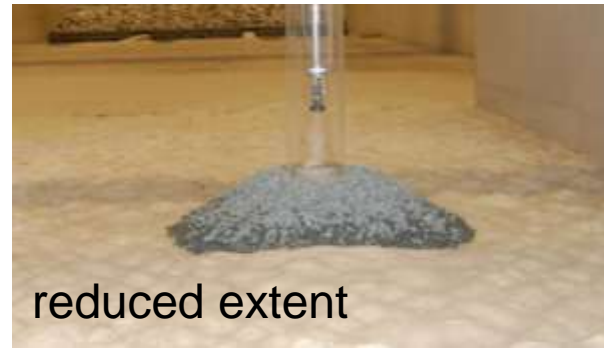
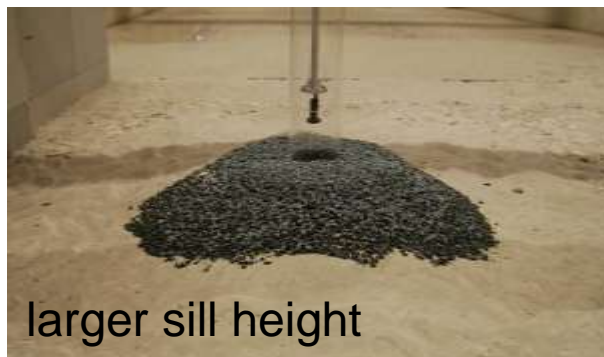
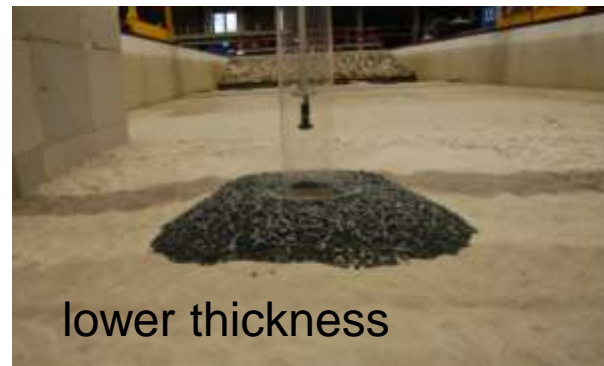
- Effects of sill height, extent and layer thickness

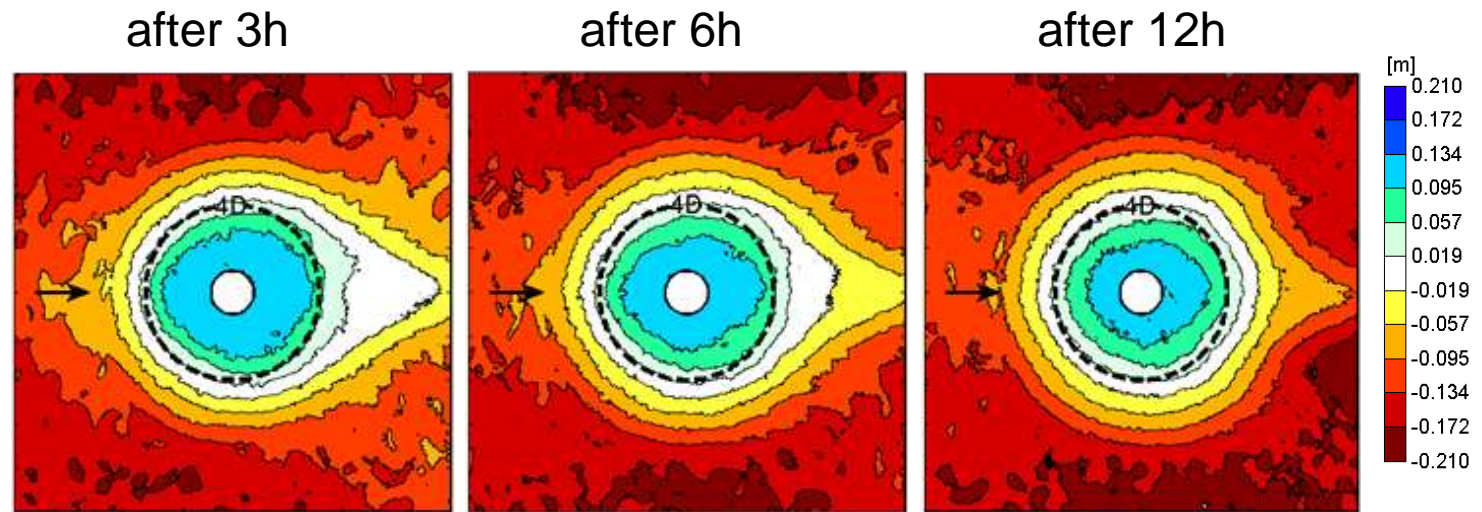
Development in time

- Largest development within first 3h.
- Hereafter, gradual erosion at upstream and downstream side

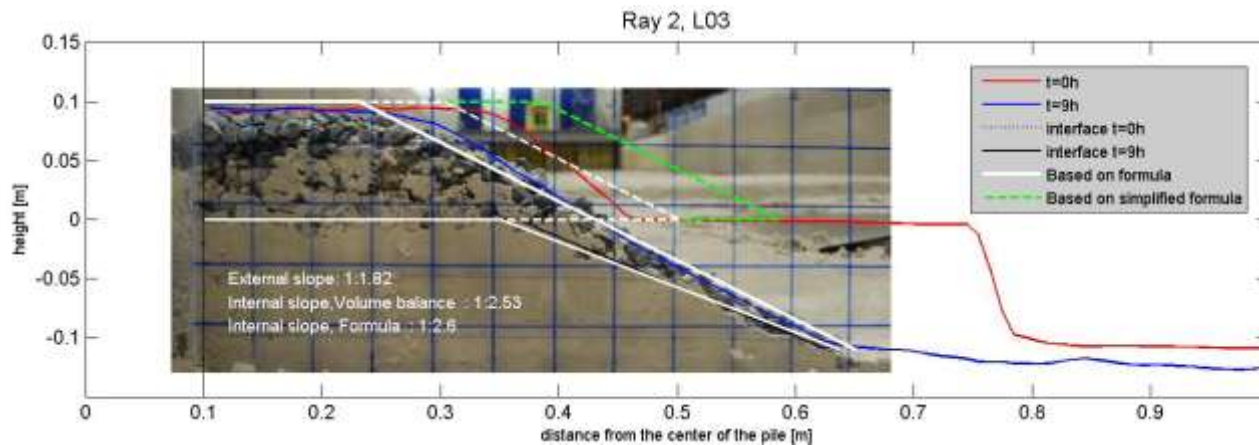
- Validation
