Reservoir sedimentation in the Demirköprü Dam, Turkey

M.A. Kokpinar & Ş.Y. Kumcu
Hydraulics Laboratory, State Hydraulic Works, Ankara, Turkey

ABSTRACT: The Demirköprü Reservoir is located on the Gediz River in West Central Turkey and has a storage capacity of 1.32×10^9 m^3 at Normal Water Surface Elevation. Construction of the dam was started in 1954 and completed in 1960. Sediment accumulation within the Demirköprü Reservoir influences the operation life of the dam. In the present study, reservoir sedimentation was assessed by two ways: comparison between successive hydrographic surveys and suspended sediment measurements. Since 1960, two hydrographic surveys were carried out at Demirköprü Reservoir, i.e., in 1977 and 1991. It is seen from the final measurement that 33% of the total storage volume of the reservoir was lost due to sediment deposition. There exists only one sediment gauging station in the drainage area of the Demirköprü Reservoir. The drainage area of the gauging station is about 50% of the total drainage area. In this study, the comparison of the two hydrographic maps together with the suspended sediment measurements is investigated thoroughly. Additionally, the

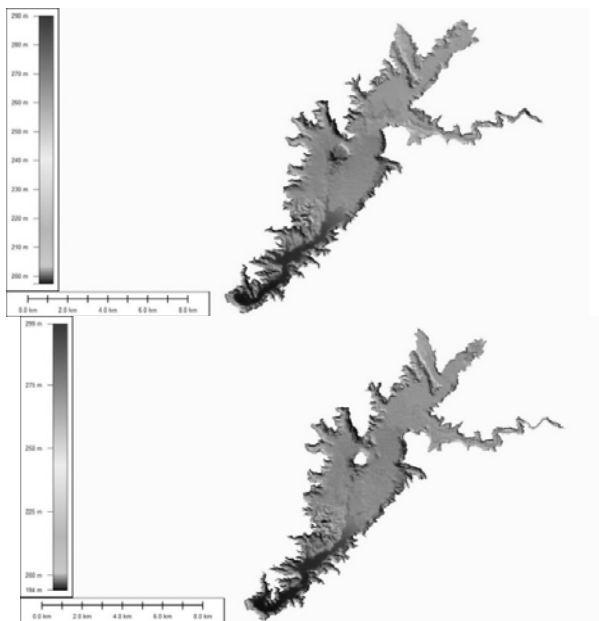
Figure 2. Images of hydrographic surveys; a) 1977, b) 1991

Two reservoir capacity surveys were carried out in the Demirköprü Dam reservoir in 1977 and 1991, respectively. Figure 2 shows two images of

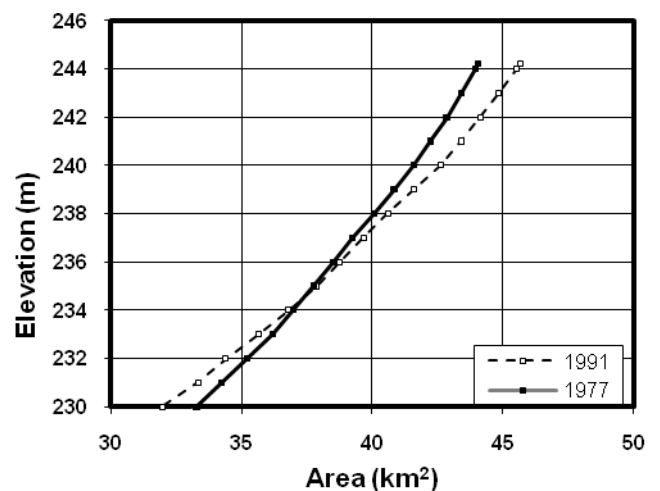
As seen from Figure 3, the variation of reservoir water surface level (elevation) with surface area above and below the elevation 235 has a different tendency in years 1977 and 1991. Above elevation 235, the reservoir surface area in 1991 is larger than the area that of the year 1977. Possible reasons for this increase may be due to the combined effects of shoreline erosion, landslides and locally sediment accumulations at the reservoir upstream due to excessive reservoir water level variations, but their particular effects could not be predicted completely for the Demirköprü Dam reservoir.

Figure 3. Variation of reservoir surface area with elevation

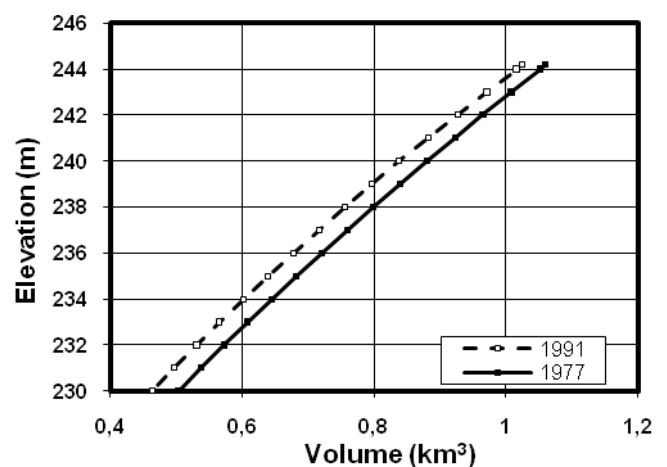
Figure 4. Variation of reservoir capacity with elevation

When the elevation-volume curve in Figure 4 is examined at the NWSE, it can be predicted that approximately 36 million cubic meters of the re-

servoir capacity was decreased from years 1977 to 1991. In other words, the reservoir was realized approximately 2.7% reduction in the capacity between 1977 and 1991.

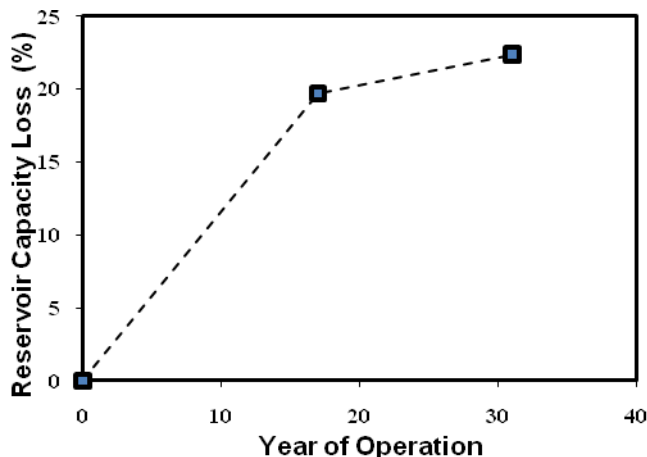
Figure 5. Reservoir capacity loss of the Demirköprü

At early periods of the reservoir operation, about 17 years of operation, the sedimentation rate in the reservoir shows a very rapid trend (i.e. about 1.15% per year). However, for the next 15 years of operation, the rate of sedimentation decreases remarkably to a value of 0.24% per year. Knowing that there is no upstream control of the Demirköprü Dam, technically it is difficult to explain about this 5 fold reduction in the sedimentation rate.

If the last survey value in 1991 compared with the original capacity value of 1.32 km^3, the total amount of volume reduction is calculated as 22.3% in 1991; i.e. the amount of volumetric reduction was 0.72% on annual basis. On the basis of this annual sedimentation rate, 36% of volume reduction may be expected in 2010.

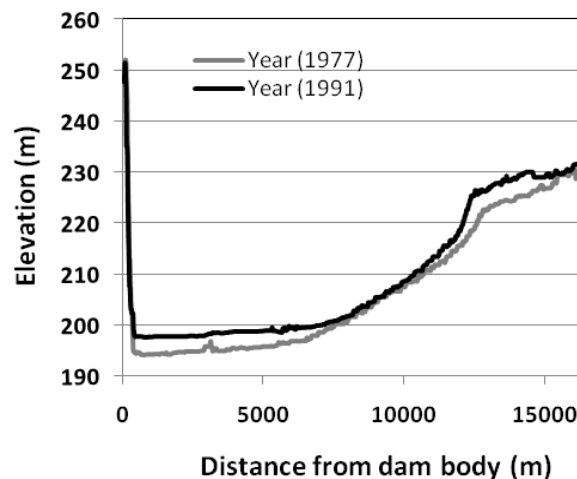
In order to find out the formation of delta deposits in the reservoir, the bottom profile passing through the centerline of the reservoir is drawn from the DEM data based on the hydrographic surveys conducted in 1977 and 1991 as shown in Figure 6. With the comparison of these two hydrographic surveys, two types of deposition pattern can be clearly observed from the bottom profile; i.e. bottom-set deposits and delta deposits.

Figure 6. The profile of delta formation along the reservoir axis

The bottom-set deposits are developed in the main body of the reservoir basin and close to the dam as well, and built-up from fine and very fine suspended sediment transported by turbulent suspensions and by turbidity currents when they occur, and are deposited in quiescent water. In the case of Demirköprü Dam reservoir, according to the hydrographic survey data of 1977, the slope of the bottom-set deposits next to the dam is approximately equal to 4.14x10^{-4}. However, in 1991, the slope of the bottom-set deposits next to the dam body becomes nearly horizontal and re-

duced to a value of 3.40×10^{-4}. In addition, within this period approximate increase in the bed level just upstream of the dam body due to the fine sediment deposits is 3.2 m in total, i.e. 0.23 m increase per year.

The separation between the topset and foreset deposits occurs by virtue of a pivot point at a location which depends primarily on the reservoir operation and on the existing channel slope in the delta area. The pivot points at the delta of the Demirköprü Dam deposits in years 1977 and 1991 are clearly seen in Figure 6. Referring to this figure one can conclude that the progress speed of the delta towards the dam body is 25 m/year in the Demirköprü Dam reservoir between 1977 and 1991. However, Batuca and Jordaan (2000) noted that depending on the reservoir hydrology, hydraulics, sediment transport, size and configuration, the speed of progress of the delta is variable from 50 to 200 m per annum.

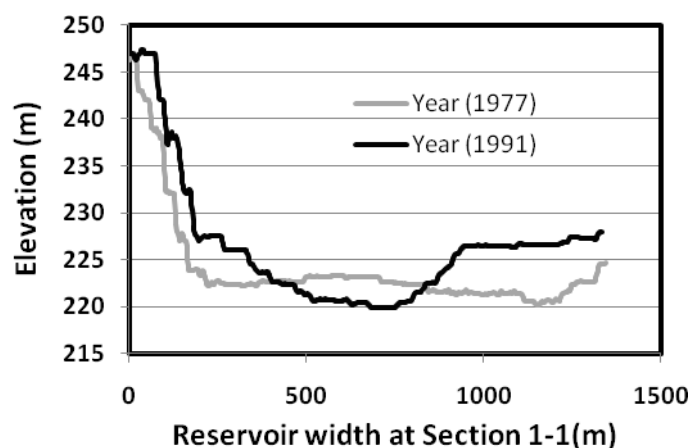
In Figure 7, Section 1-1 (indicated in Fig.2) is given to show the cross-sectional change in the lateral direction of the reservoir between 1977 and 1991. This section also indicates the encountering region of the Gediz River to the reservoir lake and shows morphological changes of the region (see the image showing the region in Figure 8). Even it is expected that sediment deposition is initially focused in the deepest part of the cross-section, creating deposits having a near-horizontal surface regardless of the original section shape; this is not the case for Section 1-1. This is actually due to locally sediment inflow from the Gediz River and channel erosion during drawdown in dry seasons. Therefore, it is clearly observed from Figure 7 that while the cross sectional shape in 1977 is almost horizontal, in 1991 the central part is scoured forming a main channel with deposited sediments at the banks of the channel.

Figure 7. Cross-sectional change at Section 1-1 from 1971 to 1999, showing the deposition of sediment in the transverse direction

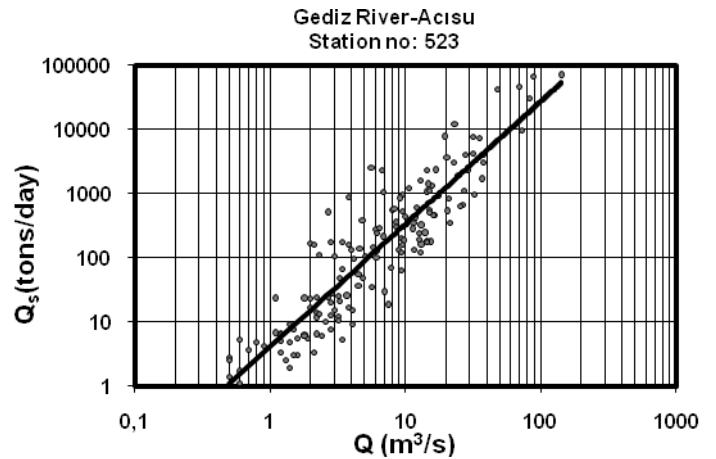
To construct a more comprehensive sediment budget for the Demirköprü Dam reservoir, the suspended sediment data that had been collected by the General Directorate of Electrical Power Resources Survey and Development Administration (EIE) between the periods of 1971 to 1984 for the gauging station 523 were used (EIE, 1987). Because of the location of this gauging station on the drainage area of the Gediz River (Figure 1), the measurements conducted at this station is important to get some information on the suspended sediment transport rate in the Gediz River. The hydrological characteristics of the gauging station 523 are given in Table 1. The drainage area of the station corresponds to 50% of the Gediz Dam drainage area, which gives representative hydrological characteristics for the whole drainage area. The suspended sediment samples taken at this gauging station was used to develop the sediment rating curves. The mean sediment concentrations were converted into tons per day of sediment load according to the instantaneous discharge. The sediment load was plotted against the instantaneous discharge on log-log scale and a straight line of power function was fitted by regression analysis as shown in Figure 9. The expression of the best fit line obtained from the data of the gauging station is in the following form with a correlation coefficient of R^2=0.82:

Figure 9. Variation of suspended sediment discharge with water discharge for gauging station 523
