**Test stretch with technical-biological  
bank protection measures  
Rhine km 440.6 to km 441.6, right bank**

**Final report of the monitoring phase  
2012 to 2017**

BAW No. B3952.04.04.10151  
BfG No. 1677

02.08.2023

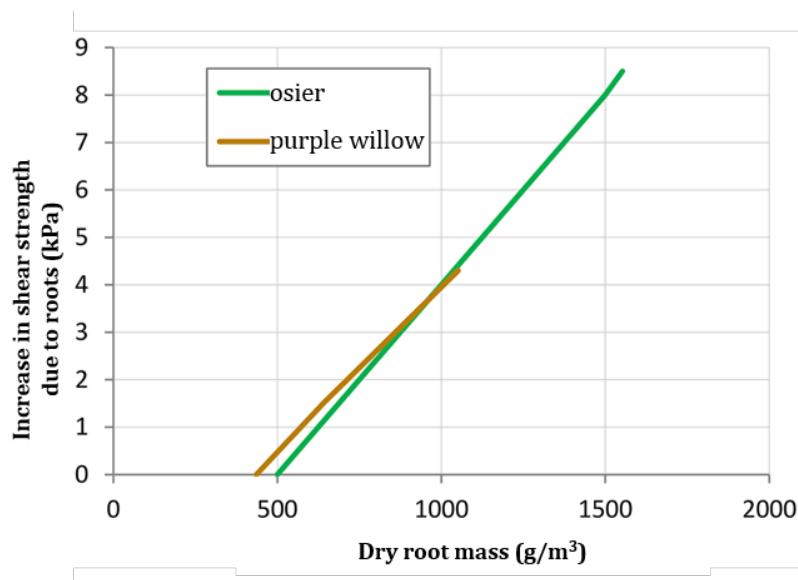
Willow brush mattresses had been pre-cultivated in boxes made of osier and purple willow branches for one vegetation period; the increase in the soil's shear strength attributable to the roots as a function of their dry root mass was determined by means of a large-scale shear test at the BAW's foundation engineering laboratory (Figure 15). Based on the correlation found and neglecting the age difference between the willows from the laboratory and from the field, it may be assumed that after around five years of initial growing the willows from the field test on the Rhine achieved an increase in the soil's shear strength compared to the unrooted soil. This increase may be assumed to be at least 10 kN/m<sup>2</sup> up to a depth of 10 cm under the ground surface (dry root mass: 4,500 g/m<sup>3</sup>); 4 kN/m<sup>2</sup> in the range of 10 cm to 40 cm of depth (dry root mass: 1,000 g/m<sup>3</sup>) and 1 kN/m<sup>2</sup> in the range of 40 cm to 70 cm of depth (dry root mass: 550 g/m<sup>3</sup>). Numerical computations with the finite element program PLAXIS for modelling slope stability show that under the given boundary conditions these shear strengths of the rooted soil can prevent sliding failure of the slope caused by a fast drawdown of 70 cm during a ship's passage. This is approximately the maximum drawdown expected to occur around the willow brush mattresses. This means that there is evidence that willow brush mattresses as installed in the field test are able to protect the bank against sliding failure.

Figure 15: Shear strength increase of the soil as a function of dry root mass (Eisenmann 2015)

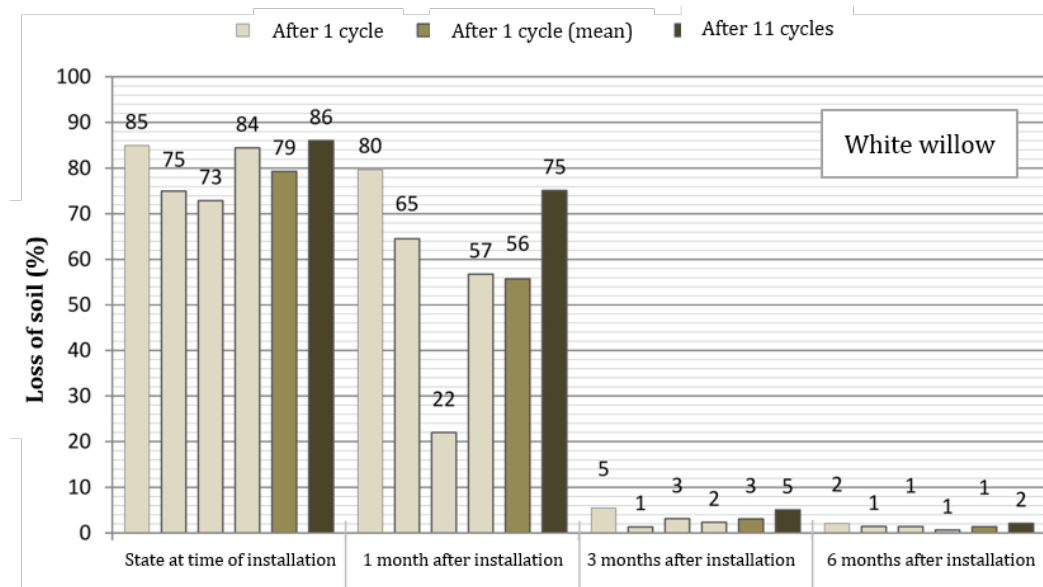
again after an initial growth phase of one, three and six months, using test equipment specifically developed for this purpose. The specimens consisting of willow branches and soil (fine-gravelly sand) were subjected to seepage under waterways conditions and loss of soil was measured (Figure 16). Immediately upon installation, and even with almost complete surface coverage, soil retention achieved by the installed willow branches was insufficient. However, after an initial growth phase of three months, the root system of the willows had developed to such an extent that soil loss could be prevented almost completely.

Figure 16: Soil retention achieved by willow brush mattresses of various ages determined in the laboratory (Sokopp 2017)

This means that additional measures may be necessary temporarily, at least during the critical initial growth phase. Therefore, a cooperation project of Fraunhofer-Institut UMSICHT Oberhausen, FKUR Kunststoff GmbH, Trevira GmbH, BNP Brinkmann GmbH & Co. KG and the BAW has recently been initiated to develop a geotextile filter nonwoven with defined biodegradability. The technical properties required (strength, permeability, filter stability) must remain intact for three years; after that the fleece is intended to biodegrade completely. First prototypes are currently being tested at the BAW and have been tested since early 2020 at a spot of the test stretch (TF 6).

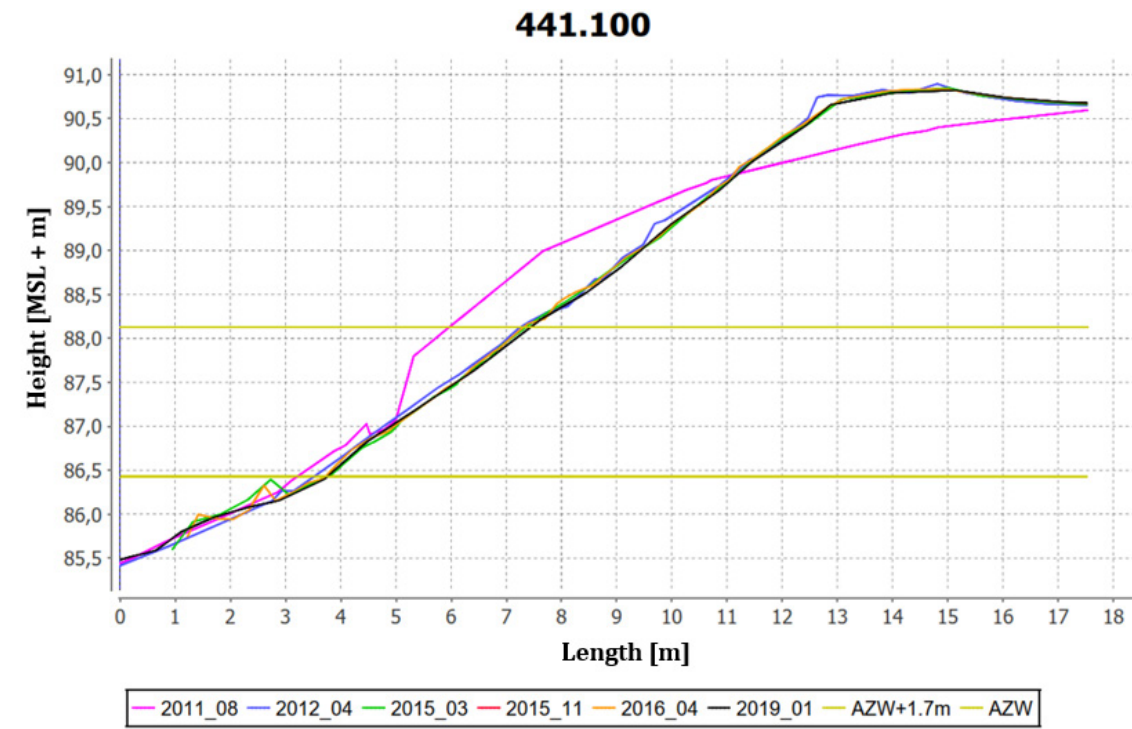
The weight per unit area of the stone mattresses, which together with the granular filter exceeds the theoretically required maximum, and the absence of gaps in the arrangement of the mattresses gave them a good and stable position on the slope from the very beginning. Up to now, the self-weight of the mattresses and their erosion-resistant and filter-stable structure, both internally and in relation to the subsoil, have ensured bank stability regardless of vegetation. The evaluation of the regular cross-sectional surveys documents the stable position (Figure 19).

Figure 19: Cross section at km 441.100 (TF 5b, stone mattresses from MW – 0.5 m to GOK)

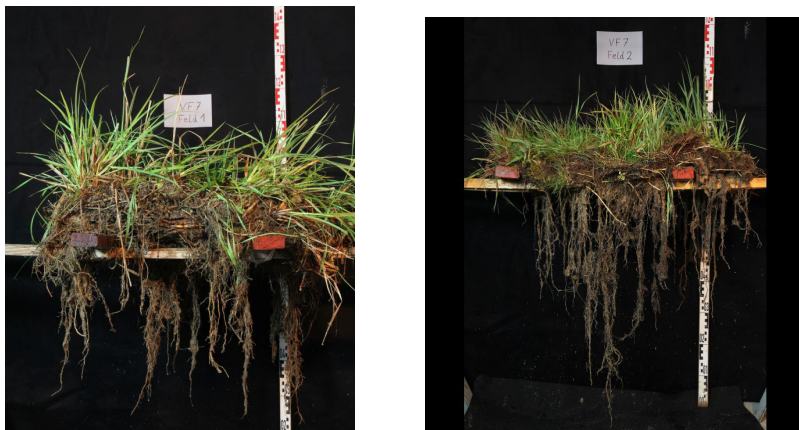
Maximum root lengths of 50 cm to 70 cm were detected in fields U1 and U2 (Figure 23). At these rooting depths, roots had developed relatively uniformly over the area with dry root mass of 900 g/m<sup>3</sup> to 2,700 g/m<sup>3</sup>. Most roots are to be found in the upper 10 cm to 15 cm (Figure 23) where they resemble a dense mat of roots, which is particularly important with regard to the filter function and for providing protection against surface erosion.

Figure 23: Excavated roots in study areas U1 and U2 (plant mats, filter mats no longer present) (Heinzner 2017b)

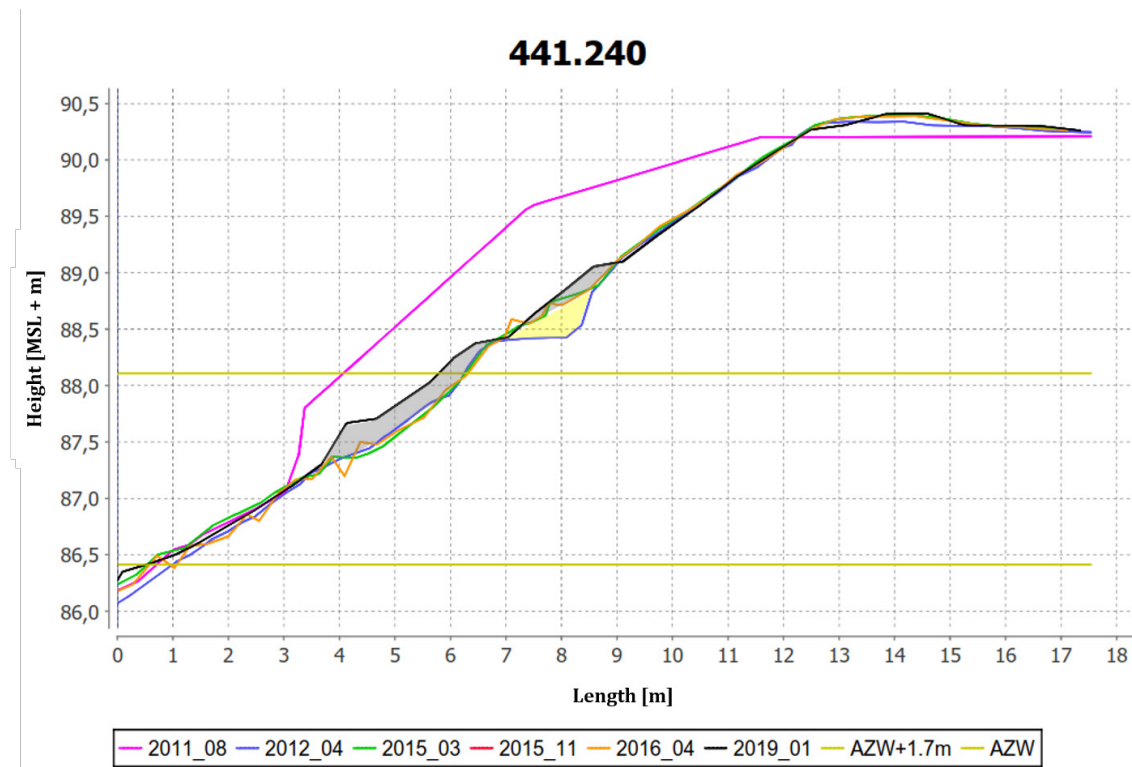
High water levels occurred repeatedly soon after installation. This led to waterlogging and simultaneous hydraulic loads on the coir mats. As, in contrast to the other areas in TF 7, the coir mats were initially only fixed at certain points, and because of the lack of filter stability, larger quantities of material were washed out and moved, which resulted in large-scale slope deformation (Figure 26). This can be clearly seen in the cross-sectional recordings (Figure 25). The areas that were eroded between installation at the end of 2011 and April 2012 are marked in yellow. There was no protection against surface erosion.

Figure 25: Cross section at km 441.240 (TF 7a, coir mat on hydroseeding between MW + 1.70 m and GOK)

Appropriate rehabilitation work was carried out as early as 2012 to prevent further material being washed away (local installation of grass sods, secured with crossbars; additional hydroseeding (BAW, BfG, WSA-MA 2013)). This area subsequently became somewhat more stable in 2013 due to the infrequent flooding (Figure 27). Grasses and herbs continued to grow and spread; however, no vegetation grew on some areas of the irregularly eroded bank relief, and particularly not on the depressions spanned by the coir mat. These areas increased in size with each successive flood.

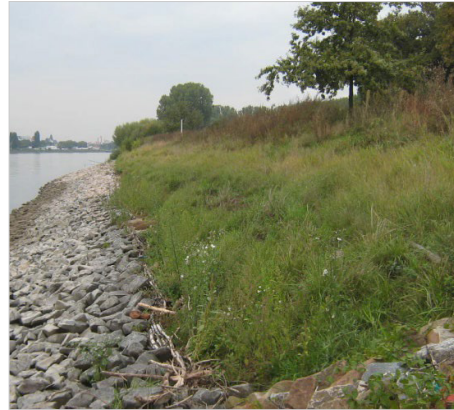
*Figure 26: Vegetation development after rehabilitation in TF 7a, upper zone (4.10.2013) (photo: BAW)*

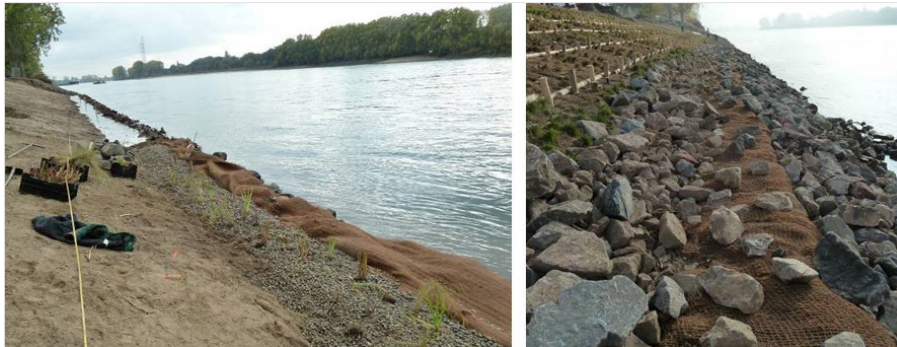
Figure 29: Reed rolls during and after installation in 2011 (photos: Katja Behrendt/  
Hans-Werner Herz, BfG)

In this area around mean water, the reed rolls were from the very start very frequently and repeatedly flooded for long periods. Simultaneous hydraulic and ship-induced loads very quickly destroyed the woven coir fabric and washed out the gravel and reed bales. The reed rolls had to be covered with armourstone as early as 2012 in order to stabilise the bank and to restore toe protection for the plant mats.

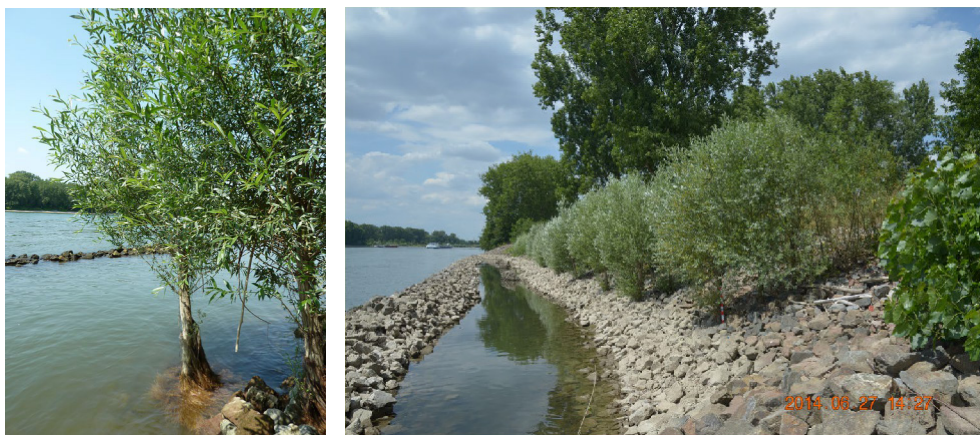
Figure 30: Left: willow branch cutting with adventitious roots (07/2013); right: vigorous development of willow plantings (06/2014) (photos: Katja Behrendt/Hans-Werner Herz, BfG)

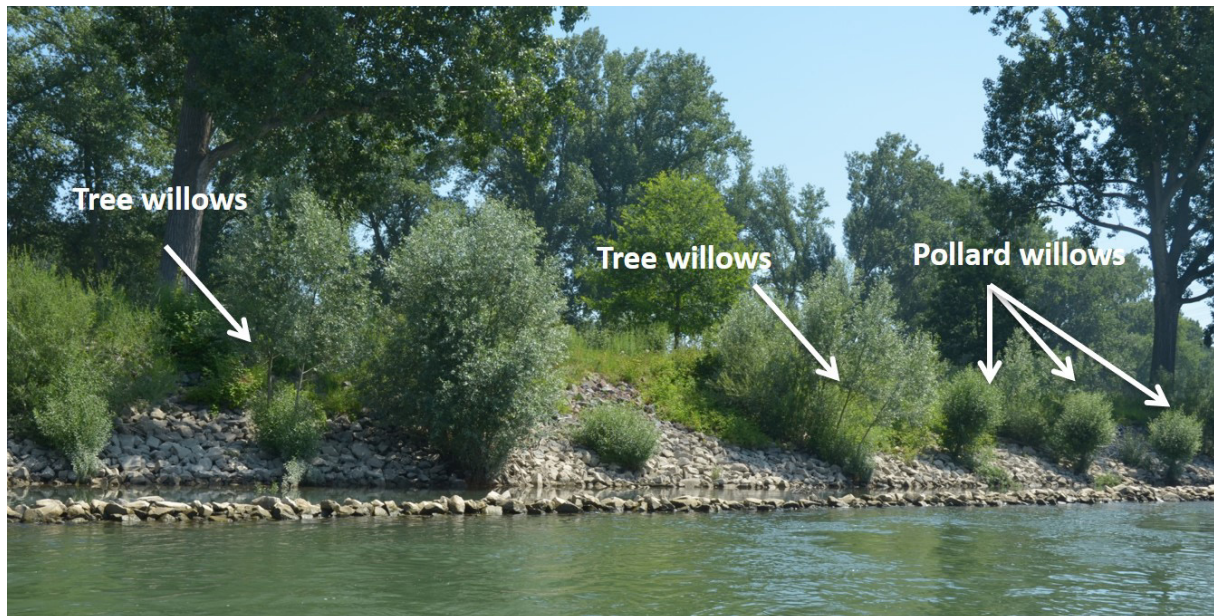
The pruned plants have since developed into a vital and dense vegetation cover. The different woody structures (pollarded willows and willow trees, bushes of willow shrubs) aimed at by the different maintenance strategies can be seen in Figure 31. The target vegetation has established as planned.

Figure 31: Richly structured woody plant population after maintenance pruning (07/2015) (photo: Hans-Werner Herz, BfG)

In February 2015 maintenance pruning of the willow branch cuttings and fascines was carried out for the first time. Different types of pruning were specified with the aim of obtaining a richly structured multi-layer woody plant population in the long term. To this end, the shoots of some of the log branch cuttings have been regularly cut back since 2015, so that they could develop into ‘pollarded willows’. The strongest shoots of an additional number of defined branch cuttings are maintained to develop into future ‘willow trees’. In places, branch cuttings were cut diagonally to a height of approximately 10 cm above the riprap to form ‘willow bushes’. Within the fascines the strongest shoots were cut back to maintain the willows' elasticity for flood protection purposes. All other branch cuttings were left unpruned. All these activities were carried out manually in close cooperation between the branch office Worms/Oppenheim, BAW and BfG. The waste was removed.

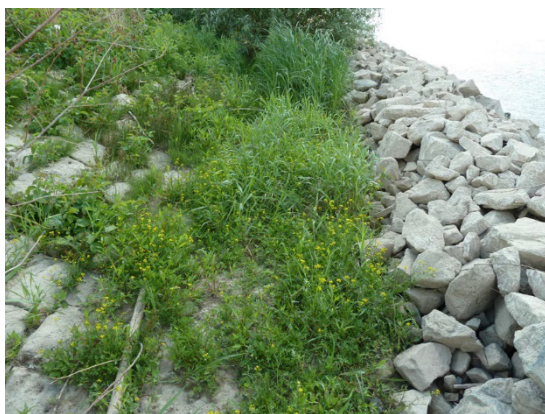
The remaining riprap and the old paving protect the bank in this test field. Here, ecological enhancement is to be achieved by raising the riprap in the paved toe area (stone wall) and promoting the existing reed cover on the berm and the adjoining lower slope zone. As long as water levels stay below the top edge of the stone wall (MW + 0.5 m), the hydraulic load on the bank is reduced. As a result, a species- and flower-rich reed zone expanded over the past six years, with tall forbs typical of humid sites, flood-meadow species and short-lived pioneer plants typical of muddy soils (e.g. round-fruited rush (*Juncus compressus*), creeping yellow-cress, creeping bent, reed canary grass, tall fescue, slender-tufted sedge, yellow loosestrife (*Lysimachia vulgaris*), pale persicaria (*Persicaria lapathifolia*), purple loosestrife, etc.; Figure 33, Figure 34).

A cm-scale mud layer, which has deposited behind the stone wall on the paved berm in this test field as well (cf. TF 1), provides a substrate for the growth and establishment of vegetation.

Figure 33: Muddy soil pioneer vegetation with flowering yellow-cress (06/2012)  
(photos: Katja Behrendt, BfG)

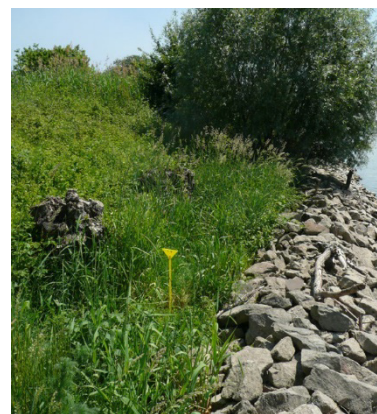
The development shows the effectiveness of the higher stone wall in reducing the impact of waves and flows on bank vegetation. The target vegetation of reed and grasses has developed as planned.

Figure 34: Well-developed reed zone in the shelter of the stone wall (05/2017)

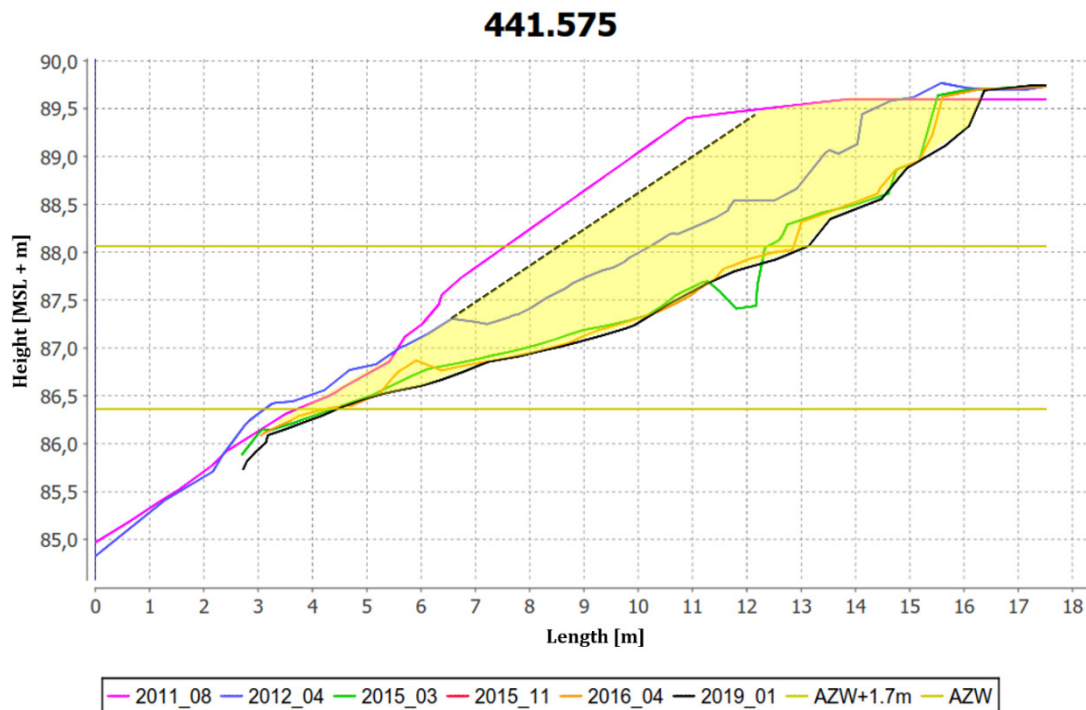
The cross-sectional surveys at km 441.575 in Figure 36 show that, after removal of the riprap, the slope edge at the end of the test field shifted approximately 5 m further inland until 2019. The eroded area is highlighted in yellow.

Figure 36: Cross-section at km 441.575 (TF 9, end of test field near log groyne)

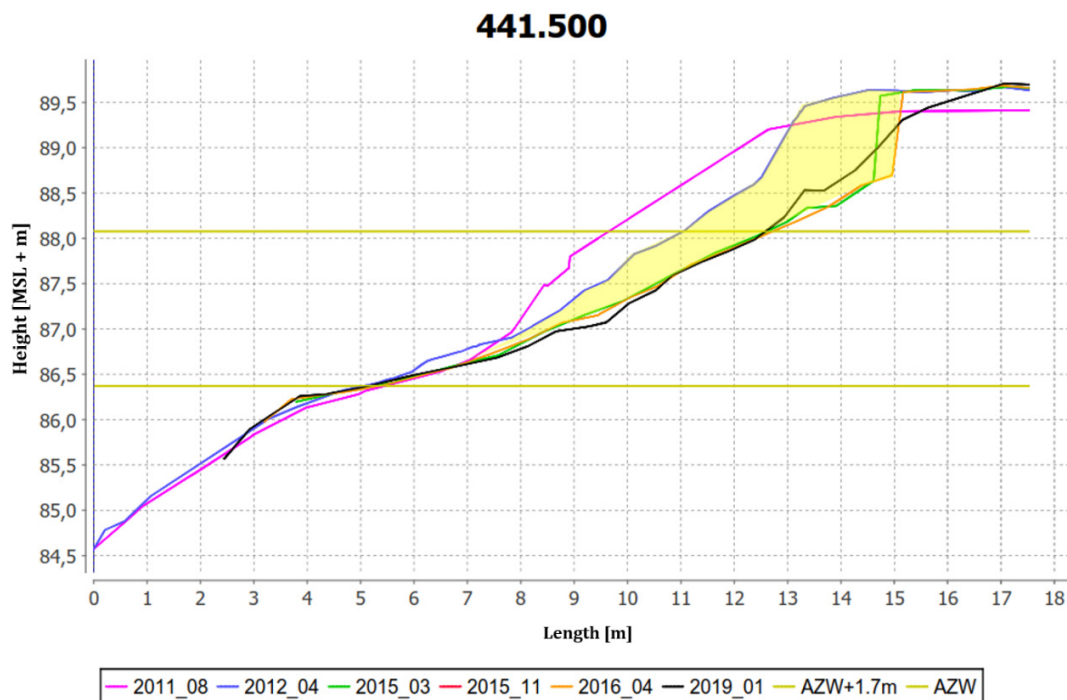
Figure 38 shows a similar development for the cross-profile at km 441.500, where the 500 m-sign is located at the top edge of the slope (Figure 35, centre and left). Although erosion was less pronounced overall in this area, it had already proceeded thus far in 2015 to reach the km-sign. In 2016 the sign was newly installed and secured with armourstone (Figure 39). The slope has levelled off across the entire test field, except for the upper slope area where nearly vertical scarps have formed in the alluvial loam. The result was that on the riverside some of the overall well-developed log branch cuttings on the adjoining plane at the top of the slope were exposed by water erosion up to the lower edge (Figure 35, right, and Figure 37, right). They no longer provide any protection to the bank. A third row of willow branch cuttings was therefore planted on the landward side in 2014.

Figure 38: Cross-section at km 441.500 (TF 9)

However, the cross-sectional surveys also show that since 2015 only insignificant changes occurred in the lower slope area, i.e. the slope is largely stable at its current inclination of around 1 : 6 to 1 : 7. This stability is due to smaller armourstones from aged bank protection structures built in the past 150 years, which have been exposed by water and now protect the bank (Figure 35, centre and Figure 37, left)

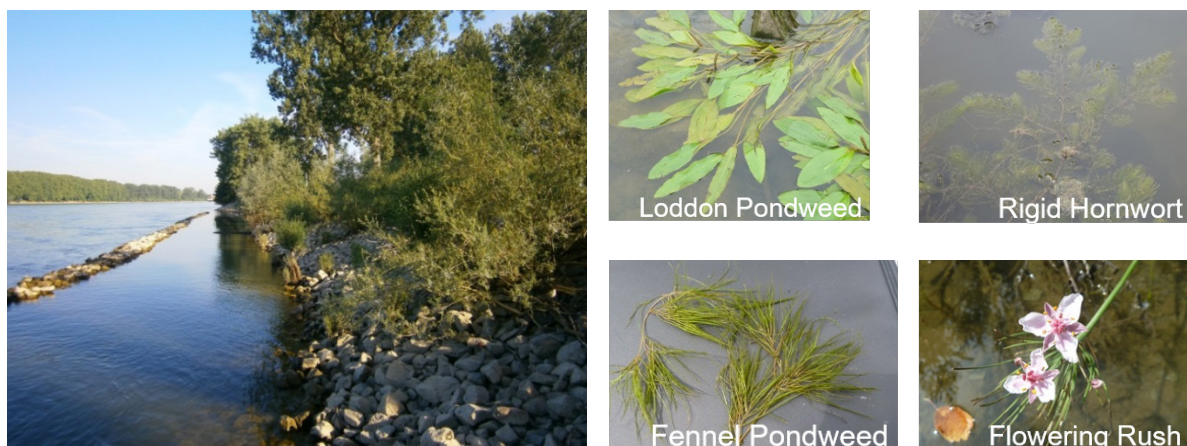
A fine substrate layer of several centimetres of thickness deposited in the shallow water zone (TF 1). Plant species of river bank communities (e.g. cursed buttercup *Ranunculus sceleratus*) and reeds (e.g. flowering rush *Butomus umbellatus*, Figure 40) established here as initials, without forming stable populations, however. The shallow water zone promoted the growth of aquatic plants thanks to the protection against waves and the ingress of substrate. In 2017, five aquatic plants typical of the Rhine were found; in addition to the native species shown in Figure 40, Eurasian water milfoil (*Myriophyllum spicatum*) and the neophyte Nuttall's pondweed (*Elodea nuttallii*) occurred. Some of the species are rather rare, such as loddon pondweed (*Potamogeton nodosus*), which is on Germany's watch list.

Figure 40: Shallow water zone with aquatic and reed plants (photos: Katja Behrendt, BfG)

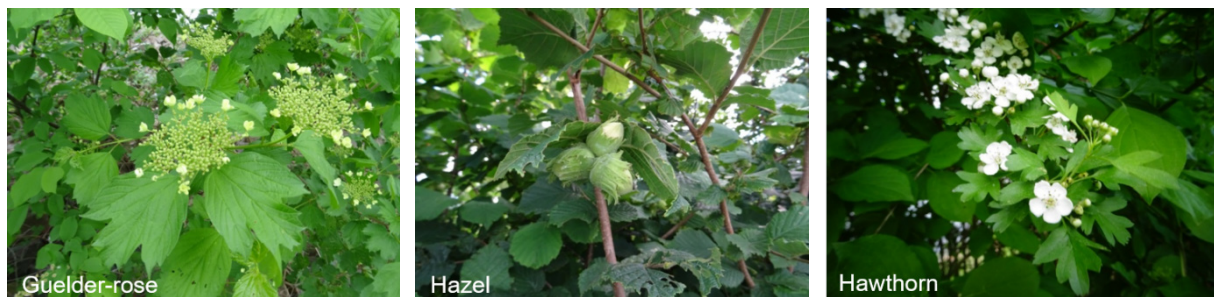
The planted shrubs in the hedge layers are species associated with the upper hardwood zone. Figure 41 shows examples of introduced species. The berry catchfly (*Cucubalus baccifer*), which has immigrated successively, is an endangered species (Chapter 5.2.7).

Figure 41: Shrub species of the hedge layers (photos: Katja Behrendt, Andreas Sundermeier, BfG)

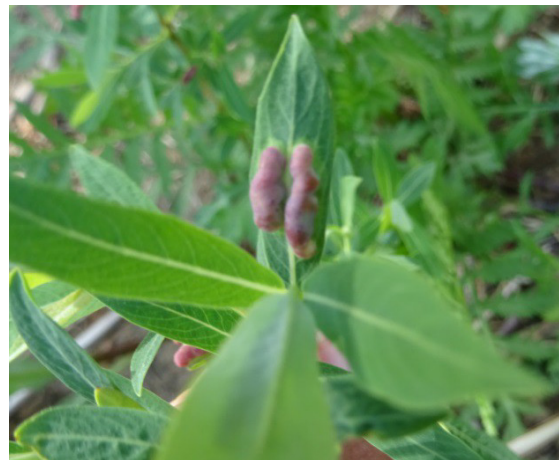
The planted willows were colonised by a number of insect species that have a narrow host plant spectrum. Although only random observations are available on this topic, these showed that the planted stands are integrated into food webs and that the species presented reproduce in the test fields. The galls of the gall wasp *Pontania virilis*, which only occur on this willow species, were regularly found on the purple willows in the willow brush mattresses of TF 2 and 3 (Figure 60). The insects induce the growth on the plant, visible as gall, to provide their larvae protection and nutrition in the gall. Many gall-inducing organisms have complex life cycles (Bellmann 2017).

*Figure 60: Gall of the gall wasp Pontania virilis on purple willow on willow brush mattresses in TF3 (photo: Andreas Sundermeier, BfG)*

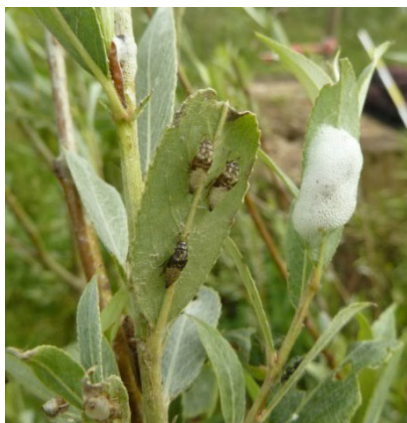
The willow spittle bug (*Aphrophora spec.*, Figure 61) lives exclusively on willows and was found on willow branch cuttings in TF 9. Caterpillars of the willow sawfly (*Nematis salicis*, Figure 62) were observed in TF 1 on willows in the vegetated riprap. The difference between these areas and the reference stretches is probably of a quantitative nature, as willows also occur there, albeit in smaller numbers and presumably therefore with a smaller quantity of colonising organisms.

*Figure 61: Willow spittle bug on willows that have emerged from willow branch cuttings (TF 9)*

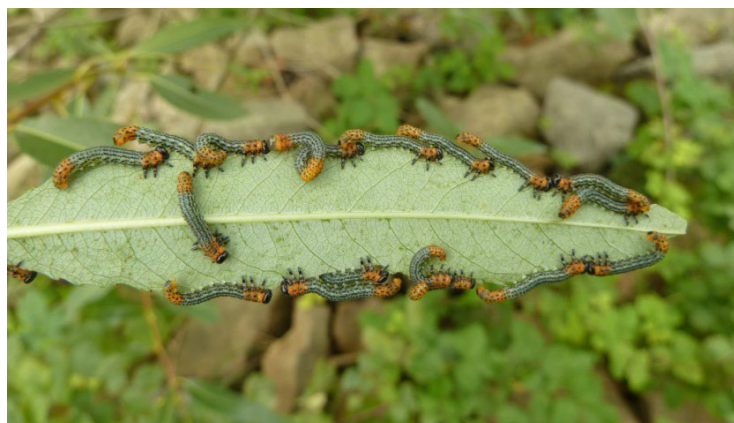
*Figure 62: Caterpillars of the willow sawfly in TF 1 (both photos: Katja Behrendt, BfG)*

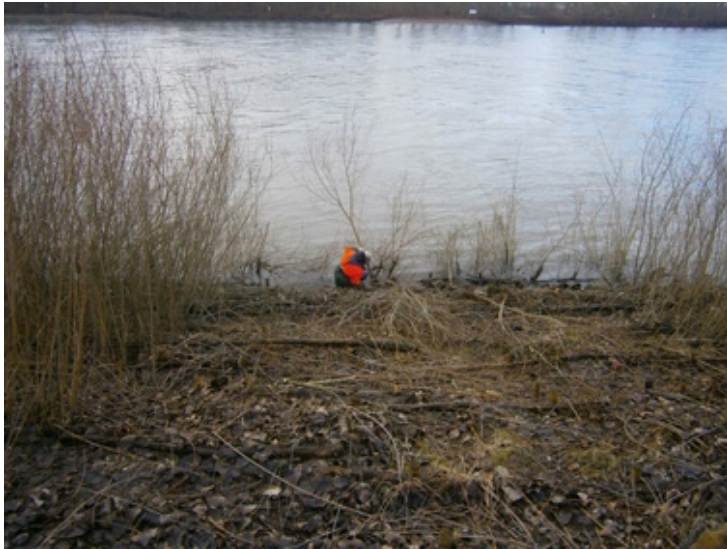
*Figure 64: Partial pruning of the willow brush mattress in TF 3 (January 2015) (photo: WSA Upper Rhine)*

Pruning and maintenance work has been carried out in test fields 1, 2, 3 and 9, all of which used woody plants (e.g. willow branch cuttings, willow brush mattresses, brush and hedge layers), since their construction in 2011. Pruning work on the willow brush mattresses (TF 2 and 3) and in TF 1 took place for the first time after three years (Figure 64). This work will have to be repeated in the coming years to varying extents. A heterogeneous woody plant population developed in TF 1 thanks to pruning work during the initial years. The reed gabions (TF 5) did not require any sizeable maintenance work in the first four years. As described in detail in Chapter 4.2.2 and Annex 3, the measure that used reed gabions was unsuccessful. The reed gabions were rehabilitated by covering them with a layer of stones. In the designs that did not use any live material (plants) (TF 4, 6, 8) no maintenance was carried out except for neophyte control. However, the dead wood fascines placed immediately below mean water level in TF 4 will have to be replaced in the near future. Initially, the plant mats in TF 7 were mowed annually, and later, every other year at an early stage to eliminate unwanted plants and to foster denser plant growth (Figure 65). The establishing vegetation is usually rejuvenated every five to ten years or cut back to the trunk on conventional riprap such as that in the reference stretch. In the monitoring period until now, maintenance work took place in one of the reference stretches in February 2019.

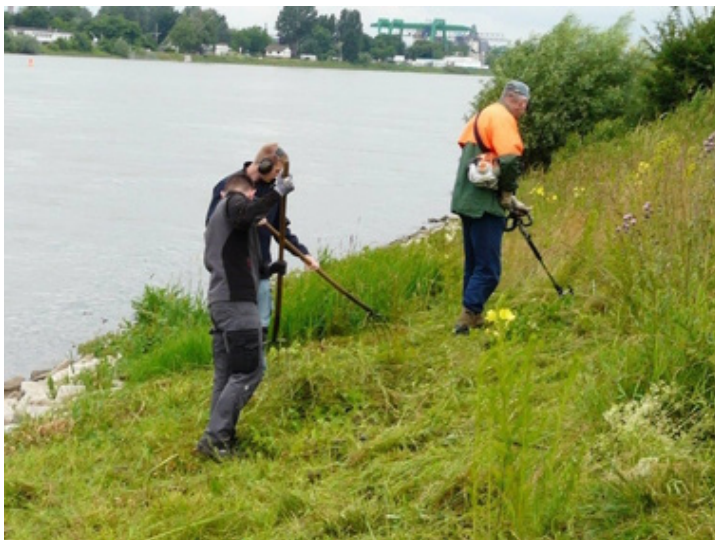
*Figure 65: Mowing of the plant mats in TF 7 (June 2015) (photo: WSA Upper Rhine)*
