Lime Treatment of Soils

The Friant-Kern Canal experience

G. Herrier
E. Berger
S. Bonelli

Lhoist R&D
Lhoist North America
Irstea

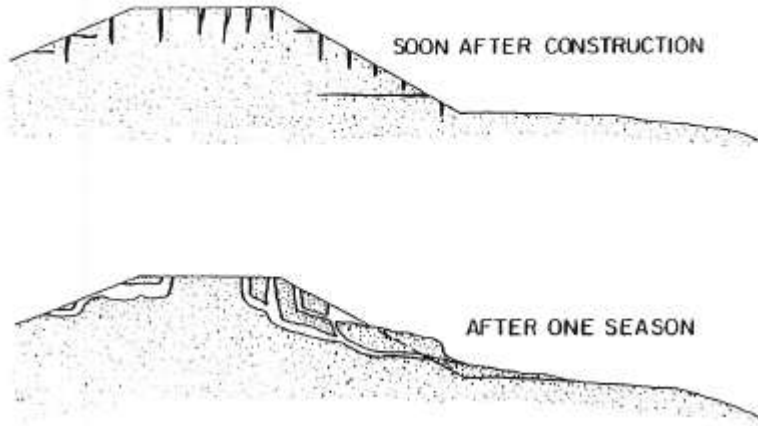
Fig. 2 Typical slide failure, Friant Kern Canal

- 87 km of the canal built with Porterville clays (montmorillonitic clayey soil)
- Below water level : volumic expansion, lowering density and strength
- Above water : shrinkage, cracks, loss of shear strength and slidings

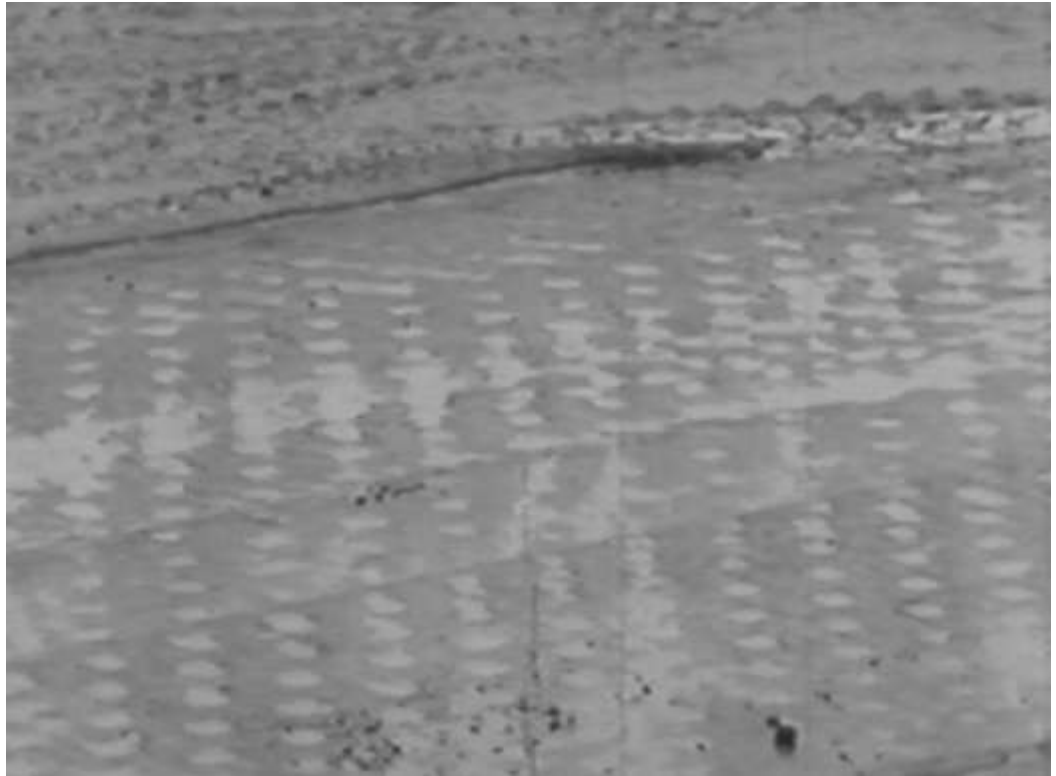
- After 1 year irrigation : sheepfoot rollers imprints still visible
- No new slips or slides since the renovation works
- Rc on cored specimens : 2.2 MPa (after 1 month) to 3.4 MPa (after 1 year)

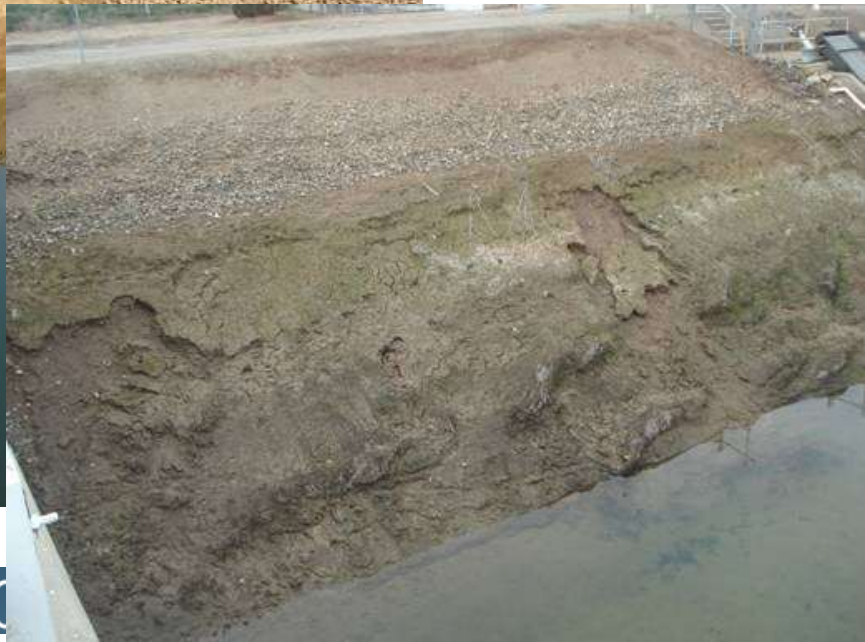
Water level

"Clay balls"

Sheepfoot roller prints

Untreated section
