A Case Study of Ground Cave-in due to Large Scale Subsurface Erosion in Old Land Fill

Mari SATO, Reiko KUWANO
The University of Tokyo, Japan

Accident of ground Collapse

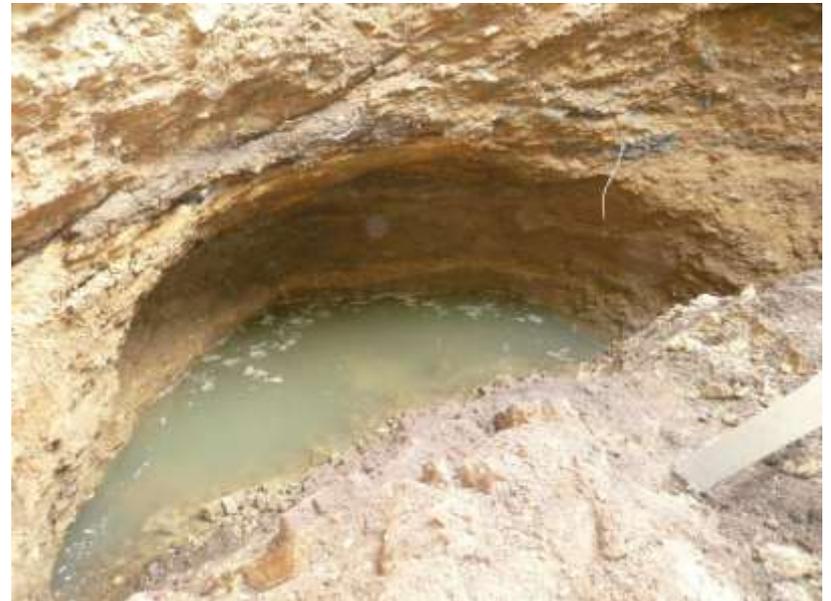
The hole was 5m deep and 7m wide at the bottom.

A flask shape with a 1 m wide opening at the ground surface and was 5m deep and 7m wide at the bottom.

There was an about 0.6m deep shallow water pool in the east side of the hole, and the water flew to the west direction.

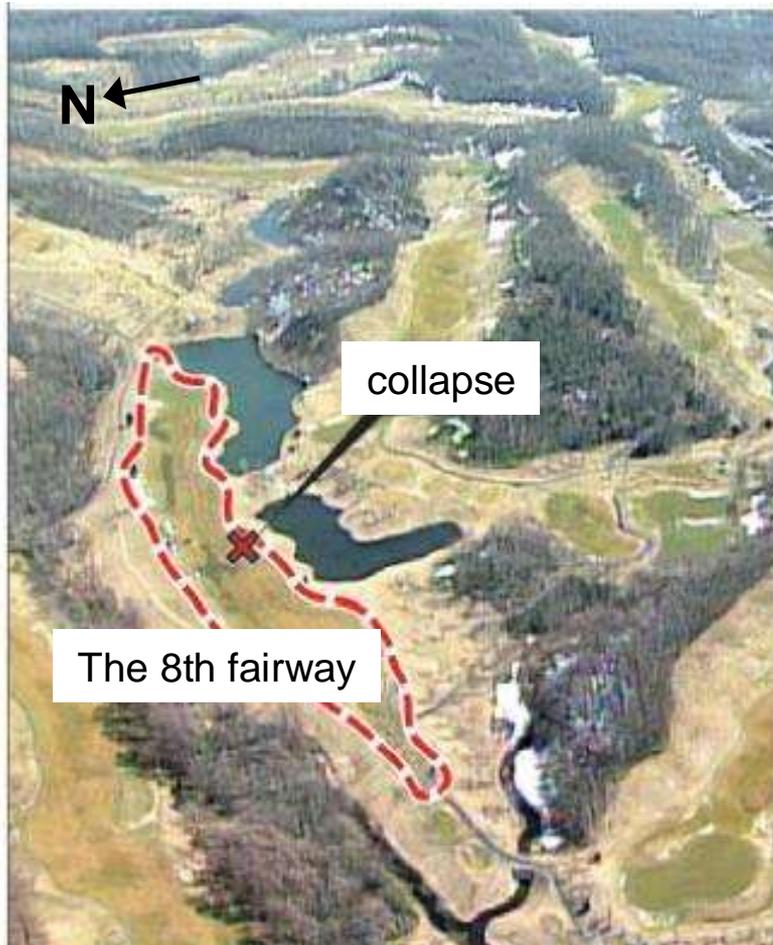
Topography and ground condition

Originally built more than 15 years ago in hilly land, by filling a valley with local soil.

Mud rock covered with silty volcanic ash. The land fill of 10 to 15 meters thick.

Gentle slope in the 8th fairway
There used to be a stream along the east-west direction at the location of the collapse.

Several artificial ponds around the fairway for water hazards

When the accident occurred, the ground water level was considered to be higher than usual, as it was the snow thawing season.

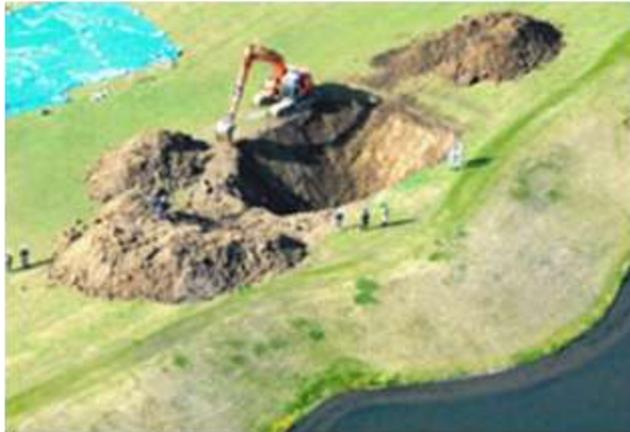
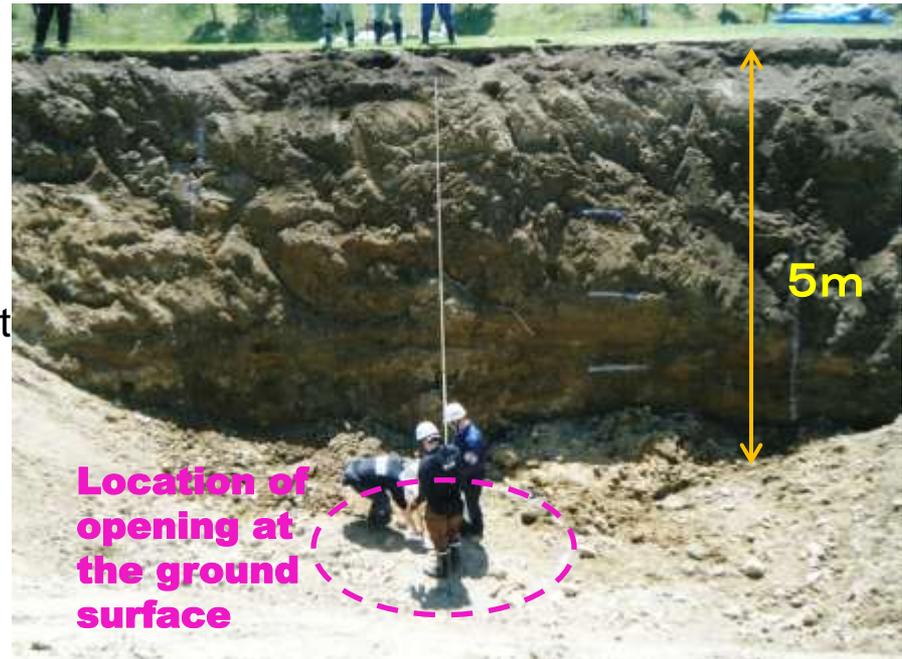
Investigation by excavation

AM, May 21, 2009

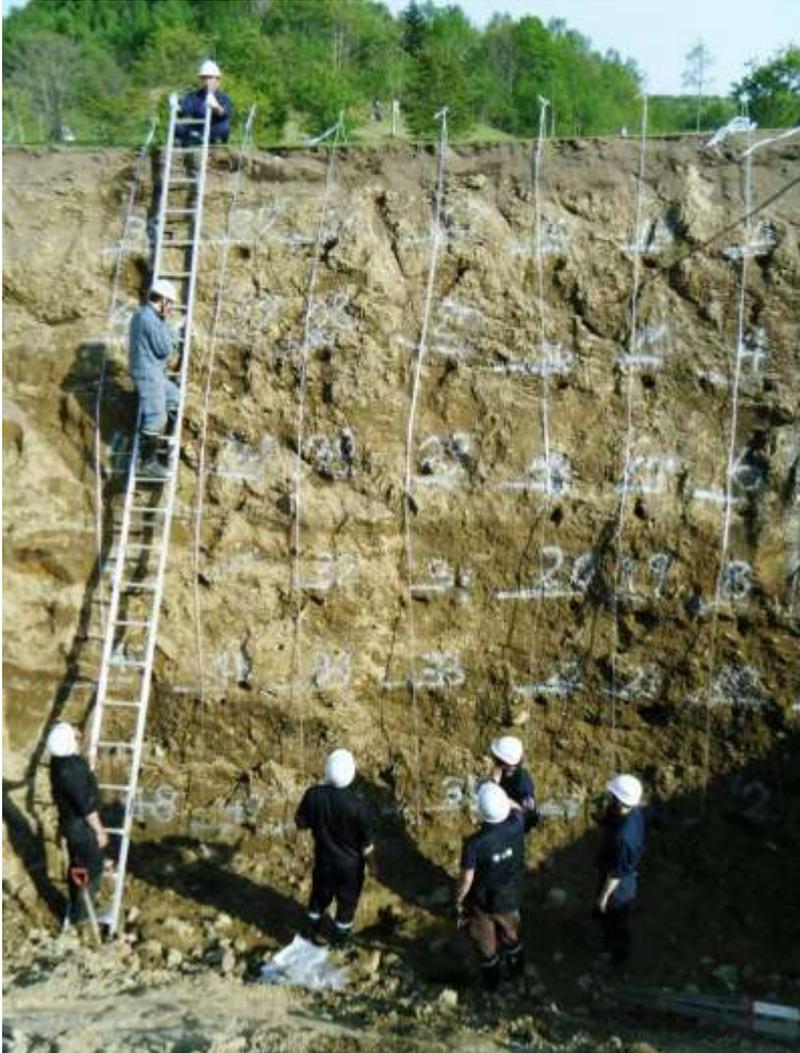
Investigation by excavation

Excavated soil was mixture of volcanic clay, silt, sand, and relatively small gravel

Roots of plants were also included, which indicates the excavated strata was filled soil.

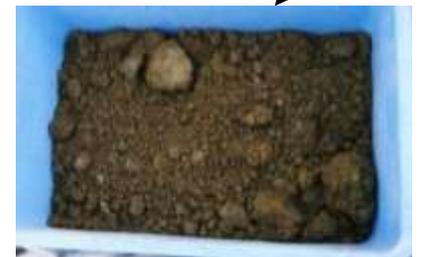
Atterberg limit

B	C
Liquid Limit	24.40	23.20
Plastic Limit	18.36	15.27
Plasticity Index	6.04	7.93

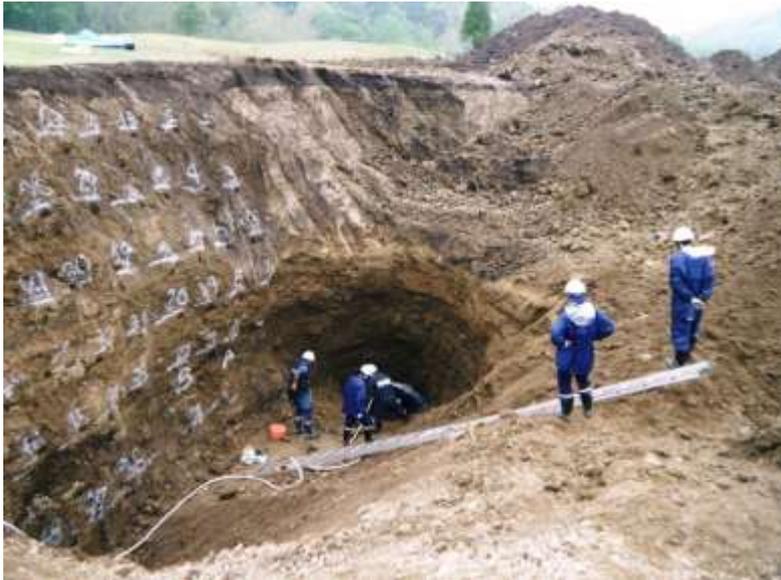
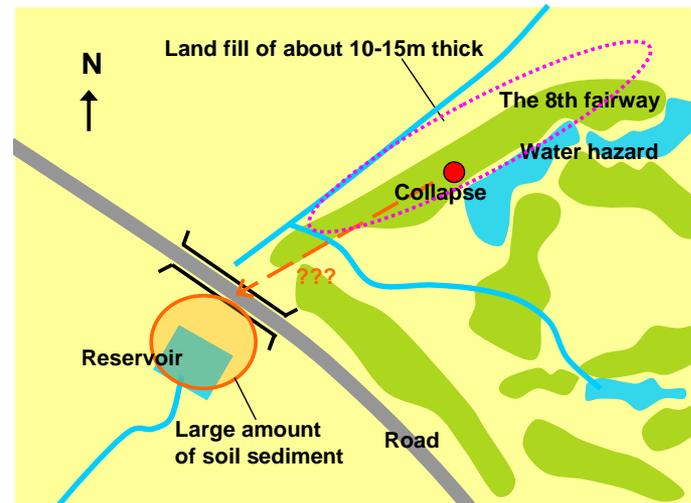
Search for the destination of the water flow in the soil pipe

the colored water started flowing out at the reservoir, 700m down from the cavity.

Water colored by fluorescent paint was poured into the cavity

A soil pipe seemed to be formed in the ground between the collapsed location and the reservoir

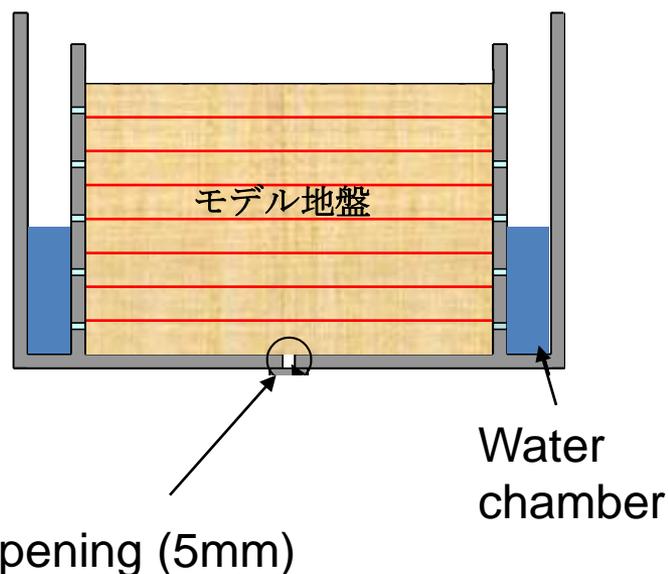
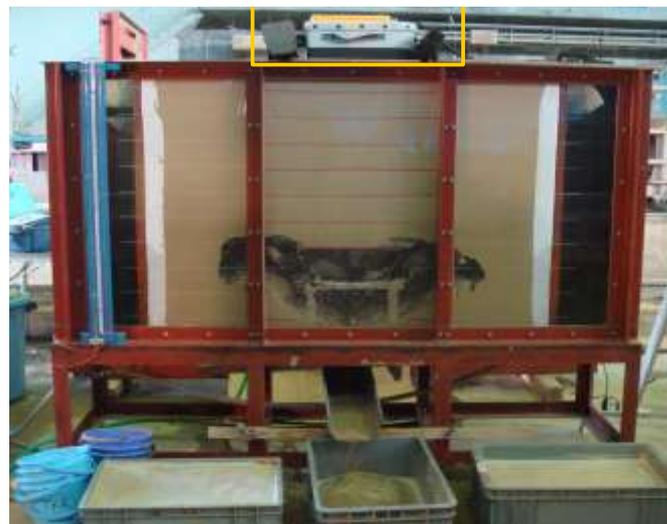
Soil chamber (2m × 0.5m × h1.2m)

According to the previous investigation of the mechanism of ground cavity and surrounding loosening due to the failure of sewer pipes, the state of water infiltration and soil properties are the governing factors for the growth of the ground cavity and loosening, while the failure of pipe is a trigger of the phenomenon.

Cavity and loosening formed in the chamber

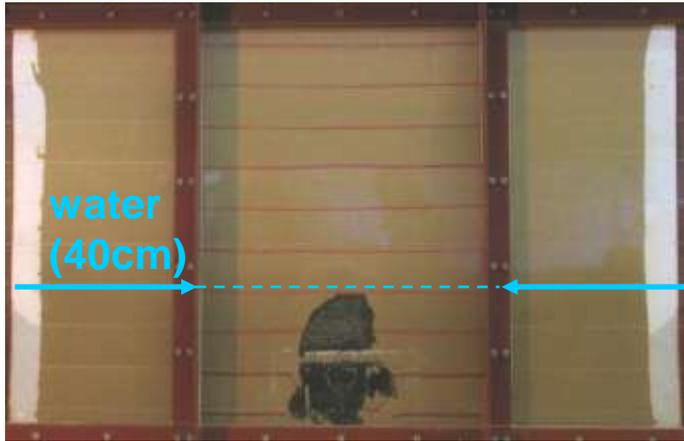
16 min.
after water table was raised to 40cm

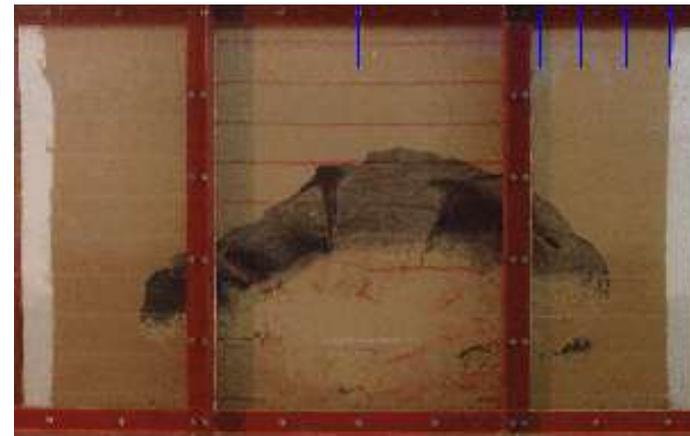
84 min.
after water table was raised to 40cm

Soil above
the cavity fell

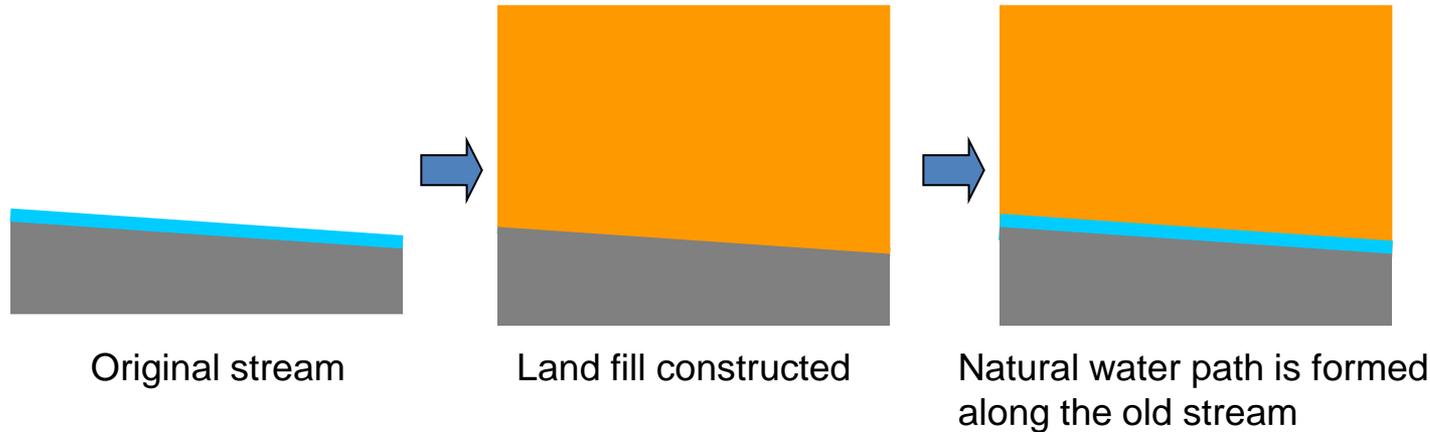
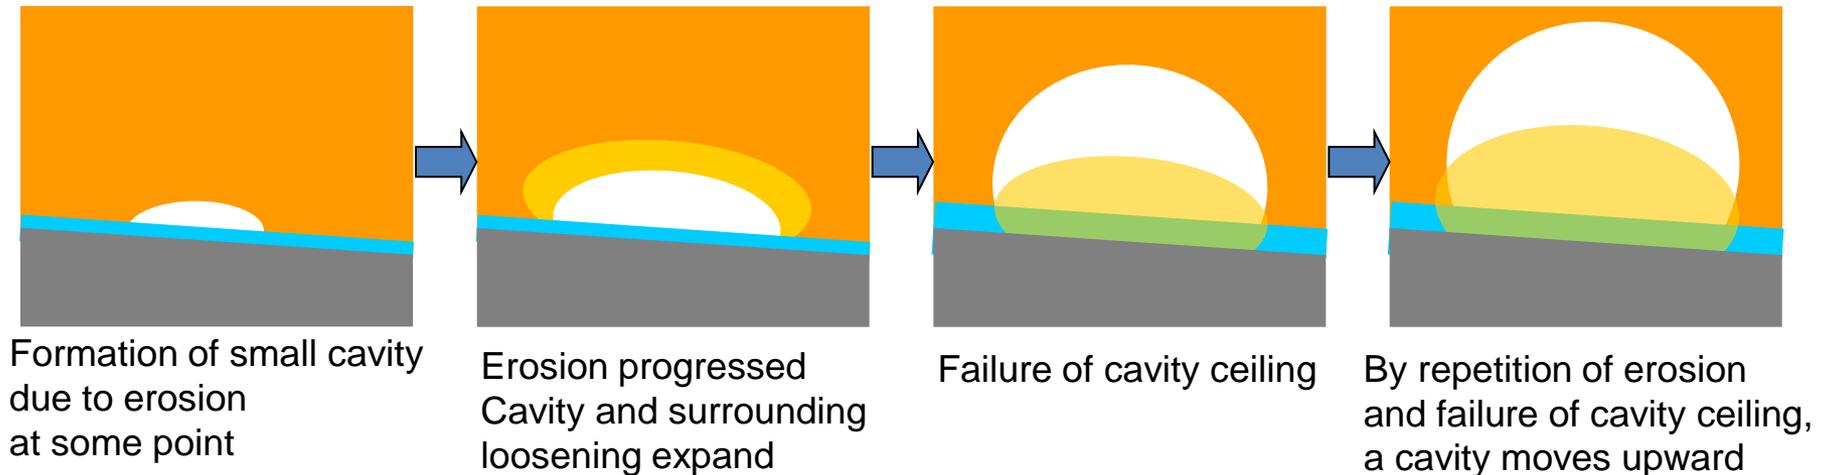
Mechanism of large hole formation

Fines can be first flown away with water, which created ground loosening around the cavity.

There was a subsurface water path which can transport soil out of the hole with water. There is also seasonal change in ground water level, which may accelerate the cavity growth as the saturation of soil at the ceiling helps failure and expansion of the cavity.

Direct trigger of the formation of natural water path may be a defect of drainage pipe. But the state and the current condition of the pipes have not yet examined.
