CHARACTERIZATION AND REPAIR OF INTERNAL EROSION IN SANDSTONE FOUNDATION

By J-J FRY & G. JORGE

INTERNAL EROSION IN DAM FOUNDATION

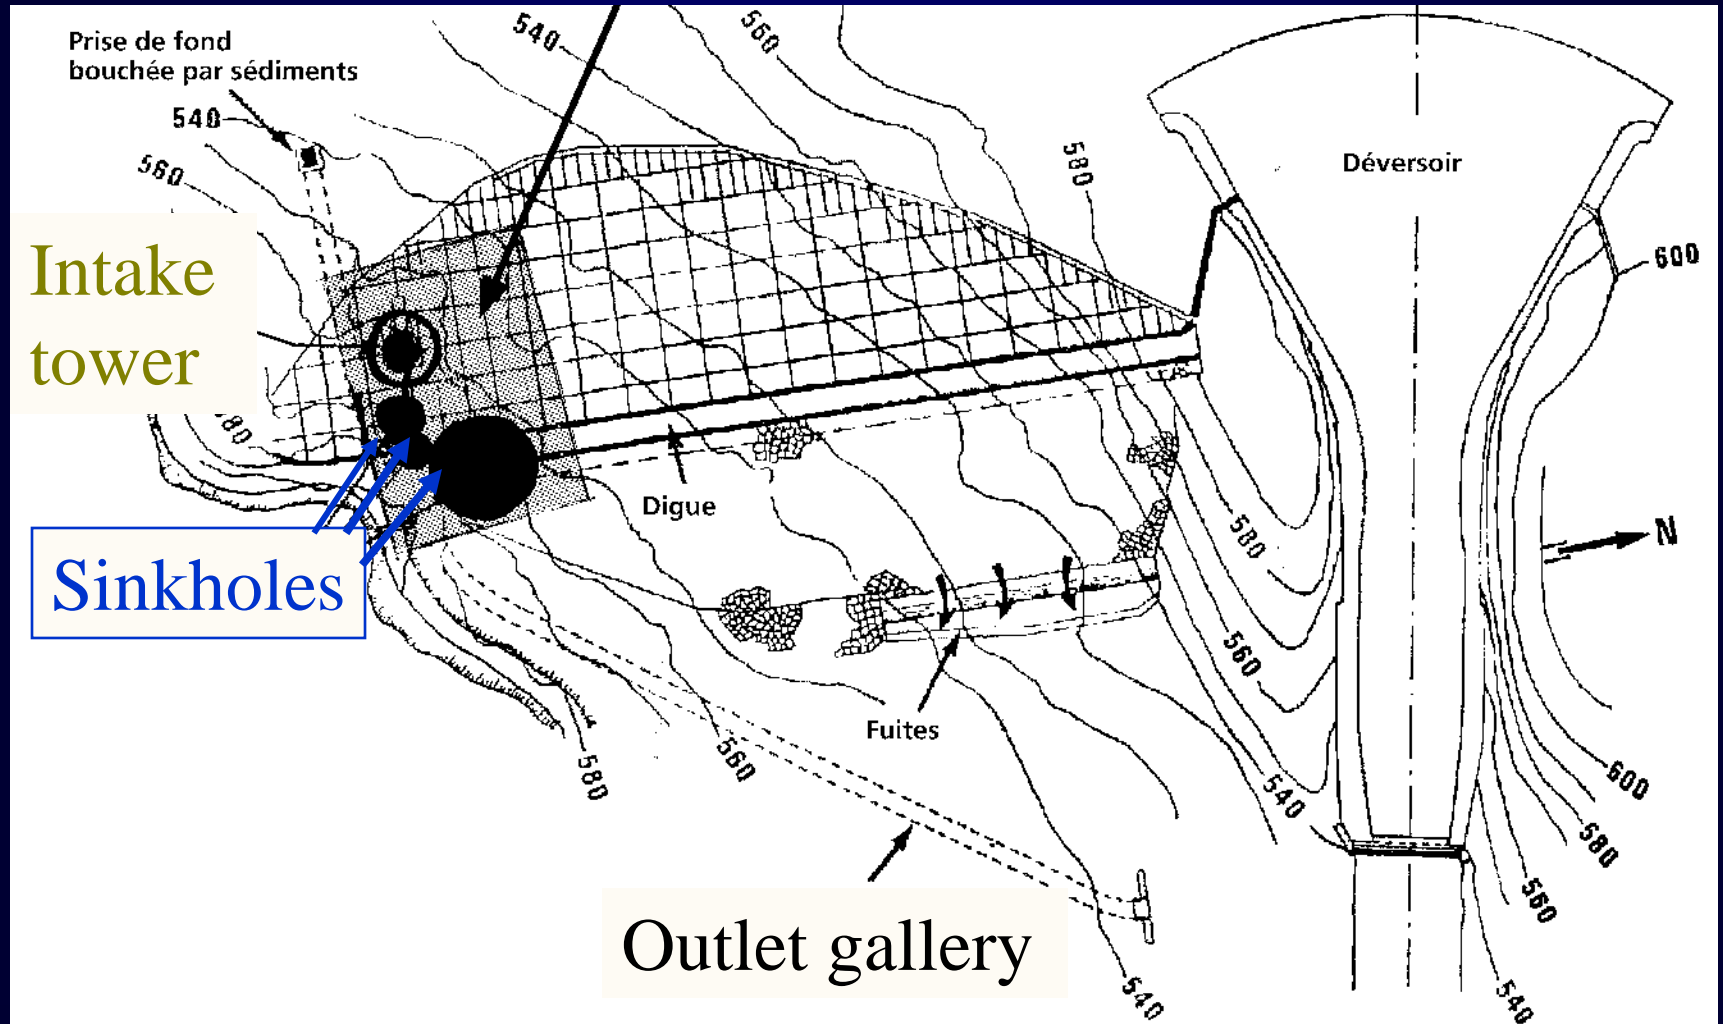
Lessons from ITIYURO dam incident

Leakages caused internal erosion in the sandstone foundation ($>1000\text{m}^3$) Sinkholes occurred in the rockfill crest and upstream face

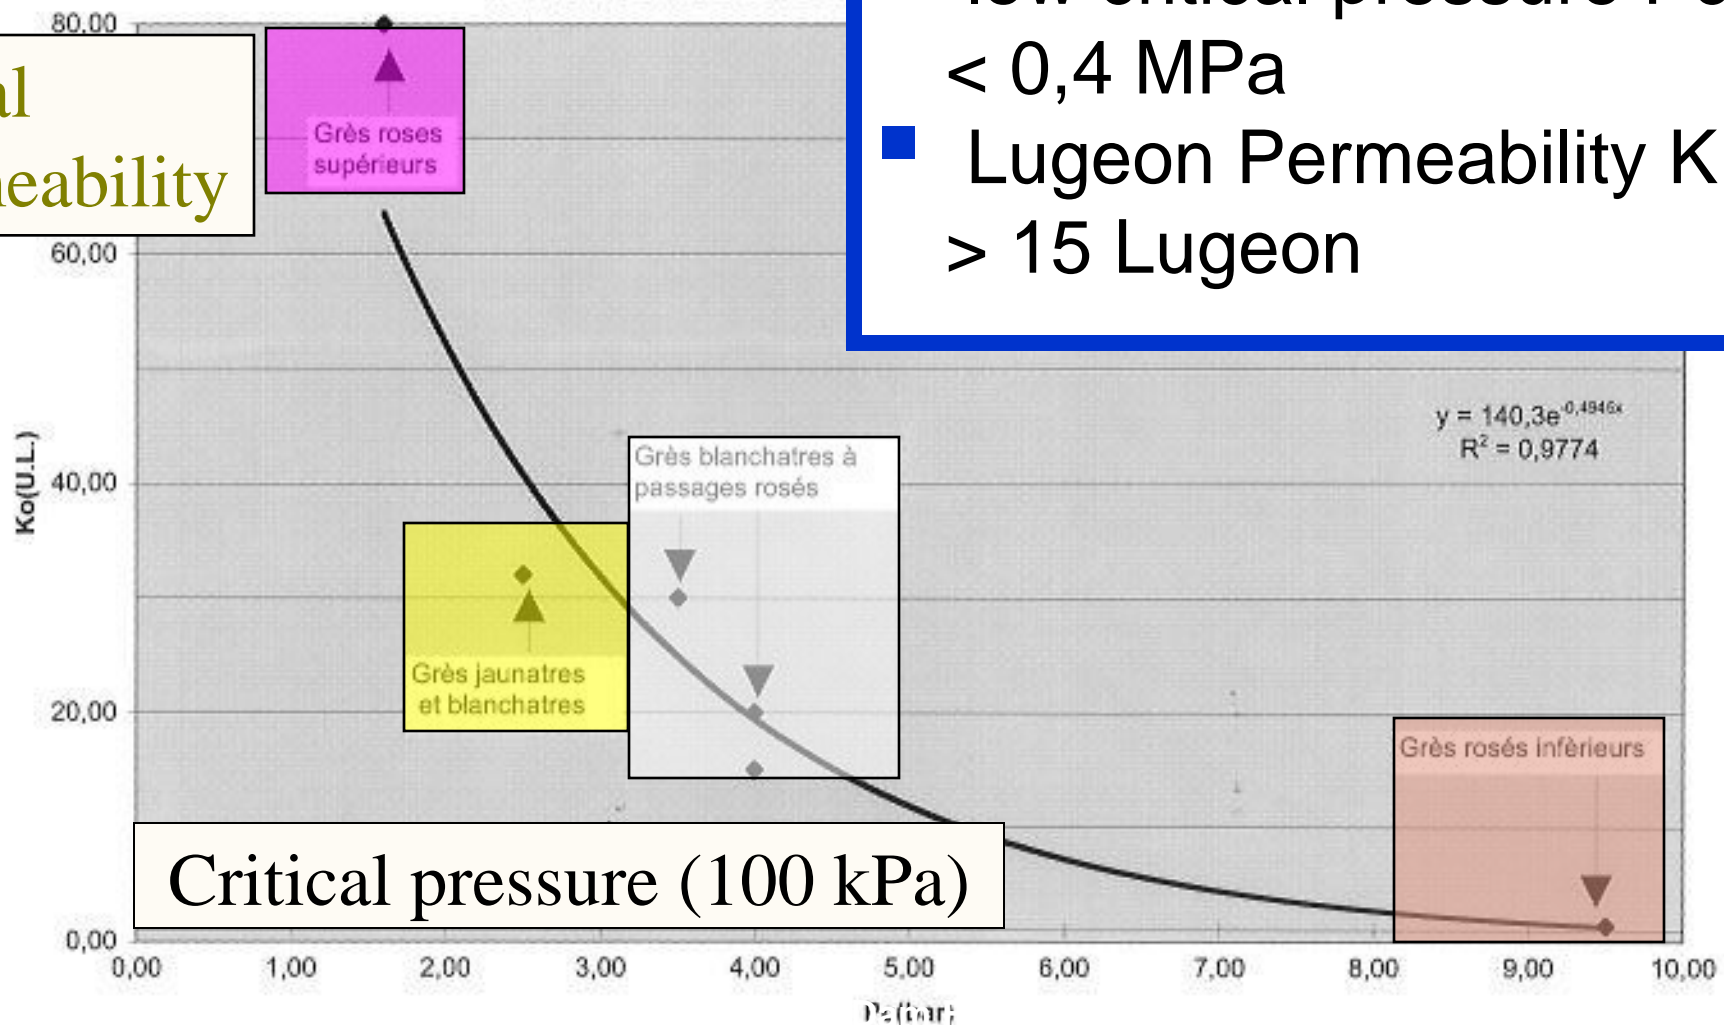
Initial permeability

- weak sandstones areas suffering internal erosion have :
- low critical pressure $P_c < 0,4 \text{ MPa}$
- Lugeon Permeability $K > 15 \text{ Lugeon}$
