# Classification of the Eroded Cavings behind Concrete-faced Embankments by Ground-Penetrating Radar

Jian-Hong Wu

Dept. Civil Engineering,

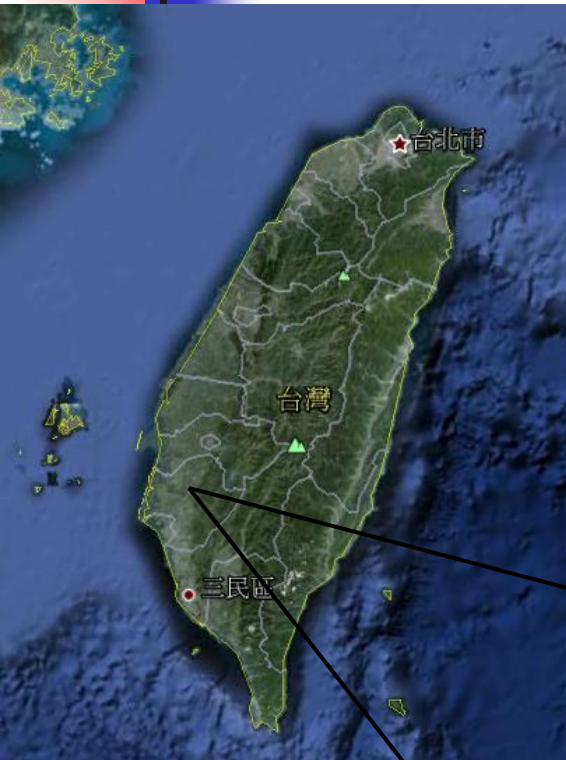
- Concentrating rainfalls in plum rain and typhoon seasons often cause floods in Taiwan.
- The flood along Tsengwen River in southern Taiwan caused by Typhoon Nari in September, 2010.
- The flooding area was about 1,293 ha, and the total loss was about 8 million USD.

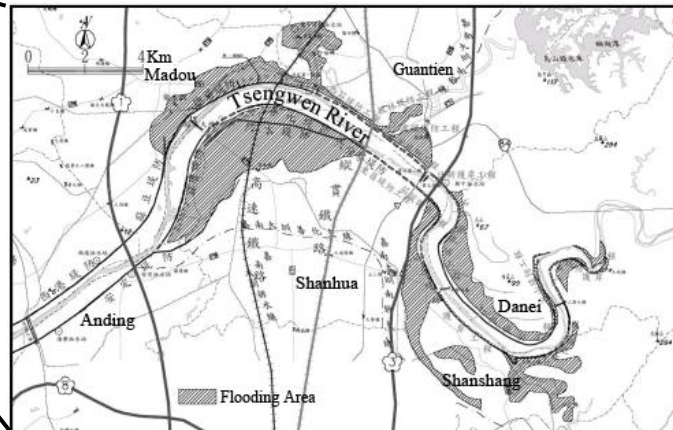
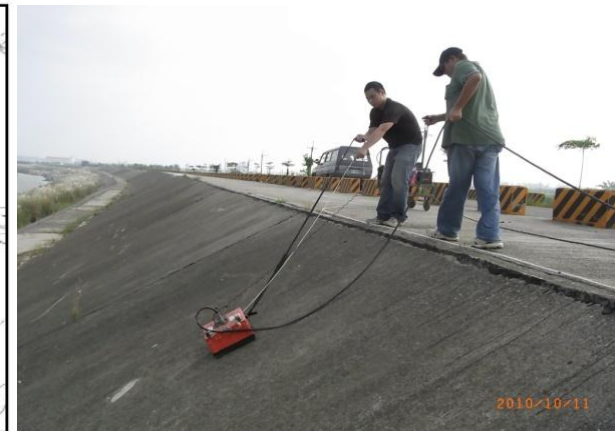
- The mechanism of the erosion at the river embankments are:
  - (1) The river water scours out the earth fill at the bottom of dike and generates cavities behind the concrete plates.
  - (2) Rainwater infiltrates to the joints and cracks on concrete plates and erodes the earth fill behind.
- The river water scouring can be determined by the scouring effect at the toe of the river dike.
- Erosions caused by the rainfall infiltration is difficult to be detected visually because the concrete plate is thick and rigid.
- In the early stages of erosions, insignificant signs of damage can be observed on the concrete plates.

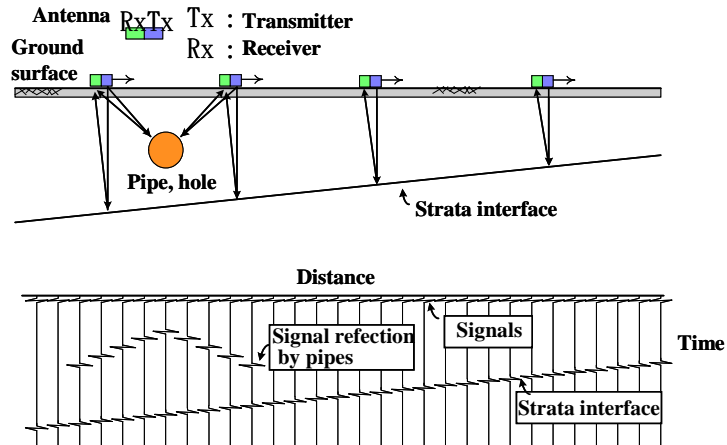
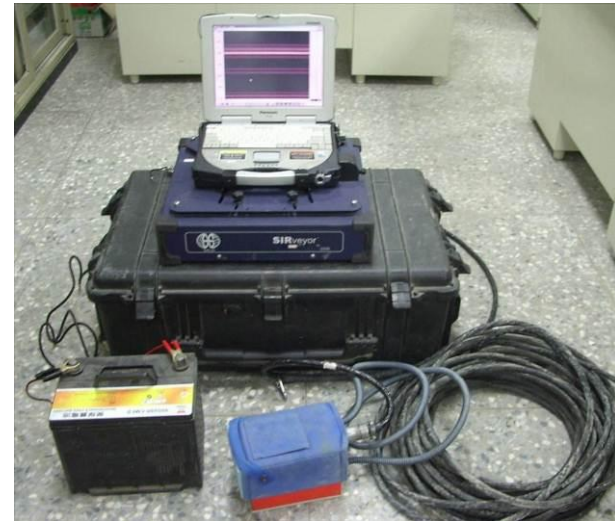
- A 400MHz antenna is used in this study.
- The wave velocity of the concrete and soils is assumed to be 0.1 m/ns.
- The maximum two-way travel time is set 50 ns in this study with the maximum signal penetration depth is 2.5m.
