# Effect of low tailwater during drought on scour conditions downstream of an ogee spillway

Seung Ho Hong, Su Jin Kim, Terry Sturm & Thorsten Stoesser

**ABSTRACT:** Low tailwater stages downstream of the stilling basin of an ogee spillway as a result of drought conditions can result in swept-out hydraulic jumps that enhance scour potential downstream of the structure. A hydraulic model study was conducted to assess the impact of low tailwater on energy dissipation provided by the stilling basin and the stability of the revetment lining in the downstream stilling pool. Detailed velocity and turbulence profiles were measured in the stilling pool for both submerged and swept-out hydraulic jumps. The results suggest that the primary scouring mechanism may be the impact of a submerged jet on the bed.

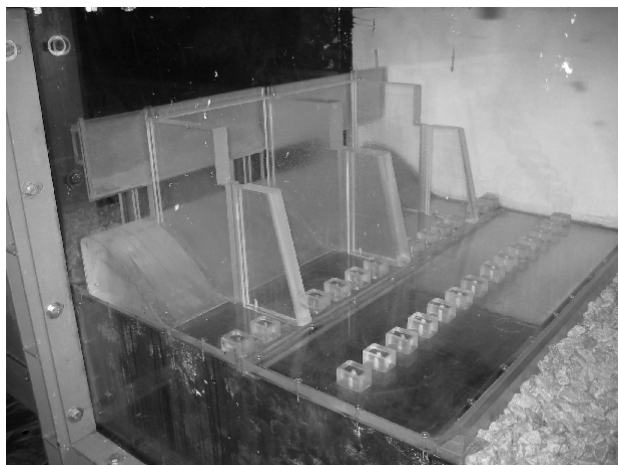
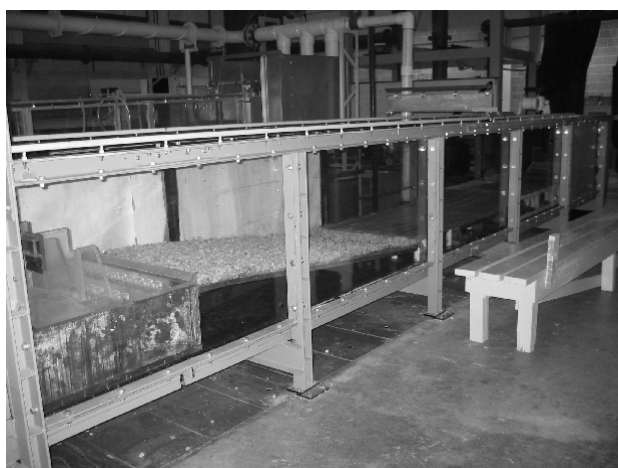
Figure 1. Spillway model with vertical gates, piers, stilling basin and tailrace

(a) Ogee spillway and stilling basin

(b) Tailrace

The experimental setup is a fixed-bed, sectional model of the spillway and stilling basin which was constructed at a 1:30 undistorted geometric scale (length ratio,  $L_r = 1/30$ ) using Froude number similarity (see Figure 1.). At the chosen scale, the model Reynolds number based on spillway head is of the order of  $10^5$ , which ensures a fully turbulent flow regime as in the prototype (ASCE 2000). The model Weber number is estimated to be of the order of  $10^3$  which indicates that surface tension effects are negligible. The spillway crest and the

The tailrace downstream of the spillway consists of a stilling pool with rock riprap revetment on the slope leading to the bottom of the stilling pool. The riprap in the model was modeled as a mobile bed and sized according to roughness similarity and Shields' criterion. To reproduce the riprap roughness in fully-rough turbulent flow, the relative roughness ratio of grain size to depth must be the same in model and prototype; that is,  $d_r/Y_r=1.0$  in which  $d_r$  is the grain size ratio and  $Y_r$  is the depth ratio. For a Froude number model, the depth ratio is equal to the length scale ratio  $L_r$ , so that the riprap is sized according to  $d_r=L_r$ . This satisfies Shields parameter similarity for initiation of motion if the specific gravity of the riprap is the same in model and prototype, the model is undistorted, and the particle Reynolds number is large enough which requires the model sediment size to be greater than about 1.5mm (coarse sand). This latter criterion is satisfied in the present model

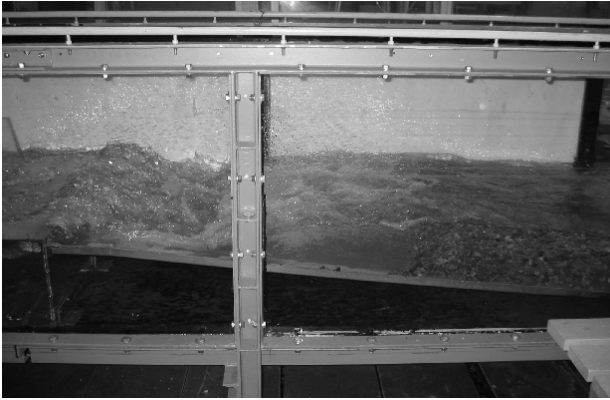
Figure 2. Hydraulic jump sweptout and riprap erosion for Test condition 1 with free orifice flow.

For the low tailwater of Test Conditions 1, 2, 3 and 7, the hydraulic jump swept out of the stilling basin and caused erosion of the downstream riprap in varying degrees of severity. Test Conditions 1 and 7 were the most severe with respect to stability of the riprap. Test Condition 1 was for the lowest tailwater elevation of 0.01m while Test Condition 7 was for a moderately low tailwater elevation of 2.21m but at the highest discharge. As shown in Figure 2 for Test Condition 1, the riprap was eroded off the floor of the downstream ramp and deposited in a broad low mound near the downstream toe of the ramp.

For the purposes of this paper, Test Conditions 1 and 5 as shown in Figures 2 and 3 are compared with respect to measured water surface profiles, velocity profiles and Reynolds stresses. The former condition corresponds to the extreme drought case of low tailwater while the latter is more representative of normal operating conditions for the spillway structure.

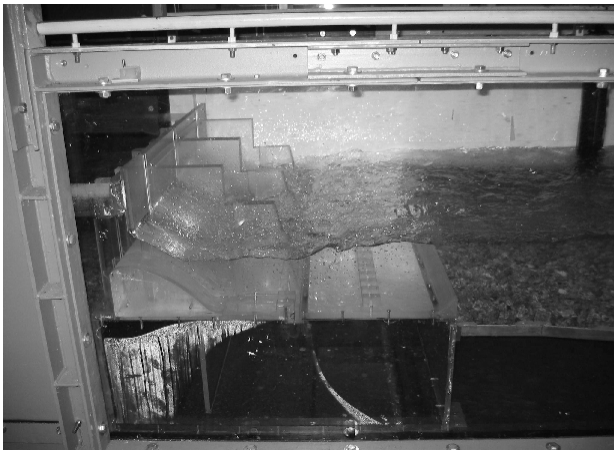
Figure 3. Submerged hydraulic jump for Test Condition 5 with free orifice flow and stable riprap.

Test Condition 4 resulted in a stable hydraulic jump in the stilling basin. For Test Condition 5, the hydraulic jump was submerged on the face of the spillway without submerging the orifice flow under the gate as shown in Figure 3. Test condition 6 produced a very weak jump high on the face of the spillway, and it oscillated upstream and downstream reflecting the sensitive transition from free to submerged weir flow. In all three of these cases, the riprap was stable on the downstream slope.

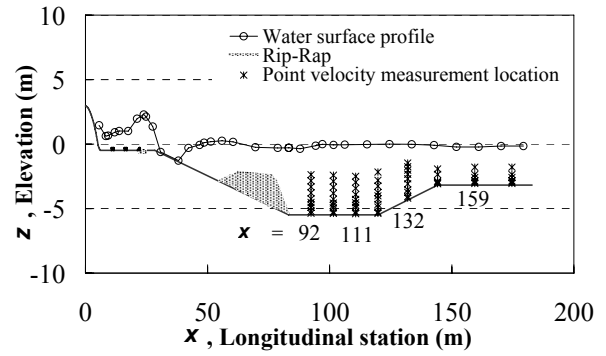
(a) Test Condition 1: Free orifice flow at low tailwater with hydraulic jump swept out

Figure 4. Water surface profiles and locations of velocity profile measurements for Test Conditions 1 and 5.

Water surface profiles for Test Conditions 1 and 5 are shown in Figure 4(a) and 4(b), respectively. In Test Condition 1 (Figure 4(a)), the low tailwater causes the jump to sweep out of the stilling basin with a high velocity jet that is flipped onto the downstream riprap-lined slope by the end sill of the stilling basin. At the impact point of the jet, the rock riprap is eroded off the downward slope of the stilling basin and deposited in a broad shallow mound at the foot of the slope. This results in a hydraulic jump on the face of the slope and a second high velocity flow over the riprap mound with an impact zone in the bottom of the stilling pool. A conceptual drawing of this flow pattern is shown in Figure 5.

In order to further investigate the hypothesized flow patterns, velocity and turbulence profiles were measured at the locations shown in Figure 4 both at the structure centerline in alignment with the middle pier and along the centerline of the right-side spillway bay.

The flow over the riprap mound in Figure 4(a) is close to critical flow resulting in an accelerated jet which separates downstream of the deposited riprap. The velocity profiles in Figure 7(a) at  $x = 92\text{m}$  exhibit a reverse flow at the bed corresponding to a recirculation zone upstream of a submerged jet splatting at the impact point for Test Condition 1. Downstream of the impact point the

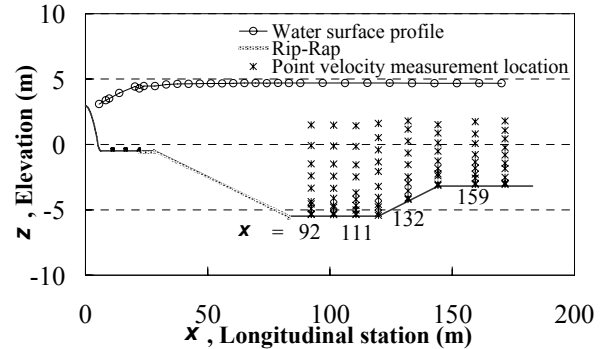
(b) Test Condition 5: Free orifice flow with high tailwater and submerged hydraulic jump

In contrast, Test Condition 5 at much higher tailwater has a water surface profile shown in Figure 4(b) that is nearly horizontal in the stilling pool area, and no riprap is eroded. Conceptually, flow velocities would be expected to decrease in the streamwise direction as the depth increases within the stilling pool, but much higher momentum fluid might be expected from the submerged jump as it exits the stilling basin in comparison to lower momentum fluid near the bed in the scour region. The conceptual flow pattern is shown in Figure 6.

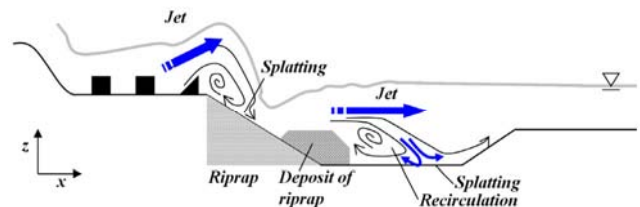
Figure 5. Conceptual flow pattern for Test condition 1.

The conceptual model suggested in Figure 5 is further supported by the vertical distribution of the shear stress. Figure 8 presents the Reynolds shear stress at stations  $x = 92\text{m}$ , and  $x = 111\text{m}$ . A strong shear layer is formed due to the separated jet flow above the recirculation region. Towards the bed, the shear stress is decaying rather rapidly

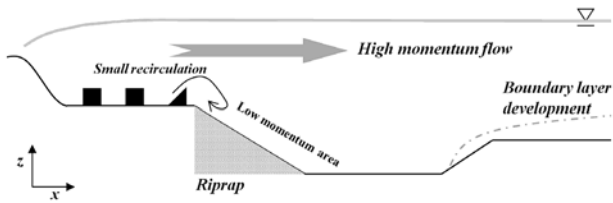
Figure 6. Conceptual flow pattern for Test condition 5.

As shown previously in Figure 6 for Test Condition 5, the flow is characterized by a submerged hydraulic jump in the stilling basin and high momentum flow above the downstream rip-rap lined slope. Velocity profiles indicate that there is no flow separation taking place; however, the flow immediately above the riprap is characterized by an area of low momentum fluid. Velocity and shear stress profiles are shown in Figure 9 at  $x=92\text{m}$  for Test Condition 5. These provide clear evidence for the statements made above; that is, the submerged jump creates an upper high momentum region in the stilling pool with a low momentum zone underlying it but without flow reversal in the bottom of the stilling pool. The velocity profile resembles more that of a mixing layer than a boundary layer. Relatively small turbulent shear stresses occur in the lower momentum region near the bed where the mixing layer is developing. The interface between high and low momentum flow is characterized by elevated values of shear stress around the area of  $z=0.0\text{m}$ , suggesting a shear layer between the two flow areas.

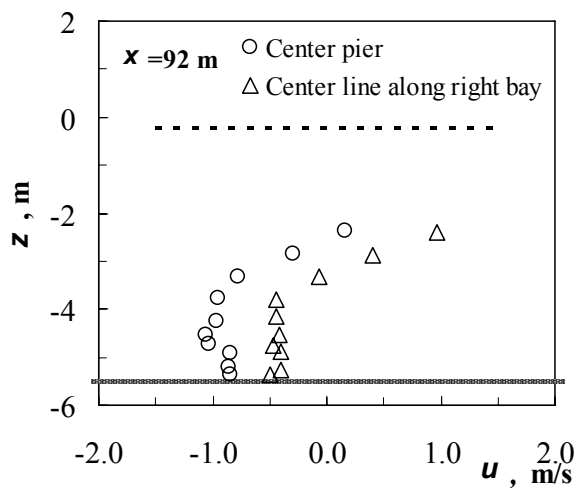
(a) Velocity profiles at  $x = 92\text{m}$

Figure 7. Velocity profiles, Test Condition 1

Velocities in Figure 7 are weaker in the lee of the center pier in comparison with the centerline of the spillway gate bay. This difference persists both upstream and downstream of the impact of the submerged jet.

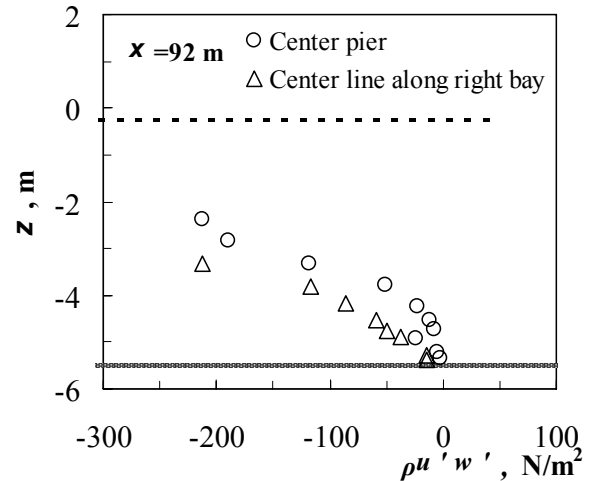
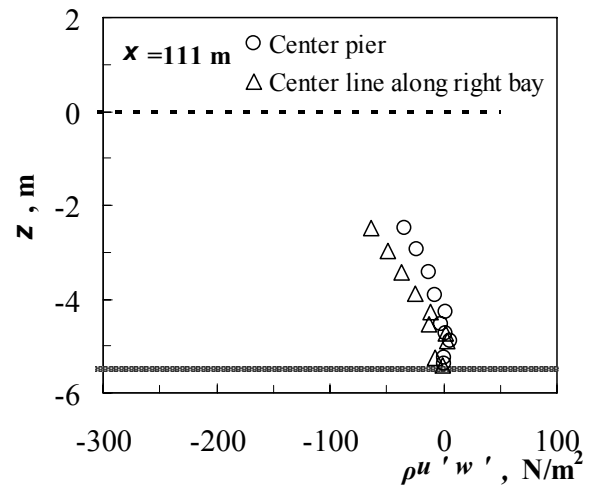
(a) Reynolds shear stress profiles at  $x = 92\text{m}$

(b) Reynolds shear stress profiles at  $x = 111\text{m}$

Figure 8. Reynolds shear stress profiles, Test Condition 1

indicating very low momentum and turbulence in that region. This is strong evidence that the observed scour hole (in the field) downstream of the riprap is not caused by strong near-bed velocity gradients but by the splatting event.

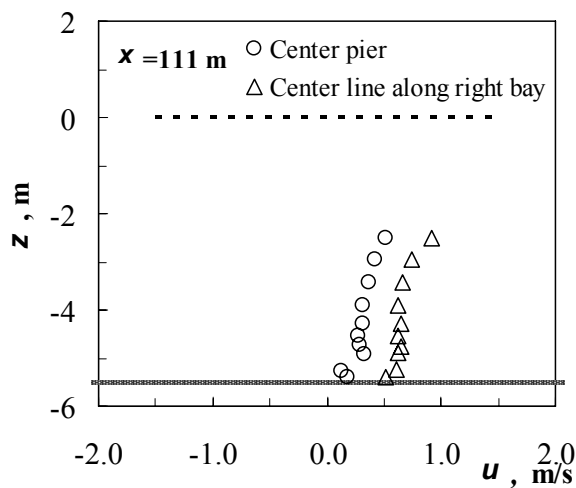
(b) Velocity profiles at  $x = 111\text{m}$

flow is accelerating near the bed as illustrated by the slight bulge and the positive velocities found there as shown in Figure 7(b). In the splatting event, high momentum fluid is swept towards the bed causing localized areas of high pressure that are expected to be responsible for erosion of the bed. The velocity profiles exhibit features similar to the recovering velocity profile behind a backward facing step or a sand dune (Stoesser et al. 2008).

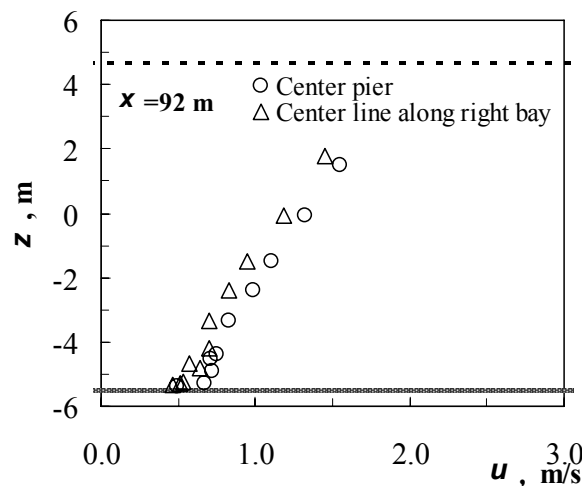
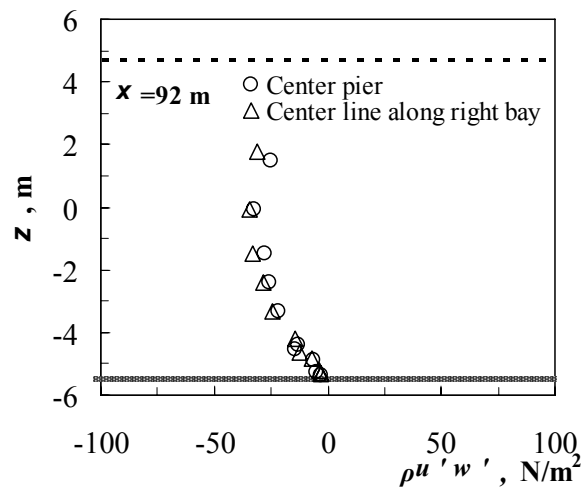
(a) Velocity profile at  $x = 92\text{m}$

(b) Reynolds shear stress profile at  $x = 92\text{m}$

Figure 9. Velocity and Reynolds shear stress profiles for Test Condition 5.
