Coastal Protection at the North and Baltic Sea: Helgoland Island

By KLAUS BEDNARCZYK, ANNE HEELING, DETLEF SCHALLER
and ULRICH VIERFUSS

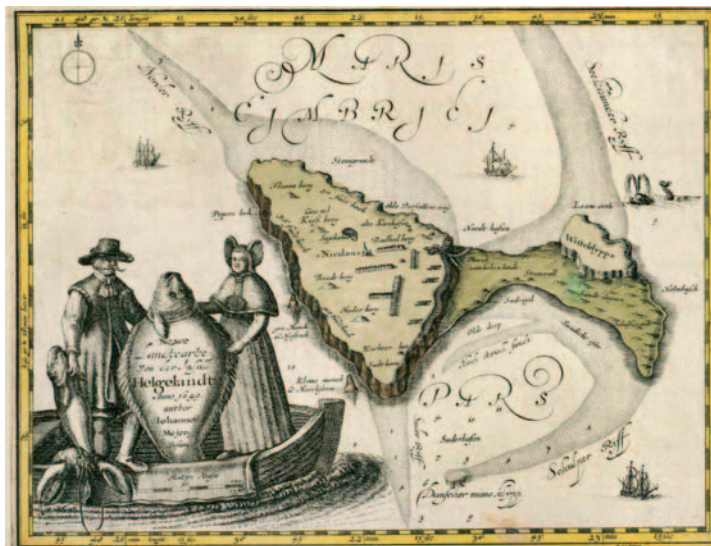
Fig. 3: The island of Helgoland with the 'Wittekliff' and 'Woal' in the 17th century (map by Johannes Mejer, 1694)

During this time, the main island was connected with the ‘Wittekliff’ by a sand spit, the ‘Woal’ (Fig. 3). Since medieval times, shell-limestone and gypsum had been mined on this cliff. This exploitation contributed to its rapid destruction up to a point of instability; it collapsed during the storm surge of 1711. Shortly afterwards, the ‘Woal’ disappeared as well. On top of the remaining cliff, the present Düne developed. The sand island is important for today’s beach activities.

In 1721, the history of Düne being an independent island begins by its separation from the main island. The breaching of the sand spit 'Woal' (Fig. 3) triggered the generation of a gully which became deeper and wider. The size of the main body of Düne decreased during the course of the centuries, and it assumed a spindle shape (Fig. 6). At its eastern end, a long-stretched flat sand and rubble spit developed. This so-called 'Aade' was continuously modified by waves and currents.

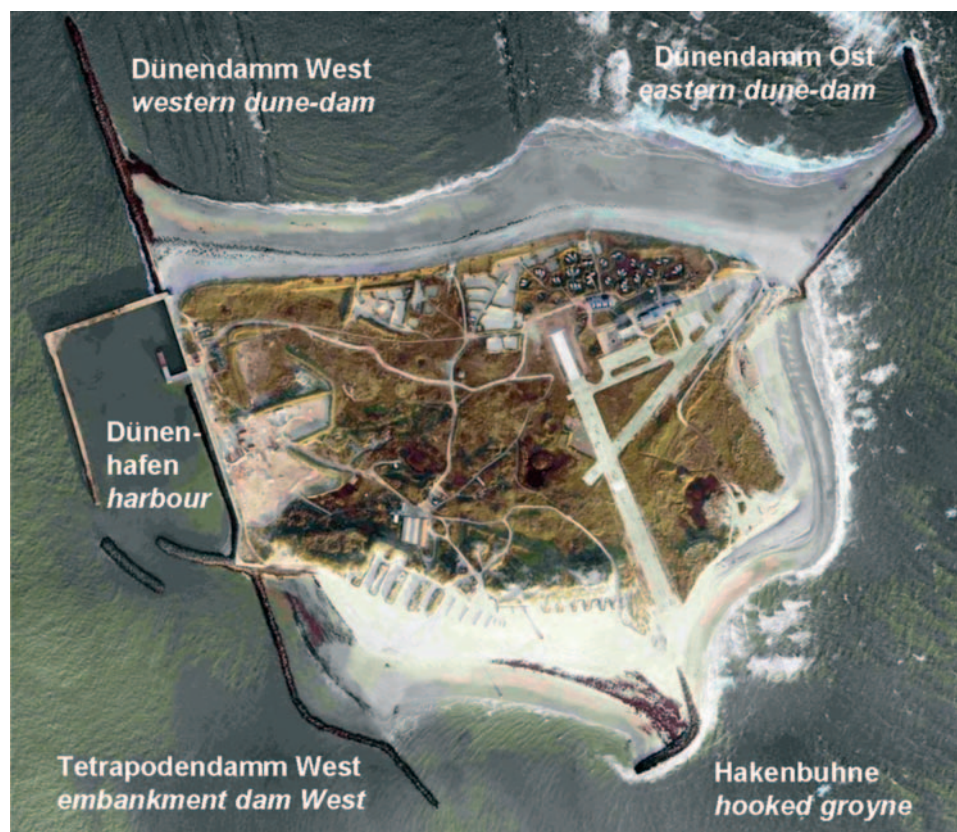
Fig. 7: The Düne of Helgoland (aerial photograph of Nov. 14, 2007)

In 1979, with the receding beach front at the eastern part of the southern beach, the HW-line moved to the immediate vicinity of the runway of the little airport, resulting in a scour at the runway head. Among others, this led to a concept for the protection of the southern side of Düne and the runway. For this purpose, a 60 m Tetrapode groyne was built in early 1983 and extended to 234 m in 1987. This hooked groyne was the counterpart to the embankment dam mentioned above. The result was an increased sand deposition and the evolution of a bay ideal for swimming. This bay has been stable until now (Fig. 7).

The counterparts of these structures at the southern side are the Tetrapode dam (1965–1974) and the hooked groyne (1983–1987; cf. Fig. 7). Finally, the dune harbour was protected by a new southern jetty and an offshore breakwater against wave impact. Moreover, these structures are to prevent the penetration of sediment. The harbour is an integral part of the protection of Düne.

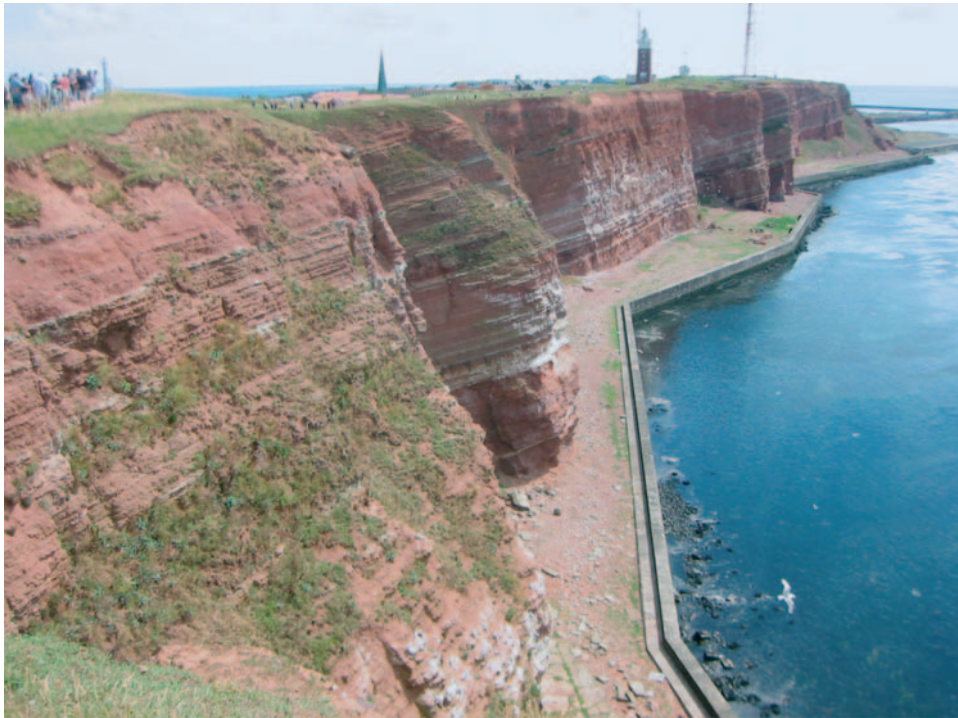
Fig. 8: View of the cliff coast and a part of the south-western sea wall
(Photo: H. J. Bennöhr, 2005, Wikipedia Commons)

The most vital structure to protect the island base is the south-western sea wall – also called the Prussian wall (Preußenmauer) – which is being maintained by WSA Tönning. It protects the rock walls and prevents wave-induced erosion processes (generation of surf grooving, surf portals and 'Stacks') at the strongly attacked western shore of the island. Moreover, it is to collect debris which is continuously generated by rain, spray, frost and wind and drops from above. Initially, this material was thought to adjust itself to form a naturally flat slope which would eventually be covered by natural growth and protect the bunter against further erosion. However wave action prevented this. Particularly during storm surges the erosion by wave overtopping is so strong that rubble and debris are carried away. Thus, the south-western wall only protects against direct wave attack.

The sea wall was erected using a combination of concrete blocks, poured concrete and a covering of natural stone blocks between 1903 and 1913 and between 1926 and 1927. It was substantially damaged by bombs during and after WWII and reconstructed in concrete between 1960 and 1963. The average crown elevation is at approx. HW + 3.50 m, and the toe of the rock slope in front of the wall is close to LW. Towards the North, the south-western sea wall merges into the northern jetty. South of the 'Kringel', which was generated by the blasting in 1947, it continues to cross over into the shore protection and jetty structures of the secure protective harbour.

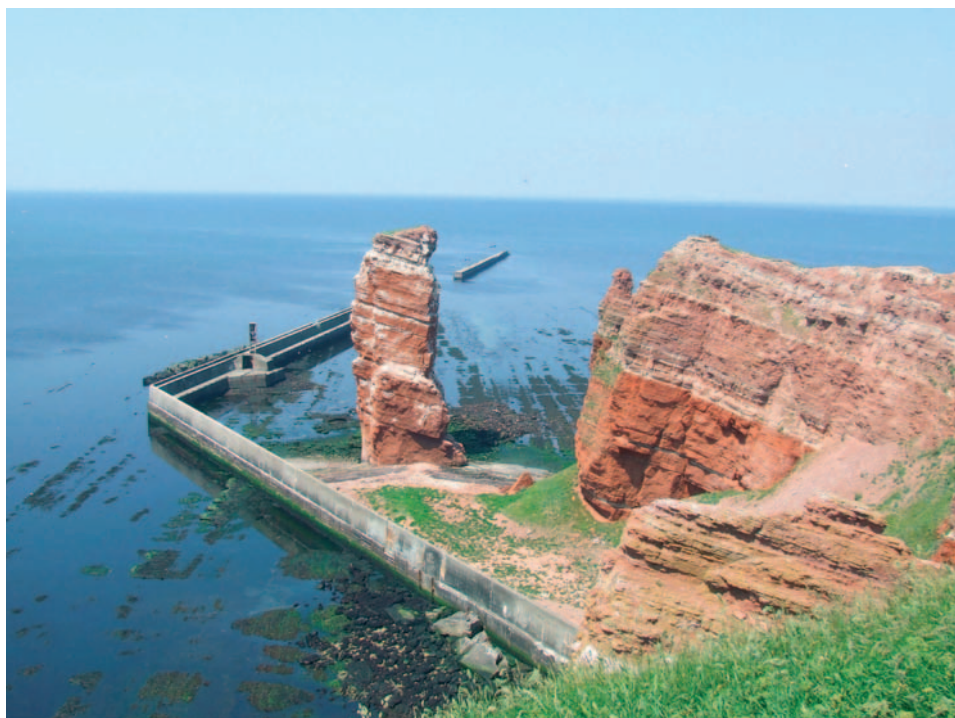
Fig. 9: View of the northern jetty and the rocky foreshore (Felswatt) north of the main island
(Photo: TomCatX, 2007, Wikipedia Commons)
