SCOUR AND EROSION ALONGSIDE BANK PROTECTION WORK: CASE STUDIES FROM BANGLADESH

KNUT OBERHAGEMANN

ABDUN NOOR

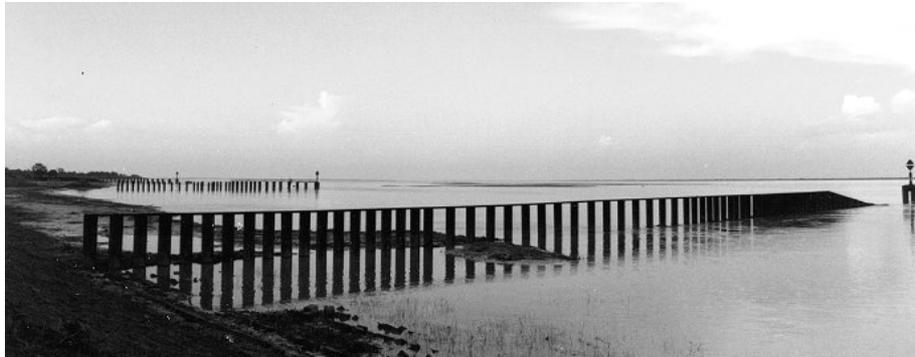
Figure 8. Permeable spurs at Kamarjani.

Scour data from different types of spurs are available from two locations along the Brahmaputra / Jamuna River: at the permeable spur field at Kamarjani and at Sariakandi at three hard points, both at the right bank. The permeable spurs at Kamarjani are shown in Figure 8, the measurements in Figure 9.
