# "SMART RIVERS 2013"

Technical-biological river bank protection – a contribution to the ecological improvement of the banks of Federal waterways in Germany – First experiences from a field test along the River Rhine

Maastricht (NL) & Liege (BE), 23-27 September 2013

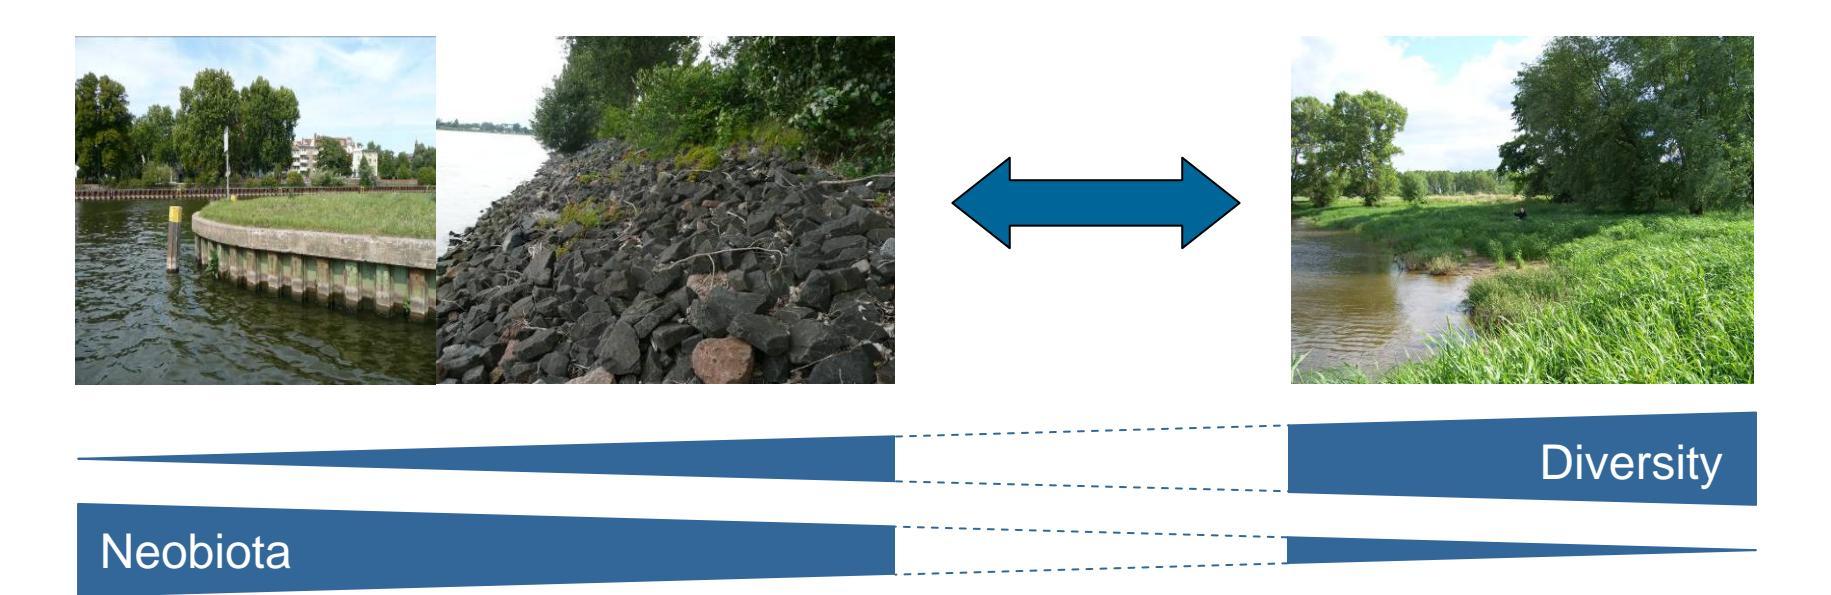
### All large rivers have been severely modified by bank fixation

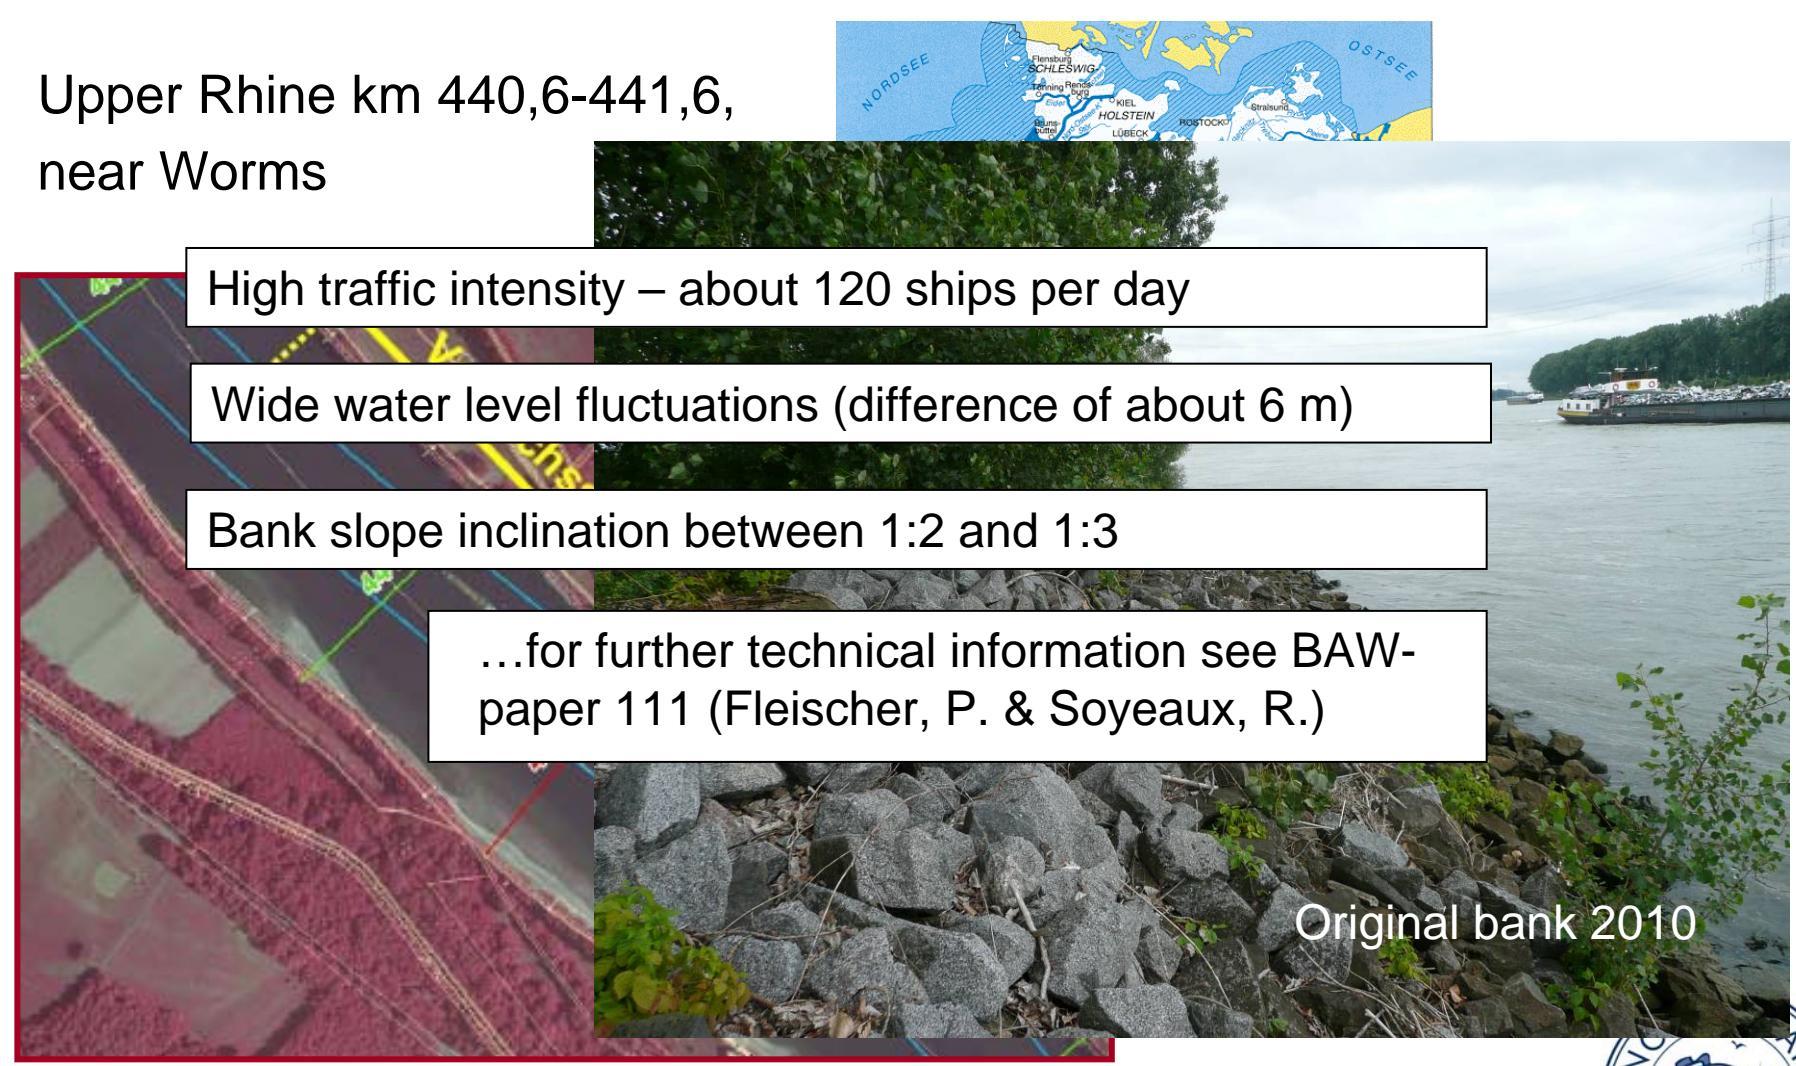
...same situation in the test stretch along the River Rhine before modification with technical-biological bank protection measures, as also shown in Petra Fleischer's previous presentation...

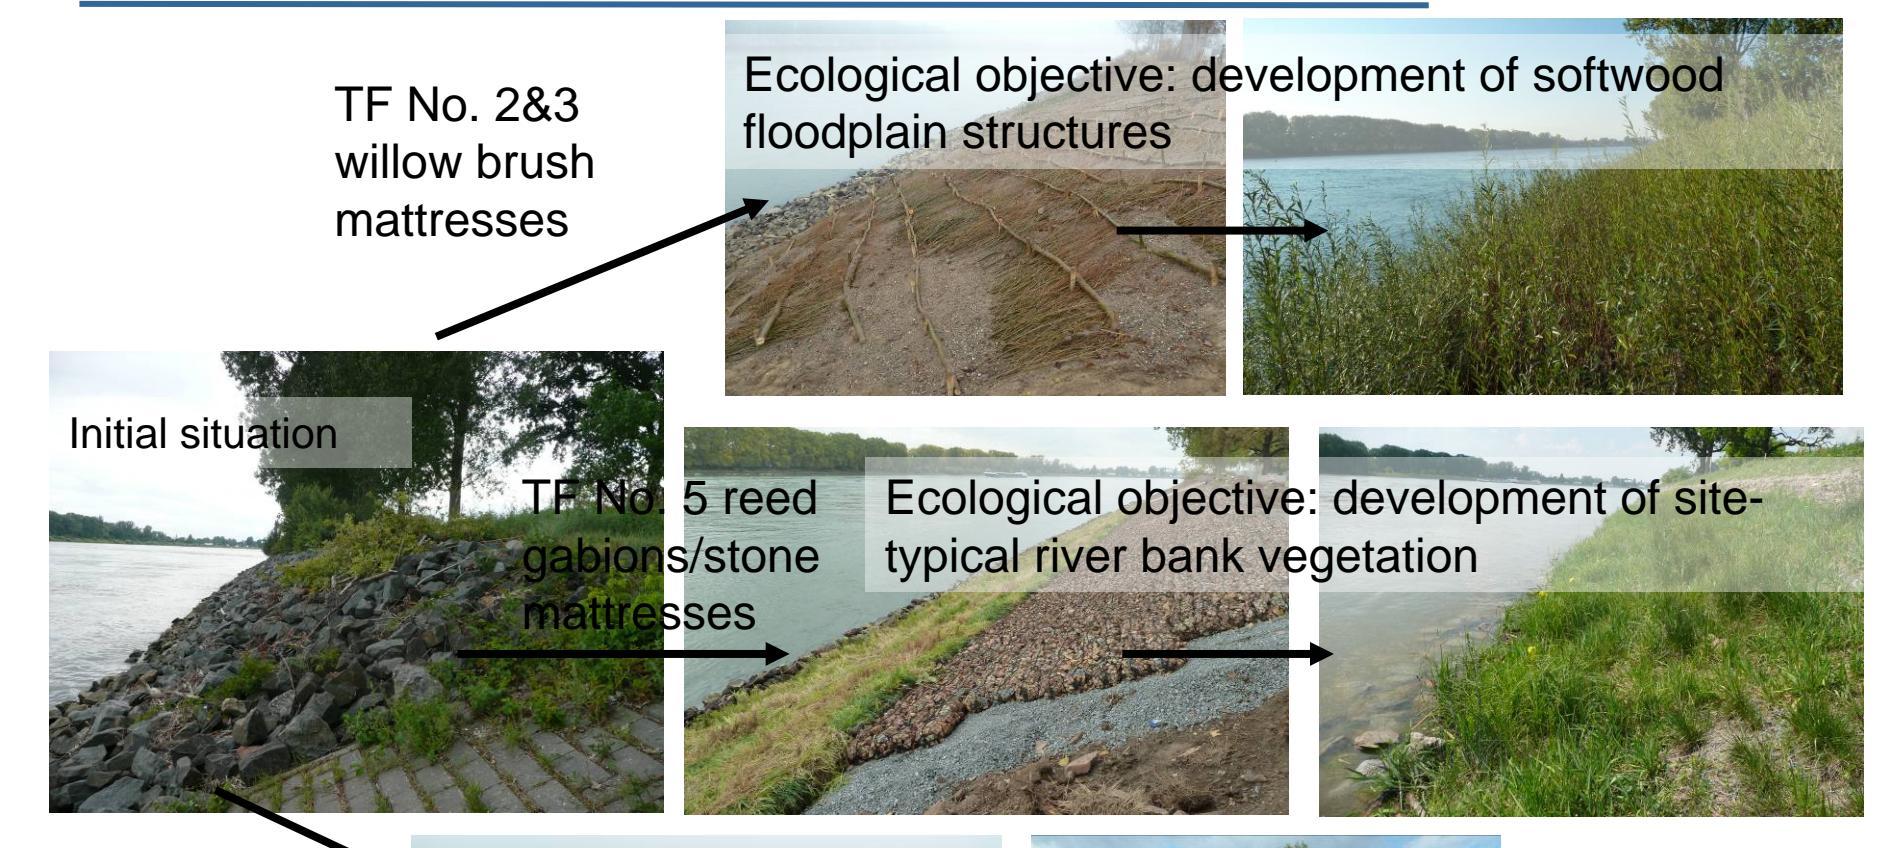
TF No. 7 precultivated plant mats Ecological objective: development of sitetypical river bank vegetation

The vitality of pre-cultivated plants at the time of installation proved to have great influence on successful rooting and growth. Plots, where the pre-cultivated plants were less vital and the systems were lightweight suffered some losses → repairs were needed in the test fields with plant mats (TF No. 5 and 7)

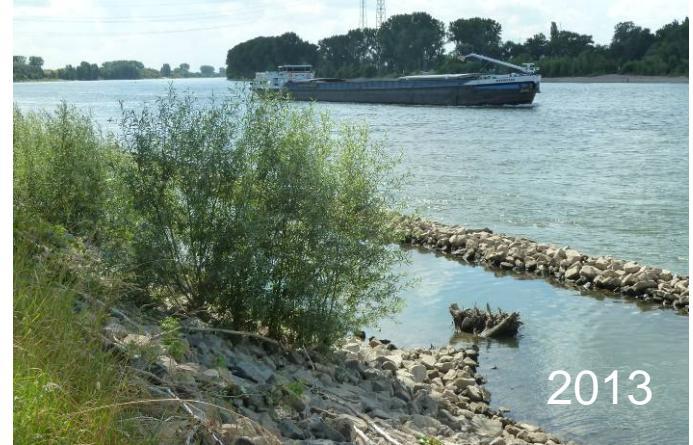
# Ecological improvement of rip-rap:

- breakwater-like stone wall with shallow water zone protected against hydraulic impacts
- inert wood trunks with roots
- willow-branch cuttings
- brush/hedge layers
- living fascines

Use of native site-typical species as: purple and white willow, hardwood floodplain shrubs cted Ecological objective: refuge for fish and macrozoobenthos Ecological objective: development of soft- and

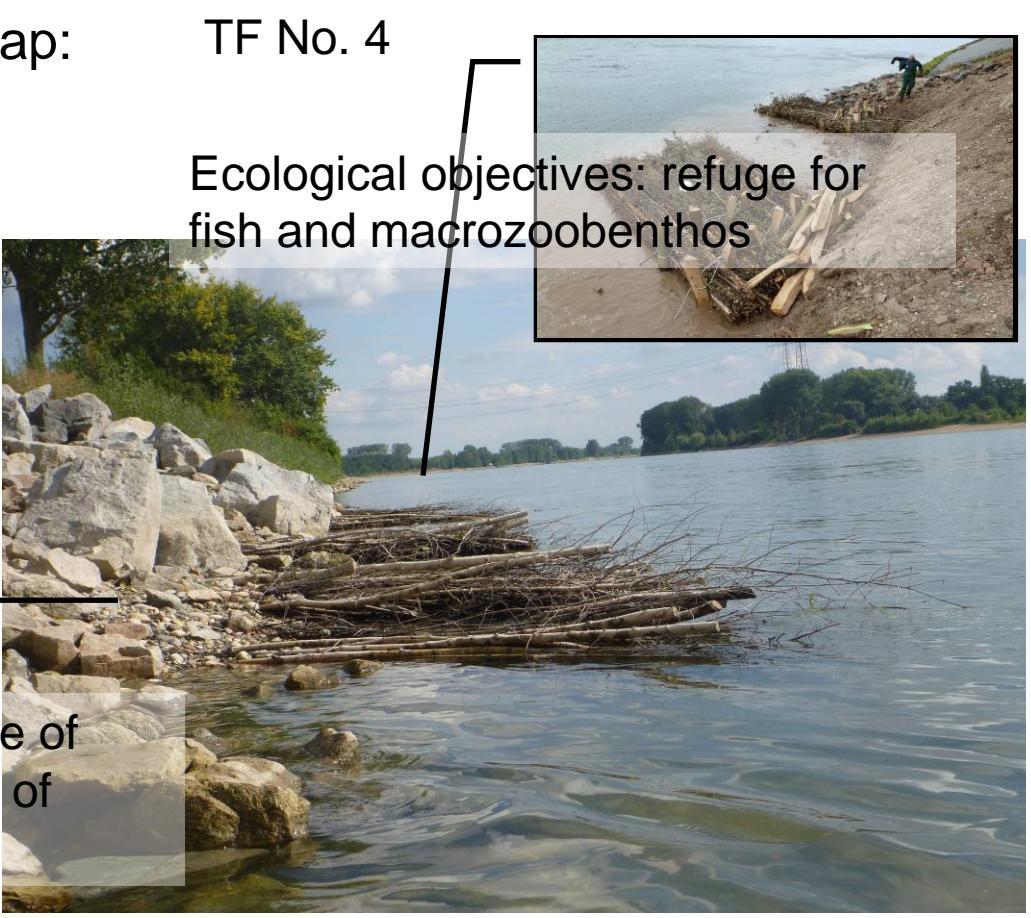
Ecological improvement of rip-rap:

- inert fascines below
  Mean Water Level (MW)
- rip-rap with gravel fill, groups of individual stones

Ecological objectives: increase of structural diversity, promotion of natural succession

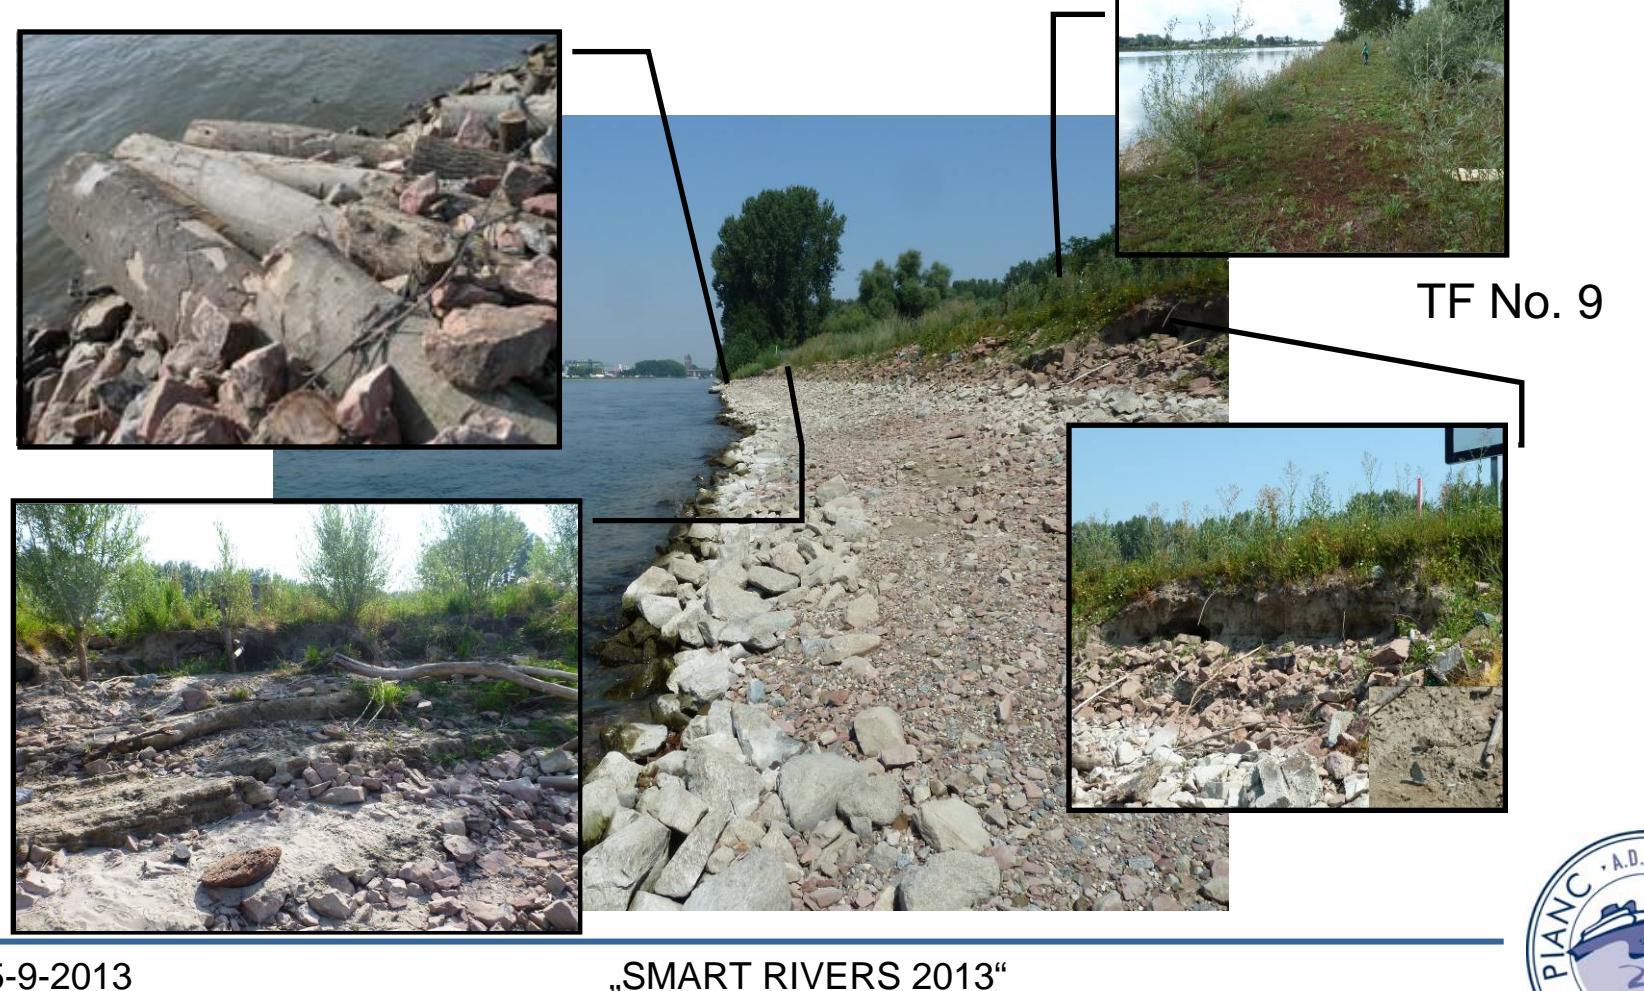
Removal of rip-rap to promote structural diversity by erosion effects
