Journal für Forschung und Praxis im Küsteningenieurwesen an Nord- und Ostsee 92 2022

DIE KÜSTE

An exceptional storm surge in the Baltic

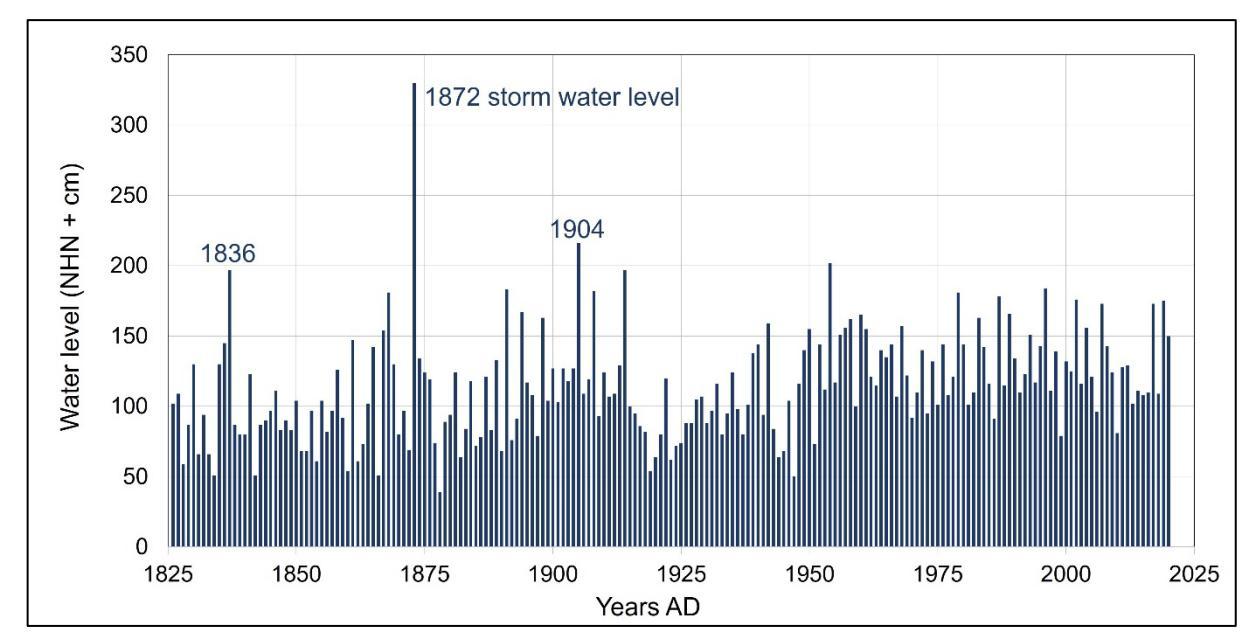
Figure 4: the yearly highest water levels at gauge station Travemünde from 1826 to 2020 (data from LKN.SH; data not corrected for mean sea level rise).

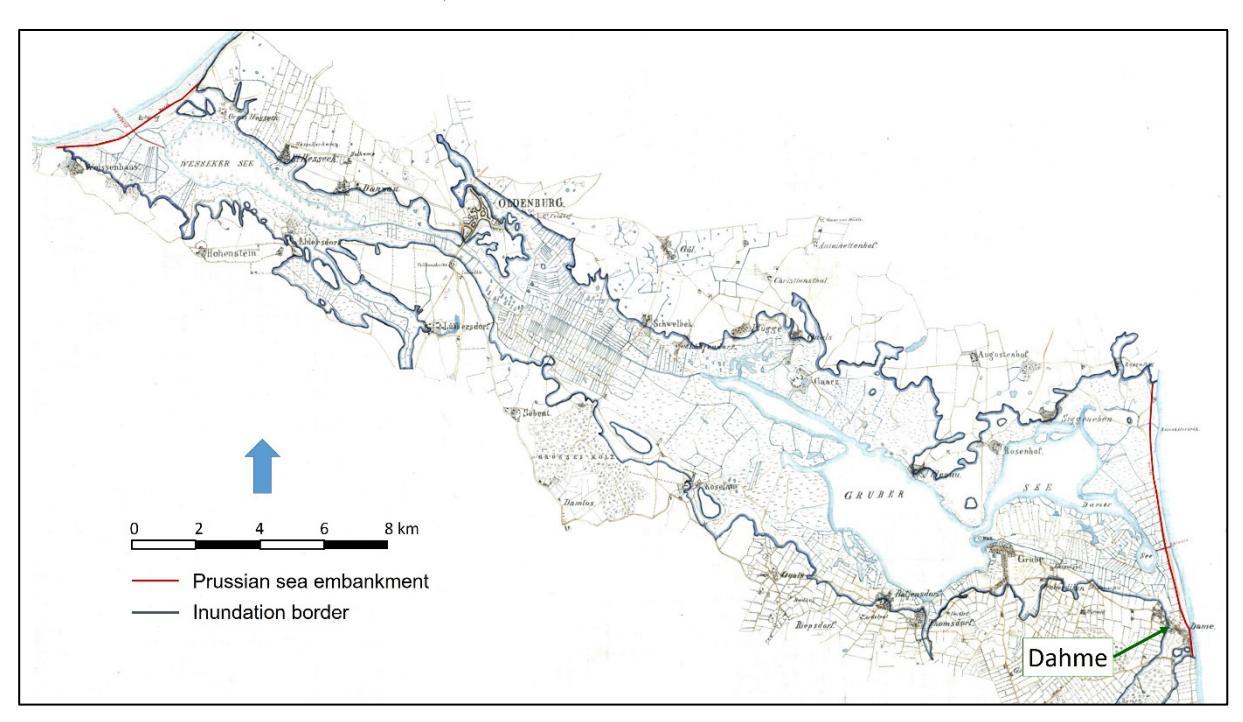
Figure 5: historical map from 1878 showing embankments and inundated area in the coastal lowland "Oldenburger Graben" (location in Figure 1) during the 1872 storm surge (source: LASH Abt. 402 A 24 Nr. 36).

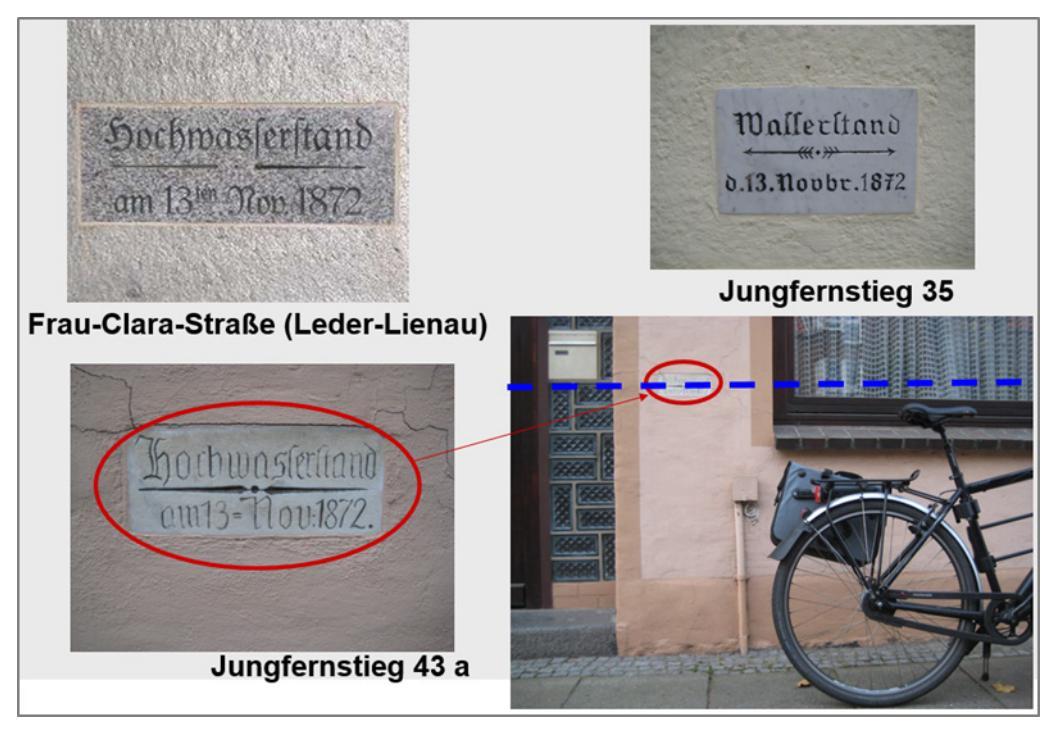
Figure 7: Flood marks in the historical town center of Eckernförde (photos: M. Hamann).

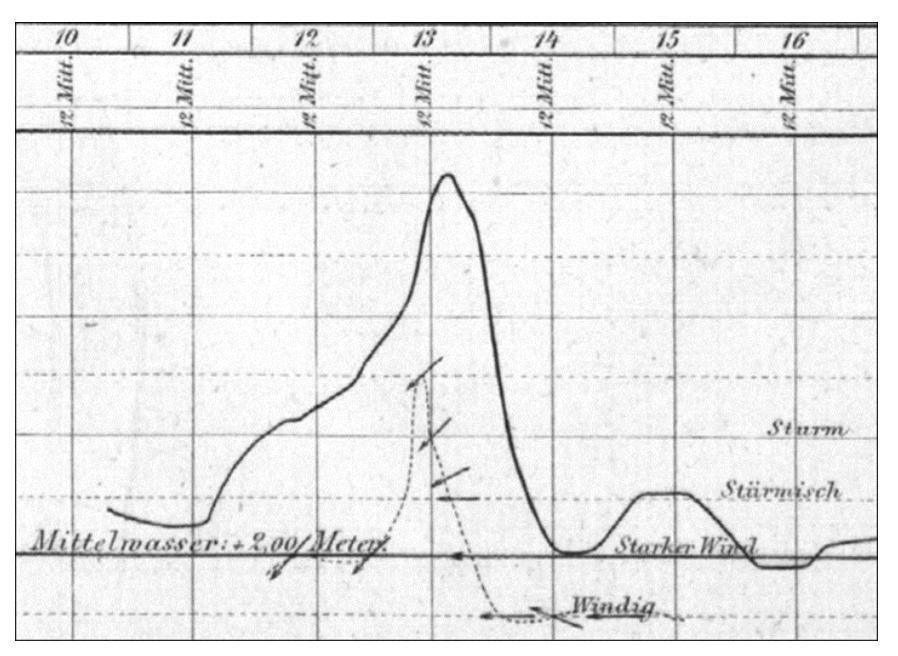
Figure 8: wind curve (dotted line) and flood hydrograph of the 1872 storm surge at Kiel gauge station (taken from Baensch 1875).

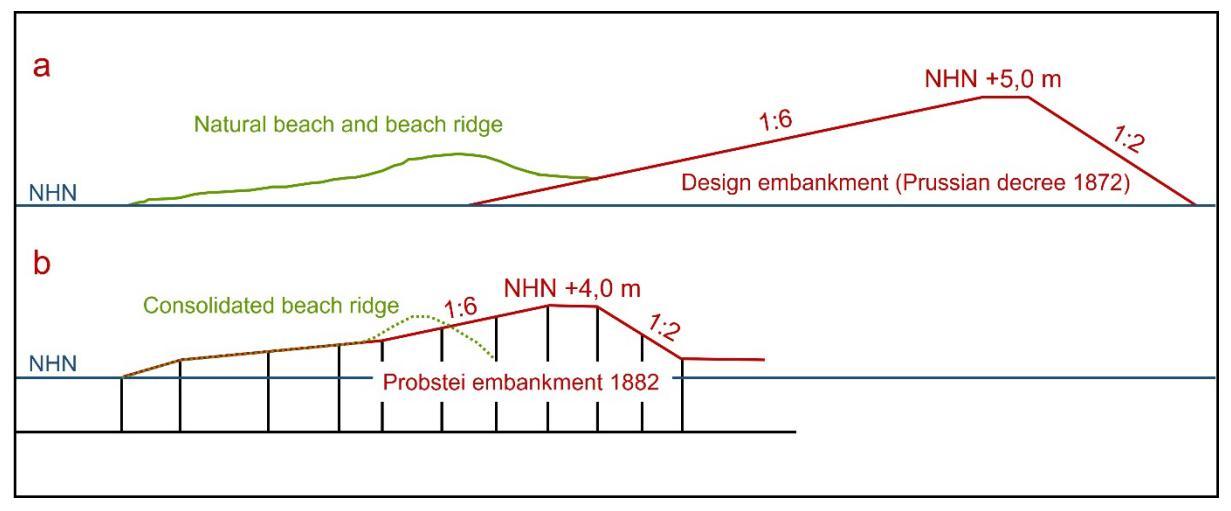
Figure 9: design profile of a sea embankment according to the Prussian design criteria (Figure 9a) and of the 1882 sea embankment in the Probstei near Kiel (Figure 9b) (adapted from Eiben 1992).
