The 1872 catastrophic storm surge at the Baltic Sea coast of Schleswig-Holstein; lessons learned?

Jacobus Hofstede¹ and Matthias Hamann²

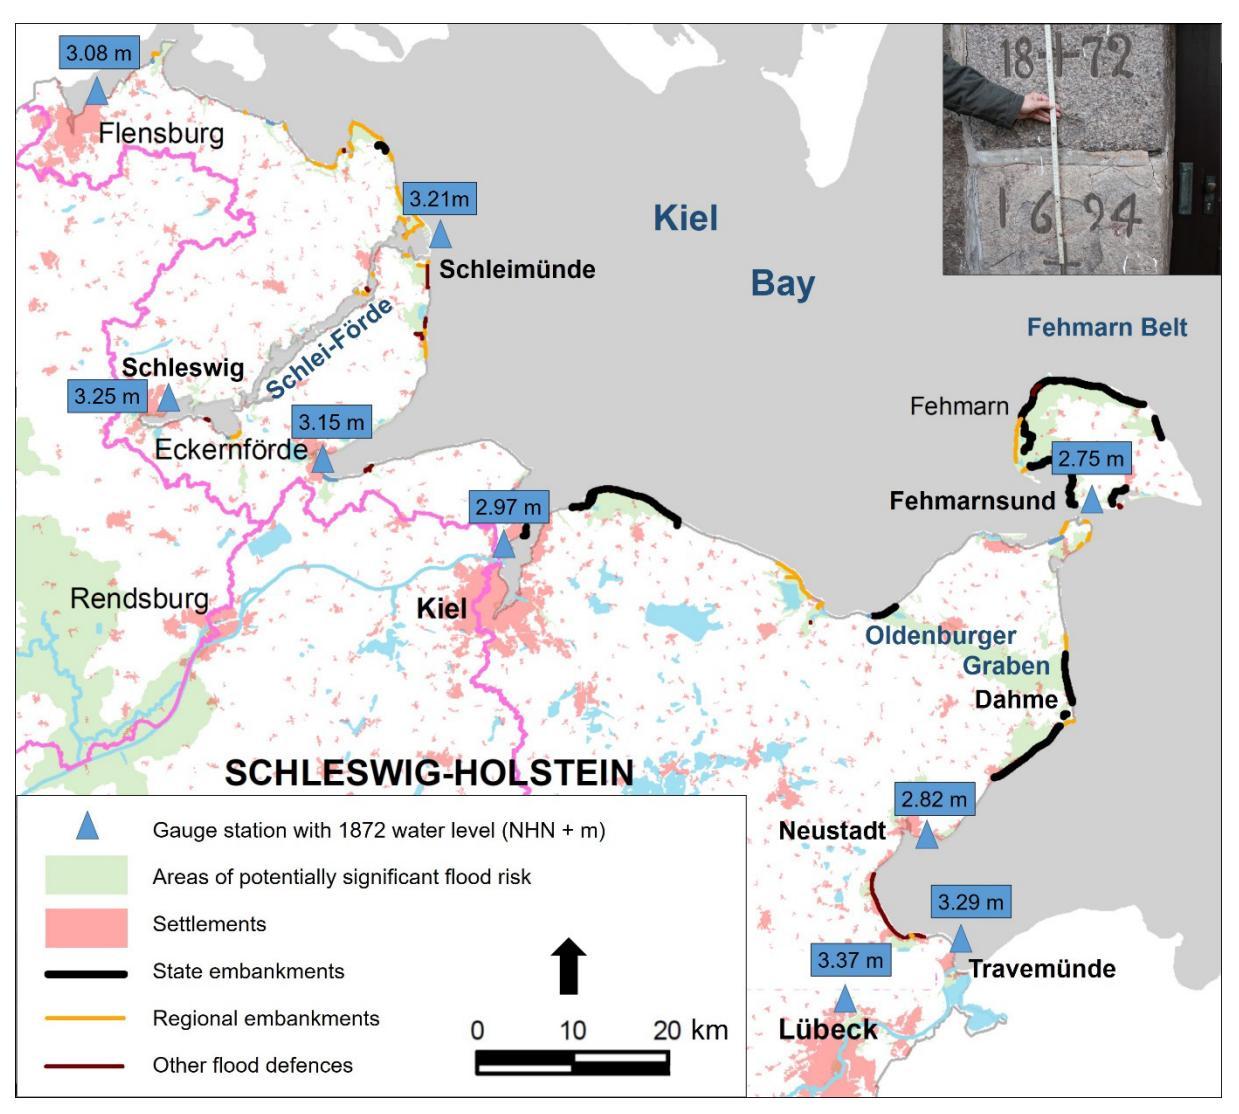
Figure 1: overview of the Baltic Sea coast of Schleswig-Holstein with coastal lowlands (in green), coastal flood defenses and 1872 storm surge water levels (gauge data: NHN = "Normalhöhennull" = German ordnance datum). The inset at the top right of the figure shows high water marks from the storm surges 1694 and 1872 at the former Gottorf water mill in Schleswig (photo: J. L. A. Hofstede).

Figure 1 depicts known maximum water levels of the 1872 storm surge at gauge stations in Schleswig-Holstein. Lübeck gauge station recorded the highest water level in Schleswig-Holstein with 3.38 m above mean water level (NHN +3.37 m). At the former "Blue Tower" in Lübeck, high water marks existed of two earlier extreme floods that occurred in the years 1625 and 1694. A regional railway company dismantled the Blue Tower in the late 19th century to make room for a new railway line. Based on these marks, Baensch (1875) established maximum water levels of 2.80 m (1625) and 2.82 m (1694) above mean water level, i.e., 0.58 resp. 0.56 m lower than the flood from 1872. Baensch applied the mean water level of his time, thus assuming that no secular mean sea level changes occurred among 1625 and 1872. According to Baensch (1875), no reliable height information exists of older storm surges, whereas the storm surges that occurred among 1694 and 1872 were significantly lower. Based on historical data, Jensen et al. (2022) reassessed the heights of storm surge water levels in Travemünde over the last 1,000 years and concluded that a comparable surge height as in 1872 may have occurred in 1320. At the former Gottorf water mill in Schleswig, high water marks exist from the storm surges in 1694, 1836 and 1872 (inset in Figure 1). According to these marks, the peak water level in Schleswig in 1694 was about 0.6 m lower than in 1872, as the water level reached NHN +3.25 m at the local gauge station (Figure 1).

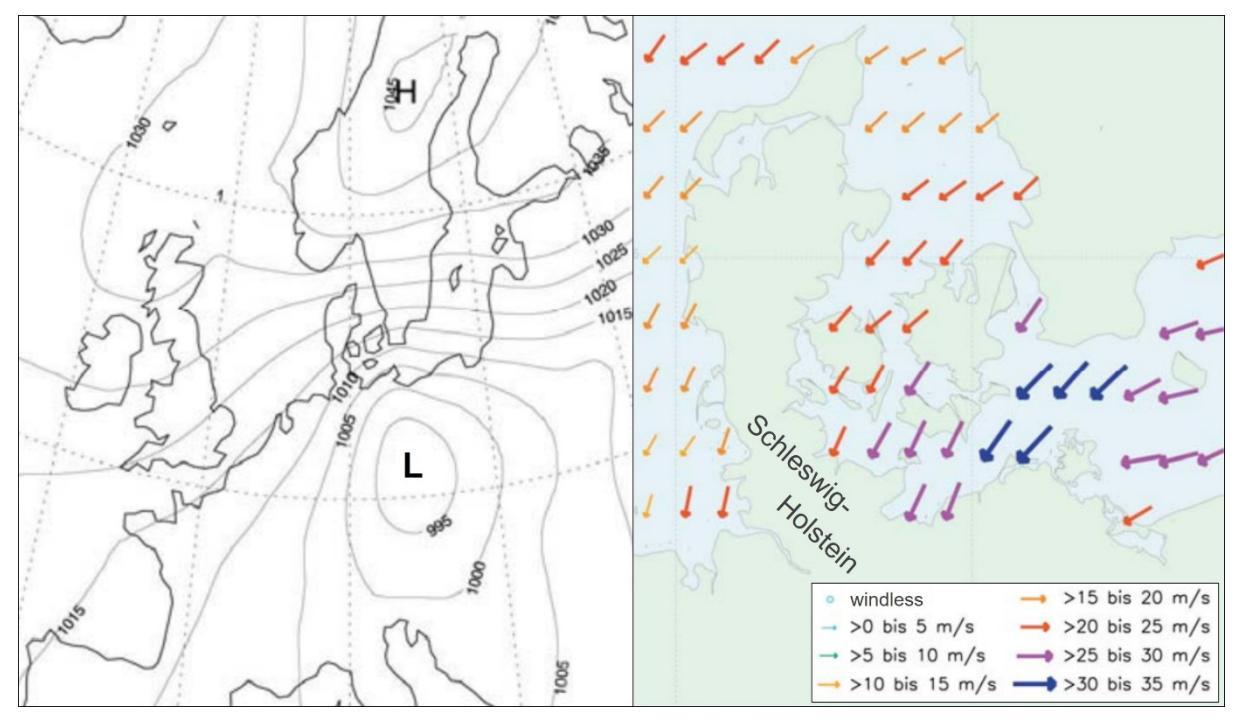
Figure 2: reconstructed air pressure fields and wind velocities in the western Baltic Sea region on November 13, 6 a.m. (source: Rosenhagen und Bork 2009).

Although the 1872 storm surge reached its maximum water levels on November 13, the causative weather situation started already two weeks before (Rodloff 1972, Rosenhagen und Bork 2009). From November 1 to 10, a strong and stable low-pressure system over Scandinavia induced strong westerly winds that "pushed" seawater away from the German Baltic Sea coasts towards the east. This resulted in falling water levels in the western Baltic Sea and, in compensation, water inflow from the North Sea via the Kattegat. In effect, the Baltic Sea filled up with water. Around November 10, the weather situation changed, the westerly winds waned and water started to flow back from the east. A high-pressure system evolved over Scandinavia, accompanied by a low-pressure system in central Europe. Both weather systems continually intensified until November 13, when extreme air pressure gradients induced a northeasterly hurricane (Figure 2). Peak wind velocities in Schleswig-Holstein occurred in the late morning. In Kiel, the hurricane reached a maximum of about 31 m/s around 10 a.m. (Baensch 1875).

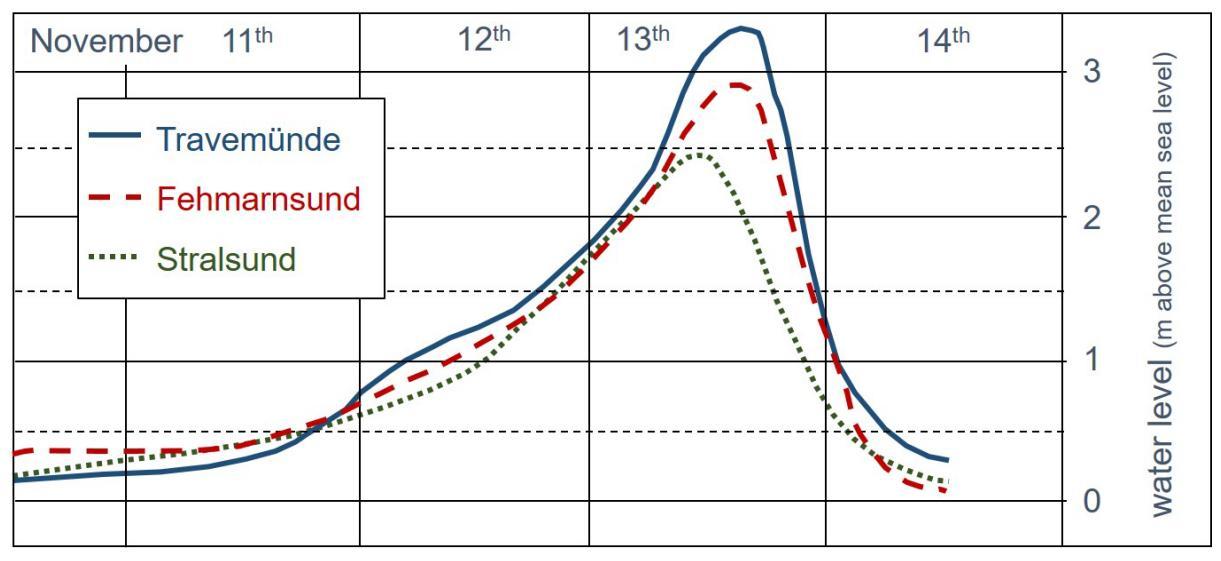
Figure 3: Storm surge curves at Travemünde, Fehmarnsund and Stralsund gauge stations from November 11 to 14 (adapted from Baensch 1875).

Baensch (1875) comprehensively described the hydrology of the 1872 event, including the establishment of 23 storm surge curves recorded at Prussian gauges in the Baltic Sea. Figure 3 depicts coastal flood hydrographs from the gauges Travemünde, Fehmarnsund (positions in Figure 1) and Stralsund (situated about 135 km to the east of Travemünde) from November 11 to 14. The curves show that water levels continuously rose for more than two days. Such a long and strong rise of sea levels as well as the resulting maximum storm water levels were and are unprecedented in the region. Further, the gauge stations Fehmarnsund and Travemünde visualize the well-known effect of increasing surge levels from the outer towards the inner parts of bights.

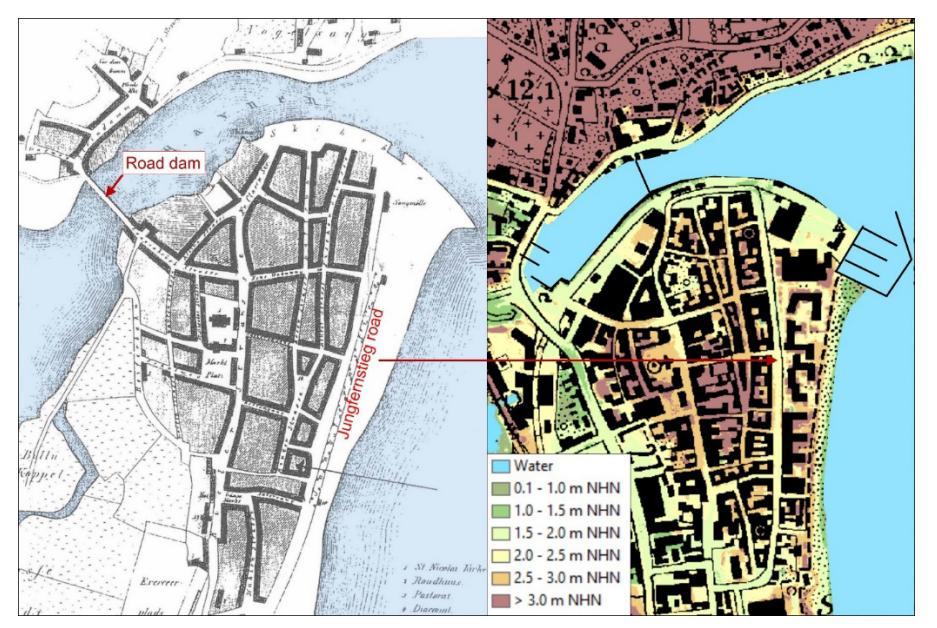
Figure 6: Maps of the city of Eckernförde. The left image displays a historical map from 1864 (source: PROKOM 2017). The right image shows the present situation; including hypsometric layers; note that the green and yellow areas are flood prone (source: KIS-SH).

Eckernförde is a coastal city with about 21,700 inhabitants (Figure 1). It is situated in the inner part of Eckernförde Bight that faces towards the northeast, i.e., that is directly exposed to northeasterly storms and waves. Major parts of the inner city are flood prone coastal lowland (Figure 6). Here, about 1,250 people live and 130 million Euros of capital assets exist (Fachplan Küstenschutz Ostseeküste 2020). In contrast to Dahme, there are no technical flood defenses in Eckernförde. An elevated promenade on former beach ridges, partly protected by revetments, and an elevated harbor area protect the low-lying inner city from flooding. Responsible city authorities are planning a comprehensive flood defense scheme (PROKOM 2017).

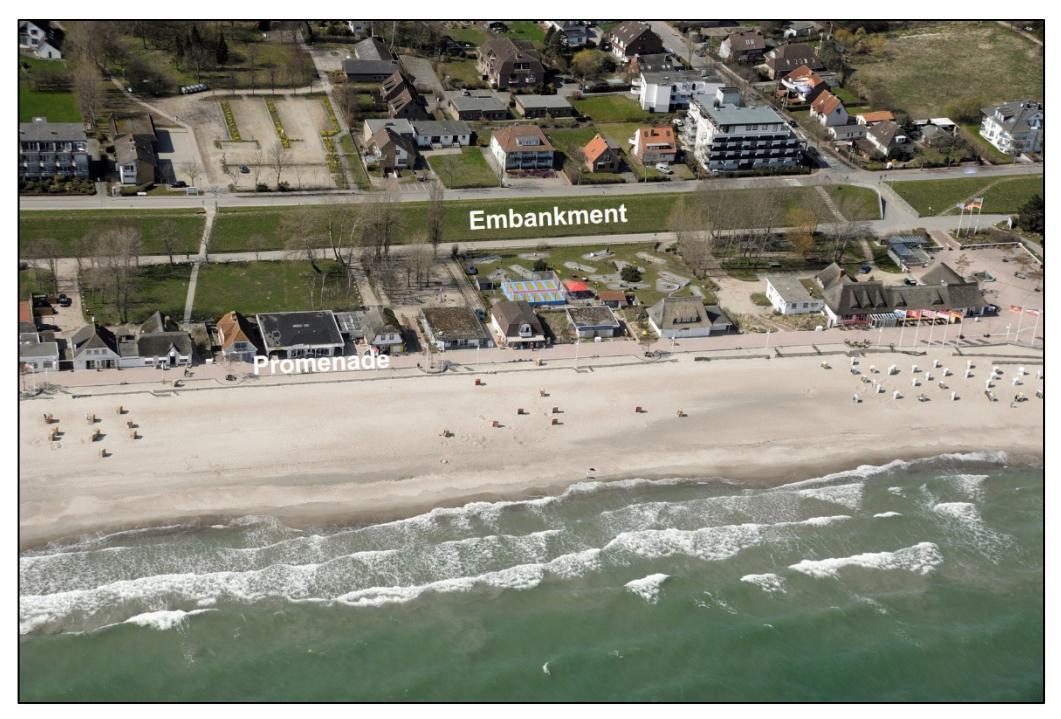
Figure 10: Aerial photo of Dahme seaside (Photo: LKN.SH / VPS).

One of the first measures after 1872 was the erection of a 5.5 km long new embankment in front of Oldenburger Graben near Dahme (Kannenberg 1958). The new crest height was about 4.2 m above mean sea level. Outside of Dahme, the new embankment ran behind the dunes and beach ridges, as stipulated in the Prussian decree. In front of Dahme, due to limited space, the new embankment lay again in an exposed situation directly behind the beach and featured relatively steep paved slopes. The expectation was that a paved outer dike slope should be able to withstand the higher hydraulic loads. The embankment and its foreland came into the possession of the newly founded local Dike and Water Board. It was governmental intention that the foreland should remain free from utilizations (Runde 1883). However, the upcoming of seaside tourism thwarted this specification. In 1920, local community erected a swimming pool in front of the embankment (Reher 1931). A concrete walking trail (promenade) on the foreland of the embankment followed, protected by a low flood defense wall situated directly on the beach. Based upon a public beach building plan from 1921, the area behind the wall but in front of the sea embankment increasingly filled up with touristic infrastructures (Kannenberg 1958). Today, dense touristic utilizations prevail in front of the embankment (Figure 10).

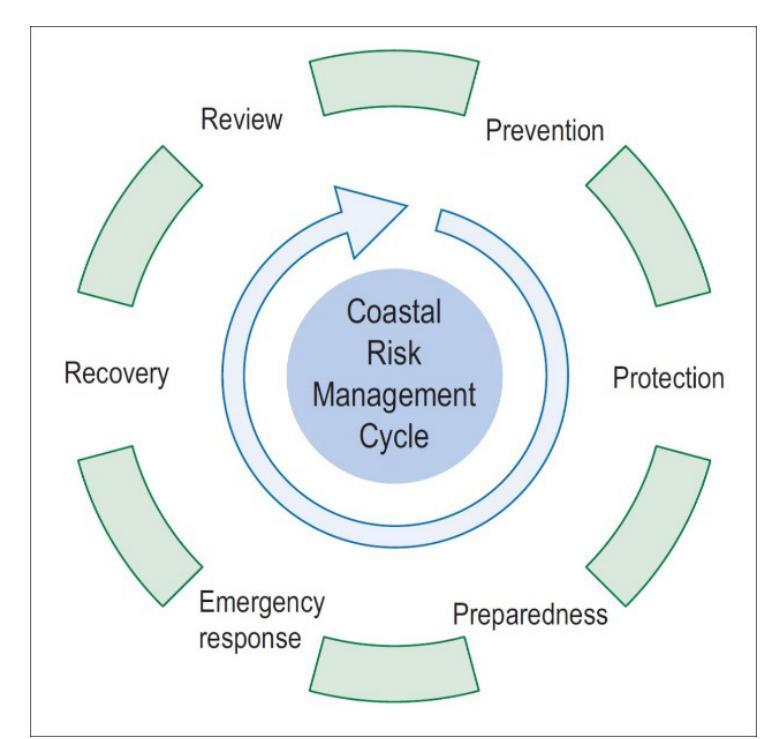
In order to minimize the risks of coastal flooding, building flood defenses is only one brick in the wall. Hofstede (2007, 2011b) describes a holistic and integrated approach that combines technical and non-technical measures in a coastal flood risk management cycle (Figure 11).

Starting point in the cycle is prevention that aims at avoided or minimized flood risks, e.g., by stipulating building ban zones in flood hazard areas. The objective of protection is a minimized probability of a harmful flood event to occur, e.g., by building sea embankments. Preparedness has much to do with flood risk awareness of the affected population and the responsible decision makers (i.e., politicians). An important instrument to achieve this is appropriate risk communication. Informed people are more willing to take resp. order preparatory actions (including evacuation). Further, they accept the high costs and other possible constraints associated with coastal flood risk management (Hallin et al.

As described above, the flood protection status differs greatly between Dahme and Eckernförde. Hence, also the elements of the risk management cycle (Figure 11) each need a different emphasis.
