Hydro-sedimentology and mitigation measures of the stream diversion of “Arroyo Corrales”, Uruguay

ABSTRACT: A mining company operates the “Arenal” gold mine nearby the Corrales Stream in Uruguay. In order to extend the mine operation, a diversion of the Corrales Stream ($Q_{100}=1700 \text{ m}^3/\text{s}$) was projected in 2005. This project included the construction of protection levees and the implementation of re-naturalization measures. These last measures involved the re-vegetation of the dikes and banks of the channel. The excavation of the new stream trace was done in rock, the length of the diversion is 1250 m including several curved reaches, and the channel cross-section is trapezoidal with a bottom width of 40 m. The hydro-sedimentological viability of the project was studied in advance in order to determine the protection actions required to ensure the stability of the stream. The stream diversion was built in August 2007, and today the diversion remains operational and the mining area has been expanded as planned. In this paper we present the methodology and the results of the hydro-sedimentological study of the diversion works. The hydraulic and sedimentological beha

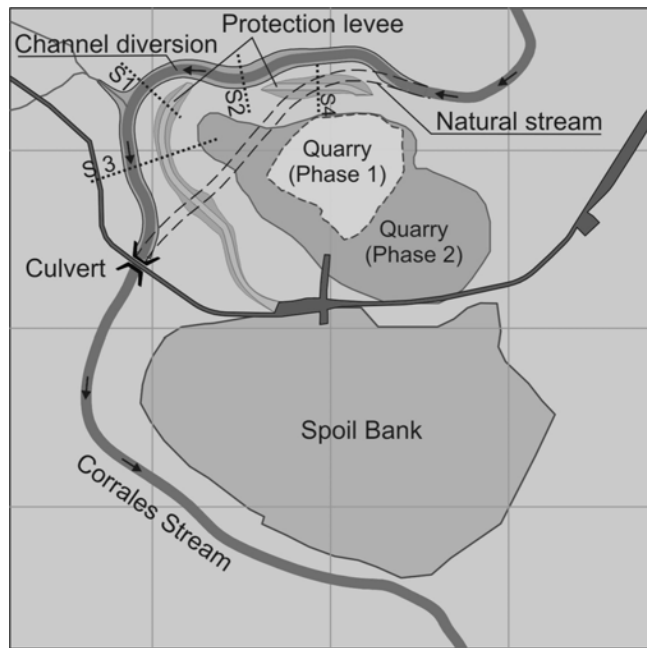
A mining company began to operate of the gold mine “Arenal” in 2003. The mine is located in the north of Uruguay, in the left side of the Corrales Stream. The first stage of this operation concluded in August 2007, when a new geological survey detected a lode that then determined the enlargement of the mine’s area. In order to extend the quarry the diversion of 900 m of the Corrales Stream and the construction of two protection levees was planned (Figure 1).

Figure 1. Sketch of the diversion.

Type 1. Corresponds to the reaches of the outlet of the Corrales Stream into the channel and to the outlet of the channel into the Corrales Stream (Figure 2, S1 in Figure 1).

Type 2. Corresponds to the central reach of the channel, where it crosses the hillside and it is excavated in sound rock (figure 3, S2 in Figure 1).

Type 3. Corresponds to the lower reach of the channel, where the excavation is made in fine soils, loose rock, and partly, in sound rock (figure 4, S3 in Figure 1).

a crest that is wide enough to permit the transit of road trucks (Figure 5, S4 in Figure 1).

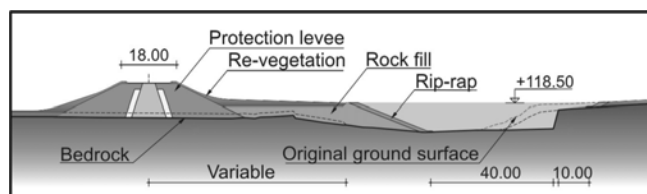
Figure 2. Diversion channel. Cross section. Type 1 (S1 in Figure 1).

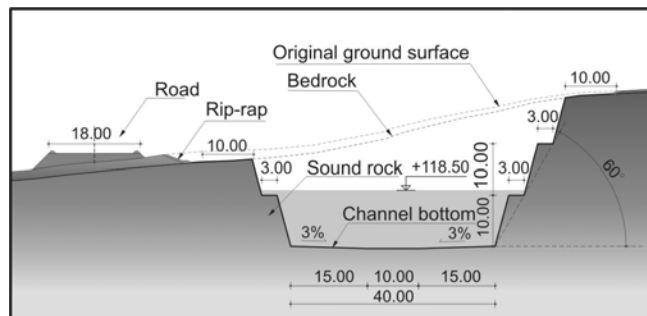
Figure 3. Diversion channel. Cross section. Type 2 (S2 in Figure 1).

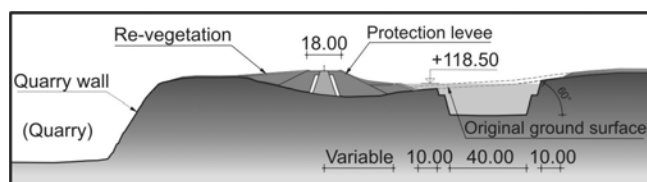
Figure 4. Diversion channel. Cross section. Type 3 (S3 in Figure 1).

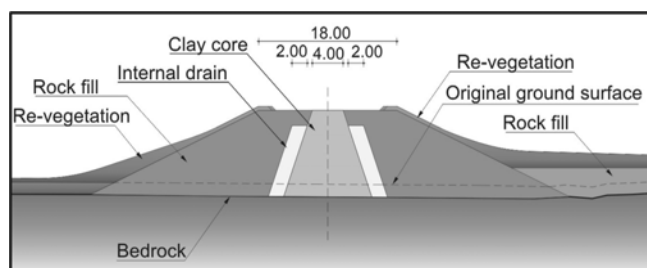
The protection embankment levees have a central rolled clay core, shoulders composed of loose rock and filters composed of sandy material. The embankment is founded in the sound rock, and has

Figure 5. Diversion levees. Cross section (S4 in Figure 1).

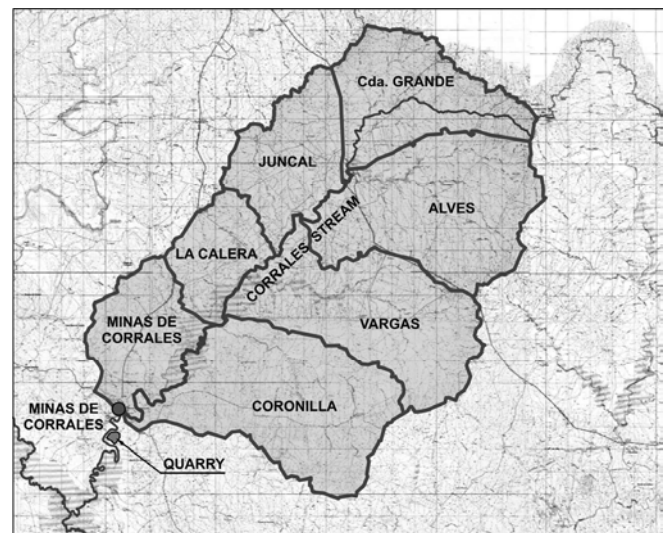
The Corrales basin situated upstream from the bridge of Route 28 was modelled in order to determine the extreme flood hydrographs. This basin covers an area of 1013 km², with the bridge of Route 28 located 5 km upstream of the diversion channel (IMFIA 2006). The implemented model was of the semi-distributed type and the total basin area was divided in seven sub-basins (Figure 6, Table 1). The hydrologic study was implemented using the HEC-HMS model (US Army Corps of Engineers).

Figure 6. Sub-basin of Corrales Stream

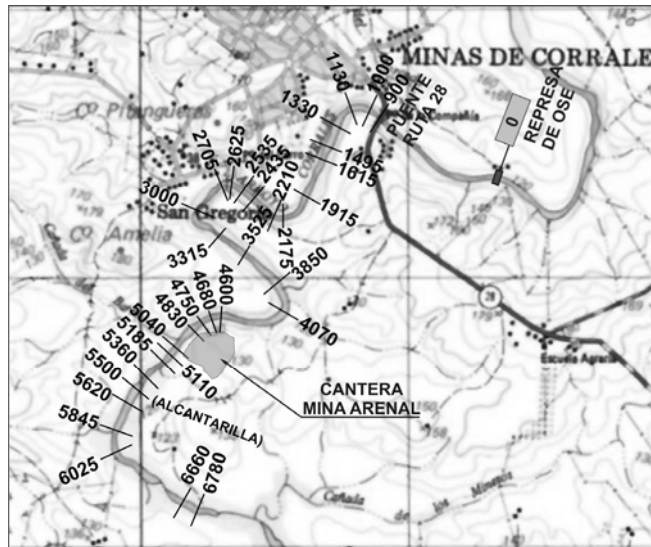
Figure 7. Surveyed sections of the Corrales Stream

The model was implemented using the MIKE 11–DHI software. A campaign of topographic and bathymetric survey was carried out in order to obtain information to feed into the model. The surveyed sections are shown in the Figure 7.

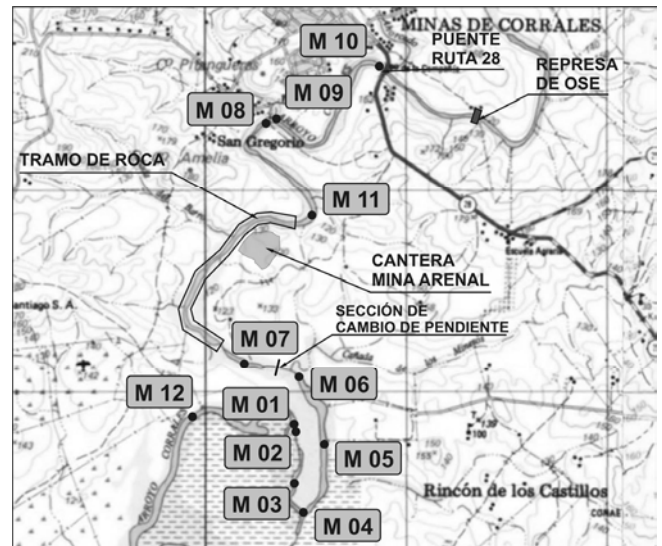
Figure 8. Location of sediment samples.

In order to identify possible modifications of the sedimentological regime and changes in the morphology of the Corrales Stream, a hydro-sedimentological model was implemented using the ST module of MIKE 11. The particle size distribution of sediments in the streambed was established by extraction and analysis of fourteen samples (Figure 8 and Table 2). A regulation dam is located upstream of the modelled reach and null sediment input at this location was assumed as boundary condition.

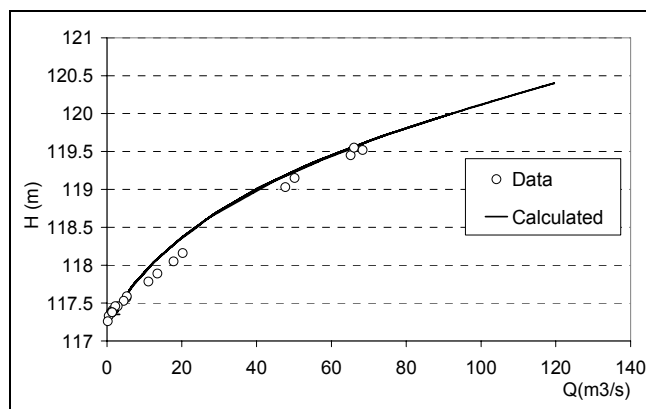
Figures 9 and 10 show the results of the hydrologic and hydrodynamic model calibration at Route 28. Figure 9 shows both the measured and modeled stage-discharge relations. Figure 10 shows the observed and computed flow hydrographs for the September 1961 event. A very good agreement between the modeled and observed conditions of the system can be seen.

Figure 9. Model calibration. Routing curve in Road 28 bridge.

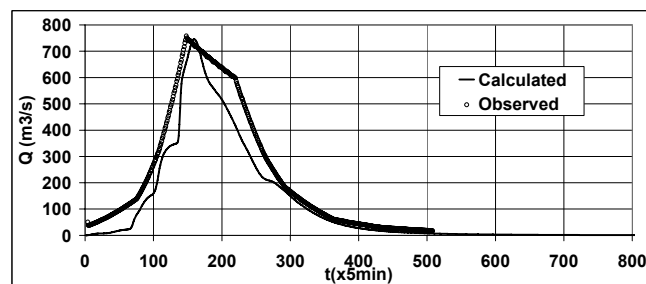
Figure 10. Model calibration. 1961 flood hydrograph in Road 28 bridge.

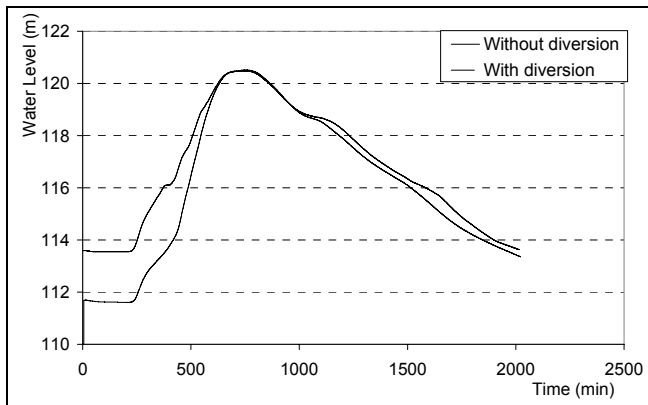
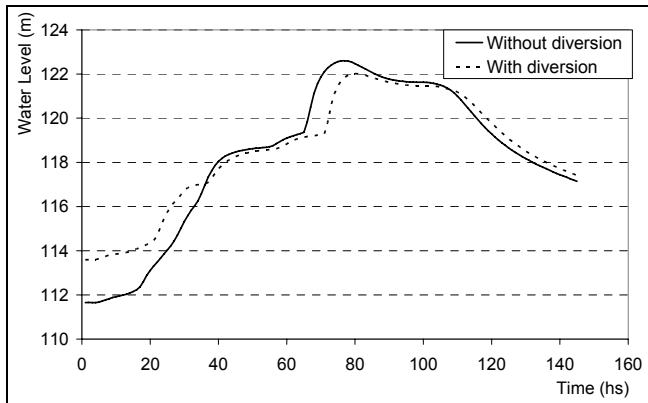
The impact of the diversion works on the water levels at different sections of the modeled reach was studied for the April 2002 and September 1961 events. As an example of these results, Figures 11 and 12 show stage hydrographs with and without the diversion works for the cross-section just upstream and downstream from the diversion.

From the results it is clear that the diversion works have had no negative effect of on the Route 28 Bridge for the two analyzed events. For discharges close to the largest ever register (April 2002 flood: 1376 m³/s) the increase on the levels at the Route 28 Bridge was less than 10 cm. Similarly, at sections close to the diversion there was no difference on the modeled water levels for large stages (large discharges). Some difference was observed for the lower stages, but the potential problems associated are no particularly significant for this case.

Figure 11. Stage hydrograph with and without the diversion works, just upstream from the diversion

Figure 12.- Stage hydrograph with and without the diversion works, just downstream from the diversion

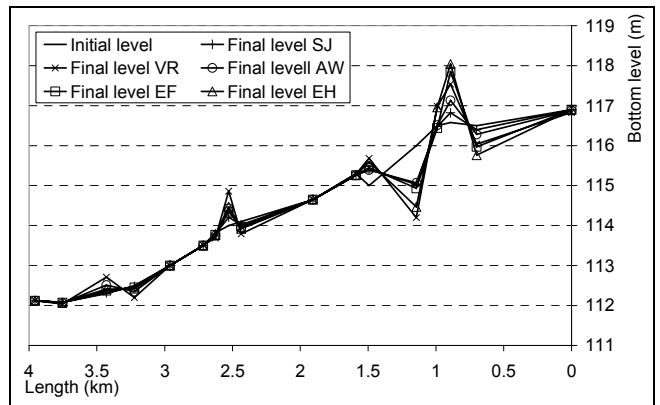
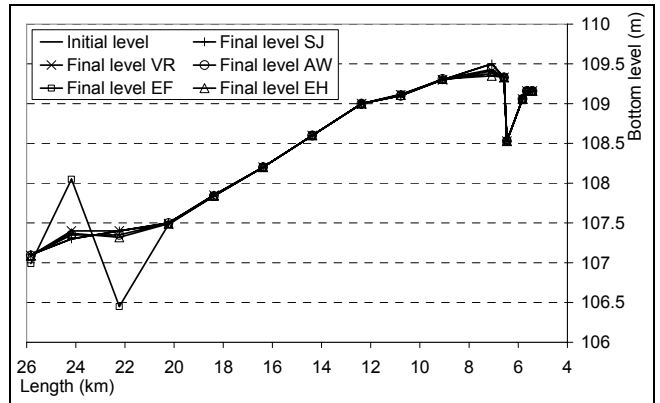
Figures 13 and 14 show the longitudinal bed profiles obtained from the application of five different equations for the sediment transport for the April 2002 event. The five considered equations were: Van Rijn (VR); Engelund-Fredsoe (EF); Engelund-Hansen (EH); Acker-White (AW) y Smart-Jaeggi (SJ). The original profile is also shown as reference.

Figure 13. Bottom channel level resulted from the different sediment transport formulation upstream of the diversion

Figure 14. Bottom channel level resulted from the different sediment transport formulation downstream of the diversion

As it can be clearly seen, the effect of using the different sediment formulations is relatively small, both on the final bed elevation as well as on the total amount of transported sediment. This shows that any of the considered formulations could represent the overall sedimentological behavior of the studied reach.

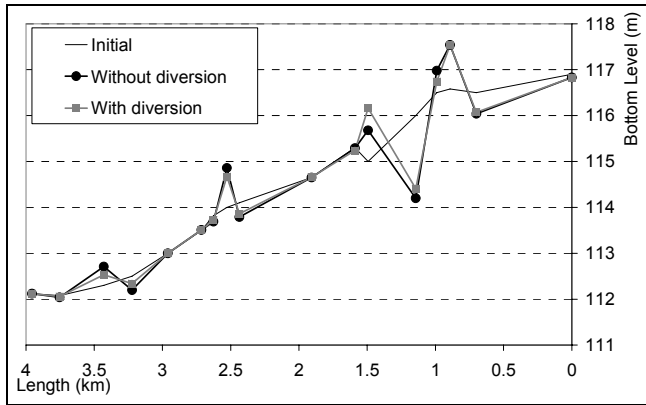
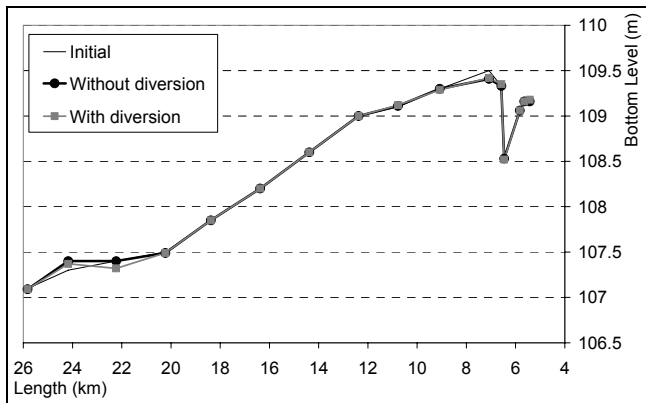
The Engelund-Hansen formulation was used to compare the original and diverted stream configurations. Figures 15 and 16 show the initial and final bed elevation for reaches up-stream and downstream from the diversion. The differences in both cases are very small: The bed remains essentially unchanged downstream of the diversion. And Up-stream of the diversion larger changes on the bed elevation are predicted for both scenarios.

The largest difference between the final bed elevation with and without the diversion is about 20 cm, which is within the error of this type of simulations. In the rock outcrop areas, where no erosion is possible, the model also shows that no deposition should be expected do to the steep slopes. Therefore no significant changes in the sdeimentological behavior of the Corrales Stream should be expected as a consequence of to the construction of the diversion channel.

Figure 15. Bottom channel level resulted from the model with and without diversion works (upstream of the diversion)

Figure 16. Bottom channel level resulted from the model with and without diversion works (downstream of the diversion)

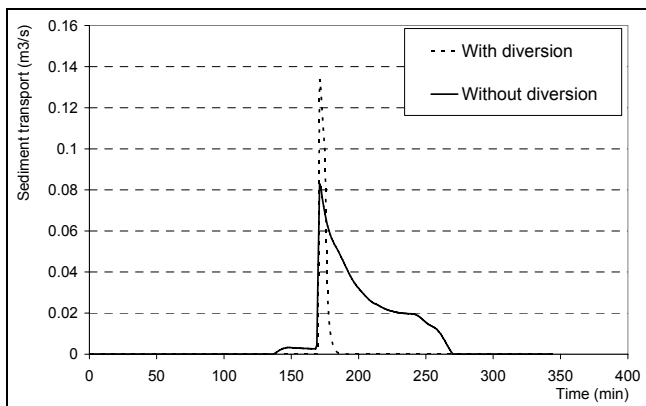
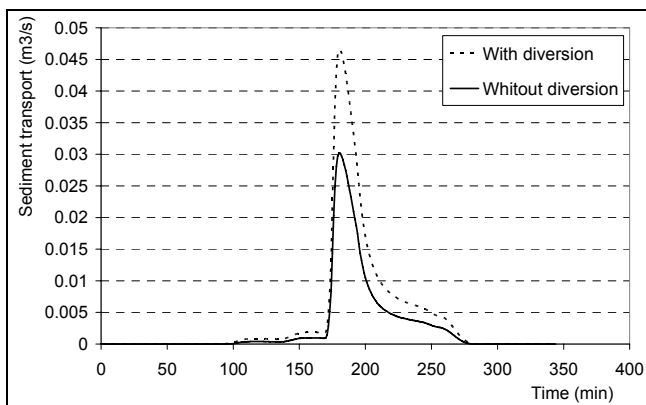
Figure 17. Sediment transport resulted from the model with and without diversion works in a section just upstream of the diversion

Figure 18. Sediment transport resulted from the model with and without diversion works in a section just downstream of the diversion

Regarding the transport of sediment, the results are shown in Figures 17 and 18 for the upstream and downstream sections. Again no significant effects of the diversion is observed.

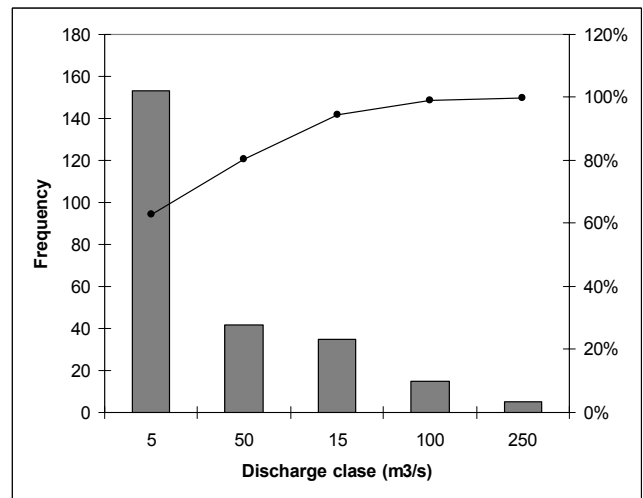
Figure 19 shows a frequency analysis of the flows registered at Corrales Stream after the construction of the diversion channel.

Figure 19. Histogram of the flow discharge for the operation time period

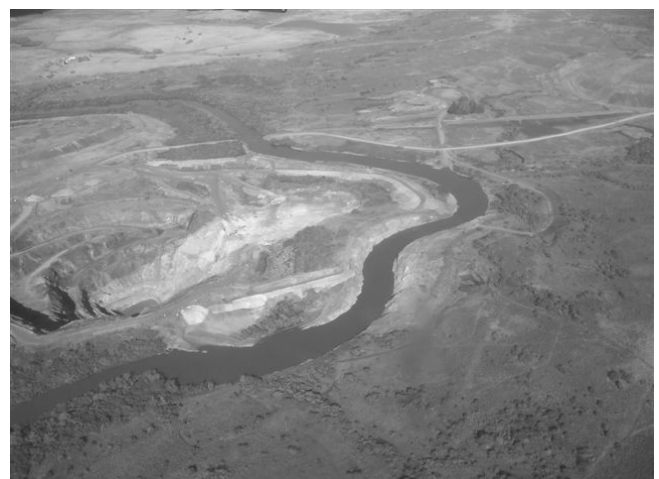
During October 2007 (Figure 20) and November 2009, two extraordinary floods occurred and no negative effects were detected. During these events peak discharges of 800 m³/s (Tr = 3 years) and 1400 m³/s (Tr = 30 years), respectively, were registered.

Figure 20. Aerial view during the flood of October 2007.

As it can be seen from the aerial photos (Figure 20) the natural look of the stream is essentially preserved. And since the construction, the system has been working normally without hydraulic affectations neither upstream nor downstream of the diversion.

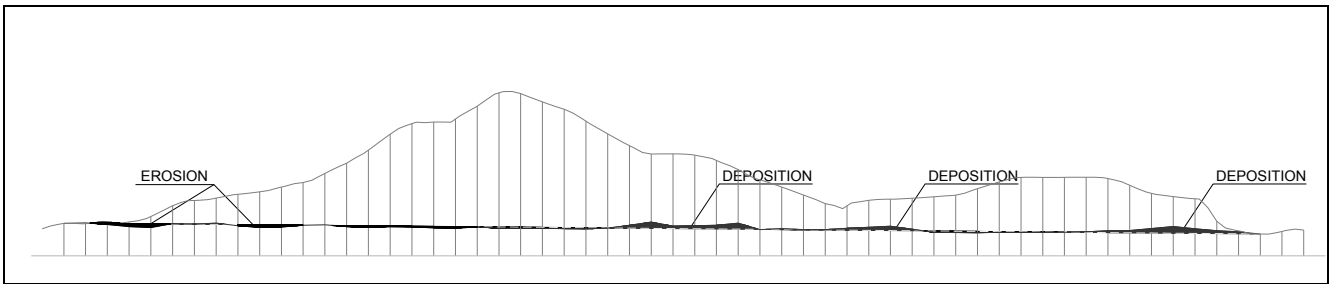
Figure 21. Sedimentation and deposition zone after the flood event in the longitudinal profile of the diversion channel

The sedimentological behavior of the stream was evaluated from topographic surveys of the diversion channel cross-sections and the its longitudinal profile. A longitudinal profile of the channel at the beginning of the diversion operation (August 2007) and after the last mayor flood event (December 2009) are shown in Figure 21. No significant changes on the bed elevation profile are observed. Erosion is observed in the first 60 meters of the channel, but it is very mild, just 20 cm. Figure 22 shows this area in detail, it can be seen that the erosion took place on the banks of the channel, while the talweg remained unchanged.

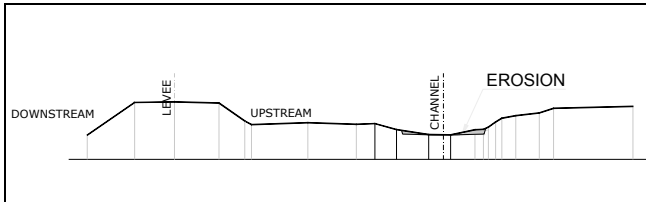
Figure 22. First cross section of the diversion channel with the erosion produced for the flood event

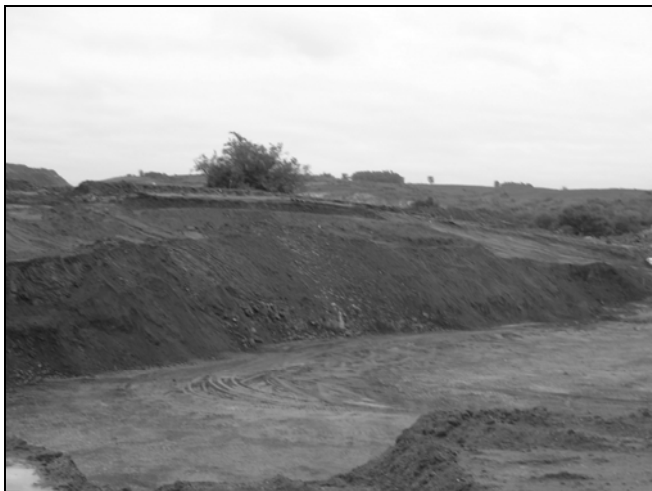
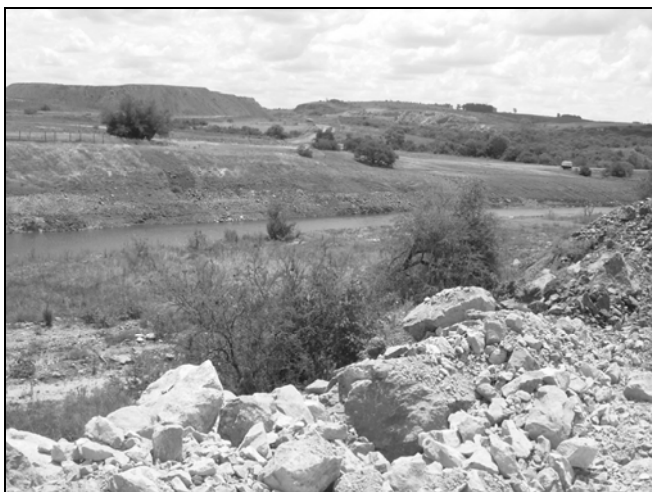
Figure 23. Upstream zone of the channel after construction

Figure 24. Upstream zone of the channel after re-vegetation

The implemented measures have been successful to rehabilitate the connectivity of the stream corridor. Figures 23 and 24 show the upstream zone of the diversion channel in two moments: immediately after the completion of construction and once the re-vegetation measures were implemented.

The success of the rehabilitation measures was the result of the fast grow of the vegetation cover in the first two years. Using these as a starting point, native tree species have also been planted more recently.
