# COASTAL EROSION IN THE TROPICAL RAPID ACCRETION DELTA – A CASE STUDY OF THE RED RIVER DELTA, VIETNAM

Do Minh DUC<sup>1</sup>, Kazuya YASUHARA<sup>2</sup>, Satoshi MURAKAMI<sup>2</sup> and Hideo KOMINE<sup>2</sup>

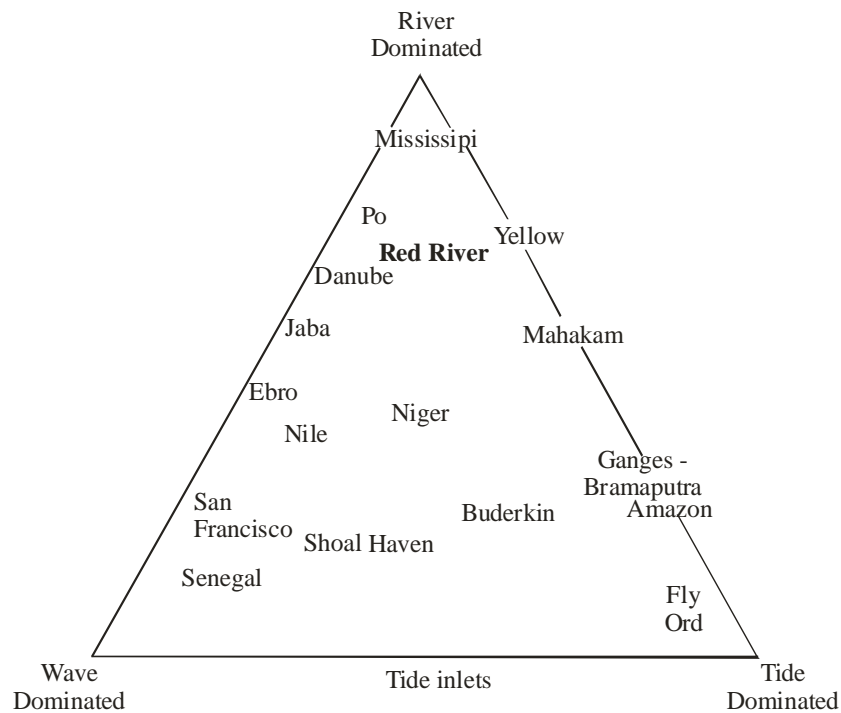
Fig. 2 The Red River in the chart of delta classification of Coleman & Wright (1975).

The Red River delta coast belongs to the river dominated coast (**Fig. 2**). The annual amount of sediment transported by the Red River system into the South China Sea is about  $82 \times 10^6 \text{ m}^3$ . In the wet season (from June to January), about 90% of the annual sediment supply is transported through the various distributaries (Nhuan et al., 1996). Of the total amount of sediment supplied, 11.7% passes through the Van Uc and Thai Binh river mouths, 11.8% through the Tra Ly river mouth, 37.8% through the Red River (Ba Lat) mouth and 23.7%

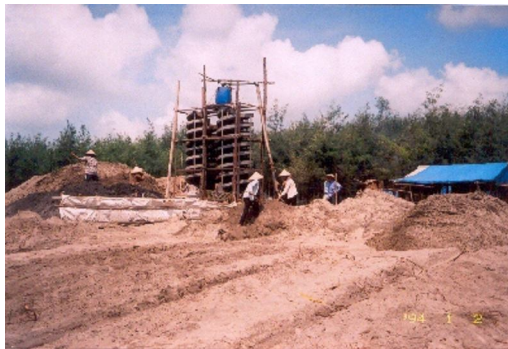
**Fig. 4** Hai Thinh, 02 September 2003.

Nowadays, the shoreline from Hai Loc to Hai Dong has been changed to accretion; however the erosion can continue to increase in other segments. The most severe erosional segment is now shifting to Hai Thinh commune. It is very clear by a series of 3 photos taken at the same place in the coast of Hai Thinh commune from 2003 to 2005. **Figures 4 and 5** show that during 10 months (from 02 September 2003 to 25 July 2004) a small tent for mineral exploitation was almost disappeared. The shoreline retreated about 30 m. Nine month later all the pine trees were also destroyed. The shoreline reached to the seadyke with a retreat of about 40-50 m (**Fig. 6**).

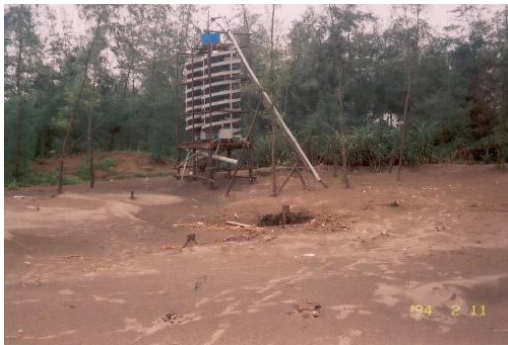
**Fig. 5** Hai Thinh, 25 July 2004.

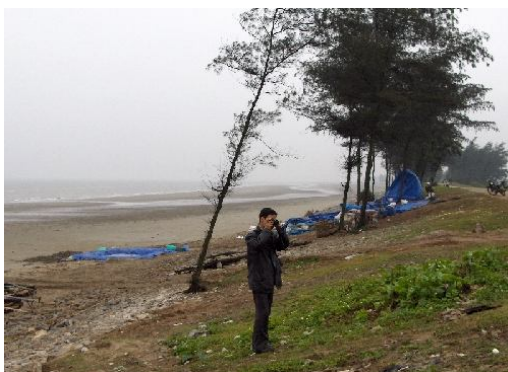
**Fig. 6** Hai Thinh, 17 April 2005.
